Wetland Biological Conditions EA Report

| Project Name | H-600 Pipeline Spread E | A/E | 124300134 | Spread | H-600 Pipeline Spread E | |
| Wetland ID | W-M20 | Crossing Start Date | 10/4/2023 | Crossing Completion Date | 10/18/2023 | |

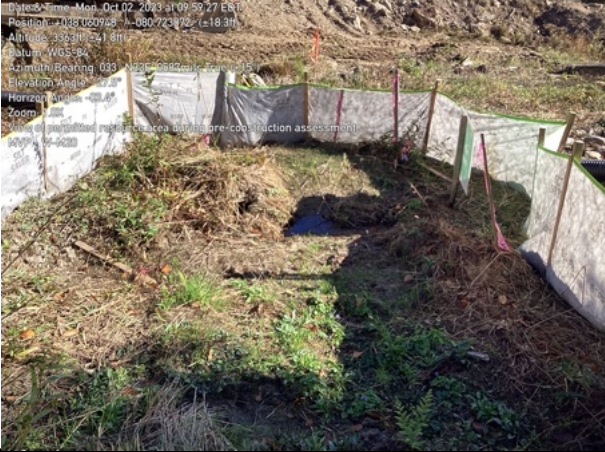
| Description | View of permitted resource impact area during pre-construction assessment. | Description | At edge of LOD, view of unimpacted resource area conditions during pre-construction assessment. | | |

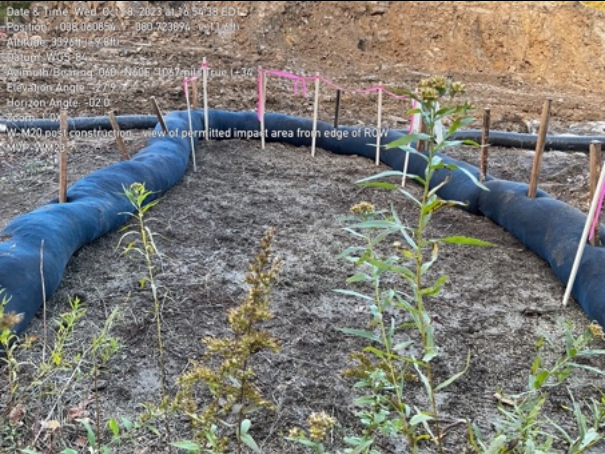
| Description | View of permitted resource impact area during post-construction assessment. | Description | At edge of LOD, view of unimpacted resource area conditions during post-construction assessment. | | |

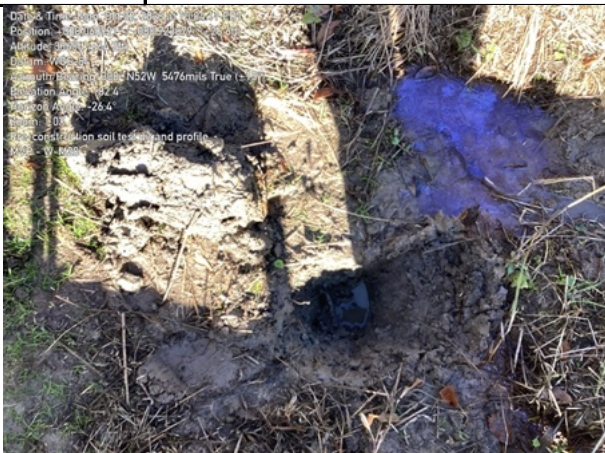
| <p>Pre-Construction Notes</p> <p>Pre-Construction Meeting - 9/18/2023</p> <p>17. Surface water, soil saturation and groundwater recharge observed in soil test pit (Photo 1).</p> <p>10/04/2023 - Contractor developed plans to minimize the impact to the permitted impact area of the wetland resource; however, due to its proximity to the centerline wetland topsoil was removed (Photo 2) Soil segregated and stored in upland area (Photo 3). Resource protected from on-going activities with the installation of P1 fencing (Photo 4).</p> <p>10/05/2023-10/17/2023 - Minimization measures were successfully implemented and other than topsoil removal, wetland resource was not disturbed (Photos 5 and 6). Trenching, hammering, bedding installation, pipe installation, welding, x-ray, sandblasting, coating, the construction of trench breakers, and the backfilling of the trench were all ongoing outside of aquatic resource during this timeframe.</p> <p>10/18/2023 - Wetland topsoil restoration (Photo 7). Survey of elevation and boundary was completed. Seed applied to resource (Photo 8). Silt sock installed around perimeter of the restored wetland resource.</p> <p>Post Construction Notes</p> <p>17. Water did not recharge in post construction test pit.</p> <p>18. Crossing and riparian areas have been recently restored. These areas will be monitored until 80% vegetative coverage has been achieved and areas that do not have 80% vegetative cover within 30 days will be reseeded.</p> <p>Trenching did not occur in resource so Condition Nos. 1, 4, 6, 9, and 10 do not apply.</p> | | | | | |

| Description | Photo 1: Wetland test pit. | Description | Photo 2: Wetland topsoil removal. | | |

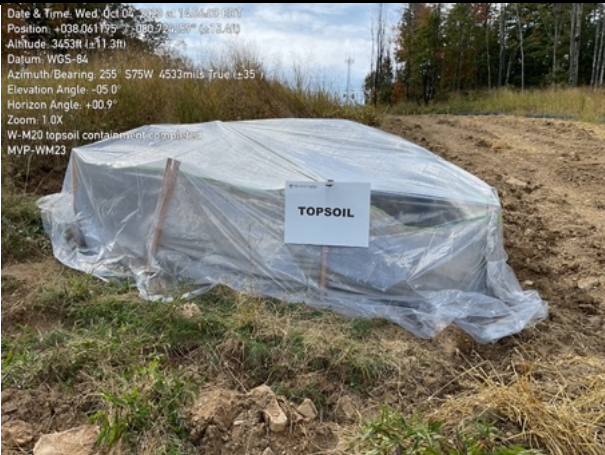
| Description | Photo 3: Wetland topsoil segregated in upland area. | | Description | Photo 4: Wetland topsoil removed; P1 fencing in place. | |

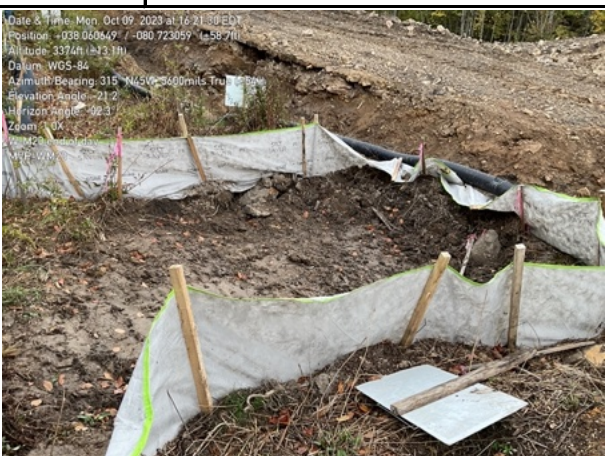
| Description | Photo 5: Wetland resource undisturbed 10/9/2023. | | Description | Photo 6: Wetland resource undisturbed 10/14/2023. | |

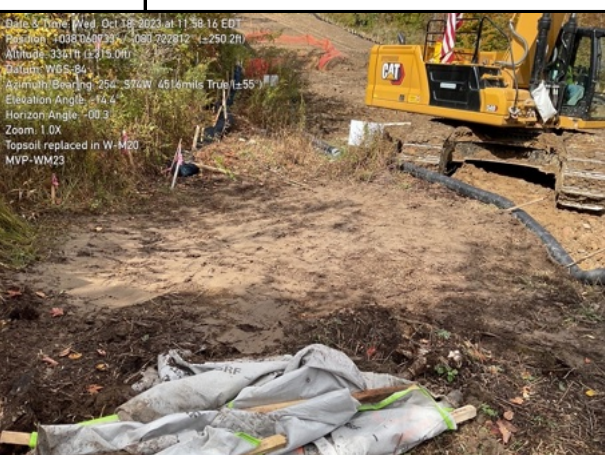
| Description | Photo 7: Wetland topsoil restoration. | | Description | Photo 8: Seed applied to wetland resource. | |
