STREAM BIOLOGICAL CONDITIONS ENVIRONMENTAL AUDITOR REPORT

Stream ID: S-E5	Crossing Start Date: 09/08/2025	Crossing Completion Date: 09/09/2025
Milepost: 298.4	Pre-Con Assessment Date: 09/05/2025	Post-Con Assessment Date: 09/09/2025
Station: 15756+46	Stream Classification: Perennial (Perennial, Intermittent, Ephemeral)	Bankfull Width (ft.): 10
County: Pittsylvania	303(d) Impairment Listing: N/A	Riffle:Pool Complexes Present? No

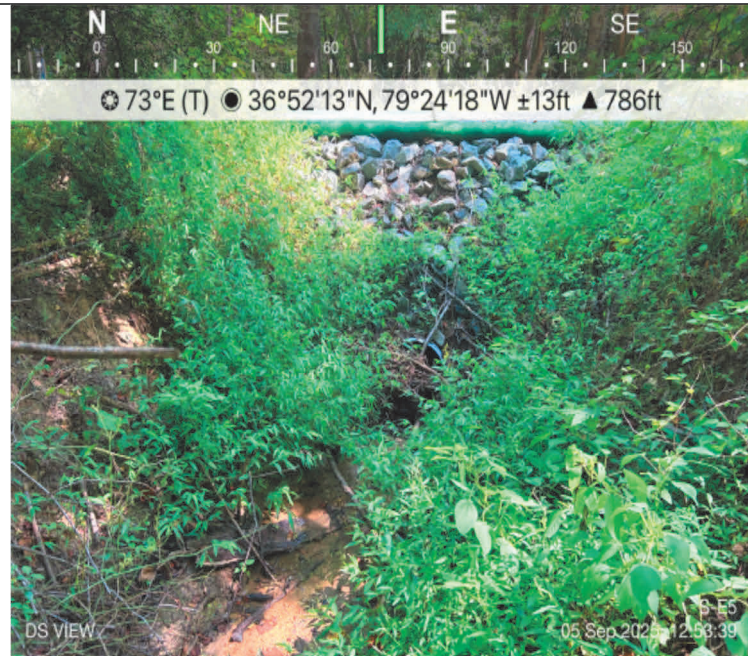
Photo Description: Downstream view of permitted impact area during pre-construction assessment.

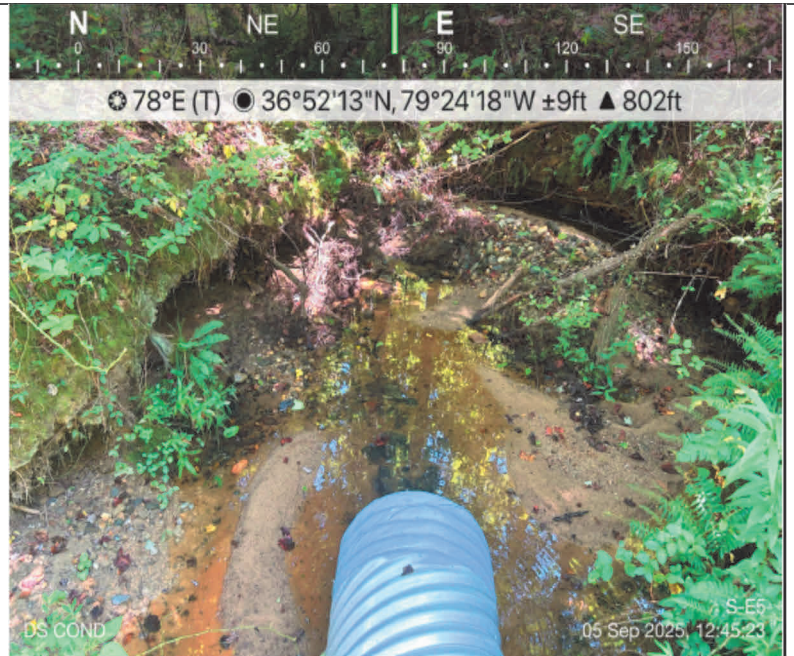
Photo Description: Conditions of the downstream area outside the ROW during pre-construction assessment.

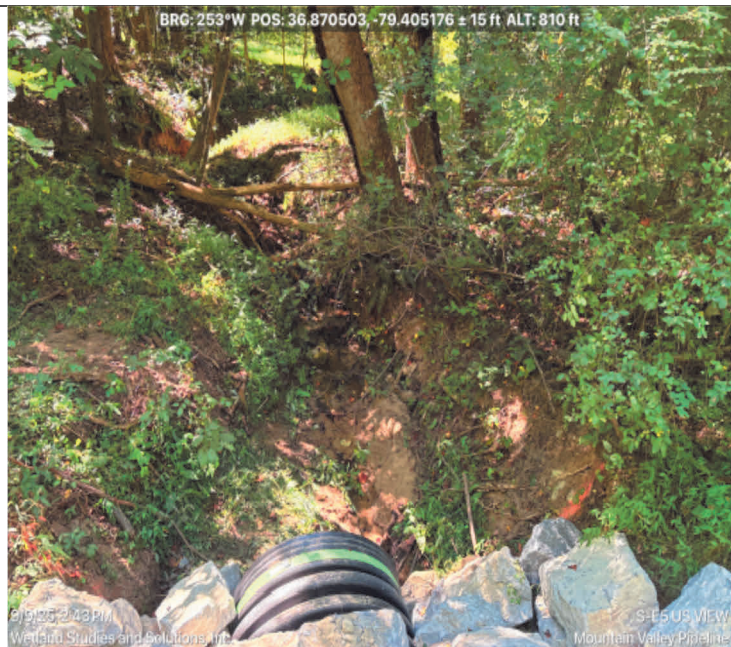
Photo Description: Upstream view from permitted impact area during post-construction assessment.

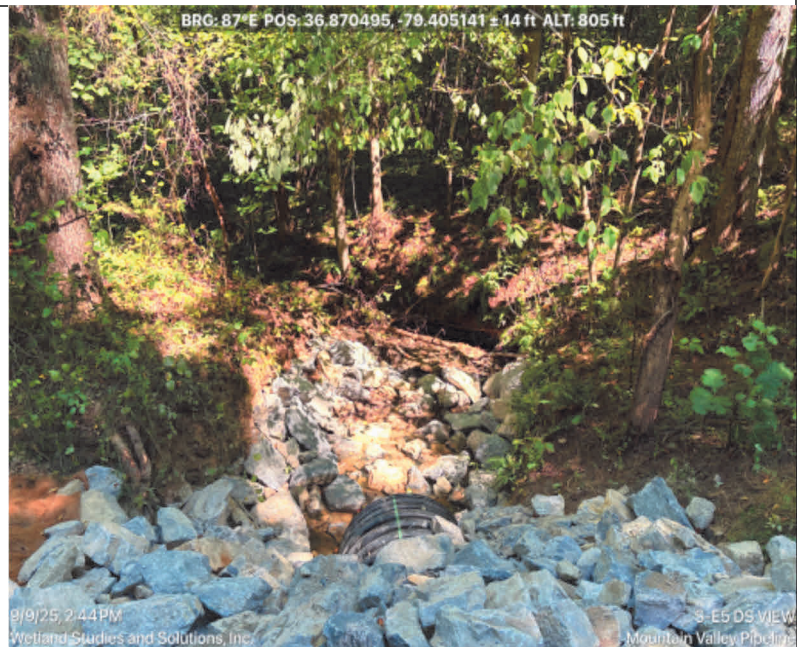
Photo Description: Conditions of the downstream area outside the ROW during post-construction assessment.

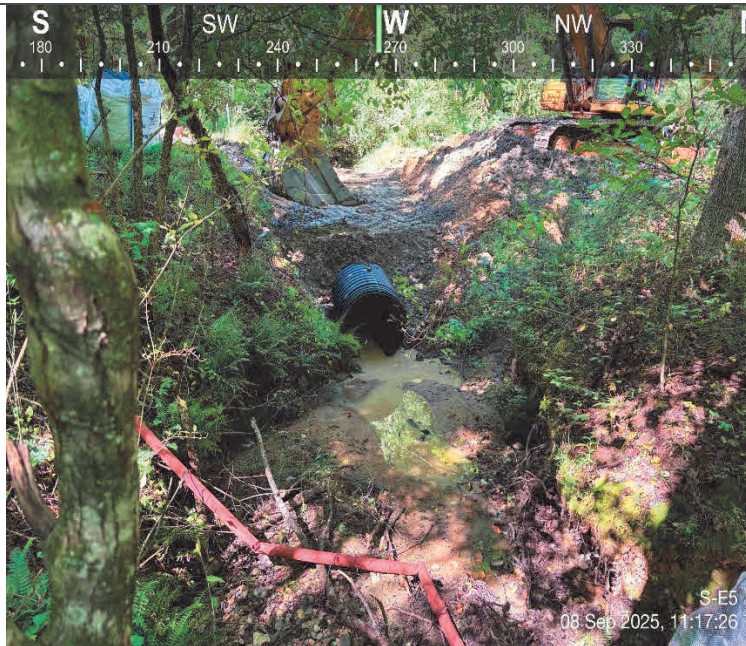
Photo Description: Culvert was replaced, countersunk, and backfilled properly. No impacts to biological conditions observed.

Item #8: Field modification to install new sized culvert to mitigate flow issues and countersink culvert ~6 inches into existing stream channel. Rip rap apron installed for channel protection and culvert outlet protection approximately 6 feet long and approximate width of bankfull channel.

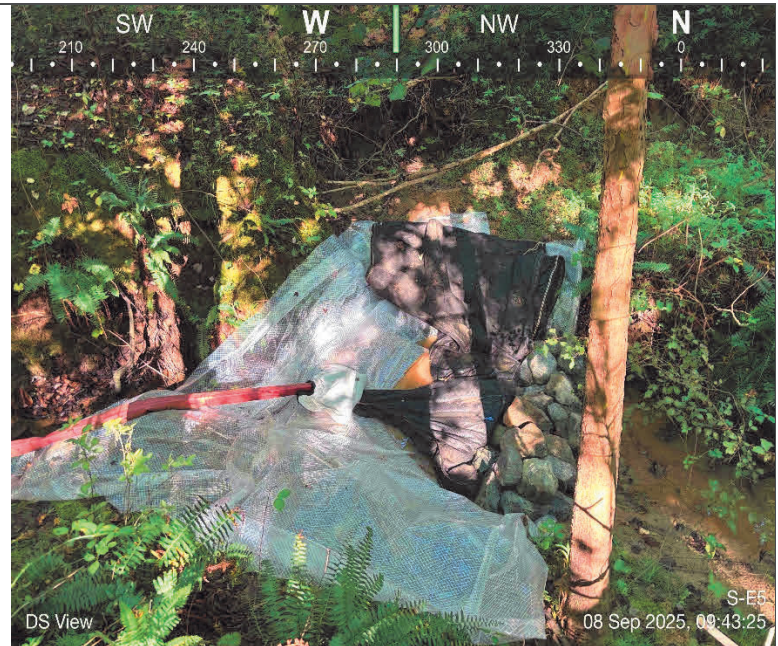
Photo Description: Discharge from pump around was filtered through a dewatering bag and filter stone.

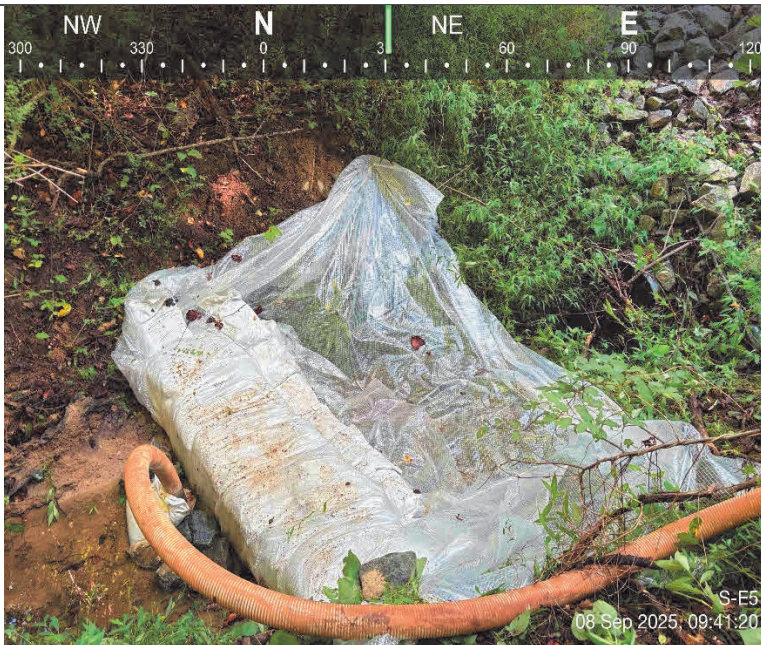
Photo Description: Dam and pump installed on the upstream end of the impact area during construction activities.

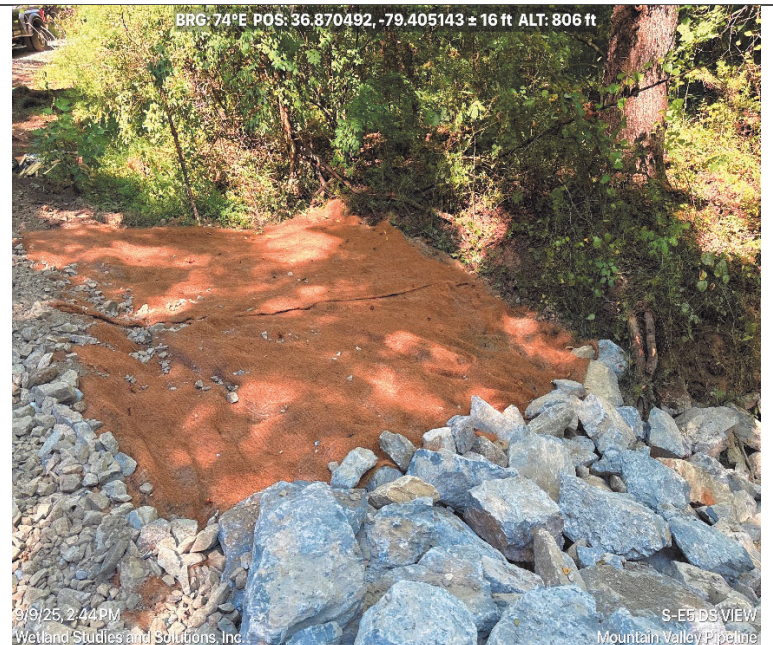
Photo Description: Disturbed areas were stabilized with ESC matting and rip rap.
