## Thermal Roof Inspection

Bob Smith  
3942 Emerald Way,  
St Johns, FL 32223

[Integral Drone Services LLC](#)  
Justin Scheiber  
904-906-5095

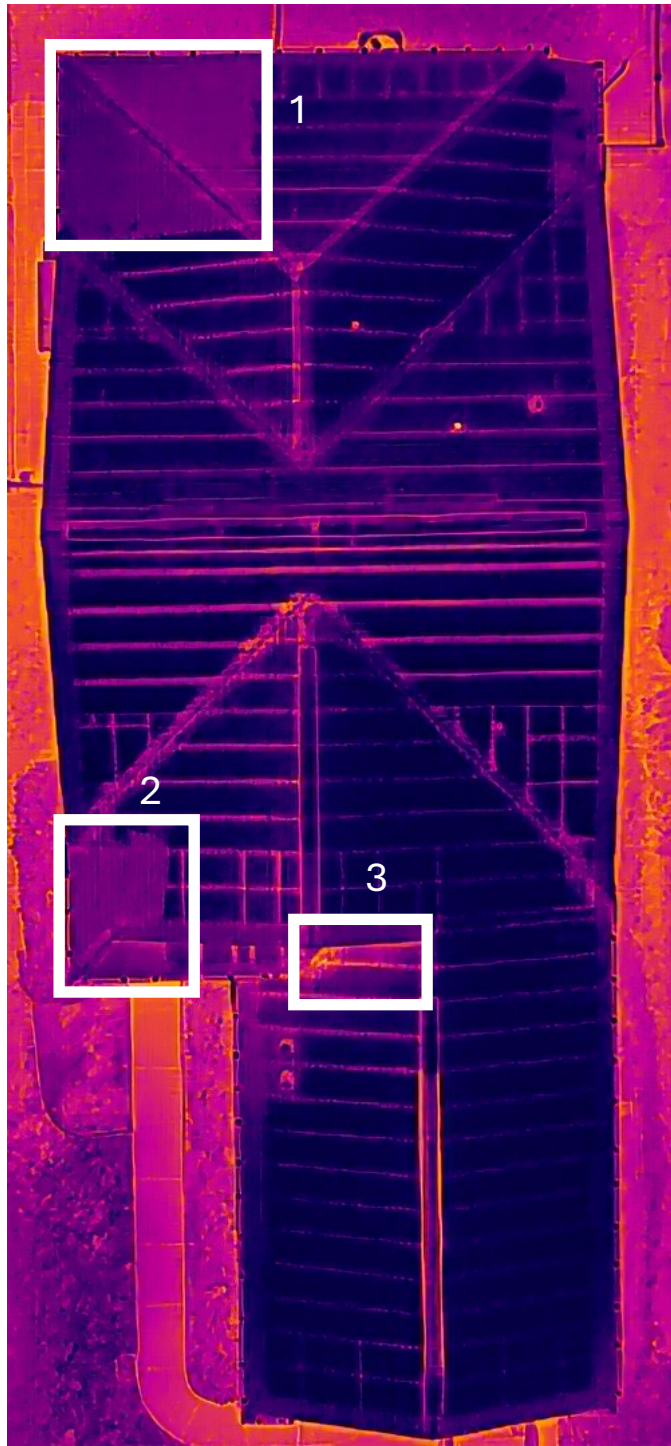
1. Back porch, confirmed not to have spray foam insulation.
2. Front porch, confirmed not to have spray foam insulation.
3. Potential thermal anomaly.

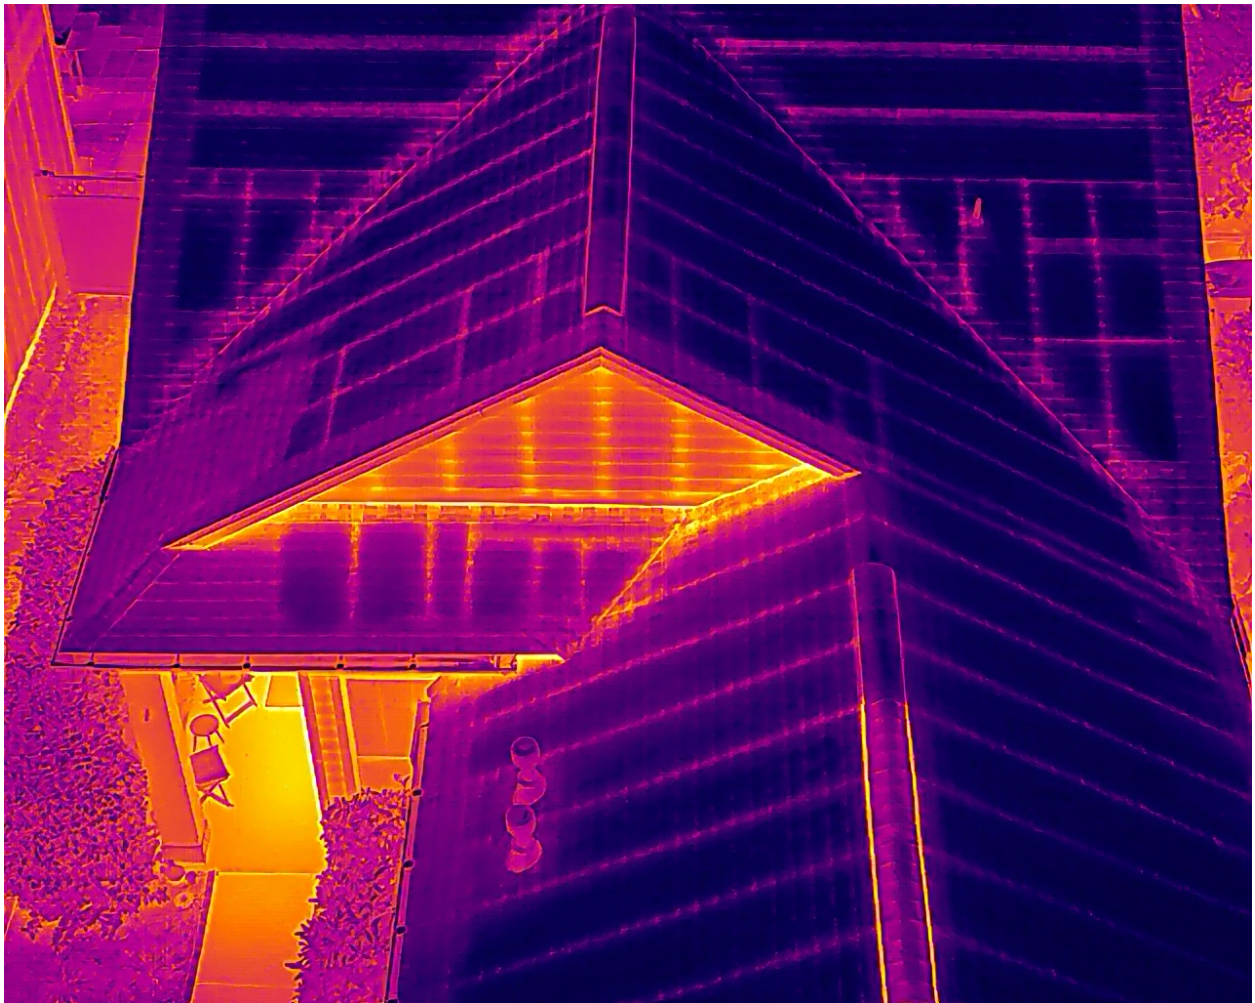
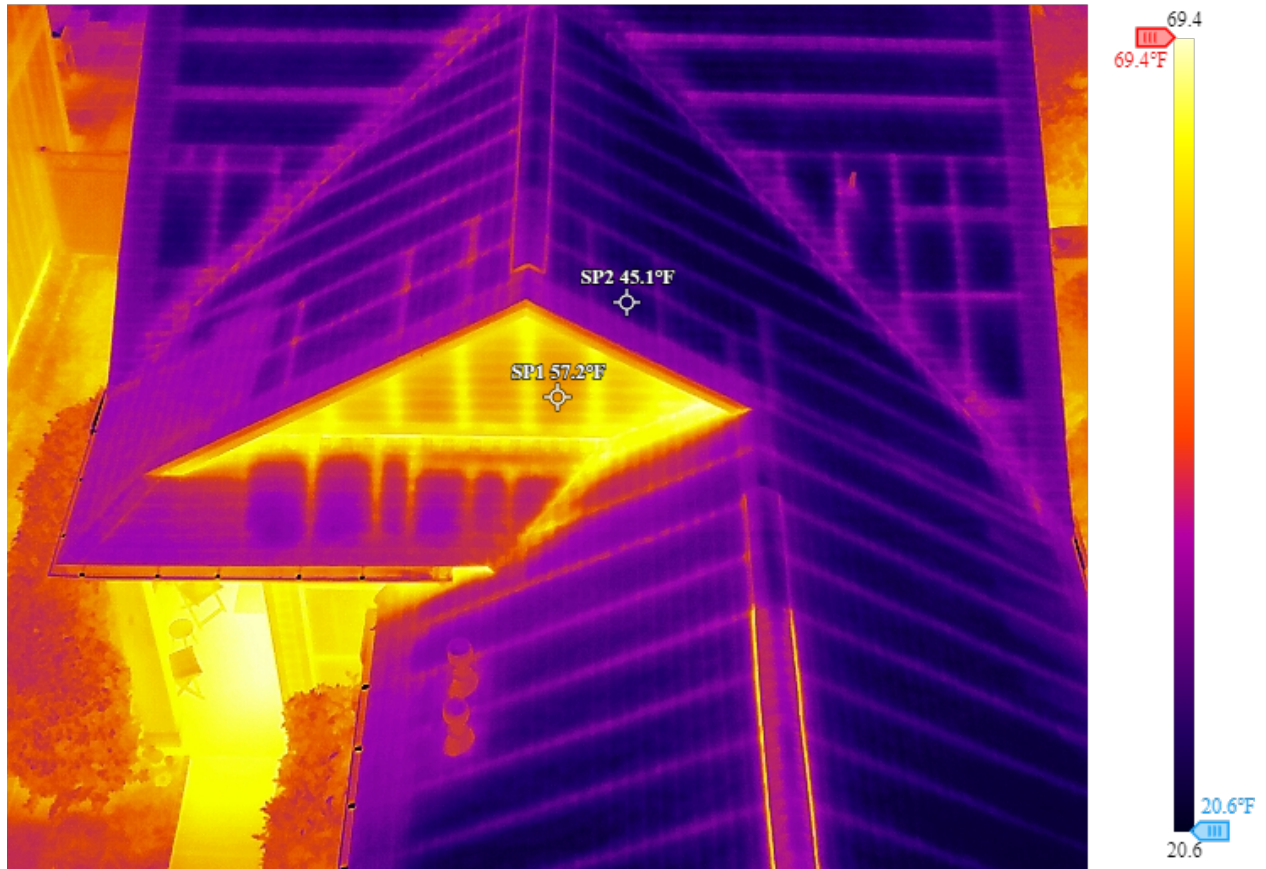
The images in this section are presumed to be a defect meaning a follow up is needed for verification. There are several conditions that may cause a part of the roof to appear warmer or colder which are not related to moisture intrusion.

The wall above the front entry and connected to the back of the garage emits approximately 7°F more than the roof. This could be due to shingles insulating the roof a little more, or it could insulation missing from the wall. Verification is required.
