# Your Inspection Report

test inspection  
niagara region, ON

# ROOFING

Report No. 1008, v.0

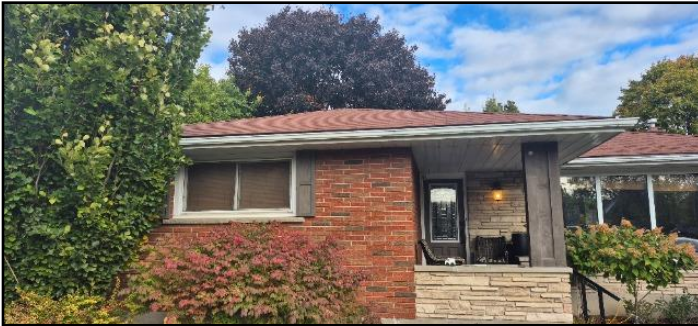
#### **1. Condition:** • [Cupping, curling, clawing](#)

**Implication(s):** Chance of water damage to structure, finishes and contents

**Location:** North Second Floor

1. Cupping, curling, clawing

Repairing an improperly patched shingle roof prevents leaks, mold, and structural damage. Neglecting repairs risks costly water intrusion, weakened insulation, and reduced property value. Timely maintenance safeguards safety, efficiency, and long-term investment in your home's integrity and durability.

**Task:** Repair

**Time:** Immediate

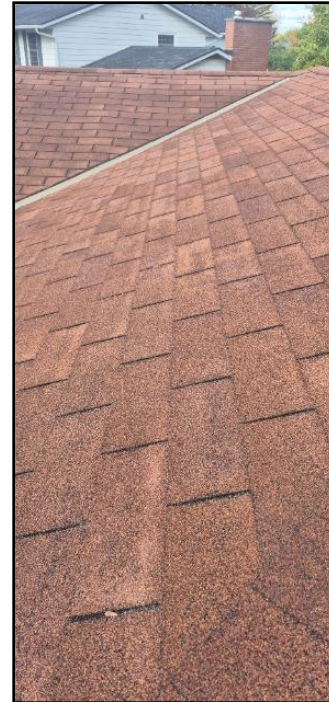
2. Cupping, curling, clawing

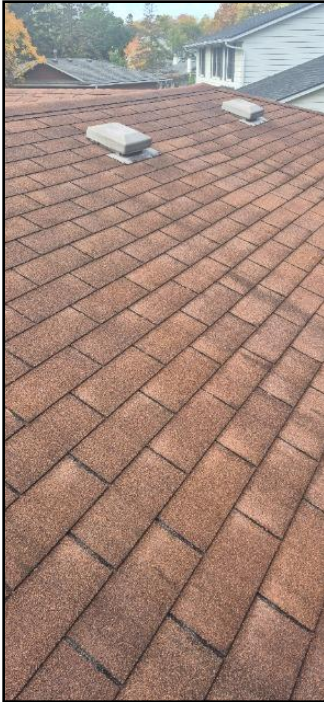
3. Cupping, curling, clawing

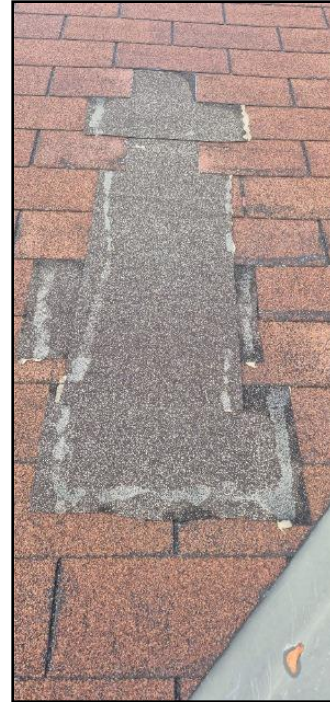
4. Cupping, curling, clawing
