## SITE INSPECTION REPORT

Phase 01 – Initial Condition Assessment – Basement Floor

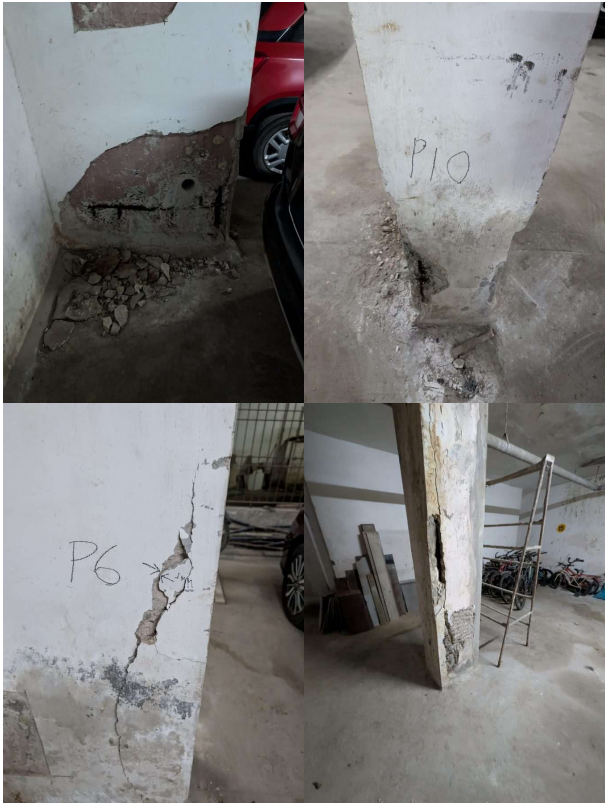
Sl. No.	Location	Observation
01	Basement Columns P6, P10, P12, P32, P36, P49 & Expansion Joint Column	<p>Significant concrete deterioration is observed across multiple columns in the basement. Concrete cover has been lost at several locations with reinforcement steel visibly exposed. Heavy corrosion is observed on the exposed reinforcement bars. Column P10 shows loss of concrete at the bottom. Standing water and active moisture are observed around the bases of several columns. The extent of corrosion and concrete loss requires a detailed NDT investigation to assess the residual strength.</p> <p><b>Site Photographs:</b></p>

<p><i>Left to right: Retaining wall area; Column P10 – concrete loss at bottom; Column P6 – vertical crack with moisture staining.</i></p>
02	<b>Basement Beams</b>	<p>Severe concrete spalling and cracking are observed on beams across the basement. Reinforcement steel is fully exposed at several locations with heavy corrosion evident. The concrete has deteriorated significantly, exposing the reinforcement cage in certain areas. This condition directly affects the load-carrying capacity of the affected members and must be treated as a high-priority item.</p> <p><b>Site Photographs:</b></p>

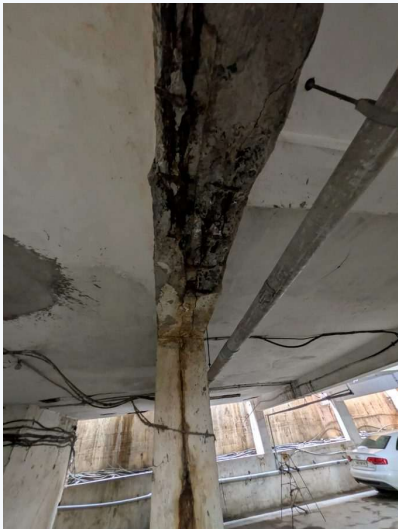
<p data-bbox="581 884 1117 905"><i>Beam concrete loss with reinforcement exposed and corroded.</i></p>
03	<b>Basement Ramp Ceiling &amp; Beam</b>	<p data-bbox="581 936 1409 1052">Concrete scaling and cracking are observed on the ceiling and beam of the basement ramp area. Reinforcement steel is visibly exposed at the beam. The damage is caused by moisture from the ramp slab above. The beam requires immediate repair.</p> <p data-bbox="581 1073 748 1094"><b>Site Photographs:</b></p>

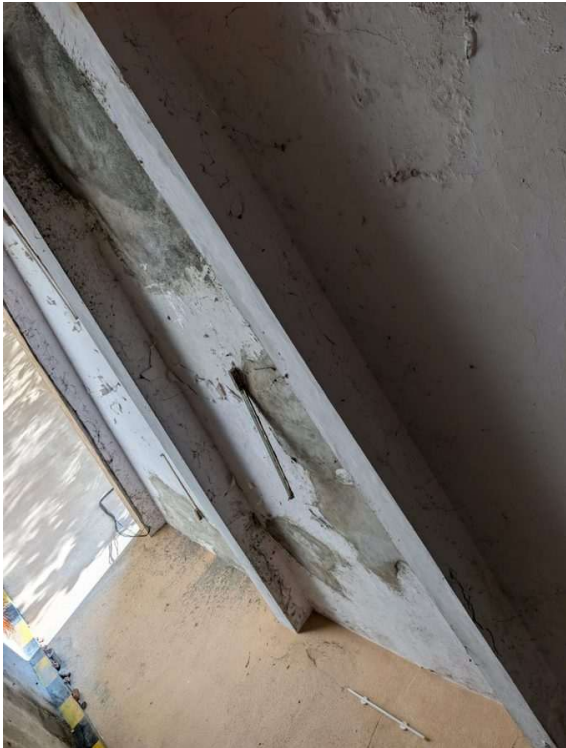
<p data-bbox="581 1850 1263 1871"><i>Ramp ceiling – concrete scaling and beam deterioration with moisture damage.</i></p>

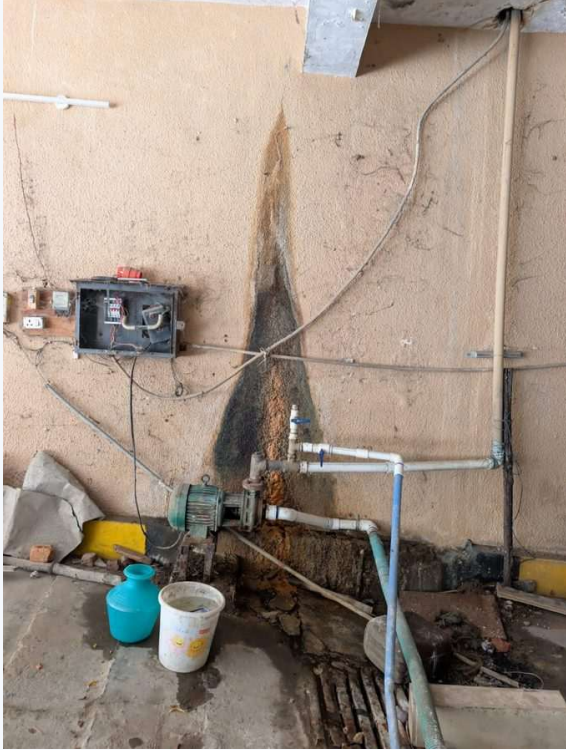
Sl. No.	Location	Observation
04	<b>Basement Ramp Side Wall</b>	<p>Active water leakage with dripping is observed on the side wall of the basement ramp. The source of leakage is moisture from the ground and soil on the external side of the retaining wall. Water is penetrating actively through the wall and accumulating on the basement floor.</p> <p><b>Site Photographs:</b></p>

<p><i>Ramp side wall – active water leakage with moisture staining and damage to electrical installation.</i></p>
05	<b>Basement Slab Ceiling – General</b>	<p>Concrete scaling and surface deterioration are observed across most of the basement ceiling slab. Extensive moisture staining, efflorescence is visible over a large area. The slab surface has lost concrete cover in many places and the reinforcement is at risk of accelerated corrosion if not addressed.</p> <p><b>Site Photographs:</b></p>

Sl. No.	Item	Details
		the external soil side. In the ramp ceiling area, concrete should be removed at one corner above the ramp ceiling to inspect the internal condition of the slab and identify the source of moisture entering below. Once the leakage sources are confirmed, appropriate waterproofing and sealing works will be recommended and carried out to prevent further water ingress and protect the basement from ongoing deterioration.

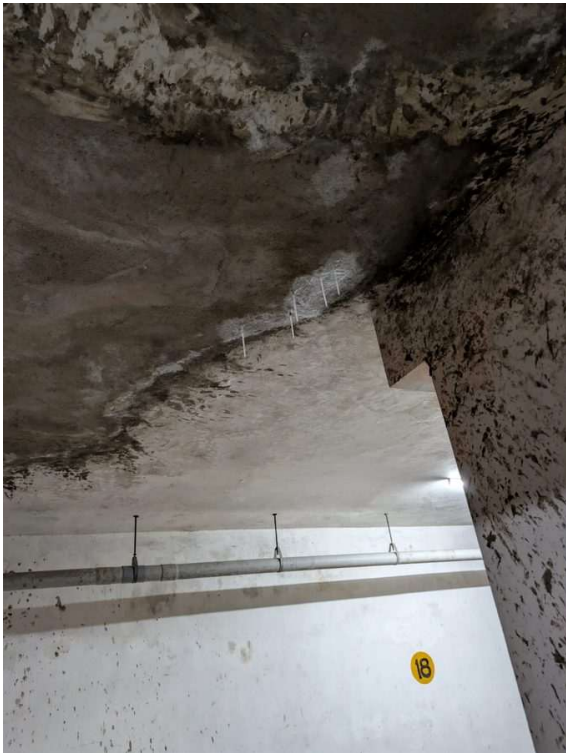
<p data-bbox="581 1104 1235 1129"><i>Basement slab ceiling – widespread moisture staining, surface deterioration.</i></p>
06	<b>Community Hall Ceiling</b>	<p data-bbox="581 1157 1409 1308">Severe concrete spalling is observed on the ceiling of the community hall. A large area of concrete cover has completely fallen away, exposing the full reinforcement grid. The reinforcement bars are heavily corroded. The source of moisture is the west side car exit area drain water overflow and leakage from the commercial building above.</p> <p data-bbox="581 1325 748 1350"><b>Site Photographs:</b></p>

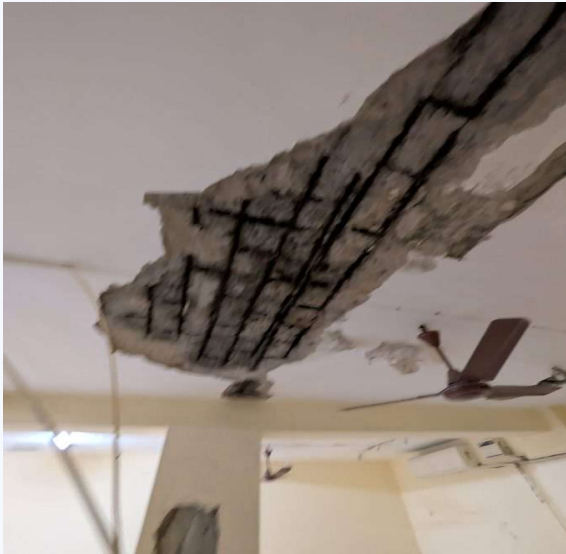
Sl. No.	Location	Observation
		<p><i>Community hall ceiling – full reinforcement grid exposed with heavy corrosion.</i></p>
<p><b>07</b></p>	<p><b>Drain Point Leakage – Commercial Floor Line</b></p>	<p>Active water leakage is observed at the drain pipe penetration point through the slab, carrying drainage from the commercial floor above. The bore packing around the pipe collar is inadequate and water is seeping through the gap. Black staining and moisture spread are visible around the pipe penetration.</p> <p><b>Site Photographs:</b></p>

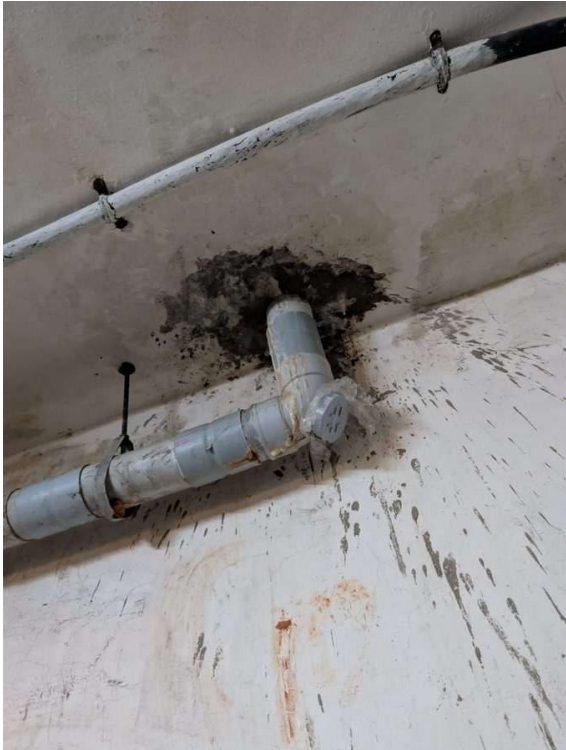
<p><i>Drain pipe penetration – inadequate bore packing with active leakage and staining.</i></p>
<p><b>08</b></p>	<p><b>Core Cutting Holes in Columns – Not Sealed</b></p>	<p>Core cutting holes made in columns for testing purposes are observed to be open and not properly sealed. These open holes are allowing moisture entry and should be sealed immediately.</p> <p><b>Site Photographs:</b></p>

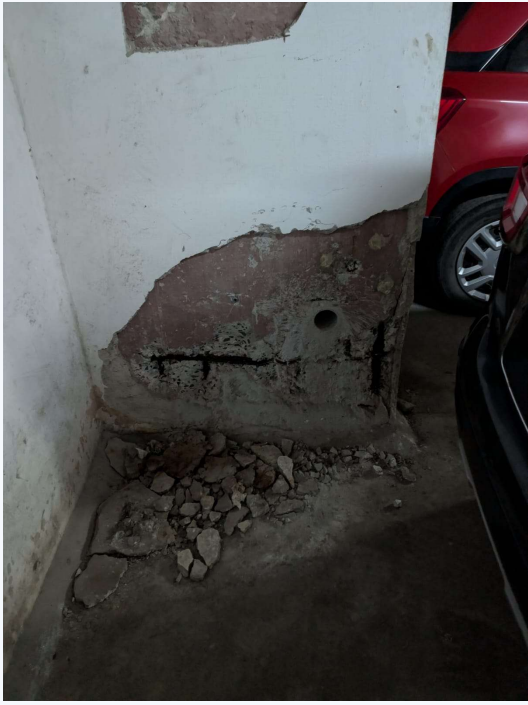
<p><i>Column with core cutting hole not sealed, moisture entry visible.</i></p>
