# SERVICE REPORT

16 AUG 2026

AURORA / SCHEDULED INSPECTION + WASH

MARINA KOPER / D-17

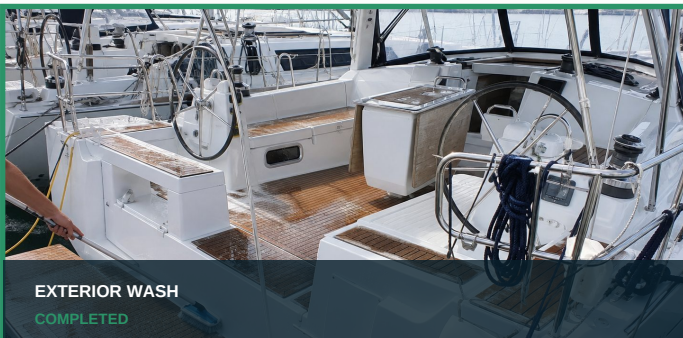
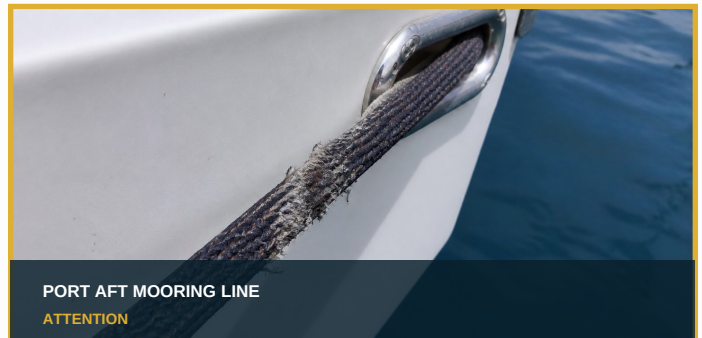
Light chafe visible where the line bears against the fairlead.

Port aft mooring line repositioned; owner review recommended before departure.

### Inspect or replace

before the next departure.
