# Technical Report – R20556-Rev 2 CWCT – Standard for systemised building envelopes – 2005

**TI Tiles International Ltd  
Aerobrick Mechanical Brickslip**

Rev 2 (Revised Report) – this report has been amended as shown in Section 10 and it replaces previous report No. R20556 dated 20<sup>th</sup> May 2020.

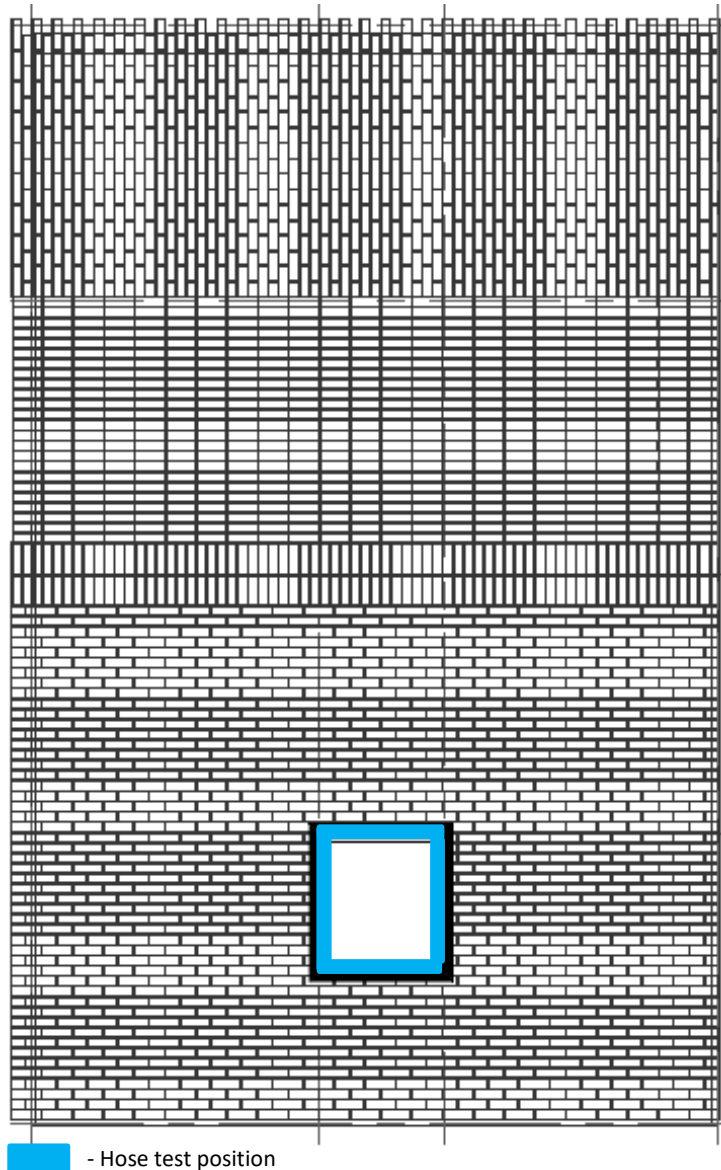
Figure 2

The sample was subjected to hose testing, as described in section 5.2.2. During the test, and for 30 minutes following the cessation of spraying, the sample was monitored for water ingress and none was found.

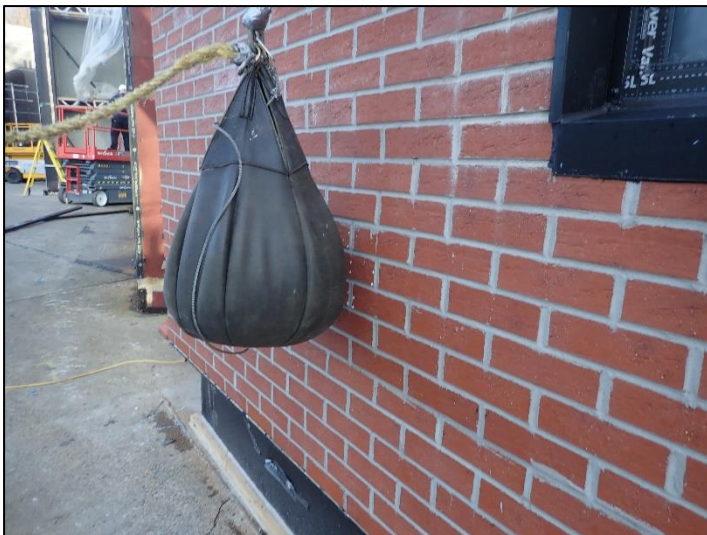
Photograph No. 3

Showing Soft Body (S1) impact of 120Nm.

During the above test, no damage was observed.

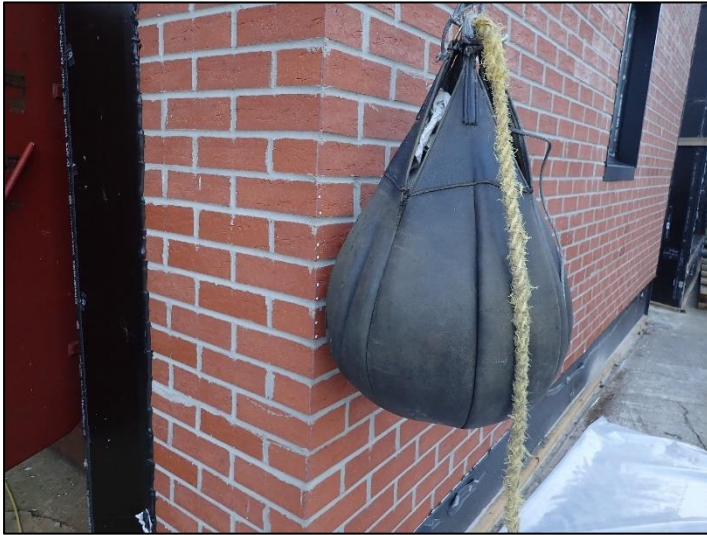
Photograph No. 4

Showing Soft Body (S1) impact of 120Nm.

During the above test, no damage was observed.

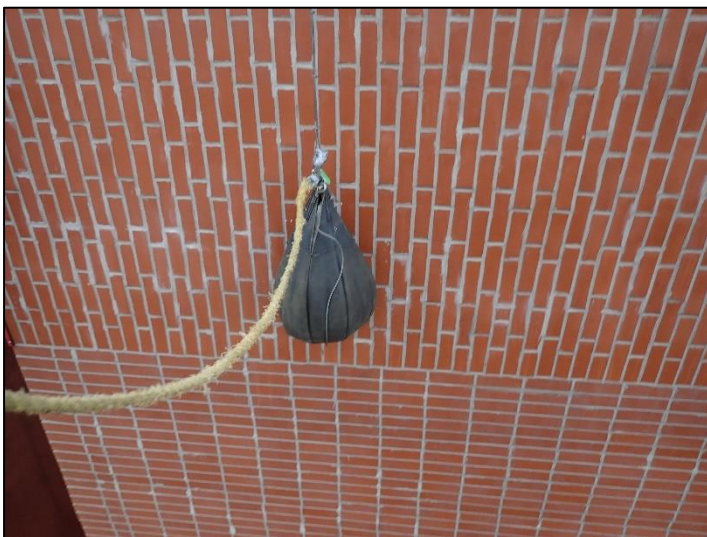
Photograph No. 5

Showing Soft Body (S1) impact of 120Nm.

During the above test, no damage was observed.

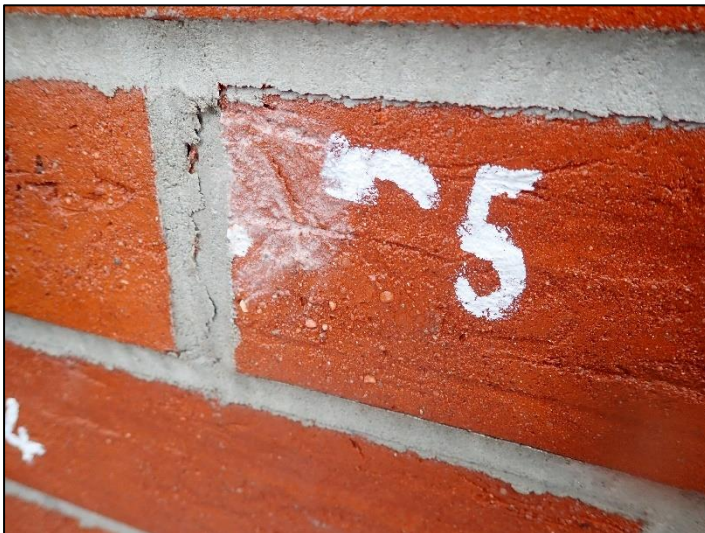
Photograph No. 6

Showing damage caused following Hard Body (H2) impact of 10 Nm.

During the above test, the mortar cracked resulting in a Class 2

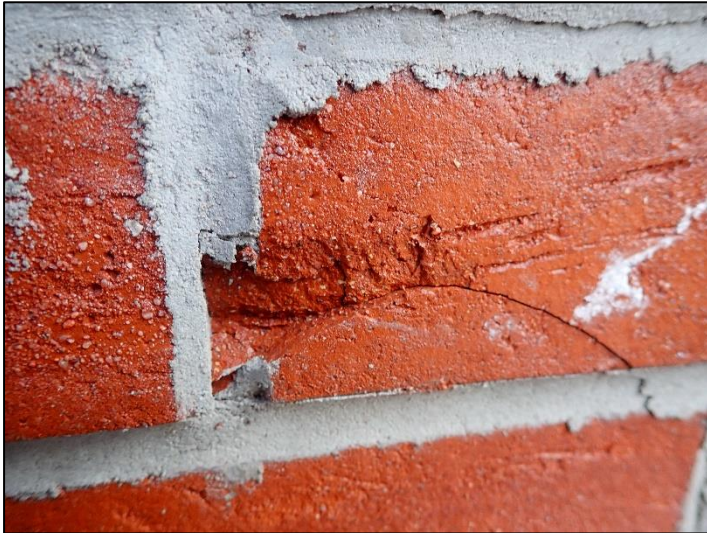
Photograph No. 7

Showing damage caused following Hard Body (H2) impact of 10 Nm.

During the above test, the brick cracked, and pieces fell off weighing 4.91g, resulting in a Class 3

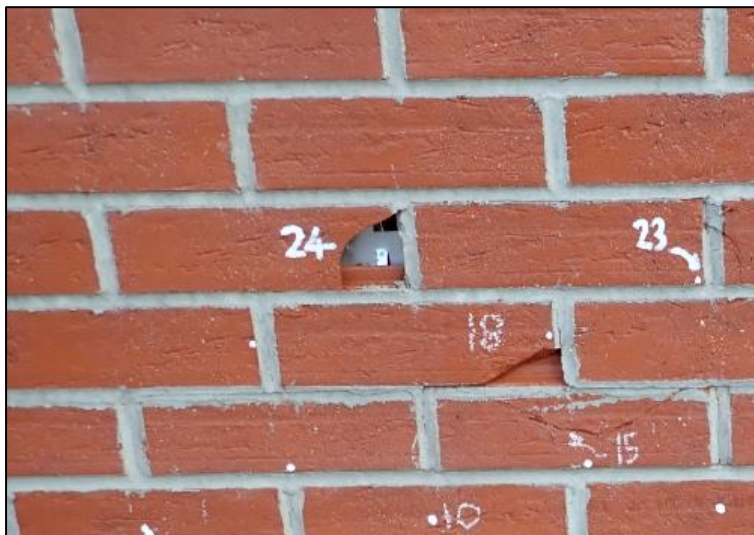
Photograph No. 8

Showing damage caused following Hard Body (H2) impact of 10 Nm.

During the above test, the brick cracked, and pieces fell off weighing 70.43g, resulting in a Class 4

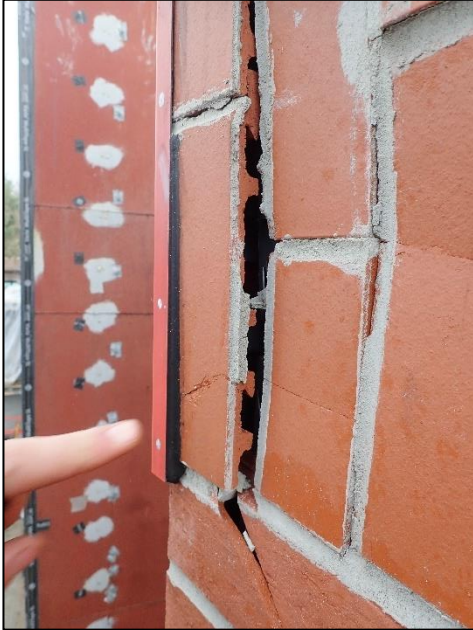
Photograph No. 9

Showing damage caused following Soft Body (S1) impact of 500 Nm.

During the above test, the brick slip and mortar cracked, and the support wall deformed, resulting in a Low Risk

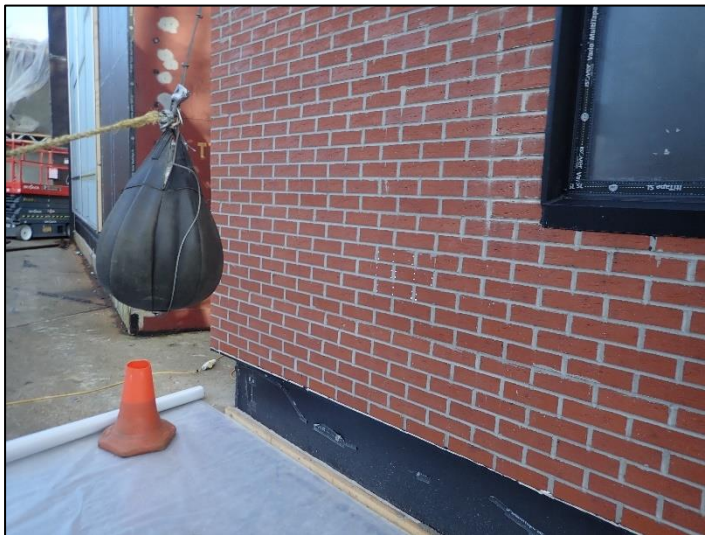
Photograph No. 10

Showing Soft Body (S1) impact of 500 Nm.

During the above test, no damage was observed.

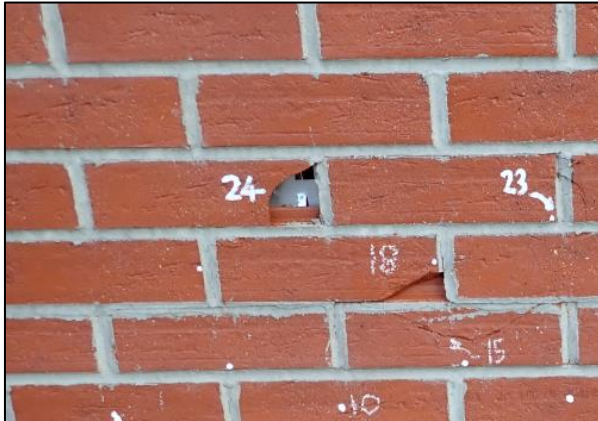
Photograph No. 11

Showing damage caused following  
Hard Body (H2) impact of 10 Nm.

During the above test, the brick cracked, and pieces fell off weighing 70.43g, resulting in a Moderate Risk

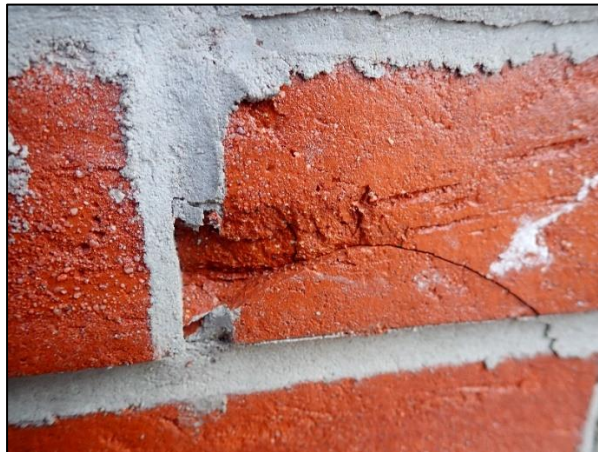
Photograph No. 12

Showing damage caused following  
Hard Body (H2) impact of 10 Nm.

During the above test, the brick cracked, and pieces fell off weighing 4.91g, resulting in a Low Risk

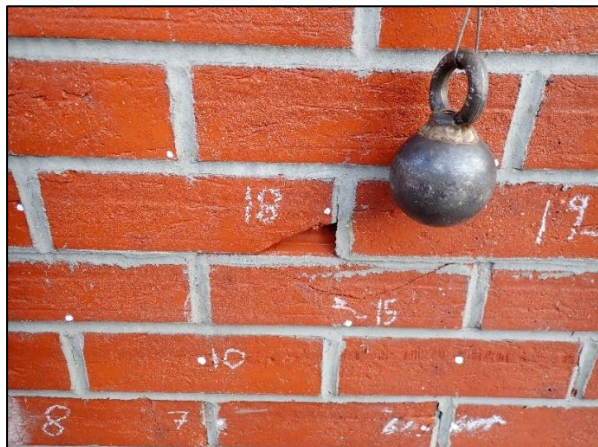
Photograph No. 13

Showing damage caused following  
Hard Body (H2) impact of 10 Nm.

Following the above test, on a different area, a piece fell off impact area reference 18 weighing 22.56g, resulting in a Low Risk

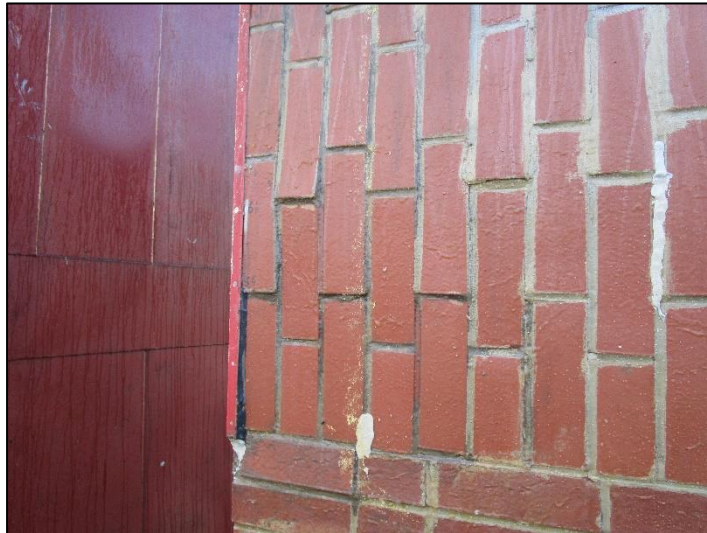
Photograph No. 26

Remedial work conducted  
on vertical corner detail

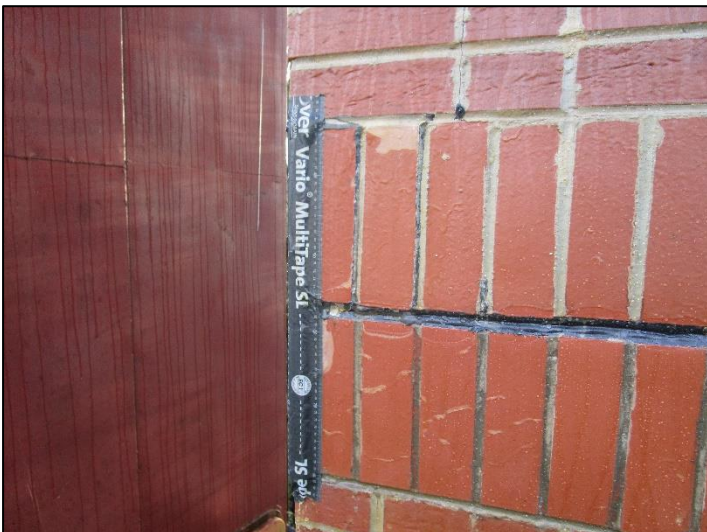
Photograph No. 27

Remedial work conducted  
on vertical expansion joint  
corner detail

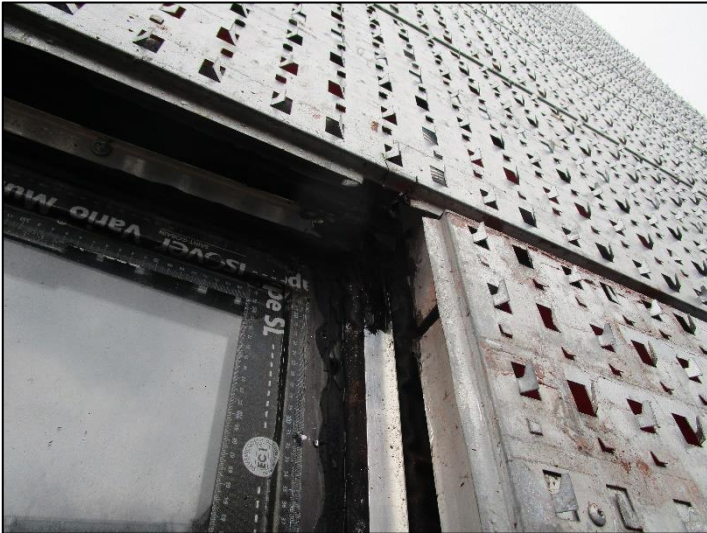
Photograph No. 31

Excessive sealant in corners  
of window pod interface

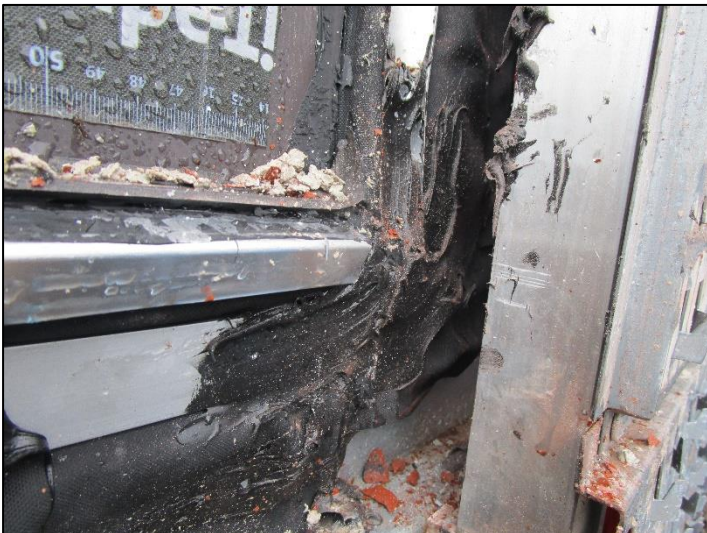
Photograph No. 32

Excessive sealant in corners  
of window pod interface

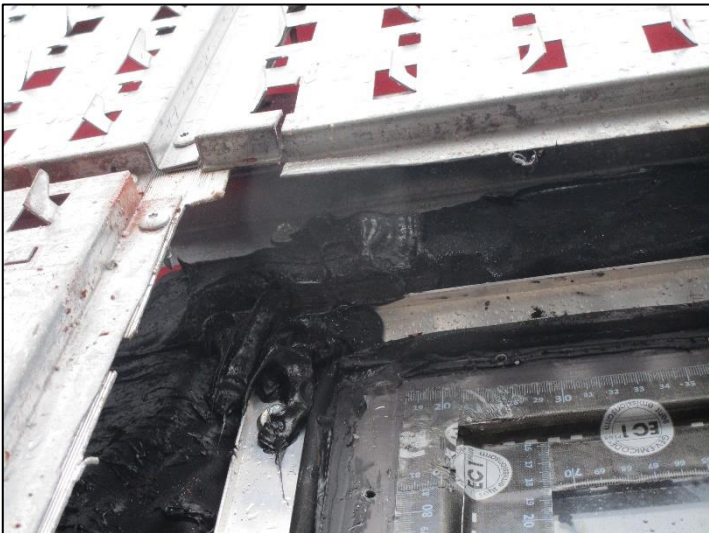
Photograph No. 34

Sealant in corner of window  
pod interface

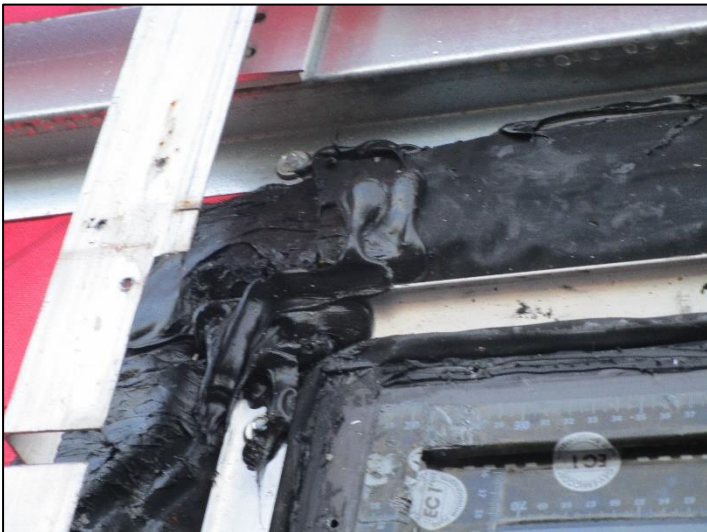
Photograph No. 35

Sealant in corner of window  
pod interface

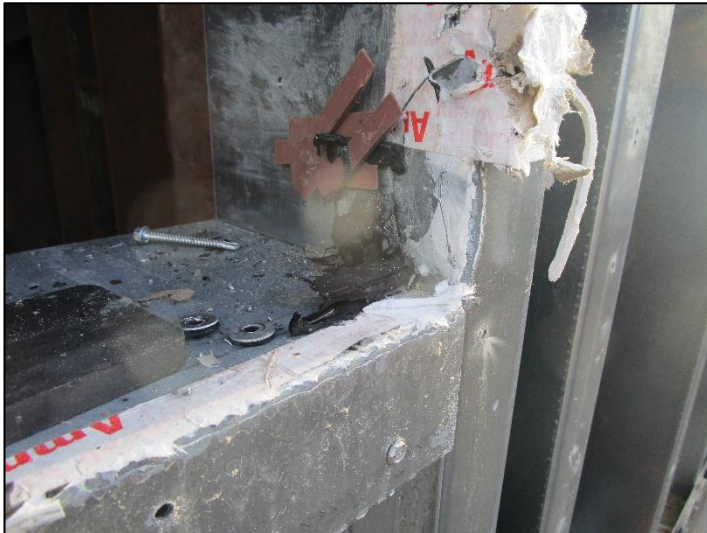
Photograph No. 45

Sealant in corner of Metsec

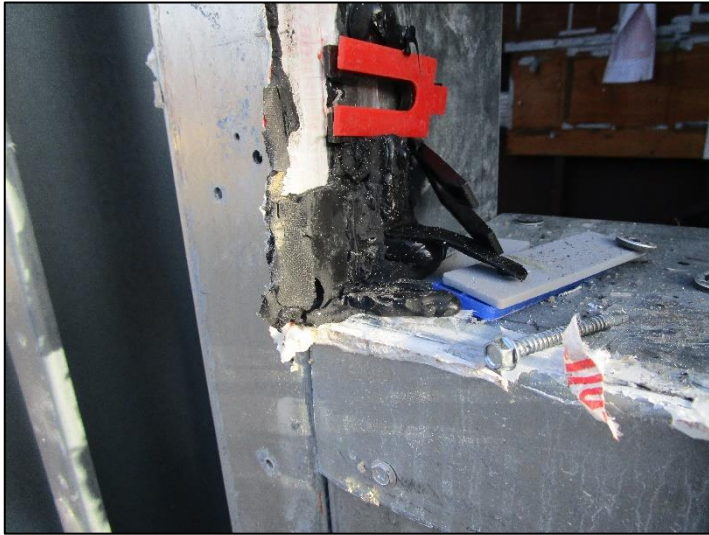
Photograph No. 46

Sealant in corner of Metsec

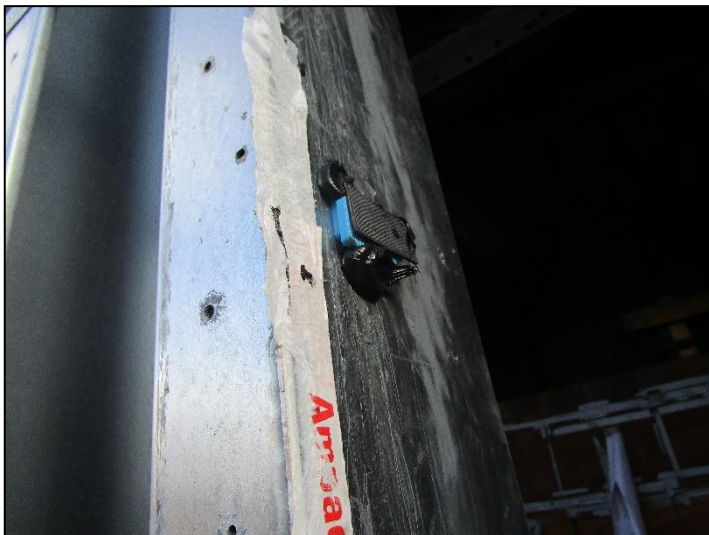
Photograph No. 47

Packers used on window pod interface to Metsec

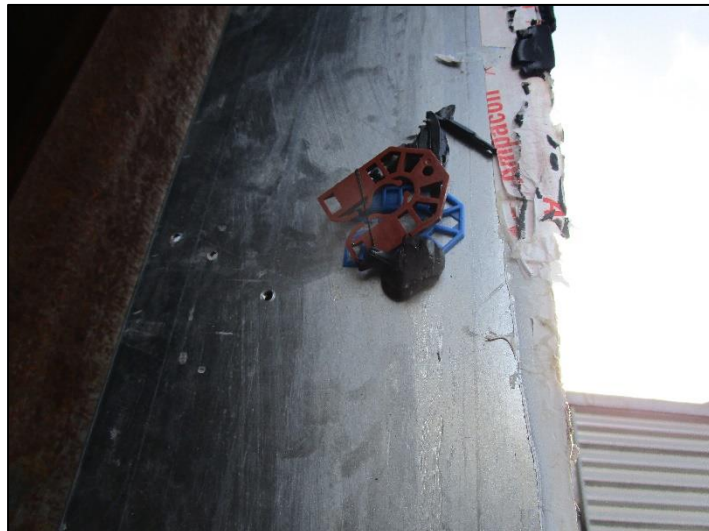
Photograph No. 48

Packers used on window pod interface to Metsec
