## 3D Tool High Pressure Water Cut Injury

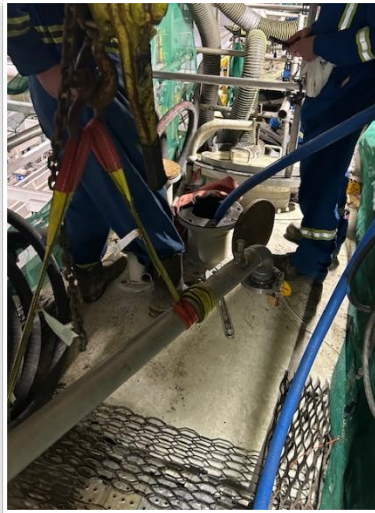
Job setup (3D tool and hose inside tank port)

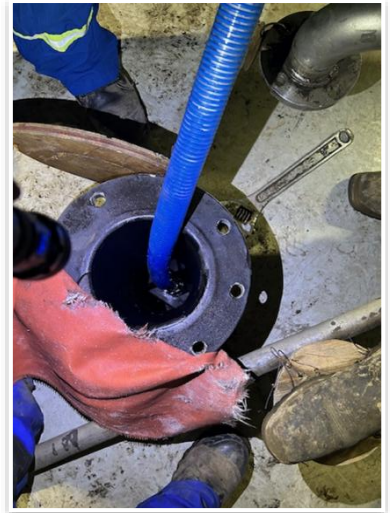
A CEDA crew was tasked with using a 3D high pressure tool to remove the rubber lining from a client's tank. A worker was directed by their supervisor to check whether the 3D tool was contacting I-beams inside the tank, and the worker unknowingly placed themselves in the line of fire by attempting to visually check inside the tank opening (port) while the 3D tool was energized. A stream of 7,000 psi water exited the tank port and struck the worker's hand, resulting in a high pressure water-cut injury.

Port where line of fire hazard existed

- A training audit was completed on high pressure technical training and field sign-offs for all FMM P&V personnel, identifying key gaps in competency training for the 3D Tool, Tube Lance Exchanger (TLE), and AutoBox (ABX) 500.
- All FMM P&V leadership at the worksite will be enrolled in CEDA's Leadership Development & Improvement Program (LDIP).
- For all high-pressure jobs, the supervisor or designate must verbally review the applicable Safe Work Procedure (SWP) with the crew.
  - This review must clarify task instructions and any industry terms or site-specific language to ensure all crew members, including less experienced workers and those from other sites, understand the SWP and required safety controls.
- Update the Leadership Kick-Off Meeting for Turnaround Events to include requirements for CEDA-specific and Alberta Occupational Health and Safety roles and responsibilities.
