Independently certified audit of the long term on-site performance of batch anodised aluminium extrusions and panels on exterior architectural applications in the UK

**UNITED
ANODISERS**

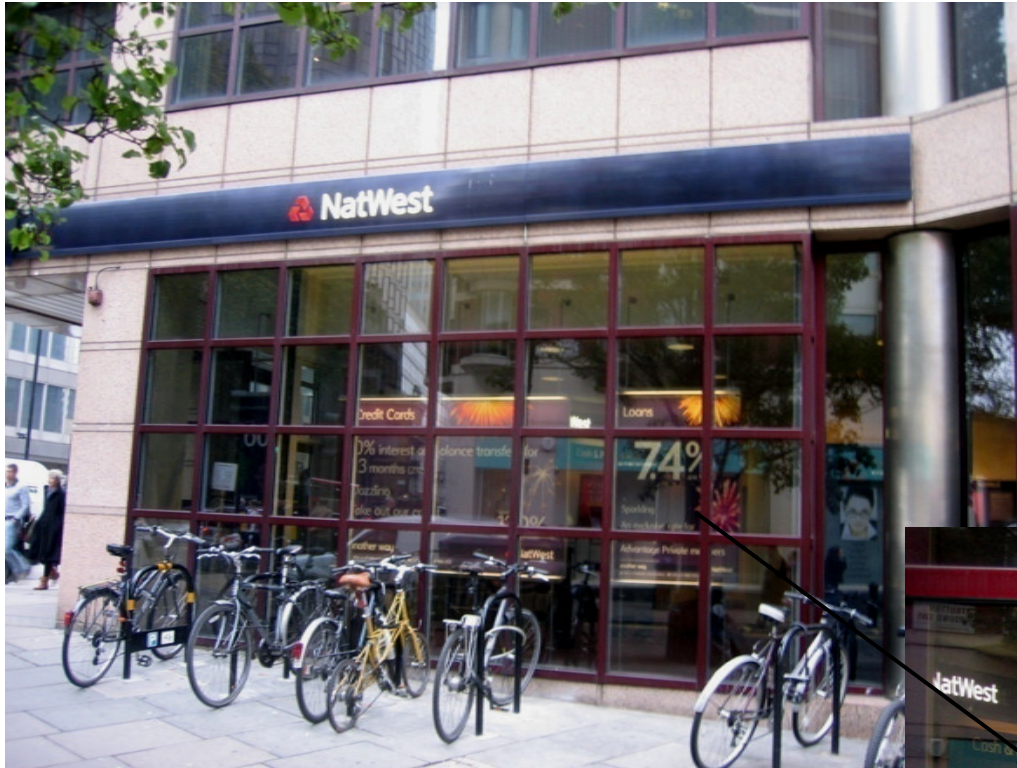
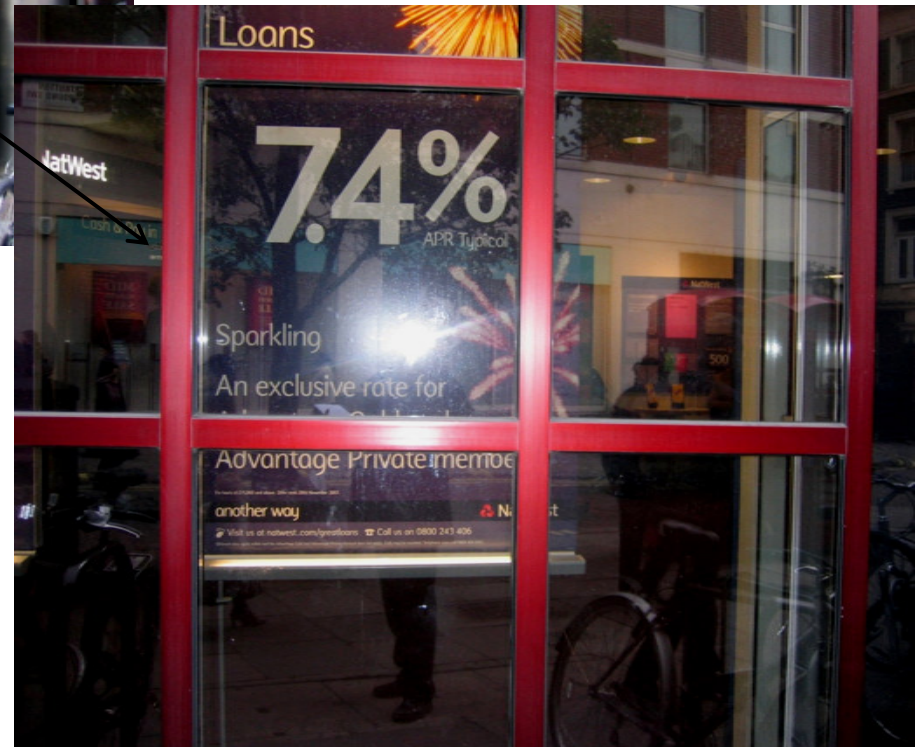
Address of building	NatWest Bank 55 Victoria Street London SW1
Date of independent inspection	October 2007
Use of building	Bank commercial offices
Date of construction	1987
Environment	High traffic density – centre of London
Evidence of regular cleaning or maintenance	No
External parts of building which were anodised	Window frames
Type of anodising	Batch
Anodiser	United Anodisers: LHT Anodisers, Uxbridge
Description of anodic colour and treatment	Sandalor Red C62/3
Original anodic film layer on anodised parts (microns)	Class 25 μm (AASC specifications)
Anodic film layer on date of independent inspection (microns)	25.5 μm
Visible signs of corrosion or surface degradation	None
Conclusion	No deterioration in anodic film protection after 20 years service life. No visible evidence of corrosion notwithstanding high density polluted urban environment. No discernable colour change

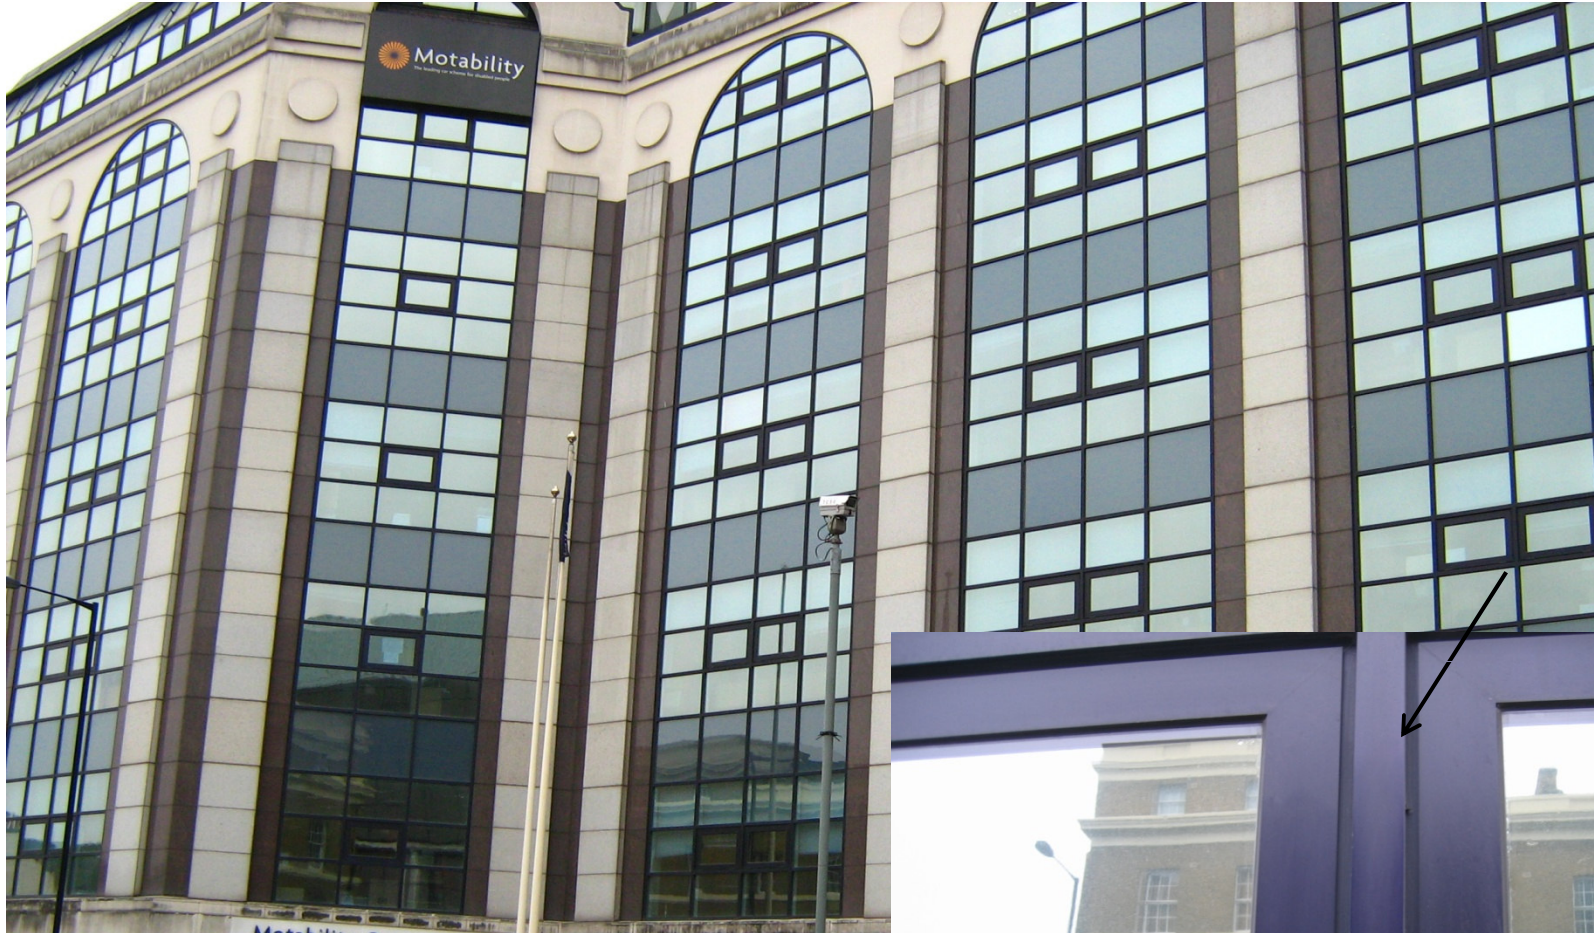
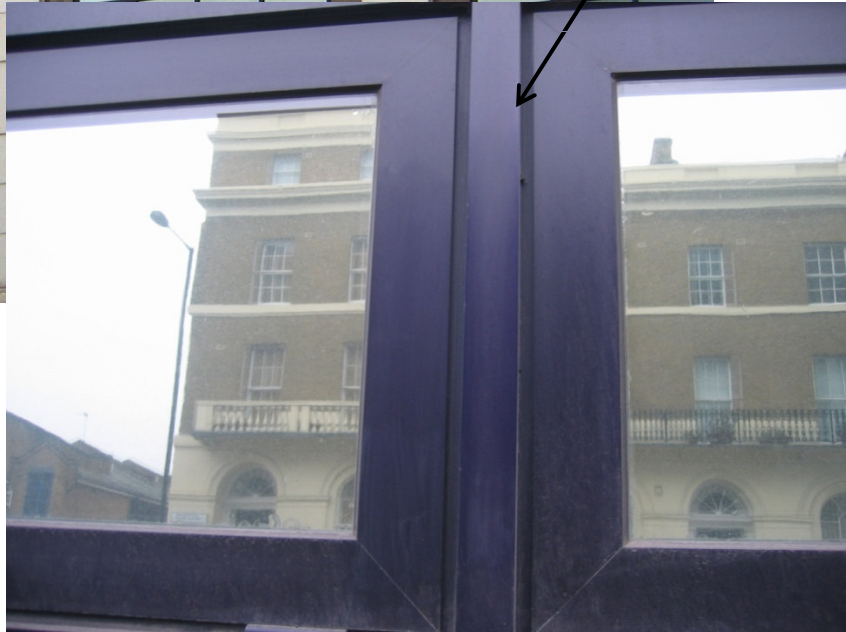
Address of building	City Gate House 22 Southwark Bridge Road London SE1
Date of independent inspection	October 2007
Use of building	Offices
Date of construction	1987
Environment	High traffic density – Centre of London – Close to the Thames river
Evidence of regular cleaning or maintenance	No
External parts of building which were anodised	Window frames
Type of anodising	Batch
Anodiser	United Anodisers: LHT Anodisers, Uxbridge
Description of anodic colour and treatment	Sandalor blue C 64/3
Original anodic film layer on anodised parts (microns)	Class 25 μm (AASC specifications)
Anodic film layer on date of independent inspection (microns)	27.6 μm
Visible signs of corrosion or surface degradation	None
Conclusion	No deterioration in anodic film protection after 20 years service life. No visible evidence of corrosion notwithstanding high density polluted urban environment. No discernable colour change.

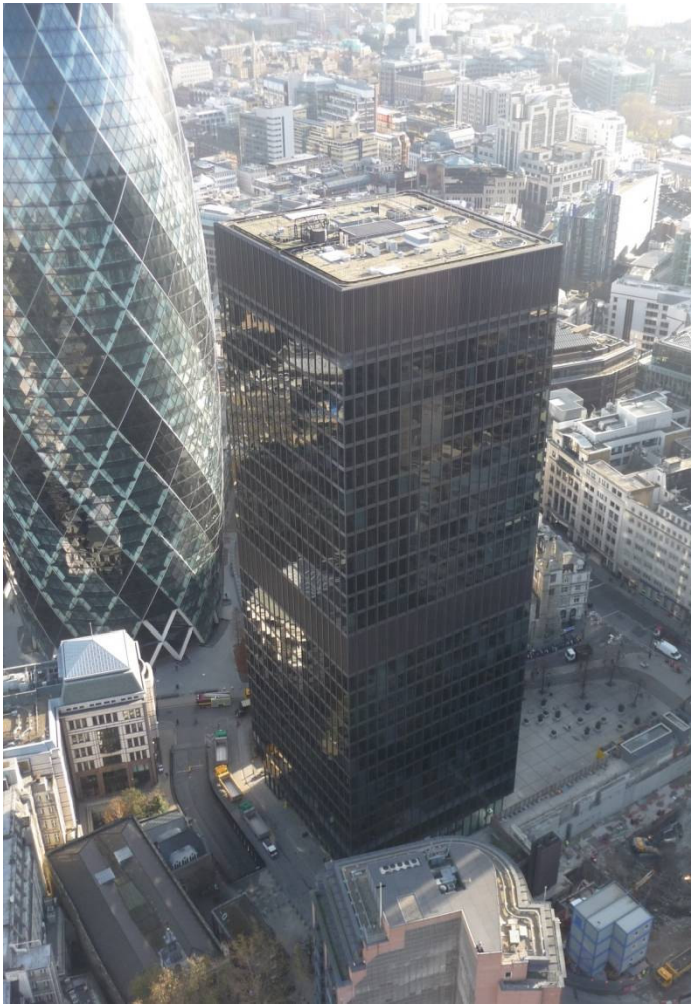
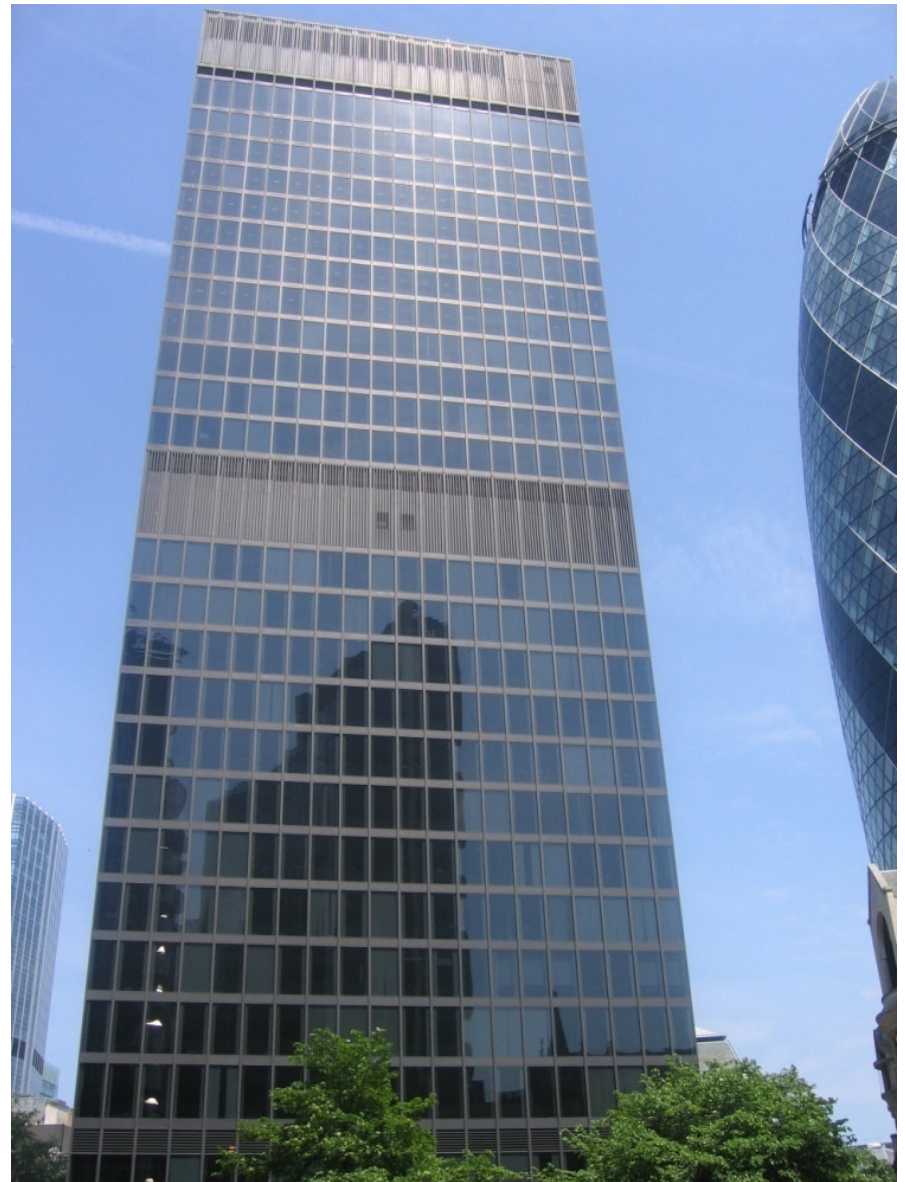
**Commercial Union HQ
St Helens, 1 Undershaft
London EC3**

Address of building	Commercial Union HQ St Helens, 1, Undershaft London EC3
Date of independent inspection	October 2007
Use of building	Offices
Date of construction	1993 (revamping after bomb attack)
Environment	High traffic density – financial district of London
Evidence of regular cleaning or maintenance	No
External parts of building which were anodised	Window frames
Type of anodising	Batch
Anodiser	United Anodisers: LHT Anodisers, Uxbridge
Description of anodic colour and treatment	Anolok II Dark blue-grey – B 717
Original anodic film layer on anodised parts (microns)	Class 25 μm (AASC specifications)
Anodic film layer on date of independent inspection (microns)	26.4 μm
Visible signs of corrosion or surface degradation	None
Conclusion	No deterioration in anodic film protection after 14 years service life. No visible evidence of corrosion notwithstanding high density polluted urban environment. No discernable colour change.

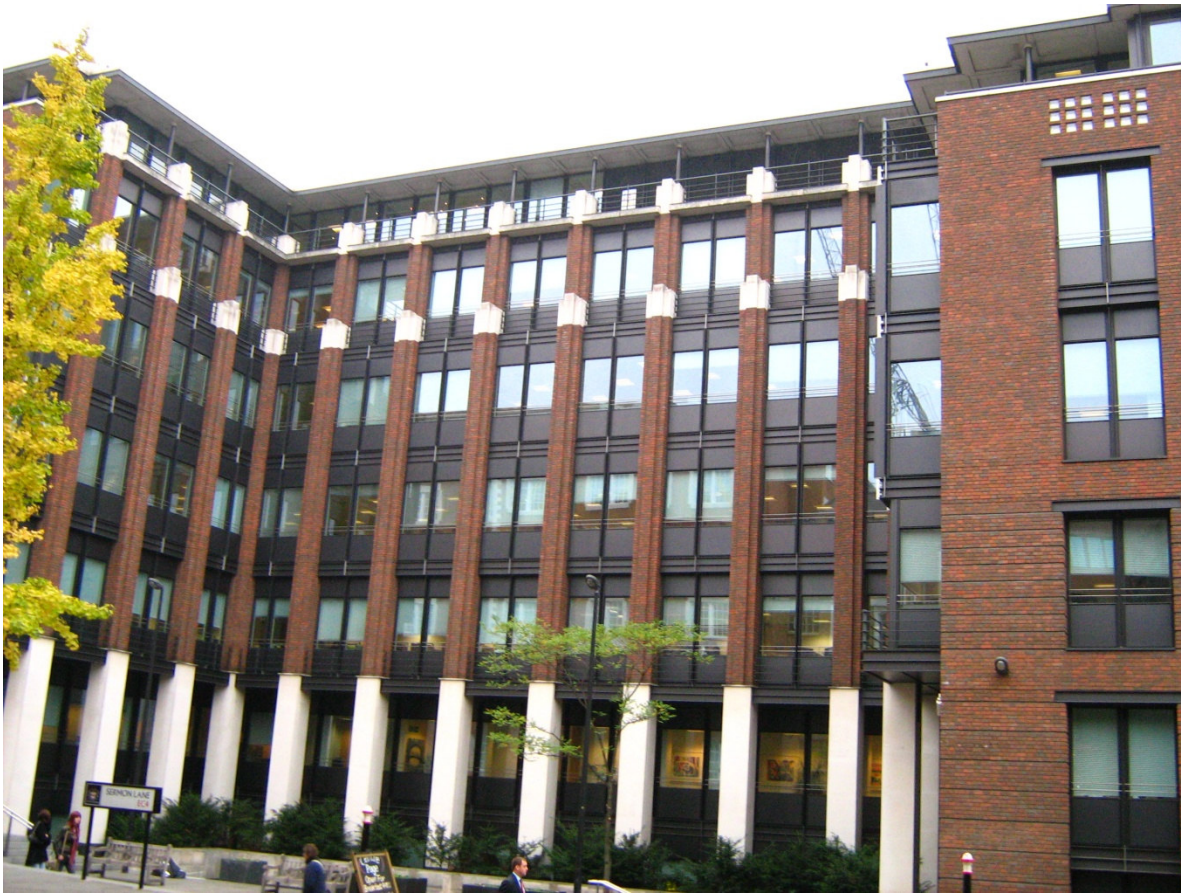
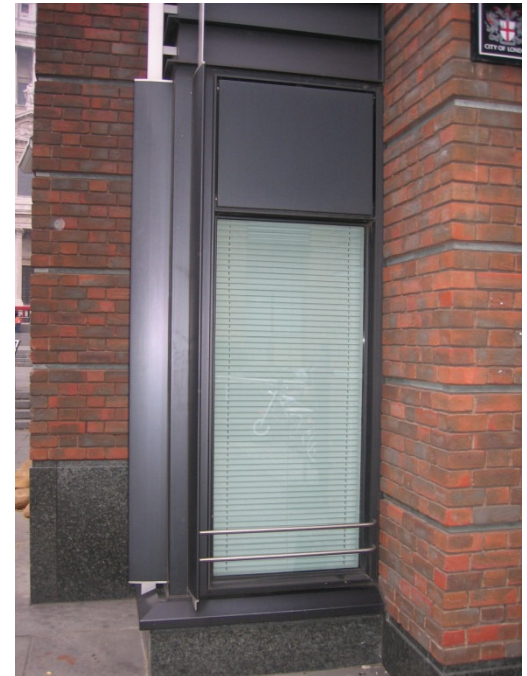
Peter's Hill House
1 Carter Lane
London EC4

Address of building	Peter's Hill House 1, Carter Lane London EC4
Date of independent inspection	October 2007
Use of building	Offices
Date of construction	1996
Environment	Urban – Quiet location – Adjacent to River Thames
Evidence of regular cleaning or maintenance	No
External parts of building which were anodised	Window frames – Window sills – Solid panels
Type of anodising	Batch
Anodiser	United Anodisers: LHT Anodisers, Uxbridge
Description of anodic colour and treatment	Anolok II Dark blue-grey B 717
Original anodic film layer on anodised parts (microns)	Class 25 µm (AASC specifications)
Anodic film layer on date of independent inspection (microns)	24.4 µm
Visible signs of corrosion or surface degradation	None
Conclusion	The very minor variation between the original treatment specification and the test result could either be due to: (1) a very limited erosion of the anodic film or (2) a variance in the anodic film layer in production. In either case, the surface protection is intact after 11 years service life. No visible evidence of corrosion. No discernable colour change.

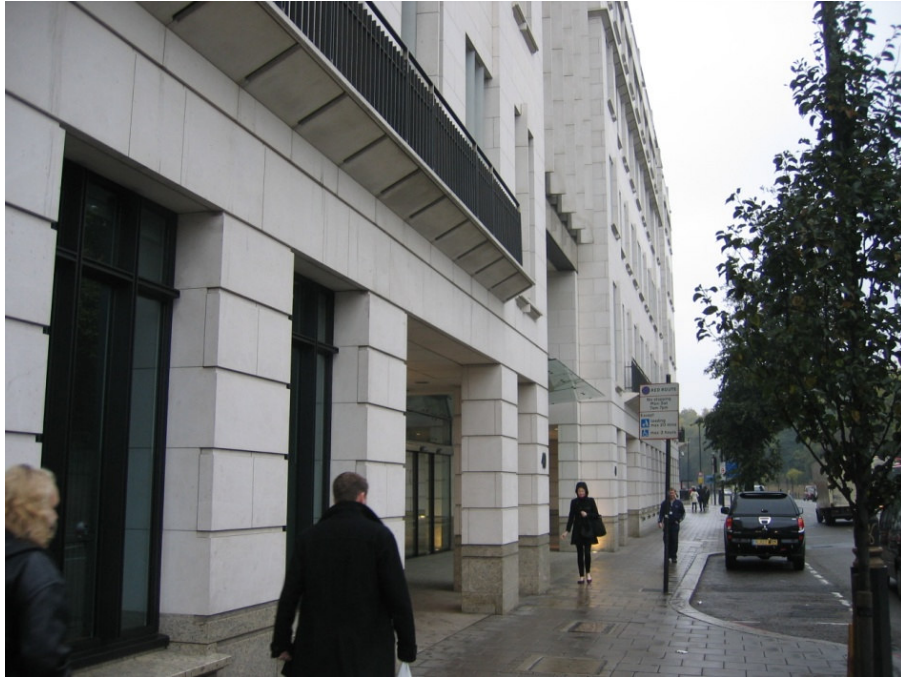
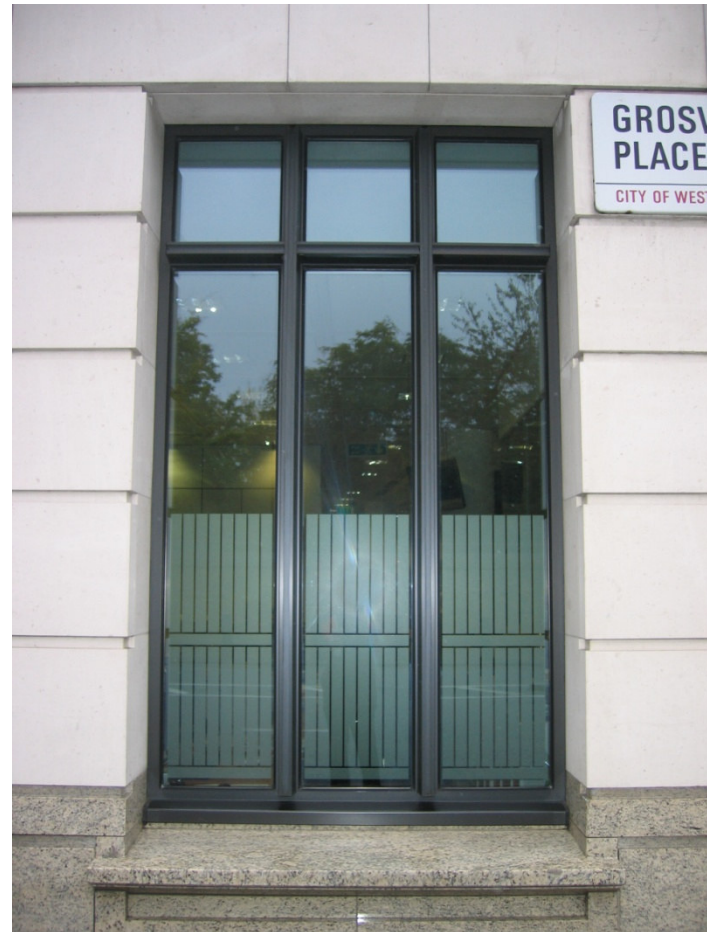
**Hobart House
10 Grosvenor Place
London SW1**

Address of building	Hobart House 10, Grosvenor Place London SW1
Date of independent inspection	October 2007
Use of building	Offices
Date of construction	1998
Environment	High traffic density – centre of London
Evidence of regular cleaning or maintenance	No
External parts of building which were anodised	Window frames
Type of anodising	Batch
Anodiser	United Anodisers: LHT Anodisers, Uxbridge
Description of anodic colour and treatment	Anolok II Dark blue-grey B 717
Original anodic film layer on anodised parts (microns)	Class 25 μm (AASC specifications)
Anodic film layer on date of independent inspection (microns)	26.4 μm
Visible signs of corrosion or surface degradation	None
Conclusion	No deterioration in anodic film protection after 9 years service life. No visible evidence of corrosion notwithstanding high density polluted urban environment. No discernable colour change.

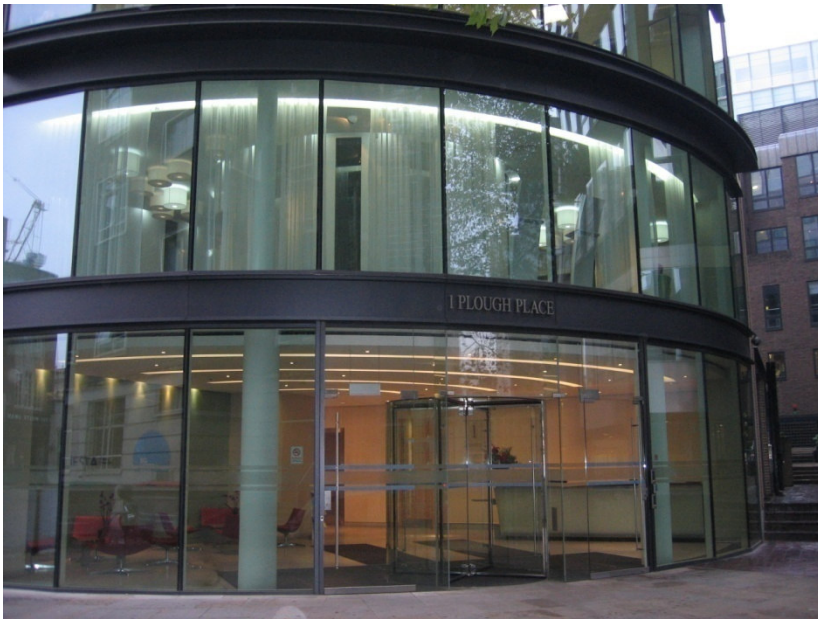
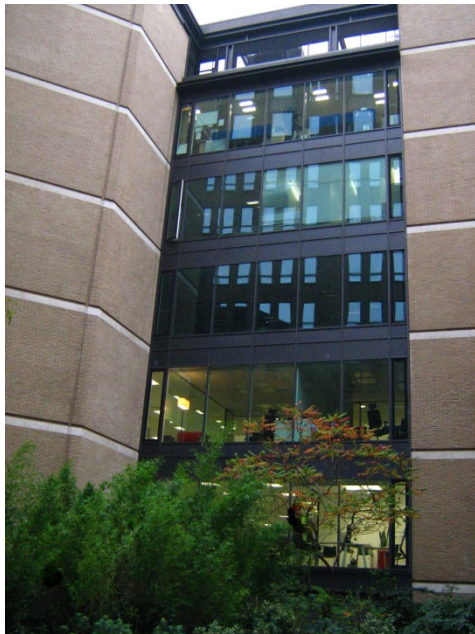
**40rty building
3-5 Plough Place
London EC4**

Address of building	40rty building 3-5 Plough Place London EC4
Date of independent inspection	October 2007
Use of building	Offices
Date of construction	2000
Environment	Urban – Quiet street – Centre of London
Evidence of regular cleaning or maintenance	No
External parts of building which were anodised	Window frames – Solid panels
Type of anodising	Batch
Anodiser	United Anodisers: LHT Anodisers, Uxbridge
Description of anodic colour and treatment	Anolok II blue-grey 715
Original anodic film layer on anodised parts (microns)	Class 25 μm (AASC specifications)
Anodic film layer on date of independent inspection (microns)	27.4 μm
Visible signs of corrosion or surface degradation	None
Conclusion	No deterioration in anodic film protection after 7 years service life. No visible evidence of corrosion. No discernable colour change.

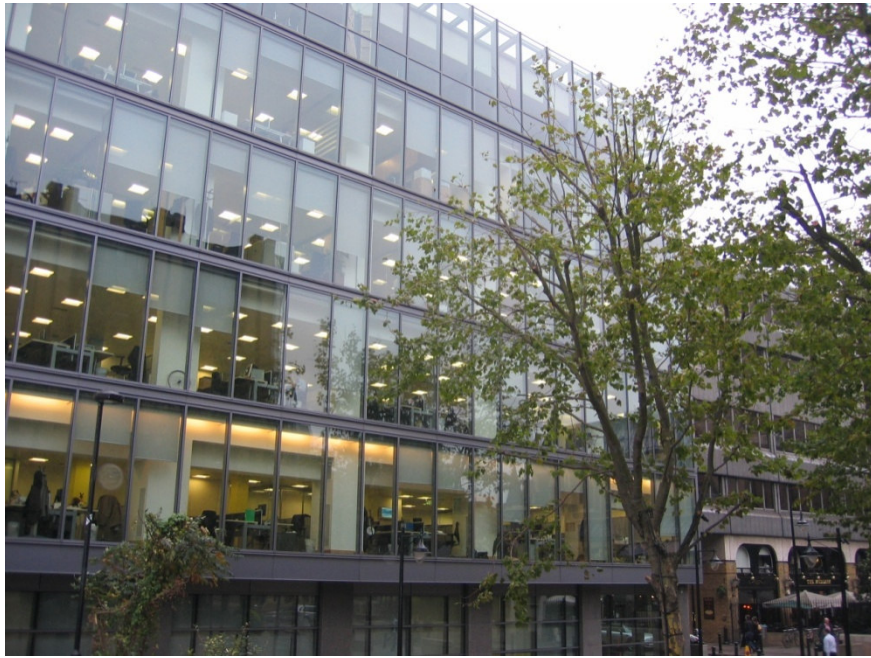
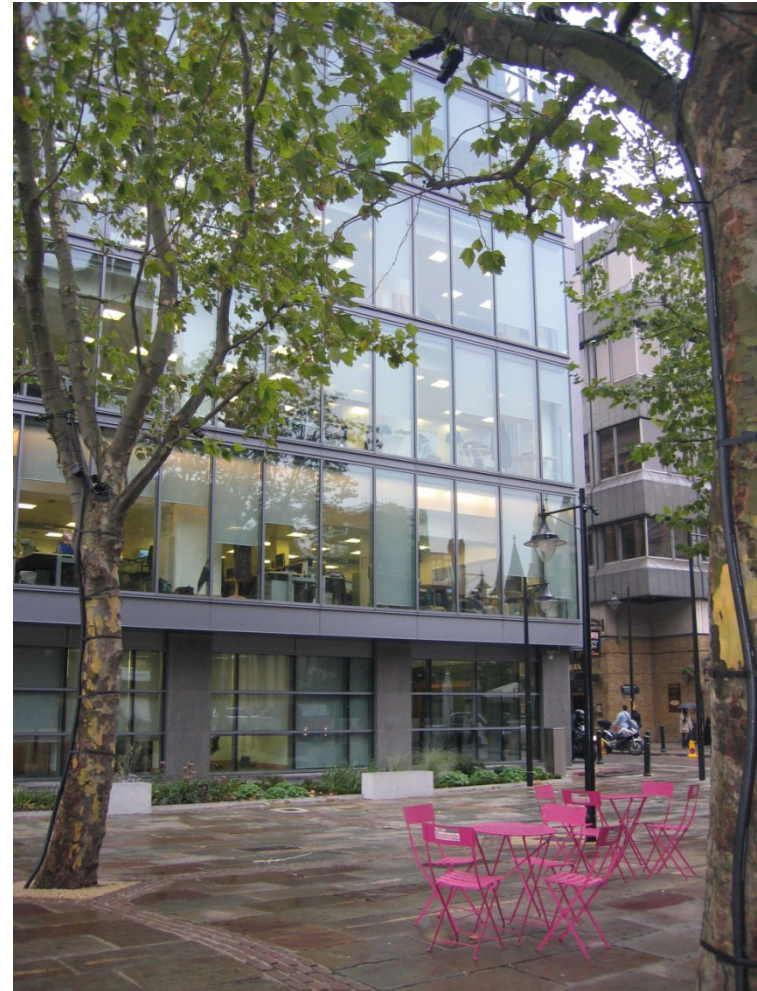
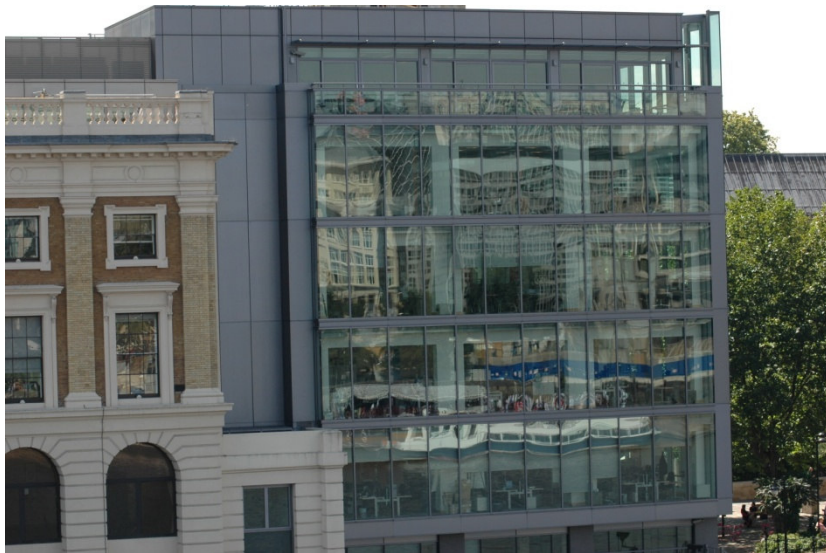
**Two London Bridge
Southwark
London SE1**

Address of building	Two London Bridge Southwark London SW1
Date of independent inspection	October 2007
Use of building	Offices
Date of construction	1997
Environment	Urban – Adjacent to the River Thames – Centre of London
Evidence of regular cleaning or maintenance	No
External parts of building which were anodised	Window frames – Solid panels
Type of anodising	Batch
Anodiser	United Anodisers: LHT Anodisers, Uxbridge
Description of anodic colour and treatment	Anolok II Pale blue-grey B 711
Original anodic film layer on anodised parts (microns)	Class 25 μm (AASC specifications)
Anodic film layer on date of independent inspection (microns)	27.8 μm
Visible signs of corrosion or surface degradation	None
Conclusion	No deterioration in anodic film protection after 10 years service life. No visible evidence of corrosion notwithstanding high density polluted urban environment. No discernable colour change.

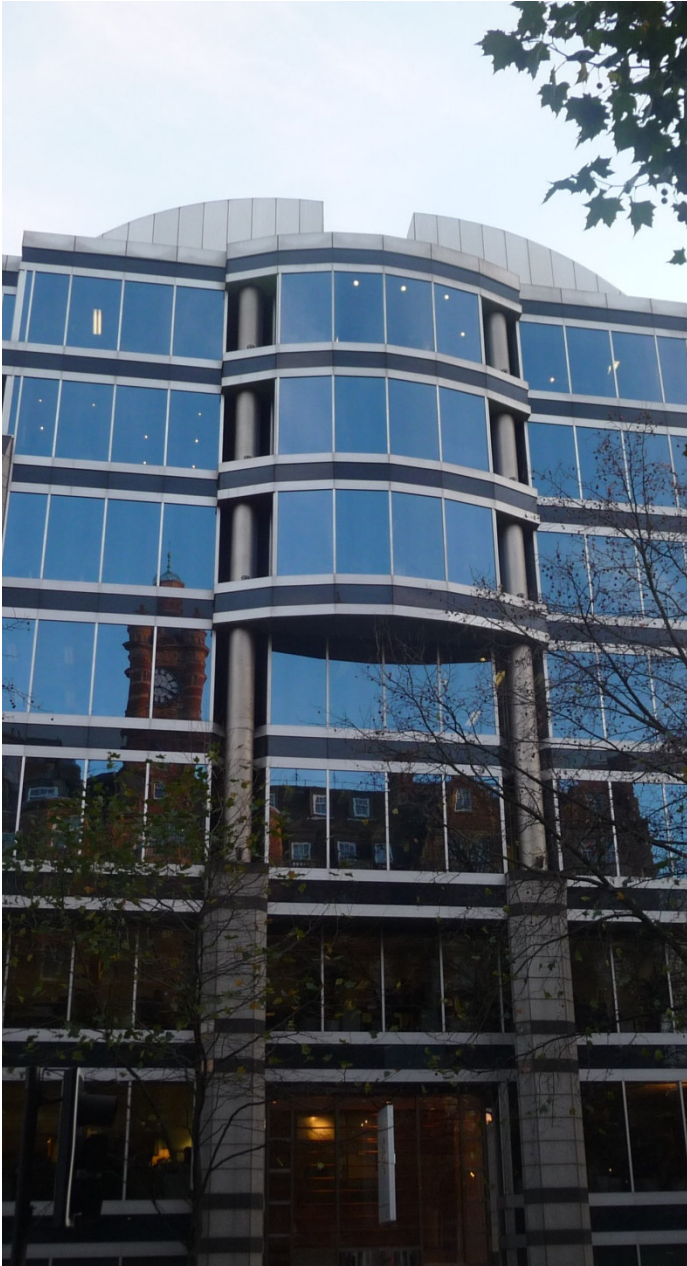
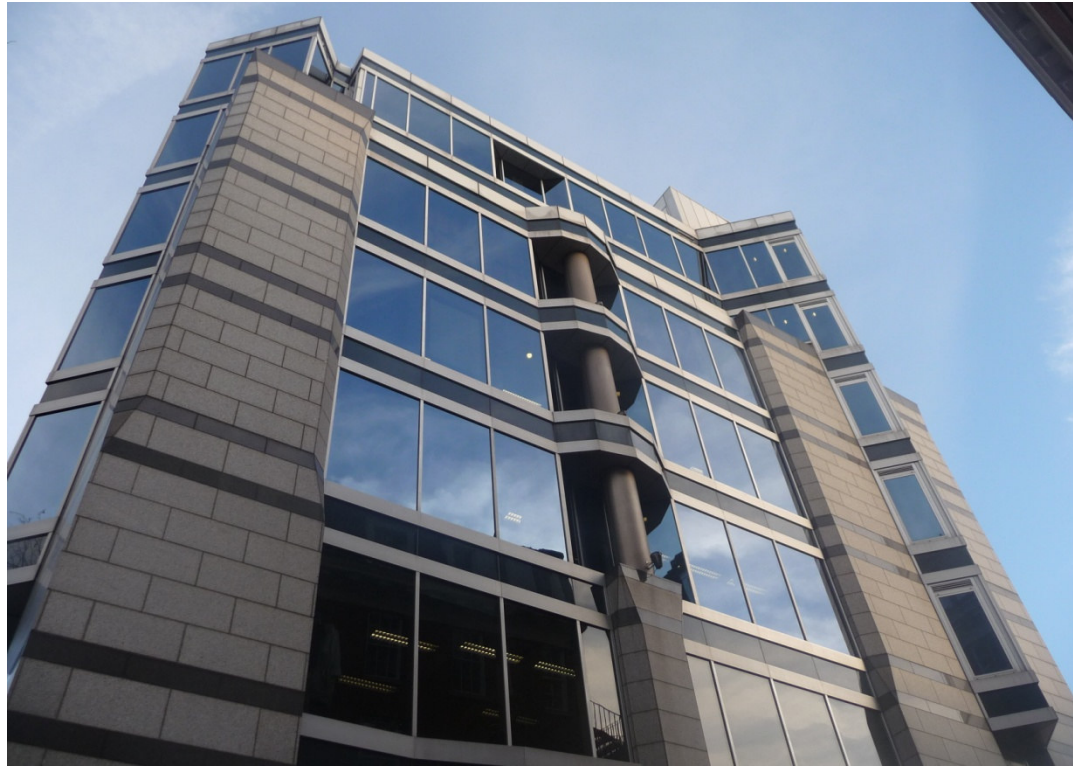
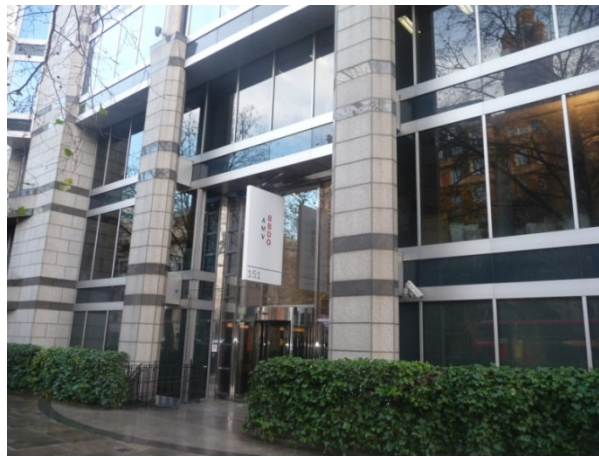
**Enford House
191 Marylebone Road
London NW1**

Address of building	Enford House 191 Marylebone Road London NW1
Date of independent inspection	November 2008
Use of building	AMV – BBDO offices
Date of construction	1990
Environment	Urban - High traffic density
Evidence of regular cleaning or maintenance	No
External parts of building which were anodised	Window frames – Solid panels
Type of anodising	Batch
Anodiser	United Anodisers: LHT Anodisers, Uxbridge
Original anodic film layer on anodised parts (microns)	Class 25 μm (AASC specifications)
Description of anodic colour and treatment	Clear Anodising
Anodic film layer on date of independent inspection (microns)	28.6 μm
Visible signs of corrosion or surface degradation	None
Conclusion	No deterioration in anodic film protection after 18 years service life. No visible evidence of corrosion notwithstanding high density polluted urban environment.

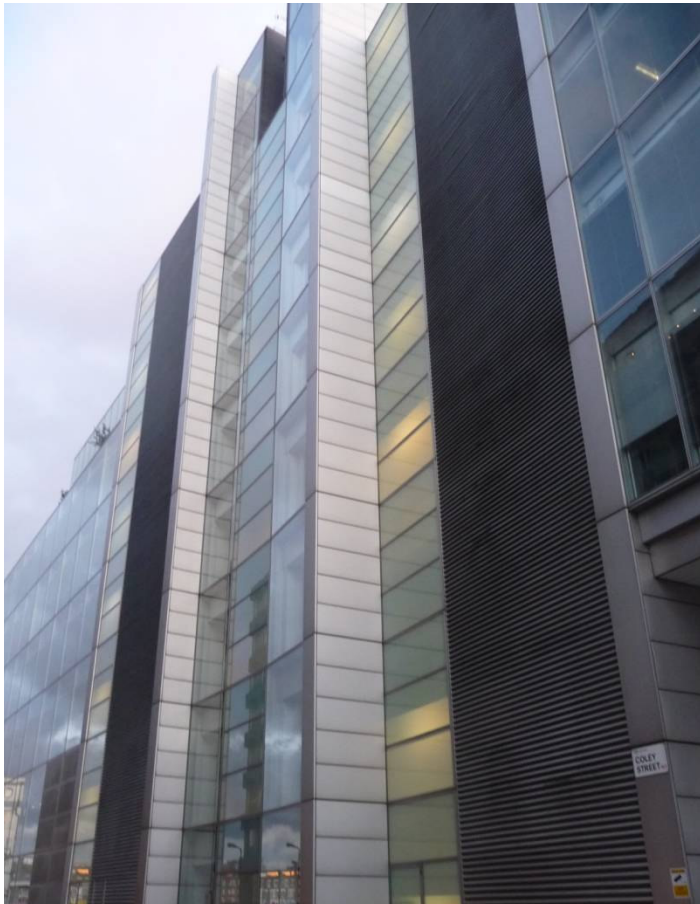
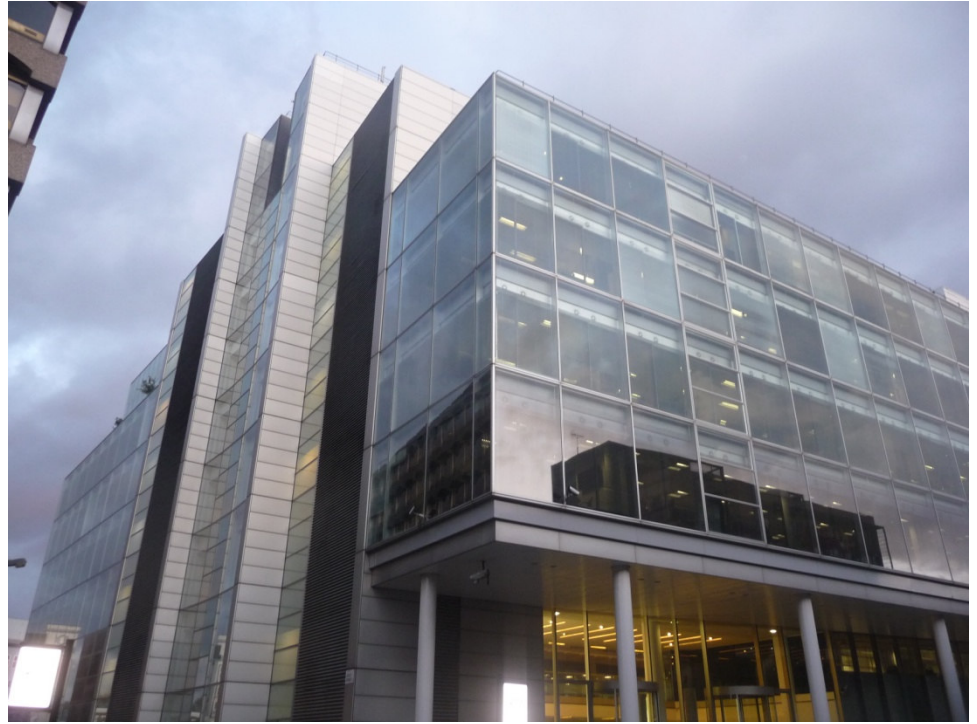
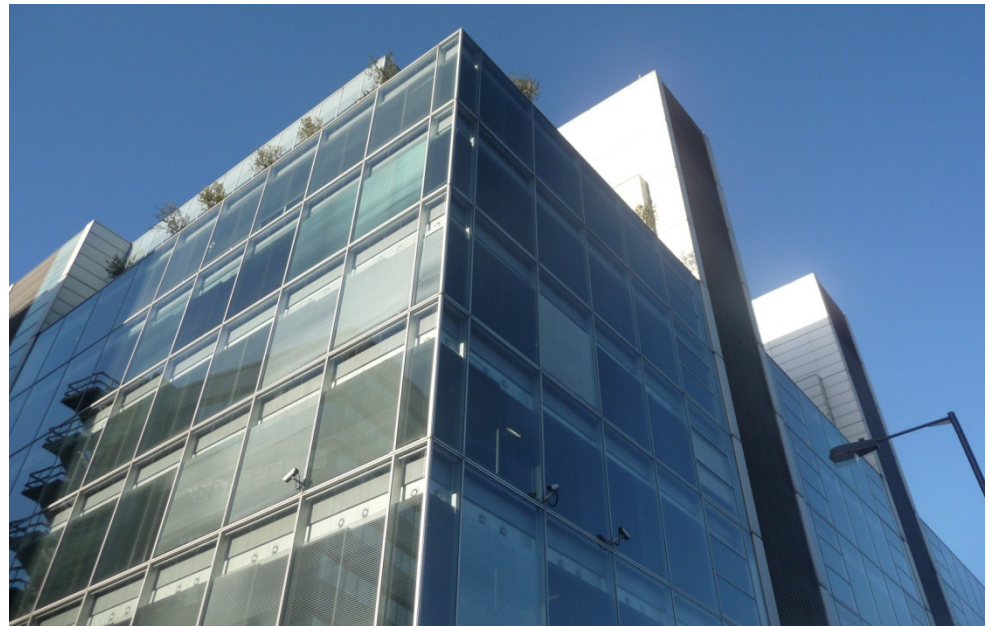
Address of building	ITN Headquarters 200 Grays Inn Road London WC1
Date of independent inspection	November 2008
Use of building	Television news company offices
Date of construction	1990
Environment	High traffic density – centre of London
Evidence of regular cleaning or maintenance	No
External parts of building which were anodised	Façade : Window frames – Solid panels Louvers : sheets
Type of anodising	Batch
Anodiser	United Anodisers: LHT Anodisers, Uxbridge
Description of anodic colour and treatment	Clear Anodising
Original anodic film layer on anodised parts (microns)	Class 25 μm (AASC specifications) for façade Not determined for louvers
Anodic film layer on date of independent inspection (microns)	28.7 μm on façade elements; 22.7 μm on louvers
Visible signs of corrosion or surface degradation	None
Conclusion	No deterioration in anodic film protection after 18 years service life. No visible evidence of corrosion notwithstanding high density polluted urban environment. Some minor colour differences between panels remain visible due to variations in the base metal supplied by the customer for anodising, which was not in accordance with the recommendations of LHT Anodisers.

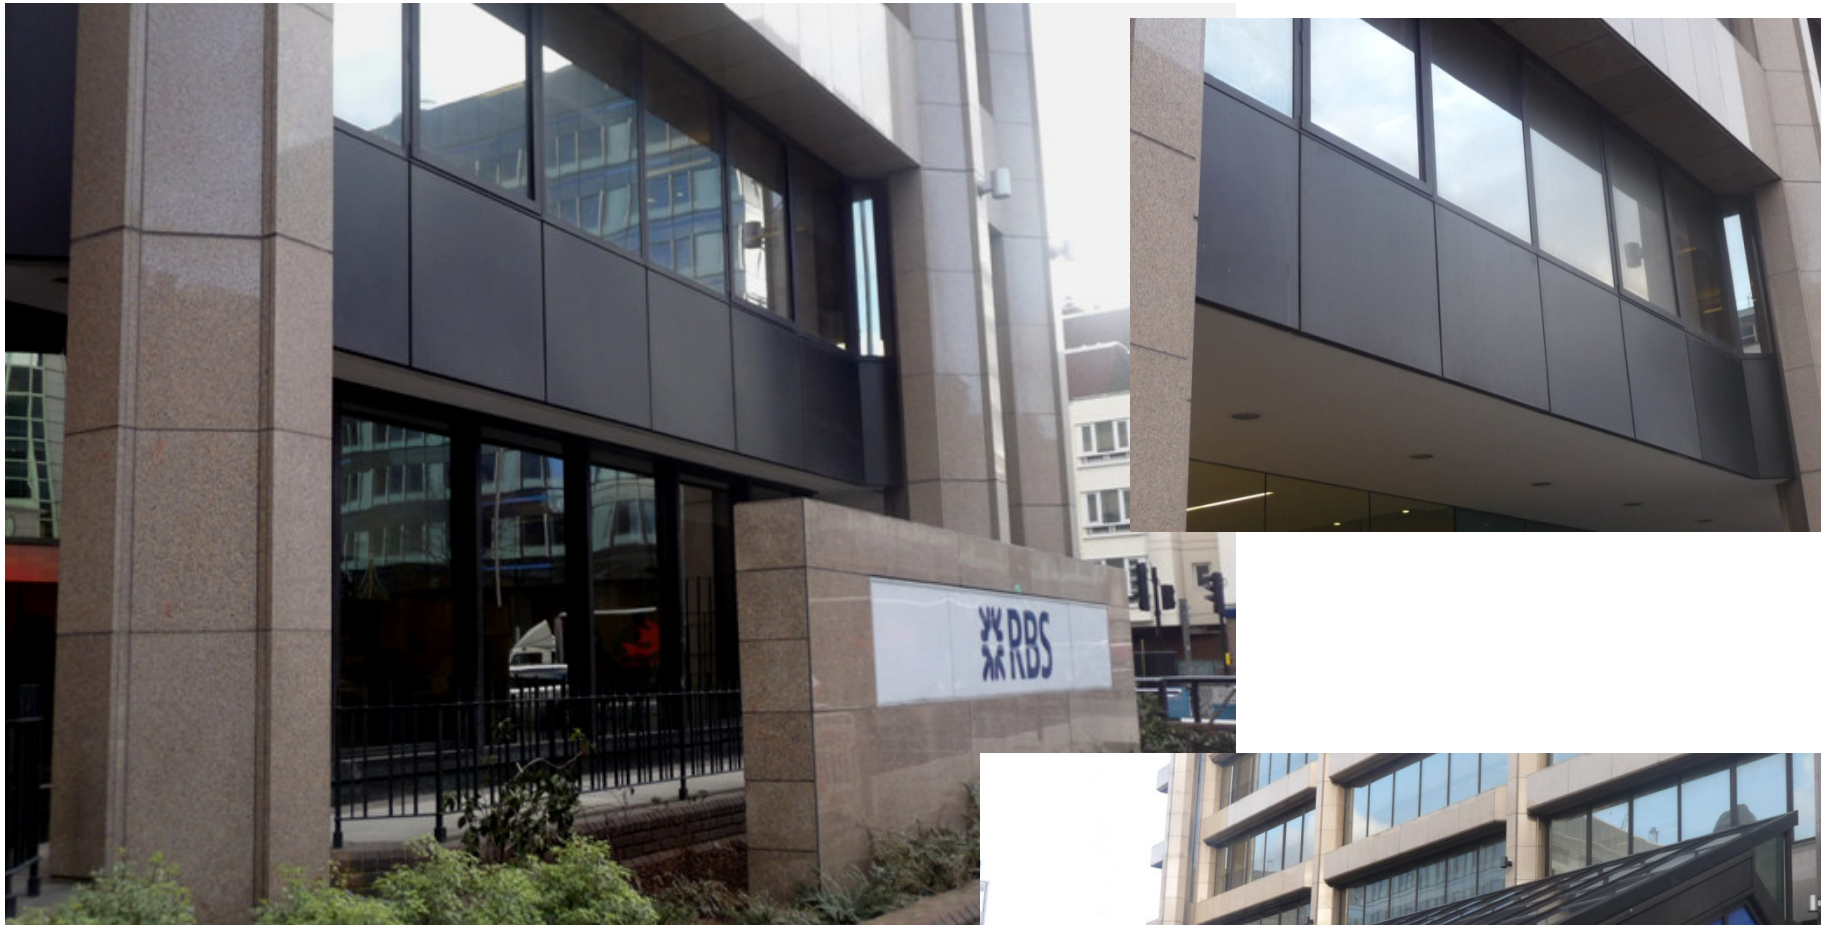
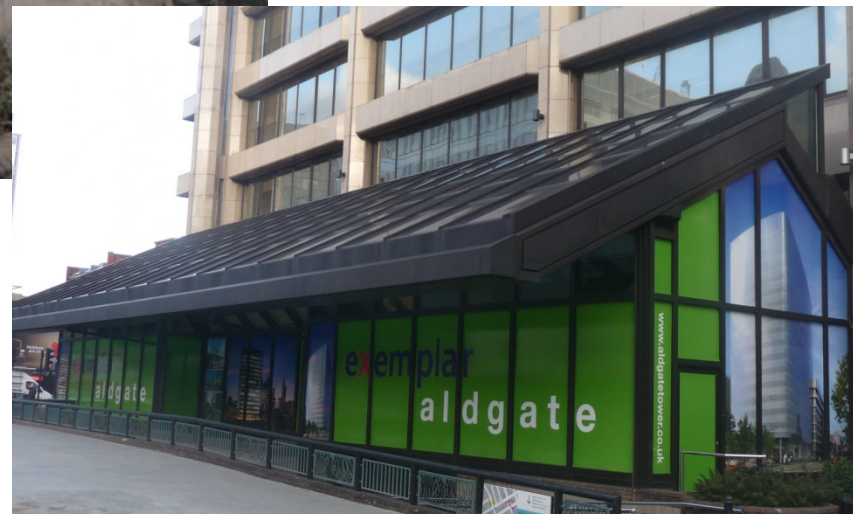
**RBS – Aldgate Building
(ex. Sedgwick centre)
Whitechapel High Street
London E1**

Address of building	RBS – Aldgate Building (ex. Sedgwick centre) Whitechapel High Street London E1
Date of independent inspection	November 2008
Use of building	Bank offices
Date of construction	1977
Environment	High traffic density – financial district of London
Evidence of regular cleaning or maintenance	No
External parts of building which were anodised	Window frames – Canopy – Solid Panels
Type of anodising	Batch
Anodiser	United Anodisers: LHT Anodisers, Uxbridge
Description of anodic colour and treatment	Anolok I - Dark Bronze – 547
Original anodic film layer on anodised parts (microns)	Class 25 μm (AASC specifications)
Anodic film layer on date of independent inspection (microns)	28.6 μm
Visible signs of corrosion or surface degradation	None
Conclusion	No deterioration in anodic film protection after 31 years service life. No visible evidence of corrosion notwithstanding high density polluted urban environment. No discernable colour change.

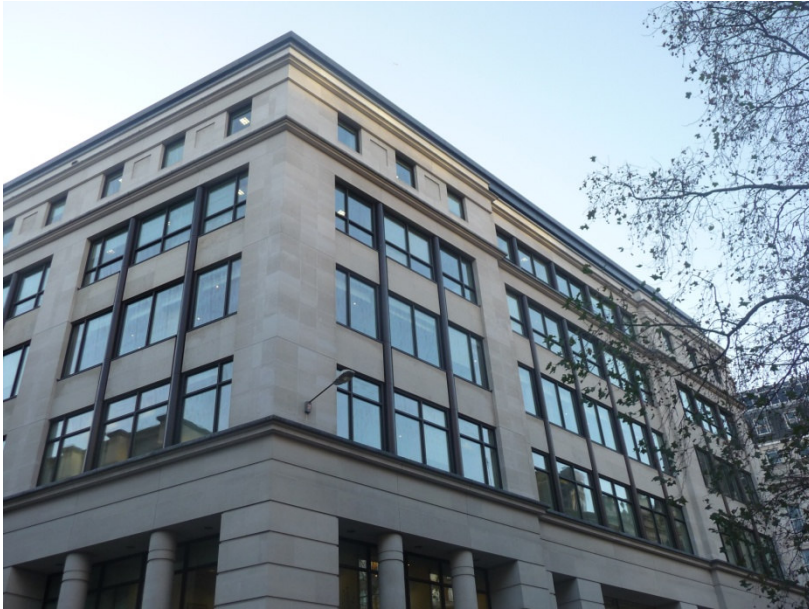
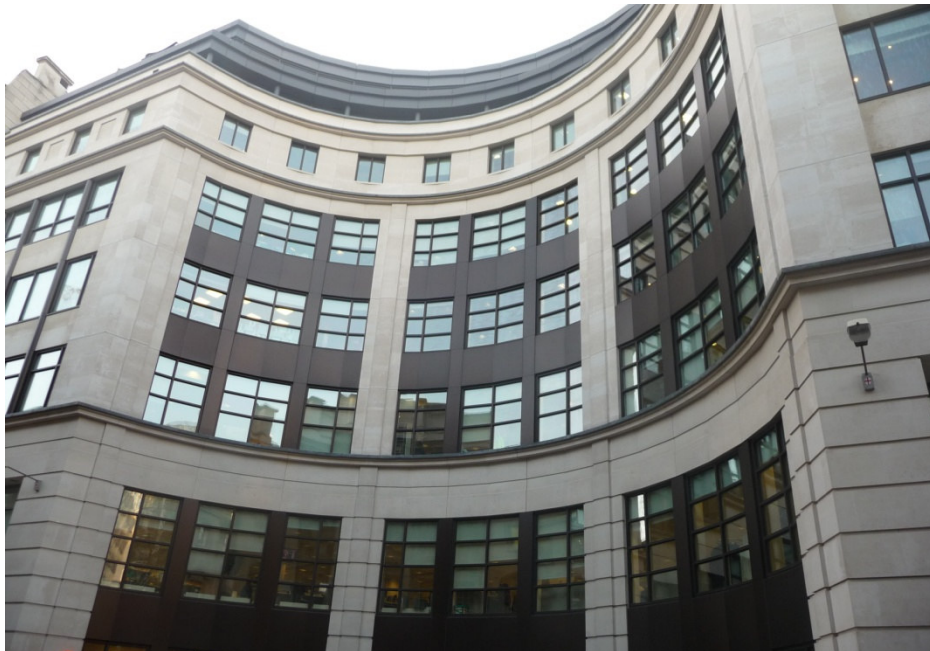
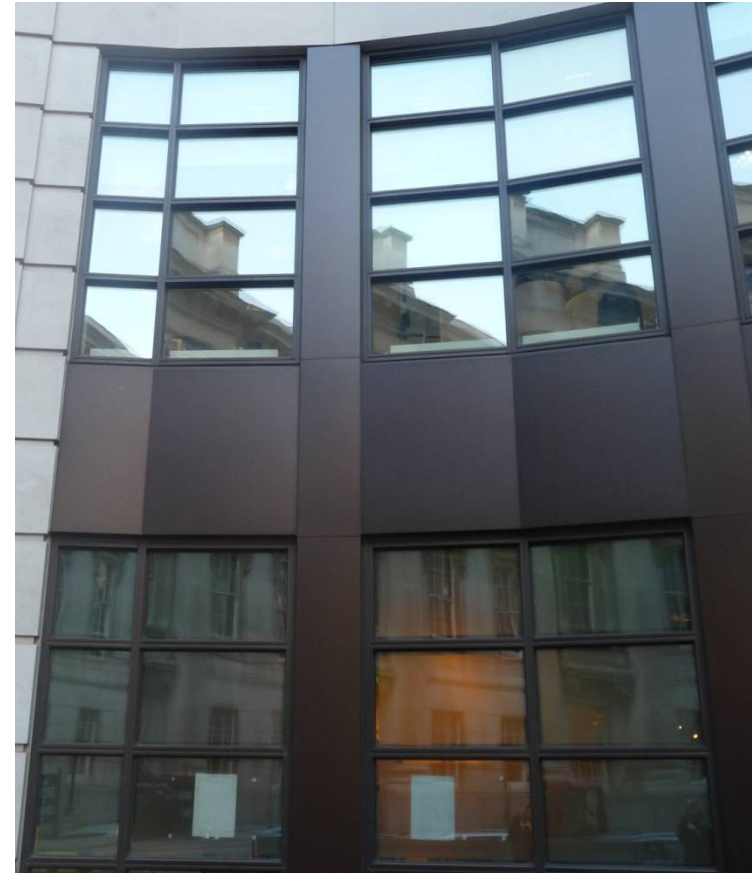
**Investec – RBS Building
2 Gresham street
London EC2**

Address of building	Investec – RBS Building 2 Gresham street London EC2
Date of independent inspection	November 2008
Use of building	Bank offices
Date of construction	1996
Environment	London centre - High traffic density
Evidence of regular cleaning or maintenance	No
External parts of building which were anodised	Window frames
Type of anodising	Batch
Anodiser	United Anodisers: Heywood Metal Finishers, Huddersfield
Description of anodic colour and treatment	Anolok I Dark Bronze -547
Original anodic film layer on anodised parts (microns)	Class 25 μm (AASC specifications)
Anodic film layer on date of independent inspection (microns)	29 μm
Visible signs of corrosion or surface degradation	None
Conclusion	No deterioration in anodic film protection after 12 years service life. No visible evidence of corrosion notwithstanding high density polluted urban environment. No discernable colour change.
