Independently certified audit of the long term on-site performance of batch anodised aluminium extrusions and panels on exterior architectural applications in the UK

**UNITED
ANODISERS**

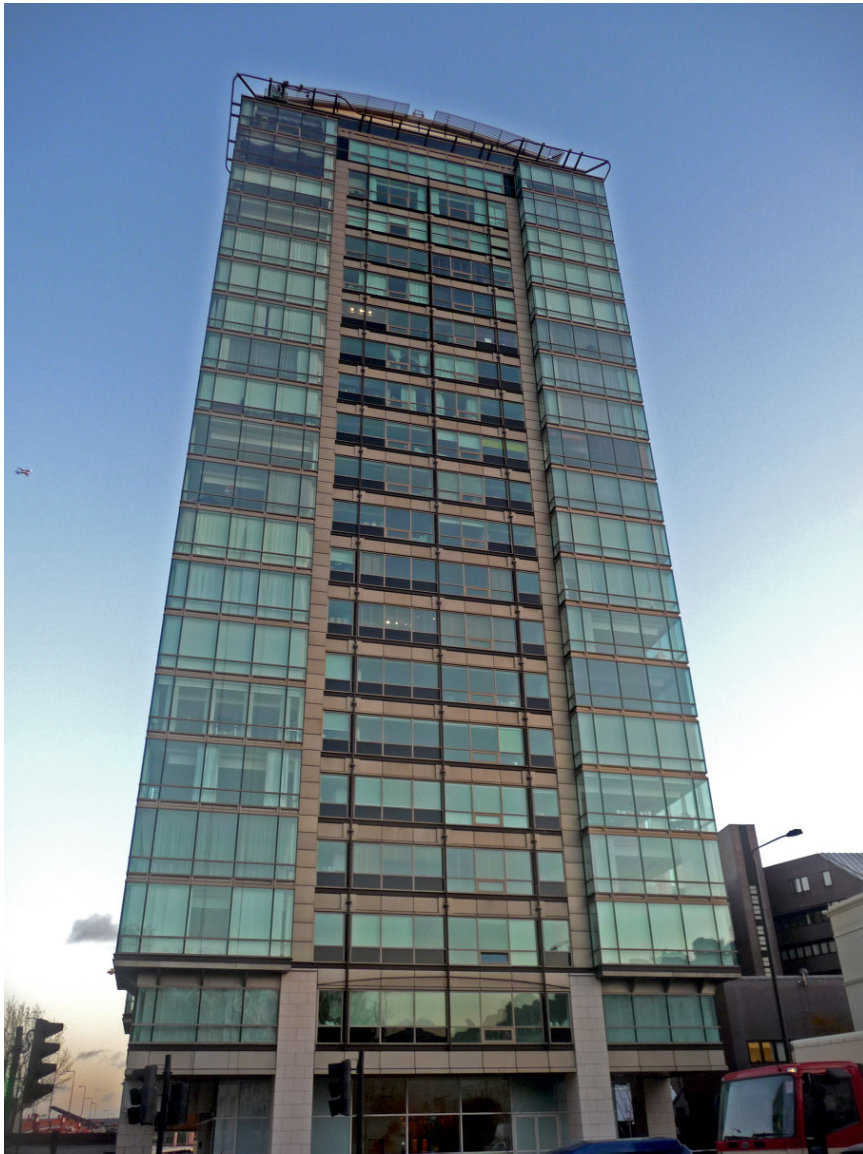
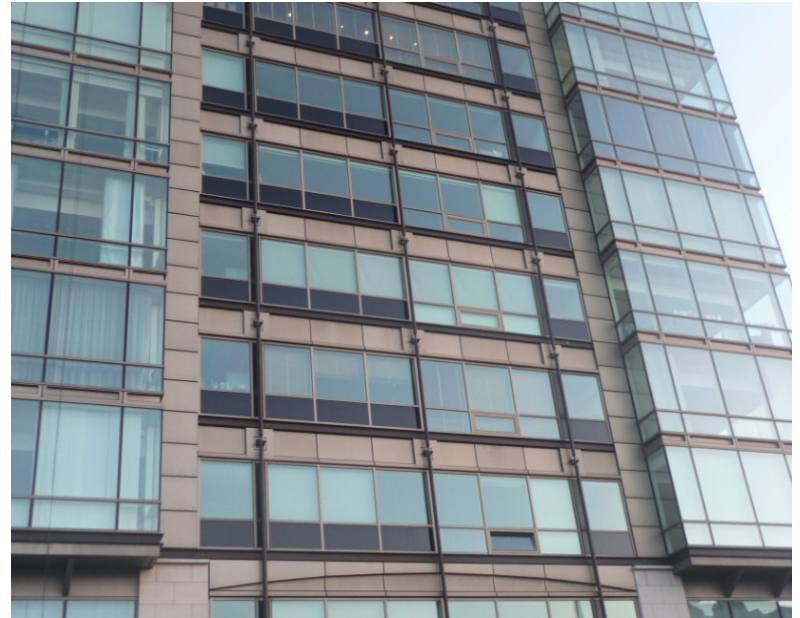
**The Panoramic-Rivermill House
152 Grosvenor Road
London SW1**

Address of building	The Panoramic-Rivermill House 152 Grosvenor road London SW1
Date of independent inspection	November 2008
Use of building	Residential
Date of construction	1999
Environment	Adjacent to the river Thames - Centre of London
Evidence of regular cleaning or maintenance	No
External parts of building which were anodised	Window frames – Solid Panels
Type of anodising	Batch
Anodiser	United Anodisers: LHT Anodisers, Uxbridge
Description of anodic colour and treatment	Anolok I - Light bronze 541 and dark bronze 547
Original anodic film layer on anodised parts (microns)	Class 25 µm (AASC specifications)
Anodic film layer on date of independent inspection (microns)	No accessible for measurement
Visible signs of corrosion or surface degradation	None
Conclusion	No deterioration in anodic film protection after 9 years service life. No visible evidence of corrosion notwithstanding high density polluted urban environment. No discernable colour change.

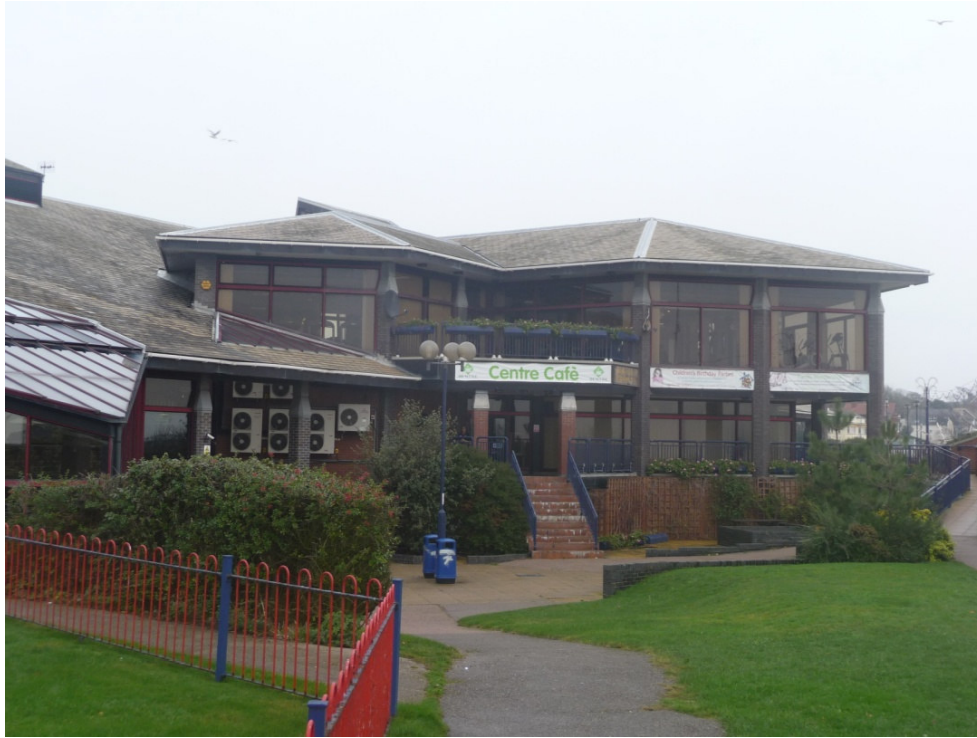
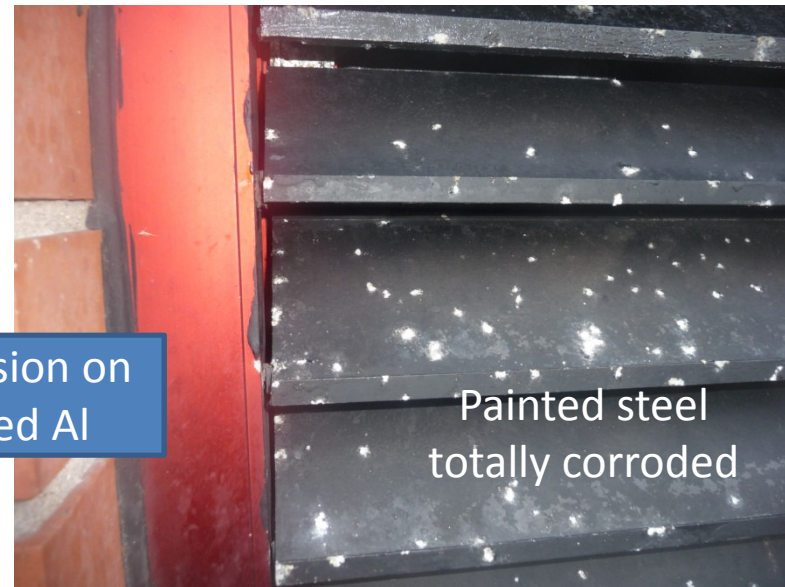
**Felixstowe Leisure Centre
Undercliff Road West,
Felixstowe, Suffolk**

Address of building	Felixstowe Leisure Centre Undercliff Road West, Felixstowe, Suffolk
Date of independent inspection	November 2008
Use of building	Leisure centre
Date of construction	1988
Environment	Marine – Sea front – North Sea coast
Evidence of regular cleaning or maintenance	No
External parts of building which were anodised	Window frames
Type of anodising	Batch
Anodiser	United Anodisers: LHT Anodisers, Uxbridge
Description of anodic colour and treatment	Sandalor Red C62/2
Original anodic film layer on anodised parts (microns)	Class 25 μm (AASC specifications)
Anodic film layer on date of independent inspection (microns)	29.1 μm
Visible signs of corrosion or surface degradation	None
Conclusion	No deterioration in anodic film protection after 20 years service life. No visible evidence of corrosion notwithstanding marine environment. No discernable colour change.

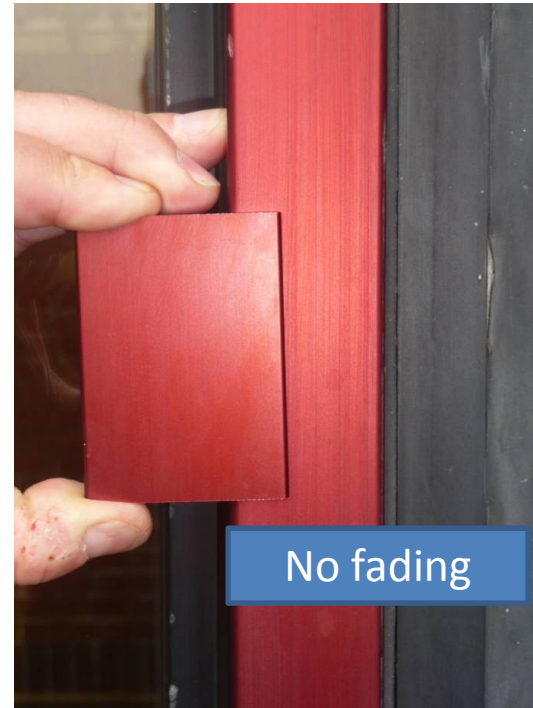
**No corrosion on
anodised Al**

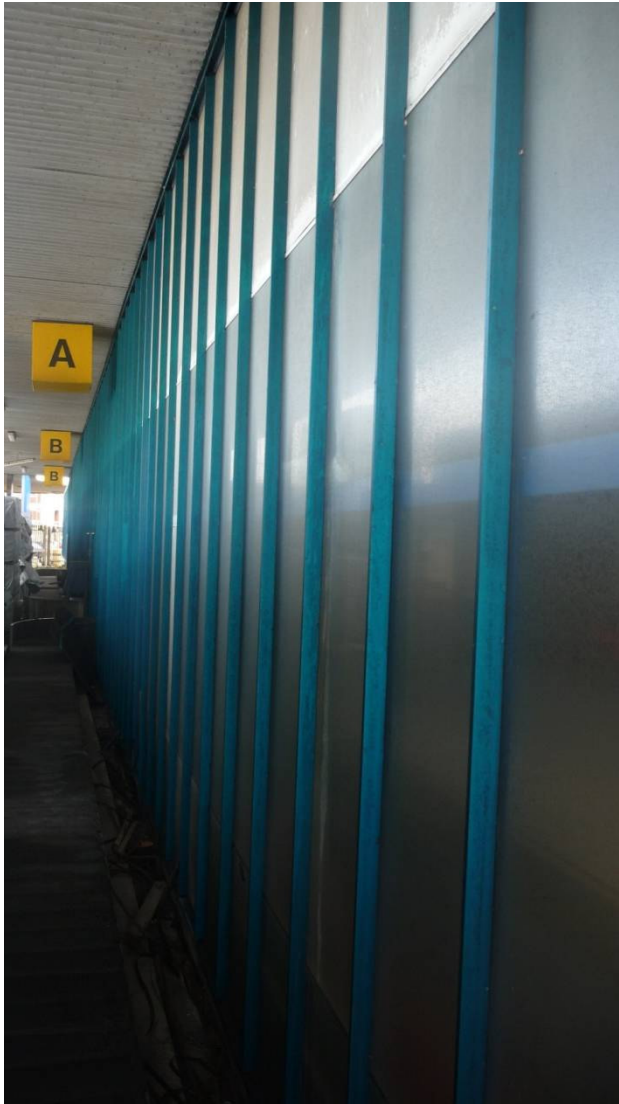
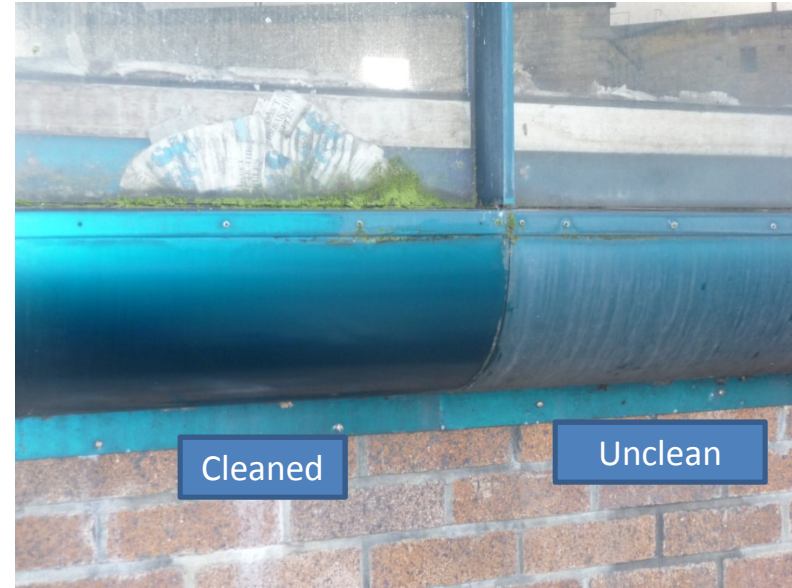
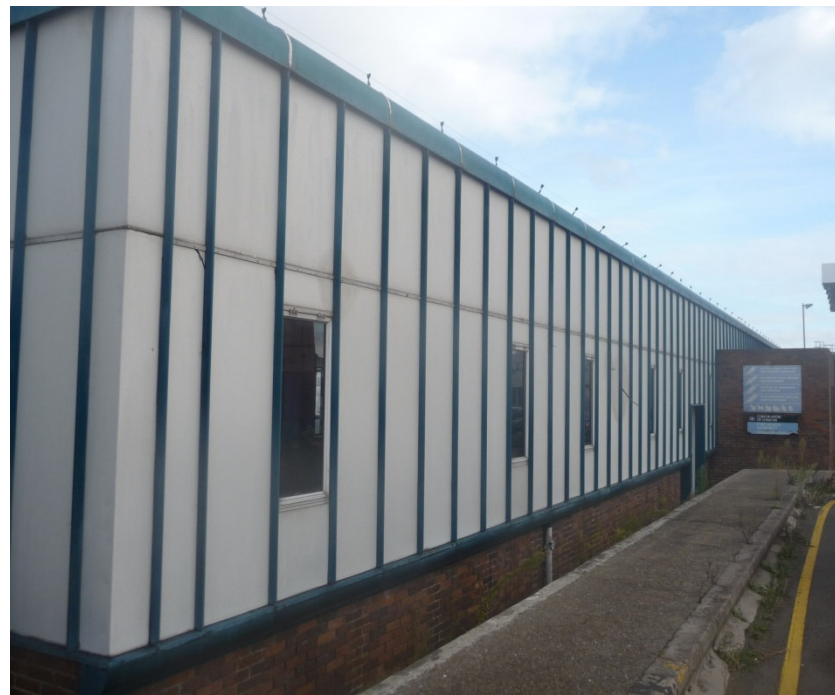
**Ex. Olau Line Offices
Port of Sheerness
Sheerness , Kent**

Address of building	Ex. Olau Line Offices Port of Sheerness Sheerness, Kent
Date of independent inspection	November 2008
Use of building	Shipping line offices
Date of construction	1985
Environment	Marine – Harbour front - Industrial – English Channel coast
Evidence of regular cleaning or maintenance	No (disaffected since 1994)
External parts of building which were anodised	Window frames – Sheets (curved)
Type of anodising	Batch
Anodiser	United Anodisers: LHT Anodisers, Uxbridge
Description of anodic colour and treatment	Sandalor Turquoise C63/3
Original anodic film layer on anodised parts (microns)	Class 25 μm (AASC specifications)
Anodic film layer on date of independent inspection (microns)	28.1 μm
Visible signs of corrosion or surface degradation	Very limited in a single place – all other materials in the neighbourhood are severely corroded
Conclusion	No deterioration in anodic film protection after more than 14 years service life. Small isolated area of corrosion. Front line marine environment. No discernable colour change.

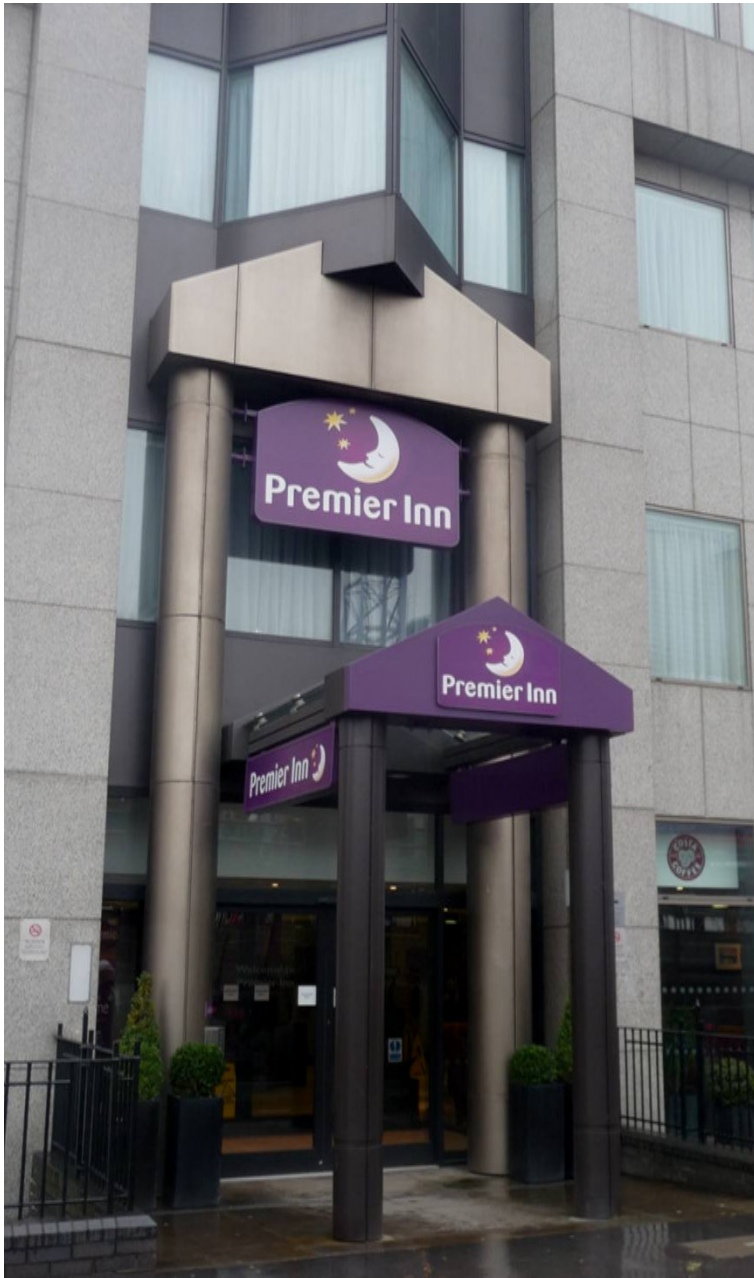
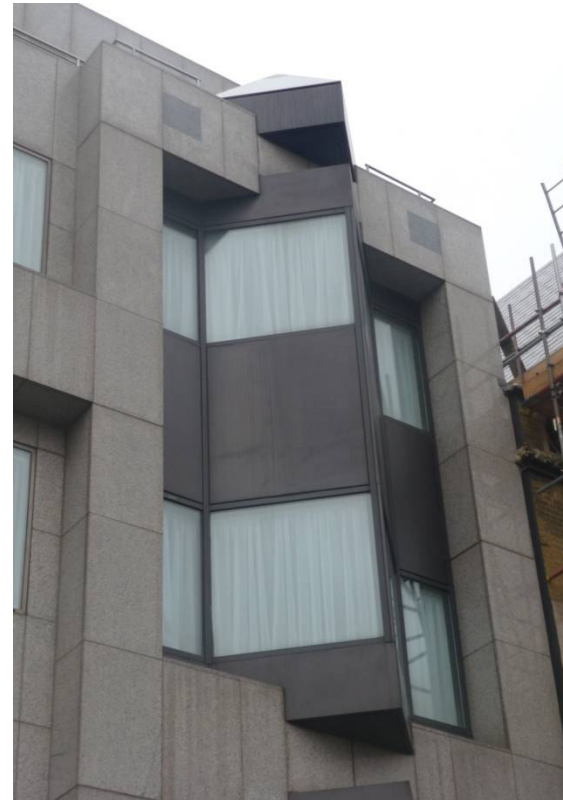
**Premier Inn
24 Prescott Street
London E1**

Address of building	Premier Inn 24 Prescott Street London E1
Date of independent inspection	November 2008
Use of building	Hotel
Date of construction	1988
Environment	Quiet street – Financial district of London
Evidence of regular cleaning or maintenance	No
External parts of building which were anodised	Flat and curved panels
Type of anodising	Batch
Anodiser	United Anodisers : LHT Anodisers, Uxbridge
Description of anodic colour and treatment	Anolok I Light bronze 541 Anolok II Dark blue-grey 717
Original anodic film layer on anodised parts (microns)	Class 25 μm (AASC specifications)
Anodic film layer on date of independent inspection (microns)	30.5 μm (only measured on bronze)
Visible signs of corrosion or surface degradation	None
Conclusion	No deterioration in anodic film protection after 19 years service life. No visible evidence of corrosion . No discernable colour change.

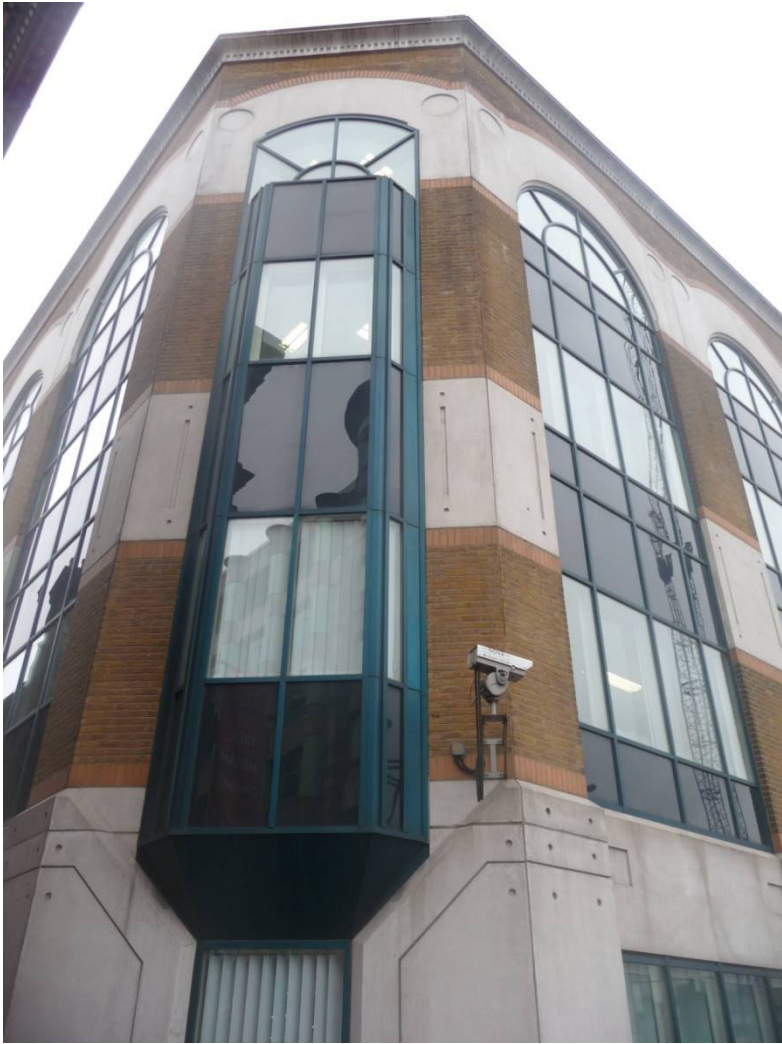
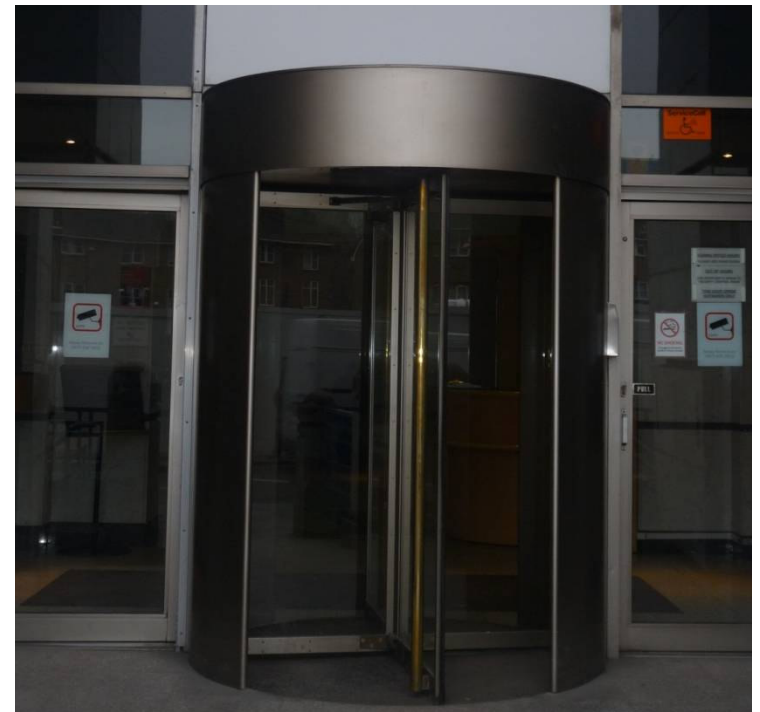
Address of building	Abbey National Building 21 Prescott Street London E1
Date of independent inspection	November 2008
Use of building	Offices
Date of construction	1989
Environment	Quiet street – Financial district of London
Evidence of regular cleaning or maintenance	No
External parts of building which were anodised	Sheets (Bronze) Windows frame (Sandalor)
Type of anodising	Batch
Anodiser	United Anodisers: LHT Anodisers, Uxbridge
Description of anodic colour and treatment	Anolok I Light bronze 543 Sandalor Turquoise C 63/3
Original anodic film layer on anodised parts (microns)	Class 25 μm (AASC specifications)
Anodic film layer on date of independent inspection (microns)	27.5 μm (bronze) 30.5 μm (turquoise)
Visible signs of corrosion or surface degradation	None
Conclusion	No deterioration in anodic film protection after 19 years service life. No visible evidence of corrosion . No discernable colour change.

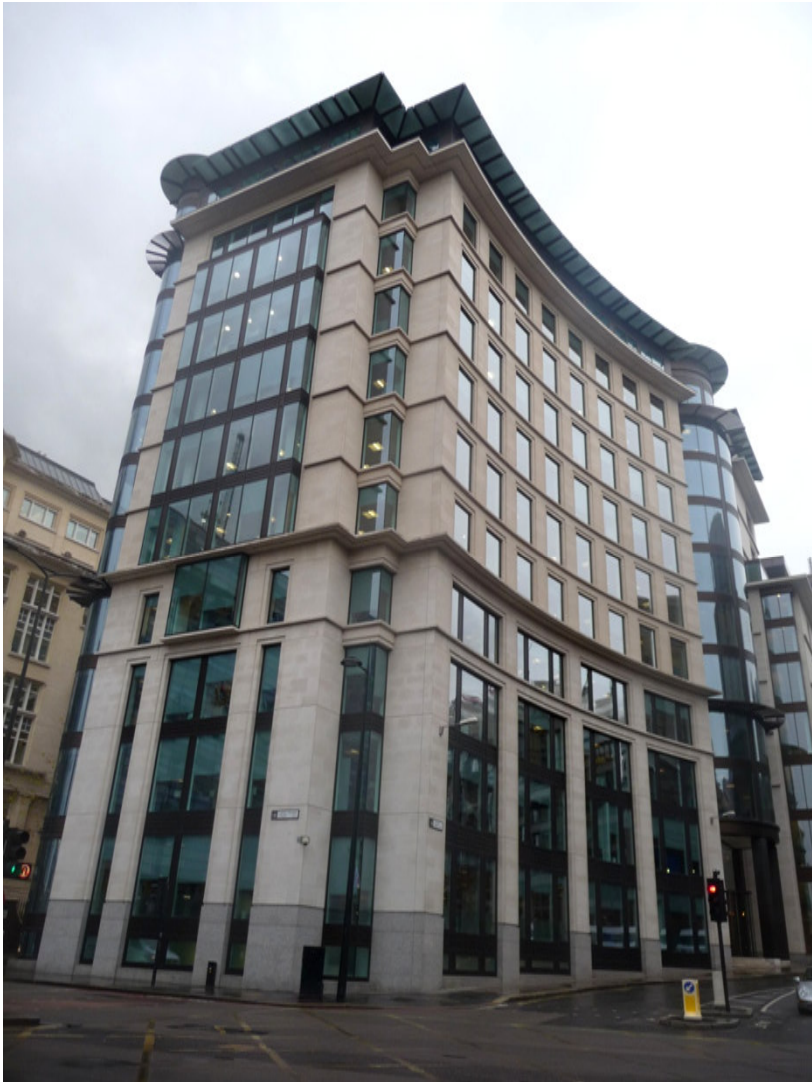
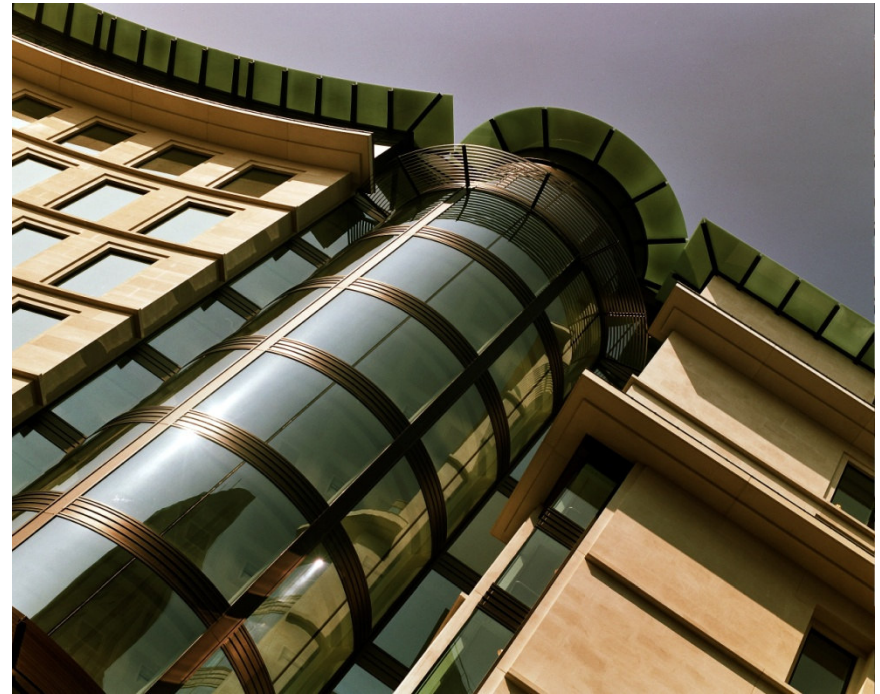
**12 Arthur Street
London EC4**

Address of building	12 Arthur Street London EC4
Date of independent inspection	November 2008
Use of building	Prestigious office complex
Date of construction	2003
Environment	Urban – Centre of London
Evidence of regular cleaning or maintenance	No
External parts of building which were anodised	Window frames – Sheets
Type of anodising	Batch
Anodiser	United Anodisers: Heywood Metal Finishers, Huddersfield
Description of anodic colour and treatment	Anolok I Bronze 547
Original anodic film layer on anodised parts (microns)	Class 25 μm (AASC specifications)
Anodic film layer on date of independent inspection (microns)	28.5 μm
Visible signs of corrosion or surface degradation	None
Conclusion	No deterioration in anodic film protection after 5 years service life. No visible evidence of corrosion. No discernable colour change.

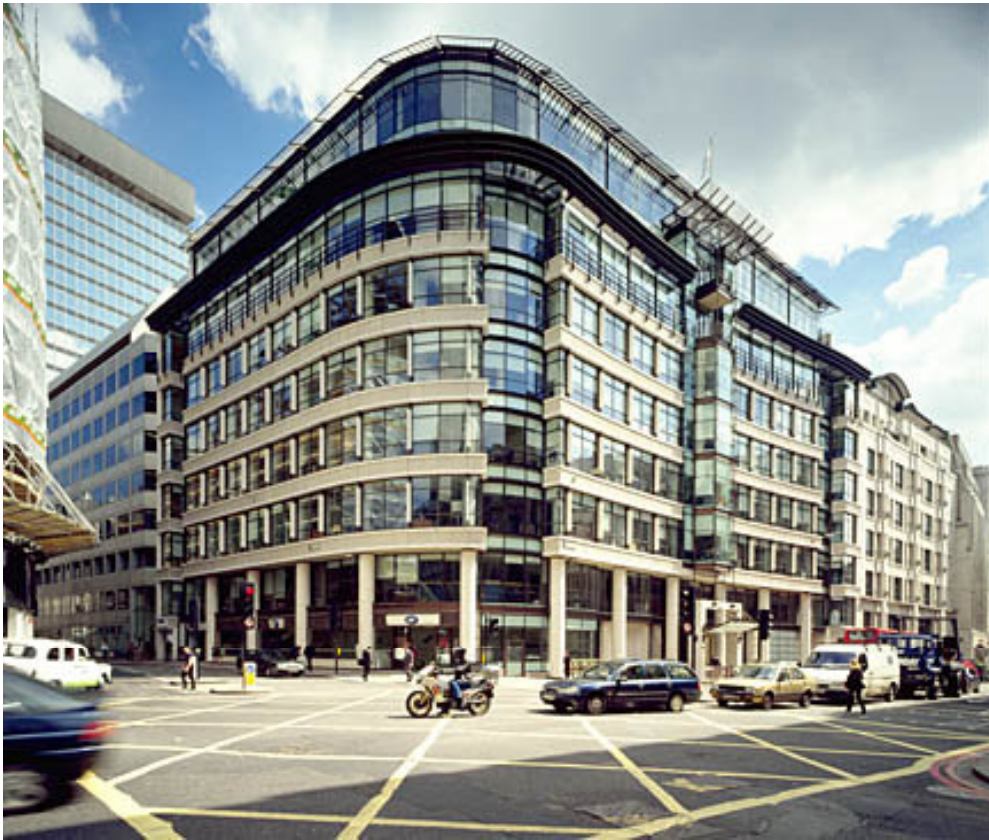
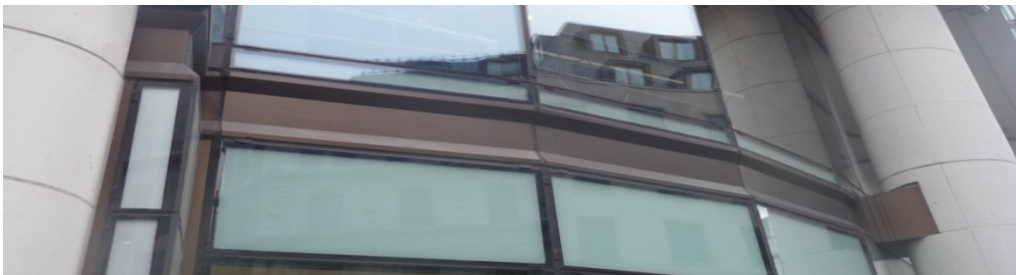
**60 Gracechurch Street
London EC3**

Address of building	60 Gracechurch Street London EC3
Date of independent inspection	November 2008
Use of building	Pharmacy + offices
Date of construction	1997
Environment	Urban – Centre of London
Evidence of regular cleaning or maintenance	No
External parts of building which were anodised	Window frames – Extrusion sections
Description of anodic colour and treatment	Anolok I Bronze 545
Type of anodising	Batch
Anodiser	United Anodisers : LHT Anodisers, Uxbridge
Original anodic film layer on anodised parts (microns)	Class 25 μm (AASC specifications)
Anodic film layer on date of independent inspection (microns)	27.4 μm
Visible signs of corrosion or surface degradation	None
Conclusion	No deterioration in anodic film protection after 11 years service life. No visible evidence of corrosion . No discernable colour change.

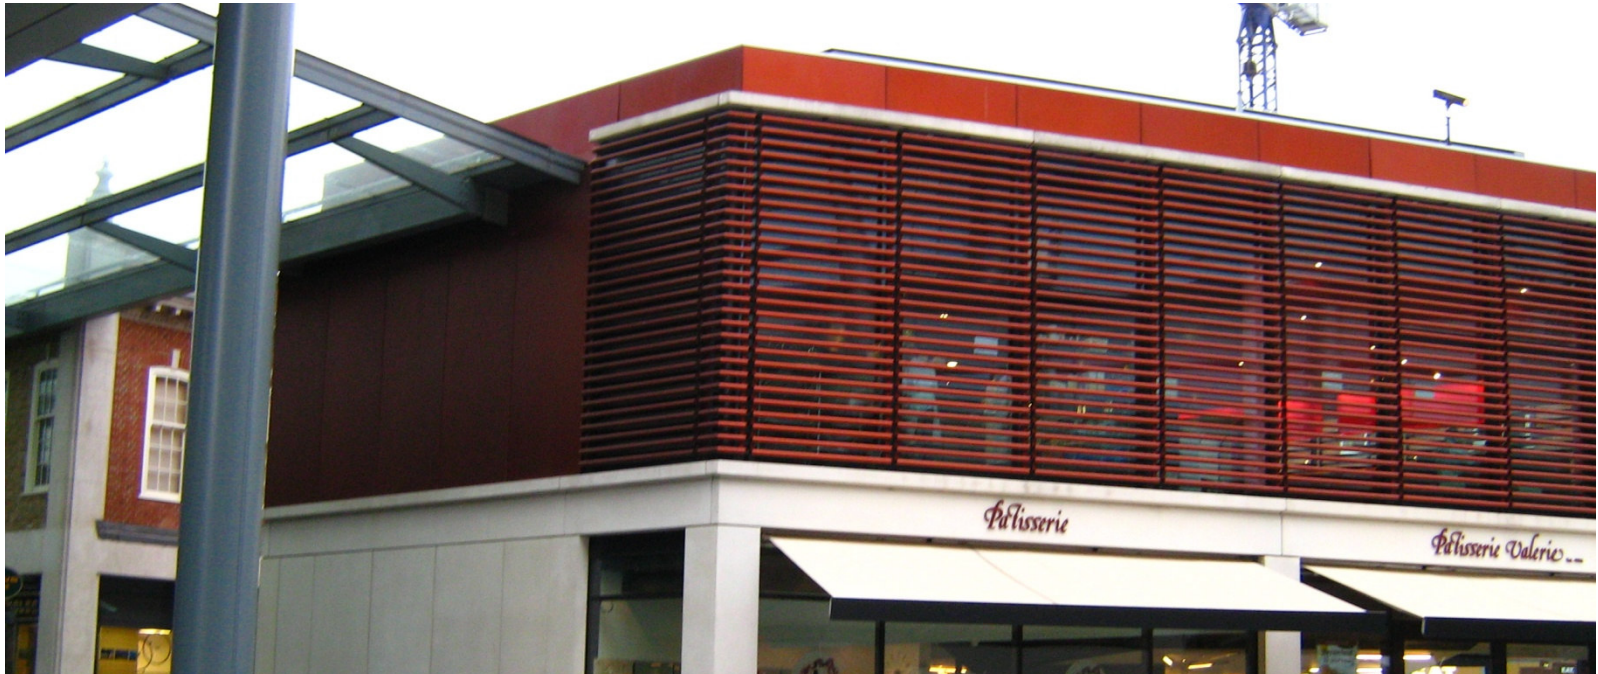
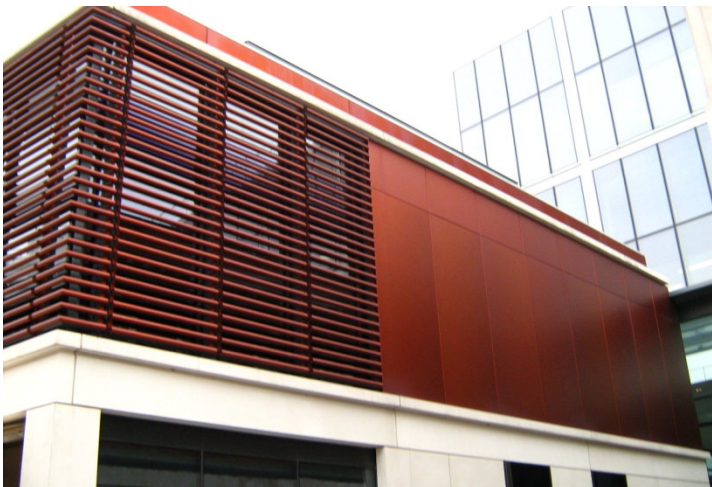
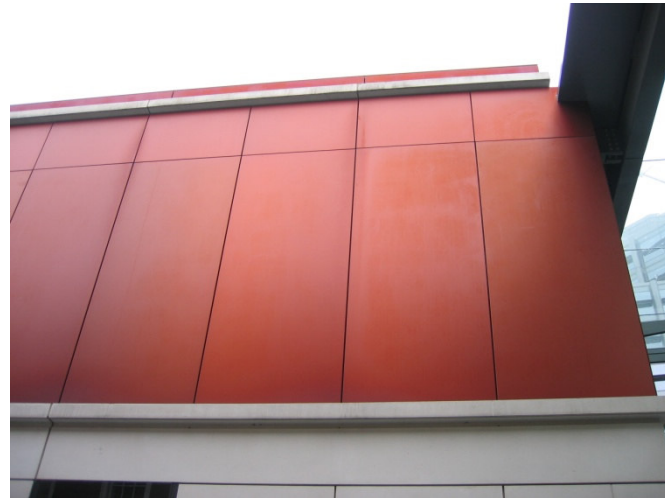
**Bishop Square
London E1**

Address of building	Bishop Square London E1
Date of independent inspection	September 2008
Use of building	Patisserie
Date of construction	2005
Environment	Urban – Centre of London
Evidence of regular cleaning or maintenance	No
External parts of building which were anodised	Tubes - Panels
Description of anodic colour and treatment	Sanodal – Orange 3LW
Type of anodising	Batch
Anodiser	United Anodisers: LHT Anodisers, Uxbridge
Original anodic film layer on anodised parts (microns)	Class 25 µm (AASC specifications)
Anodic film layer on date of independent inspection (microns)	Not accessible for measurement
Visible signs of corrosion or surface degradation	None
Conclusion	No visible evidence of corrosion or discoloration after 3 years service life in urban environment. No discernable colour change.
