August 30, 22

# Hayes Manor House

*Edenton, Chowan County North Carolina*

## Site Visit Report

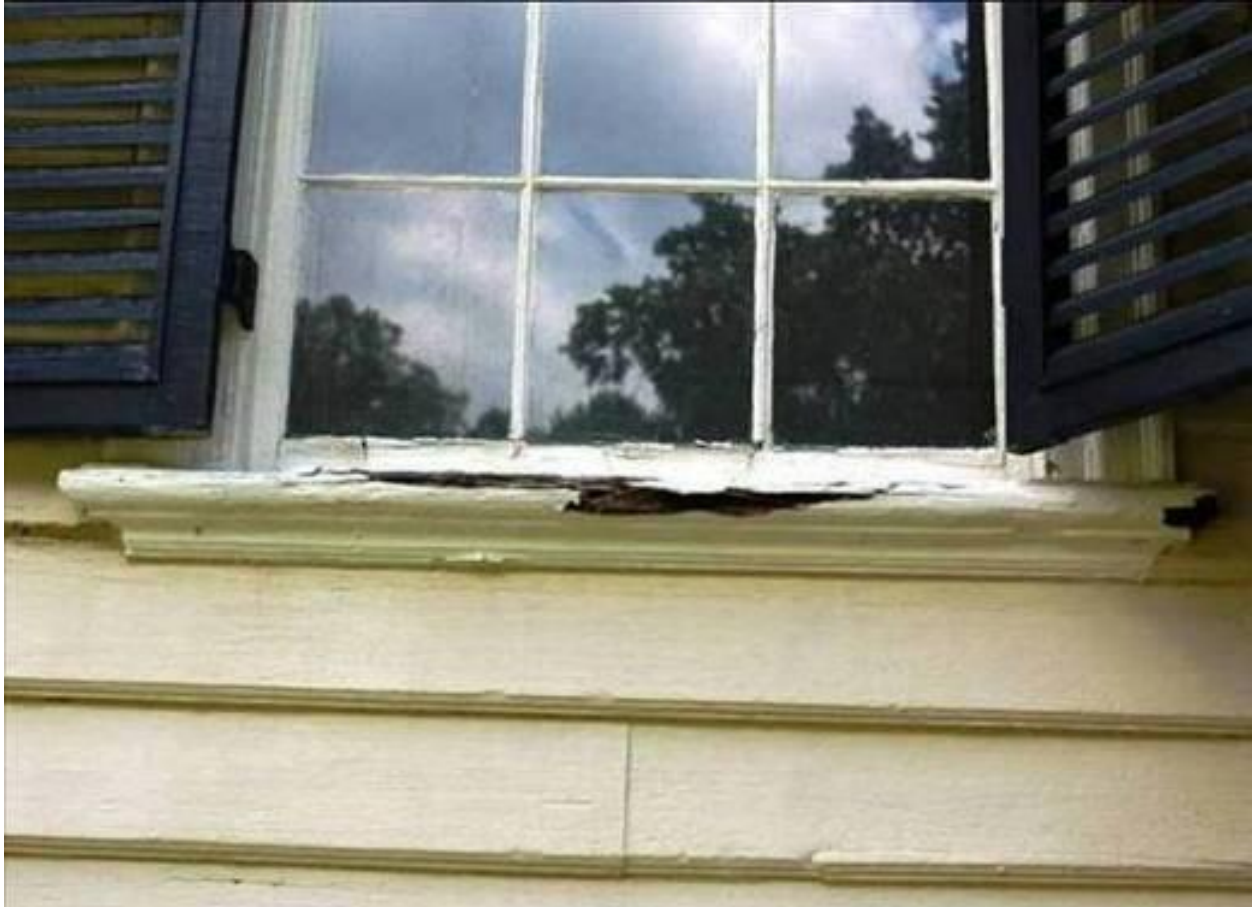
Fig. 4. Two-hundred-year-old windowsill decay, Sally Billy House, Halifax

Wood rot most commonly occurs when moisture becomes trapped inside wood. The decay in this windowsill was likely caused by a non-breathable thick-mil latex paint that was applied to the exterior woodwork. Also, note the decay in the bottom rail of the window sash. The use of low and non-breathable coatings increases the potential for wood decay on exterior woodwork - especially in areas prone to decay. Exacerbating this problem is increasing rainfall, humidity, and severe weather events. Foundation moisture issues can also significantly increase the potential for premature wood decay and other issues such as termite activity, foundation settlement, and masonry deterioration.

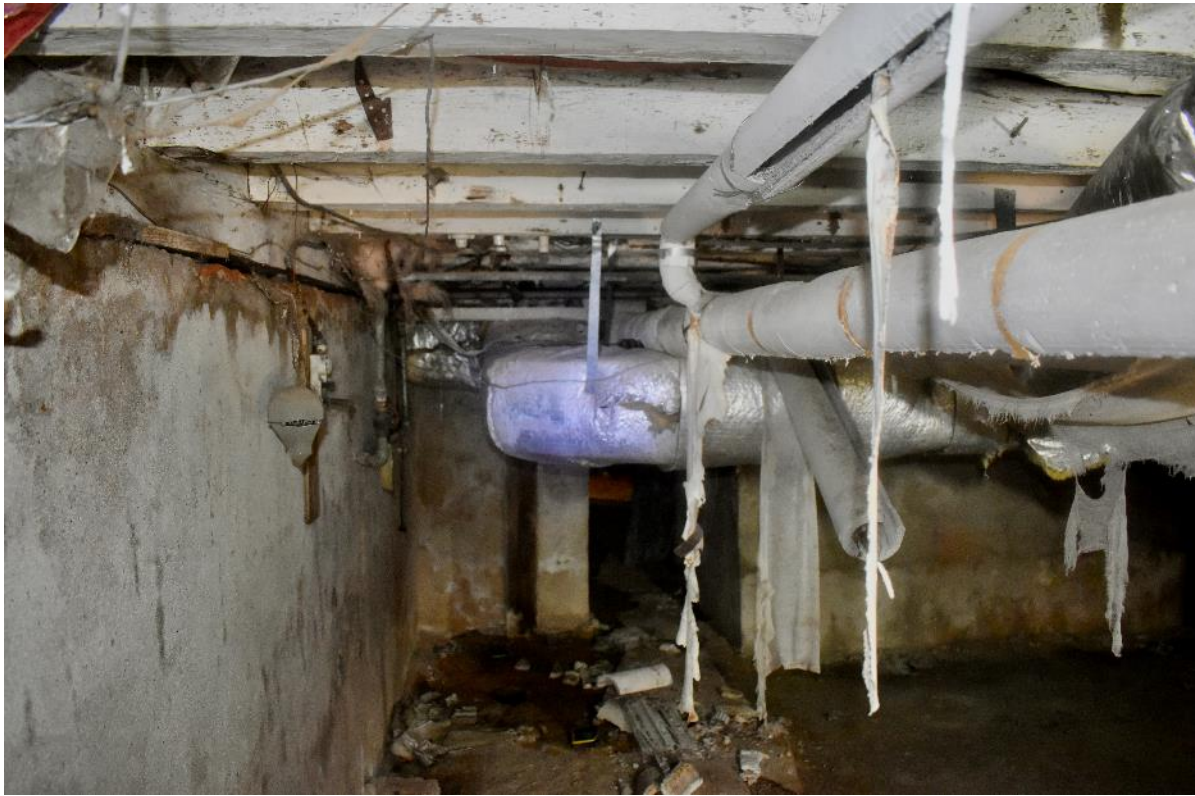
Deteriorated pipe-wrap insulation was observed in the basement (fig. 5). If the insulation contains asbestos, it can pose a serious health risk to workers or anyone spending time in

Fig. 5. Deteriorated pipe insulation in basement.

the basement. The pipe insulation along with other sources of asbestos should be inspected and abated (removed or encapsulated) by a qualified professional. It is recommended that an asbestos inspection and necessary abatement be conducted prior to other work in the basement.

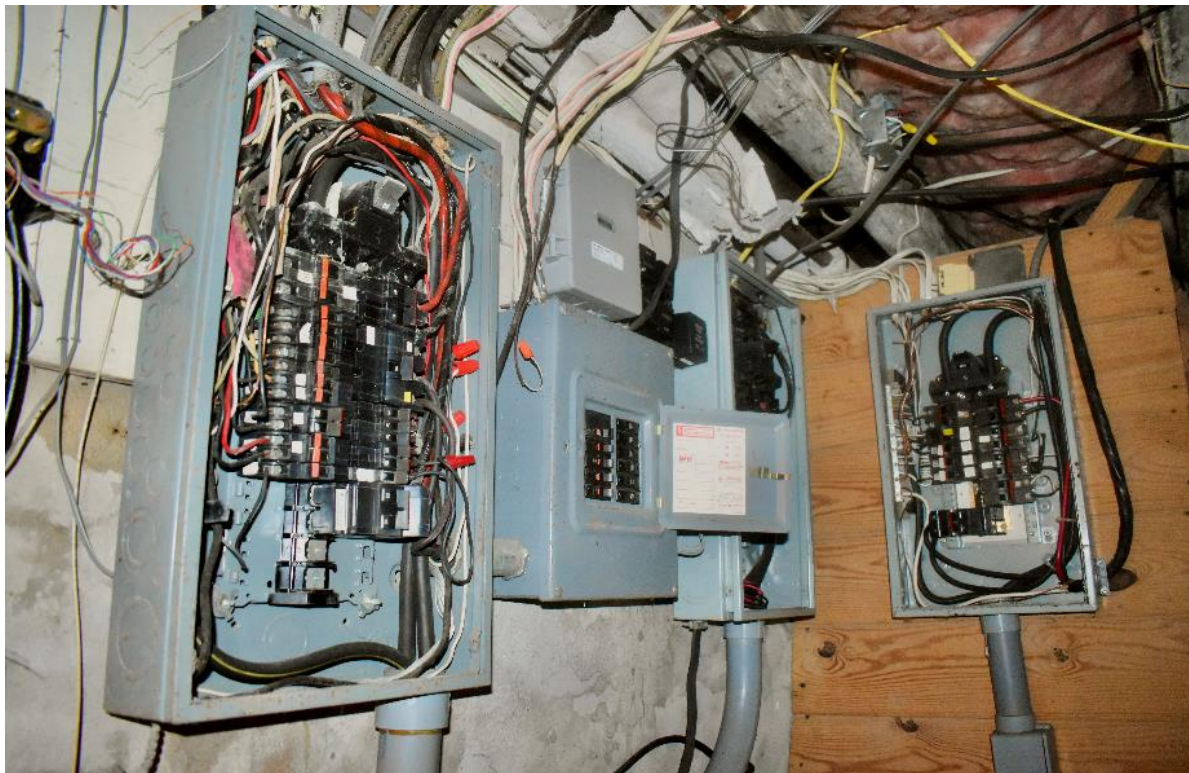
Several **safety** and potential **fire** concerns were observed with the electrical system. In our cursory walk-through we observed open electrical junction boxes (fig. 7) in several locations, uncovered panel boxes in the basement, (fig. 6), questionable splices, deteriorated condition of some wiring, and other issues.

6. Uncovered electrical panel boxes in the south wall of the basement. Note damaged water pipe insulation above the panel boxes.

An experienced and qualified electrical engineer/electrician should be hired to thoroughly inspect the electrical system. It is likely that portions of the electrical system will need to be disconnected for potential safety/fire concerns. Temporary repairs and re-routing of

some of the wiring, panel boxes, or other components may also be necessary until repairs and replacement of deteriorated and aged electrical system can be accomplished.

Temporary measures might also include upgrading panel boxes with arc fault breakers. An electrical contractor may also be able to install easy to access switches (in an accessible location) that shuts-off all non-essential power to areas of the building that are not in continuous use. For example, power could remain on 24/7 to HVAC units, security lighting, security systems, refrigerator, and any other necessary areas while shut-off to the rest of the house. When power is needed for cleaning or other uses, main power switches could be turned-on for temporary use and switched-off when finished. At Hope Plantation in Bertie County, a single switch was installed by the electrician inside the basement door. Museum staff and volunteers use this door to enter the house. When the switch is turned-on lights and outlets needed for tours and other functions inside the house are powered up. The switch gets turned off when the building is unoccupied. This measure was taken due to the aged electrical wiring in the house.

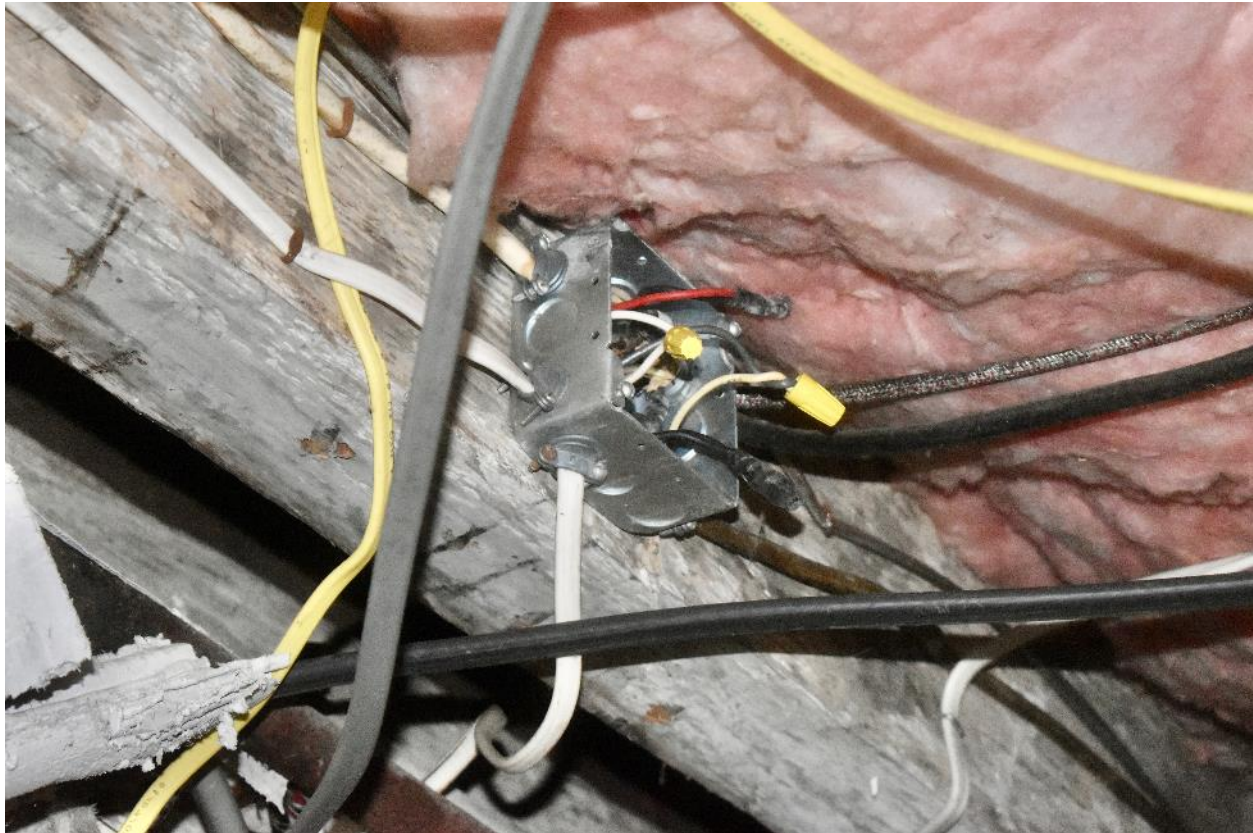
Fig. 7. Uncovered junction box in basement. Note exposed wire (at top) close to fiberglass insulation.

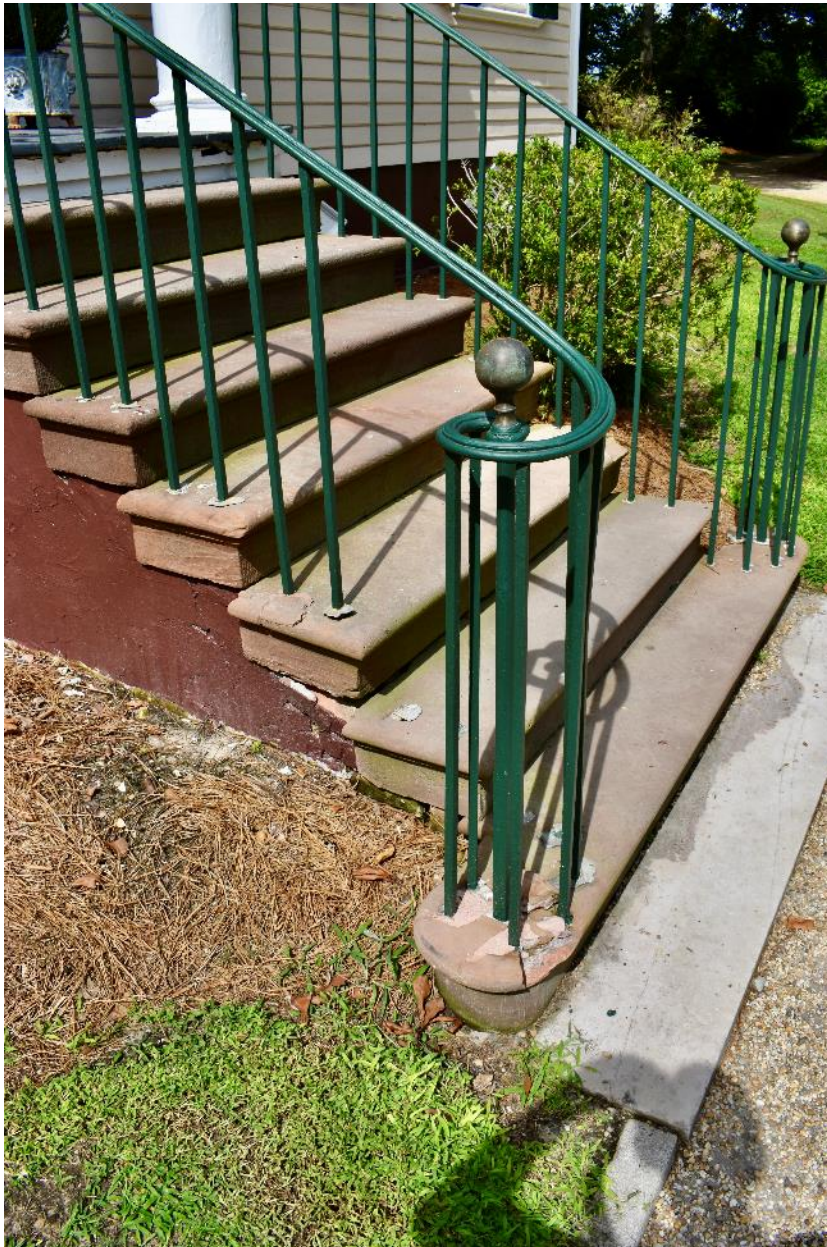
Entrance steps on both north and south elevations pose a safety risk. A few of the stones have become dislodged from the masonry base (fig. 11). On the north elevation (fig. 9) a couple of the original wrought-iron rails have been removed. Susan Wood mentioned that she has the iron balusters that were removed.

Fig. 9 North elevation entrance steps and railings.

Repairs, stabilization, and conservation work to the original stone steps and ironwork (figs. 9, 11, &12) should be carried out by an experienced restoration stonemason and metal

specialist. For safety reasons and to protect the steps and ironwork from further damage until repairs can be made, temporary measures should be considered to provide safe access to the house. Especially concerning is moving furniture and heavy objects, equipment, on the fragile and loose stone steps.

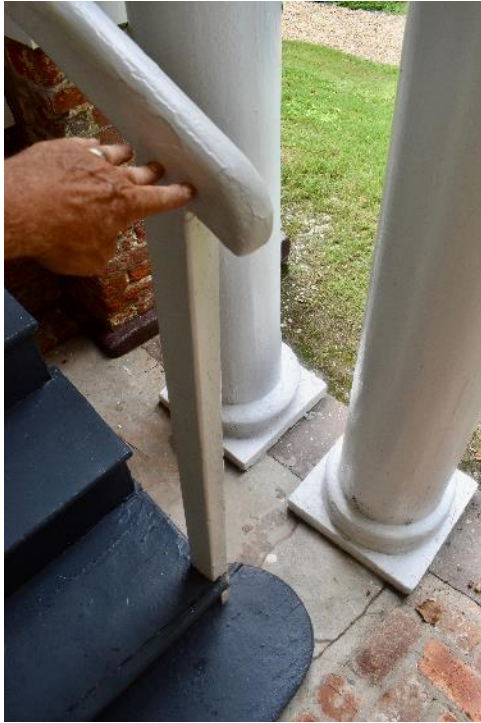
A wood railing on the south elevation, west side, is loose and poses a safety risk (fig. 10). This original or old handrail should be secured by an experienced restoration carpenter/contractor.

Fig. 10. Loose wooden handrail - south elevation, west side.

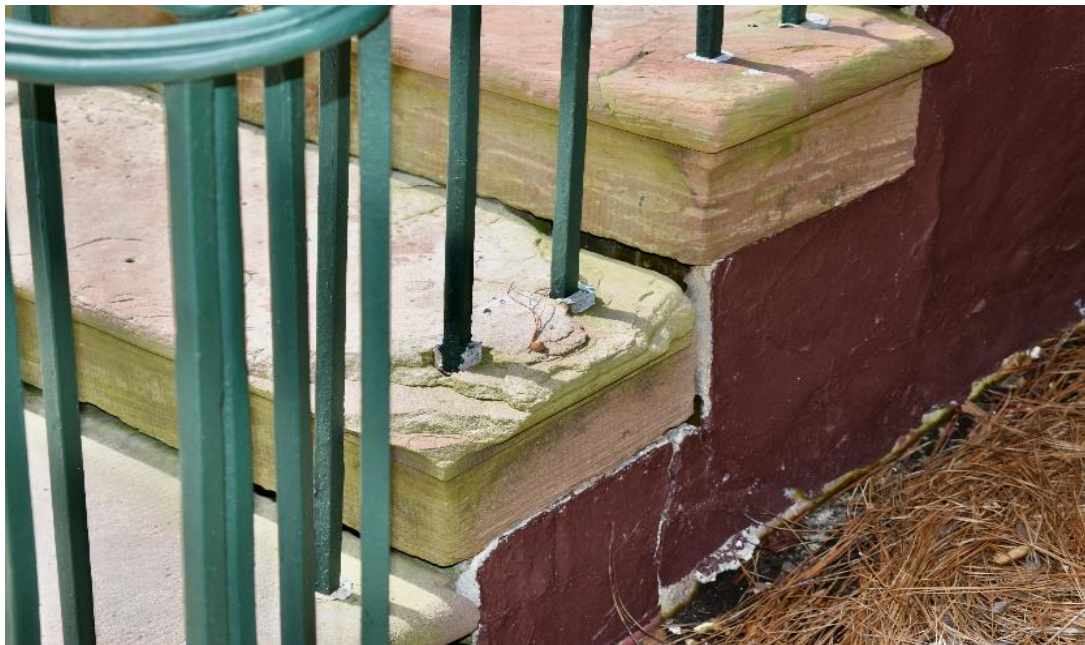
Fig. 11 - below. North Entrance steps - dislodged and spalling stone steps.

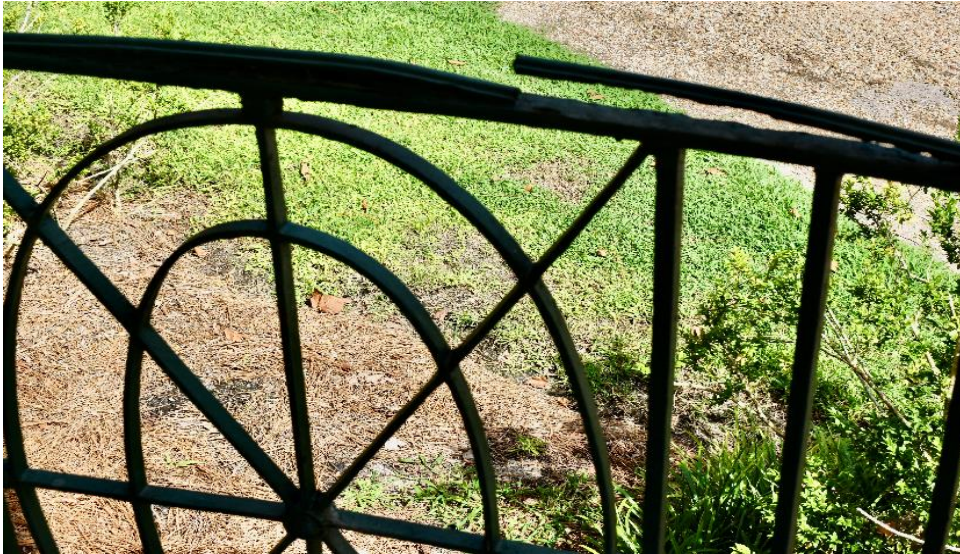
Fig. 12. Damage to original wrought iron porch railing

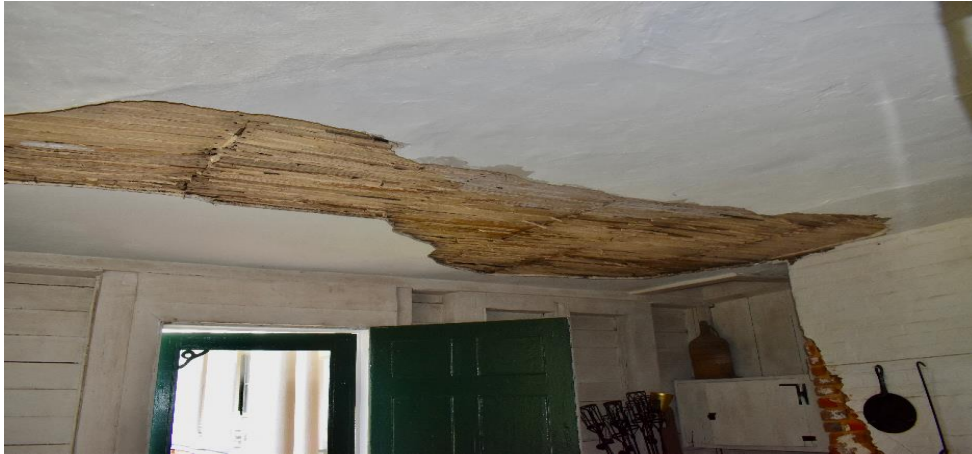
Loose and detached areas of plaster were observed in the cupola and kitchen (fig. 13) – and poses a safety risk. Loose areas of ceiling plaster (throughout the house) should be repaired or temporarily secured.

Fig. 13. Damaged and falling area of plaster in the original kitchen

One method to secure loose plaster is to install plaster washers. Plaster washers are inexpensive and easily installed. Perforated plaster washers can be installed in a temporary manor to secure plaster or permanently fixed and plastered over. There are several sources of plaster washers that can be found in a web search – such as this sample source: <https://www.charlesstsupply.com/plaster-washers>

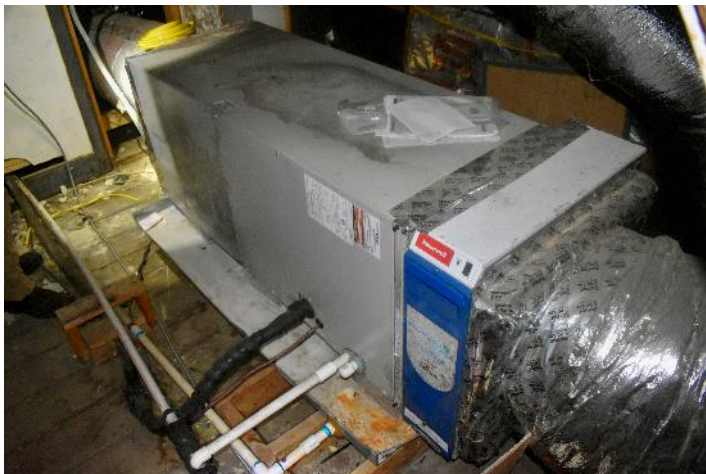
The condensation overflow pan for the attic unit is damaged and corroded in areas. The owner mentioned that the condensation overflow from the attic unit damaged the ceiling above the staircase in recent years. The pan should be inspected and repaired/replaced by an experienced and qualified HVAC technician. Both units should also be checked for

Fig. 14. Attic HVAC unit. system.

condition and serviced. Each unit has an electronic air filtration. The electronic filters along with the HVAC system filters should be inspected and cleaned/replaced per the manufacturer's recommendation.

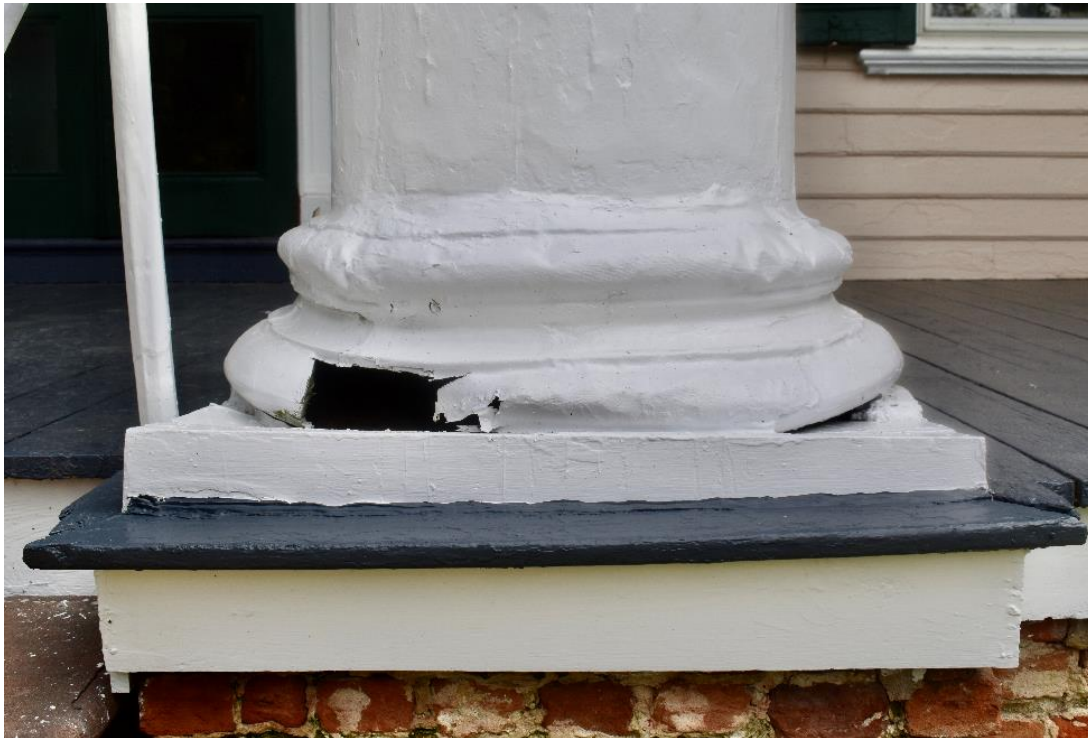
Fig. 15. Deteriorated column base – south porch

The porch structure, flooring, masonry foundation (figs. 16 & 17), and columns – especially the decayed wood column base and plinth block on the south porch (fig. 15), should be evaluated by an experienced restoration contractor, qualified structural engineer, or preservation architect. The specialist should identify structural repair needs along with recommendations for any serious structural concerns that should be addressed as soon as possible. Additional any non-structural repairs can be accomplished at a later phase.

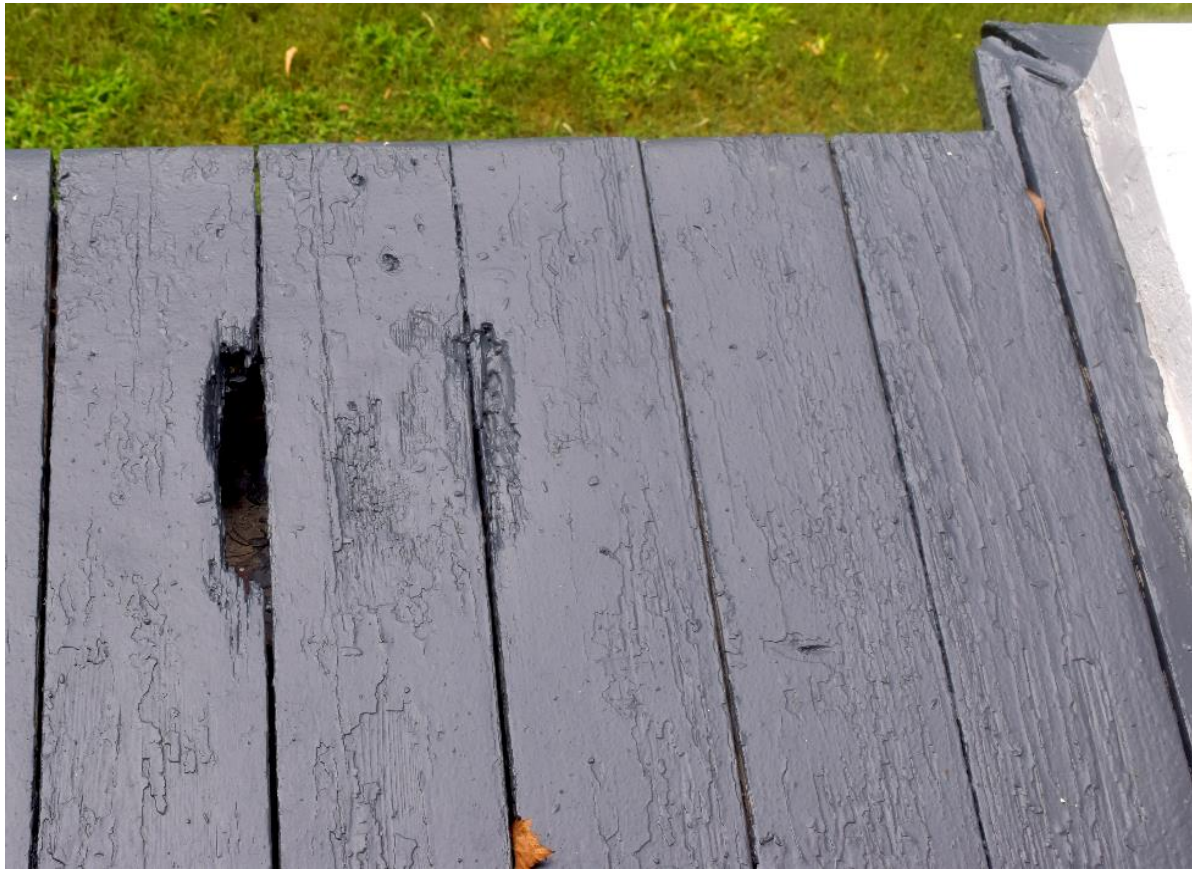
Fig. 16. South porch floor decay. Deterioration was also noted in areas of the outer porch framing member.

It appears that thick layers of non-breathable paints may be trapping moisture inside the wood - causing this decay. Fiberglass mesh was used to repair/patch the west end column (lower section) and base. This coating may not be breathable and trapping moisture in the wood column. To reduce the potential for decay in the lower sections of the column, bases and plinths, consideration should be given to removing layers of non-breathable paint, applying a wood preservative, followed by a breathable paint system (see attached articles, *Benefits of Using Wood Preservatives* and *Why Paints Fail: Common Paint Problems and Repainting Older Buildings*).

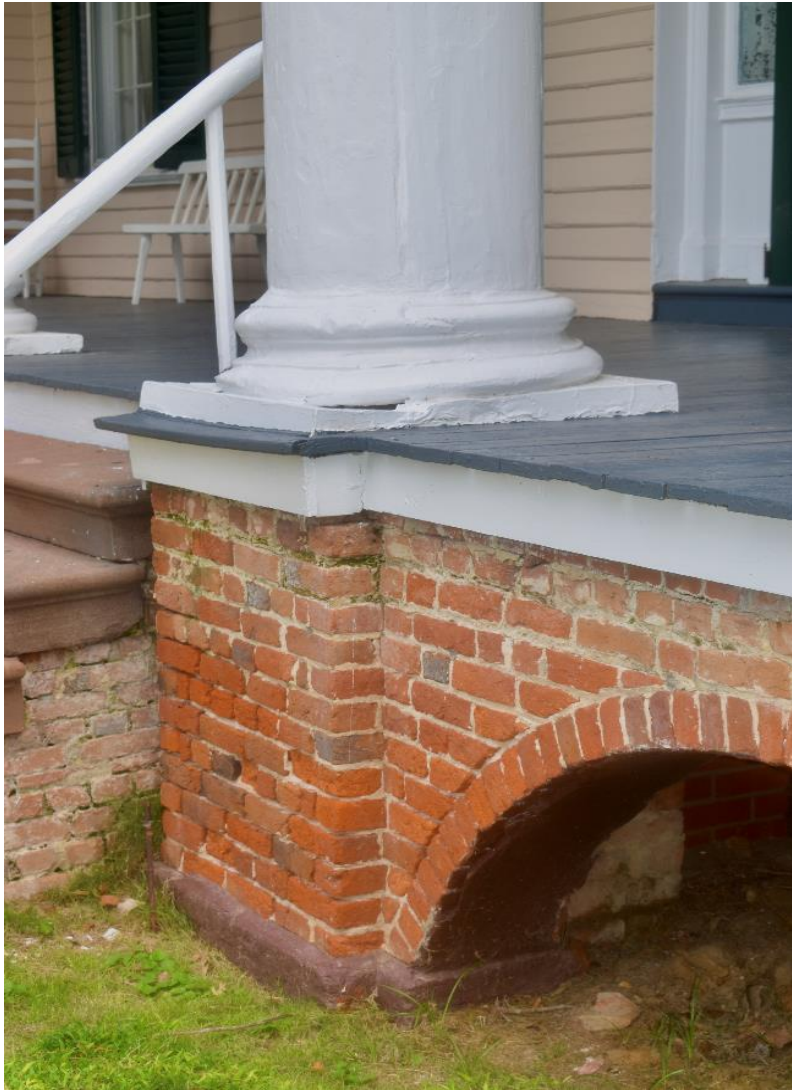
Fig. 17. South Porch – note deteriorated column plinth block and mortar loss.

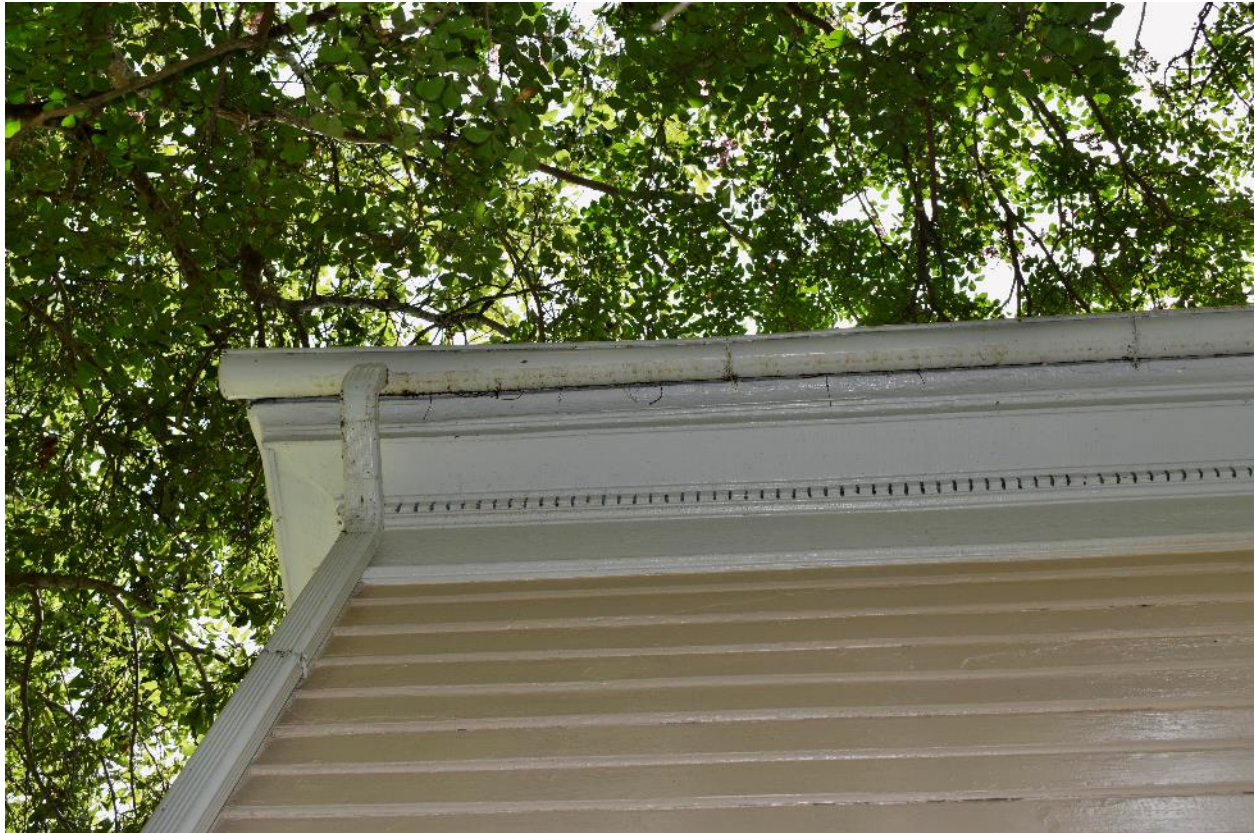
Fig. 18. Overhanging tree limbs – northwest side of library wing

Tree limbs and vegetation growing against the roof and house should be pruned during or prior to work on the roof. An experienced tree specialist/arborist should be consulted for recommendations regarding appropriate pruning or possible tree or limb removal that may pose a risk to the house.

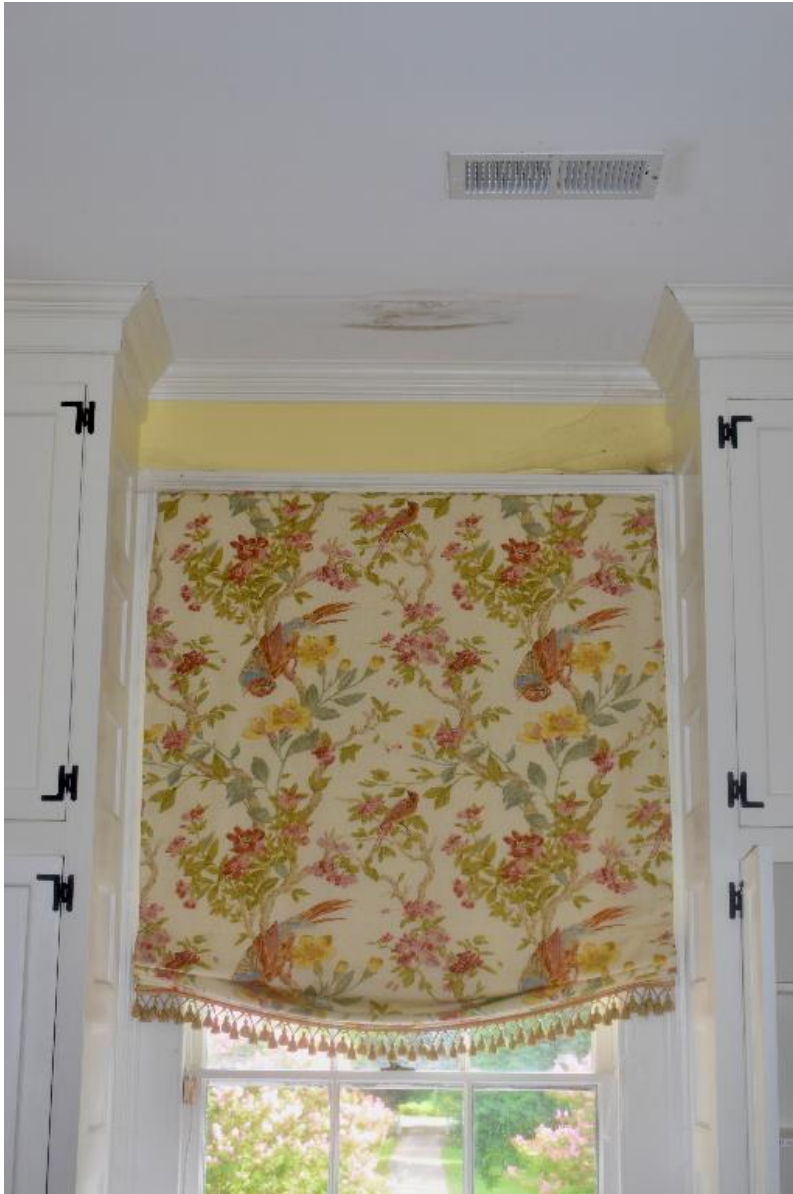
Susan Wood pointed out an active leak above the second-floor north elevation window (fig. 19). She mentioned having this recently looked at by their roofer who was unable to find a source of the leak. Although we were not able to inspect the slate roof, it is possible that this leak may be a gutter-related issue.

Fig. 19 Ceiling stain from active leak – second floor hallway – north end.

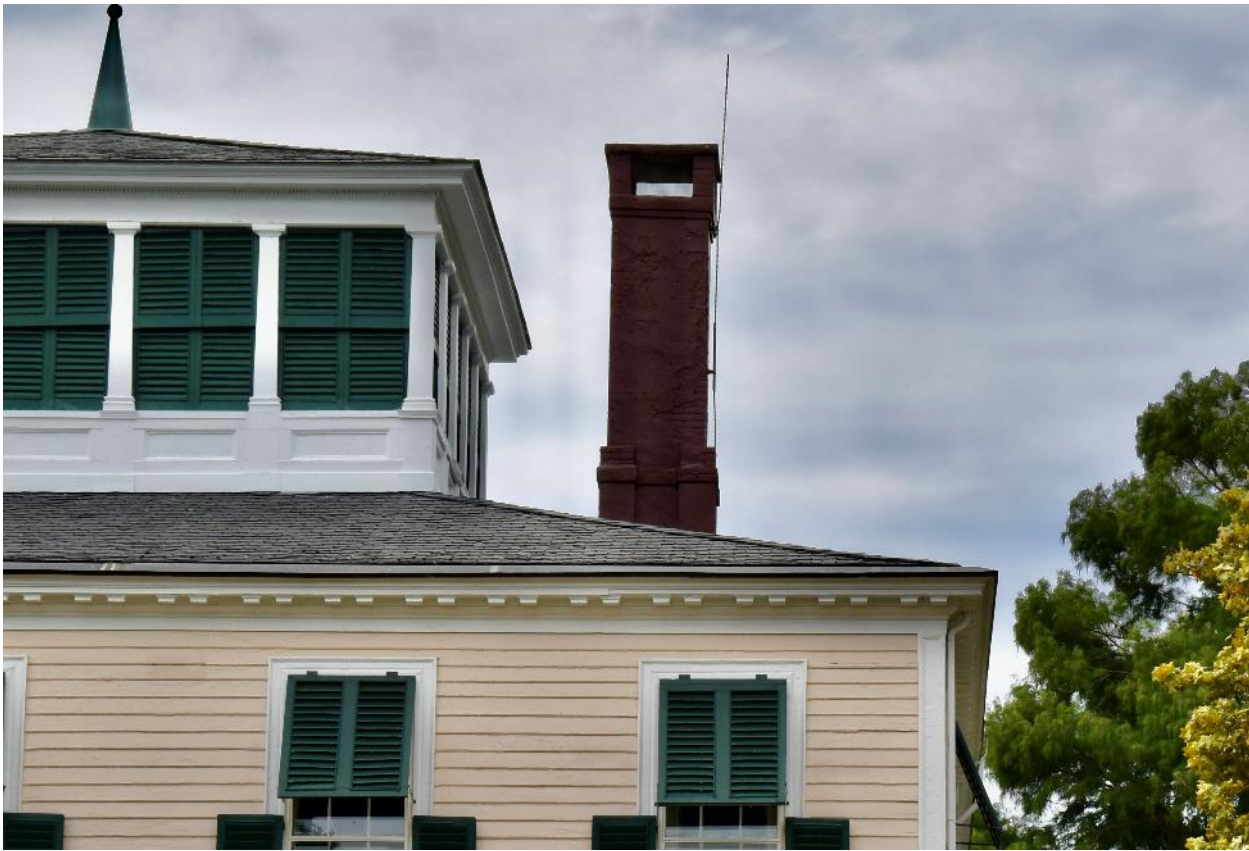
The main portion of the house has built-in gutters (fig. 20). We were unable to determine from the ground if the built-in gutters are operational or covered over and not in use. Downspouts for the built-in gutters system appear to be undersized and may cause the gutters to back-up with water during a heavy rain event.

Fig. 20. North Elevation - note location of built-in gutter where the slate stops at the eave

While the roof is being inspected ask the roofer to take photographs of the chimney stacks (fig. 20). The photographs can be helpful in determining if an experienced brick mason needs to be consulted, at this time, for repairs or stabilization work to the chimneys.

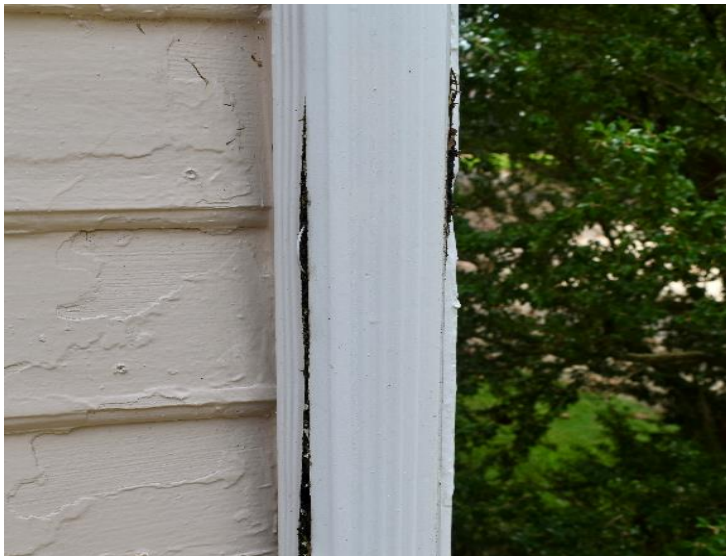
Clogged downspouts were also observed (fig. 21) in addition to debris in the half-round gutters on the hyphens and wings (fig. 22). A roofing contractor who has extensive experience working with historic slate roofs is recommended to inspect and make necessary repairs. The gutter system on the main house, hyphens and wings should also be inspected and repaired by an experienced roofing contractor or gutter specialist. The modern-style “K”-style gutter rectangular downspouts should in the future be replaced with half-round downspouts.

Fig. 21. Clogged downspout – note split in downspout.

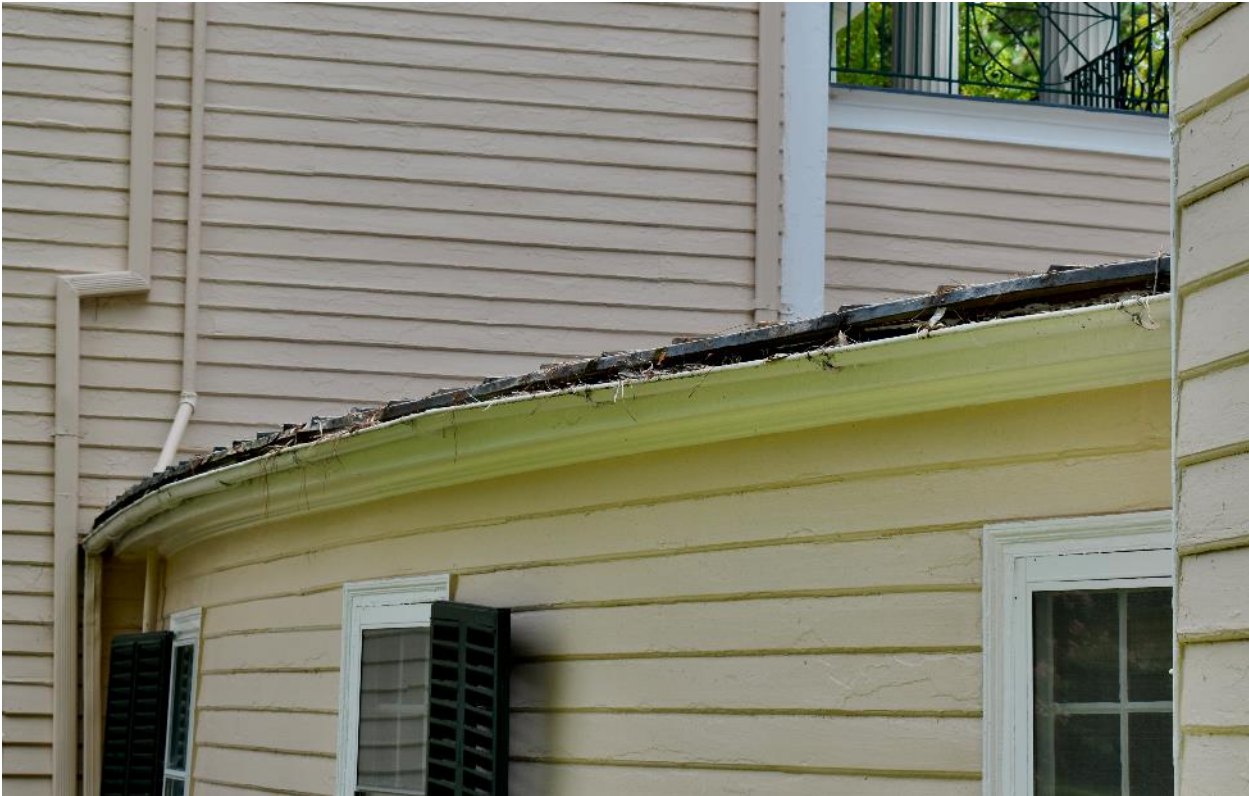
Fig. 22. West (north elevation) hyphen – note damaged and clogged gutter..

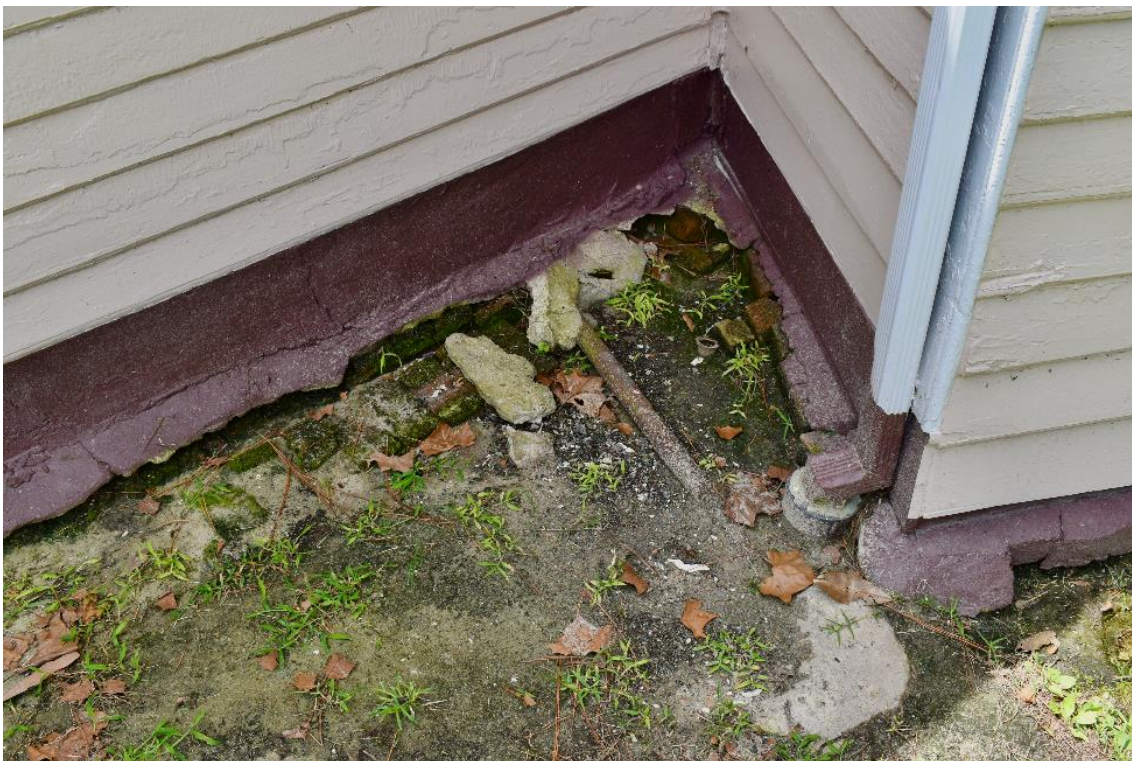
Fig. 23. Foundation erosion on the north elevation, west side

Controlling the rainwater runoff from the roof of the main house, hyphens, and wings is recommended. While gutters and the in-ground drainage system will require periodic maintenance and repairs, the benefits can outweigh the effort and cost. Controlling the rainwater runoff from the roof should resolve and mitigate many of the issues noted above.

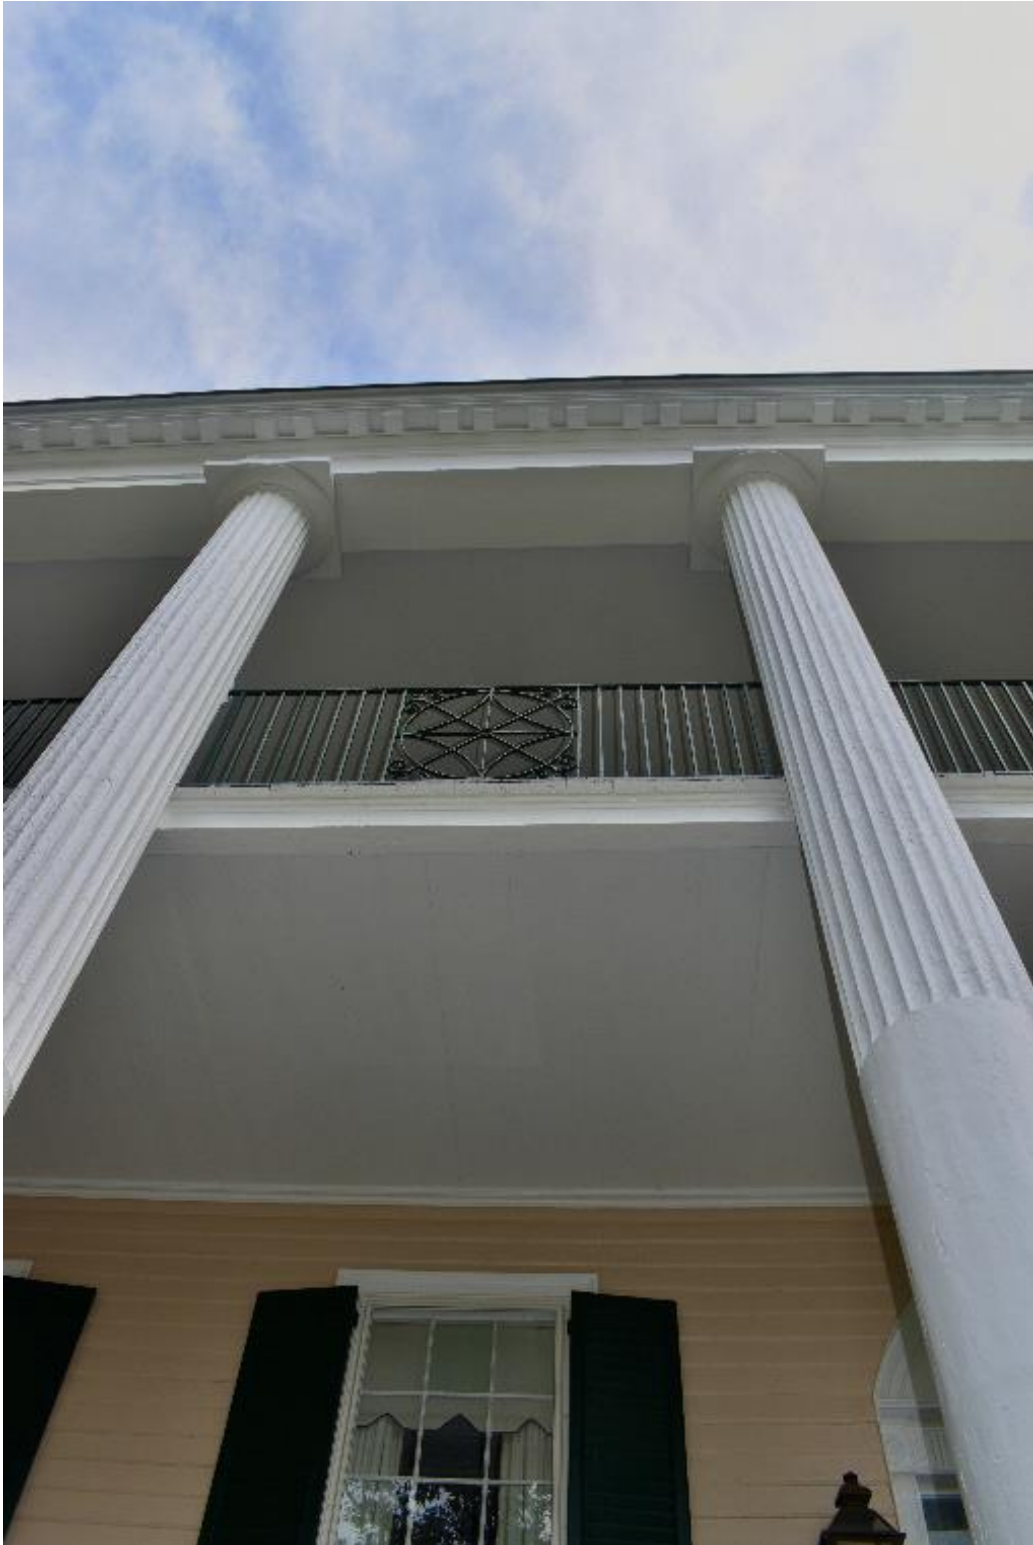
Fig. 24 South Elevation.

There is evidence of minor flooding in the basement - and portions of the floor were wet during our inspection (fig. 27). One and possibly the main source of the minor flooding is roof rainwater runoff. Rainwater runoff from the high roof on the main house - especially on the south elevation (fig. 24), appears to be draining towards and ponding under the

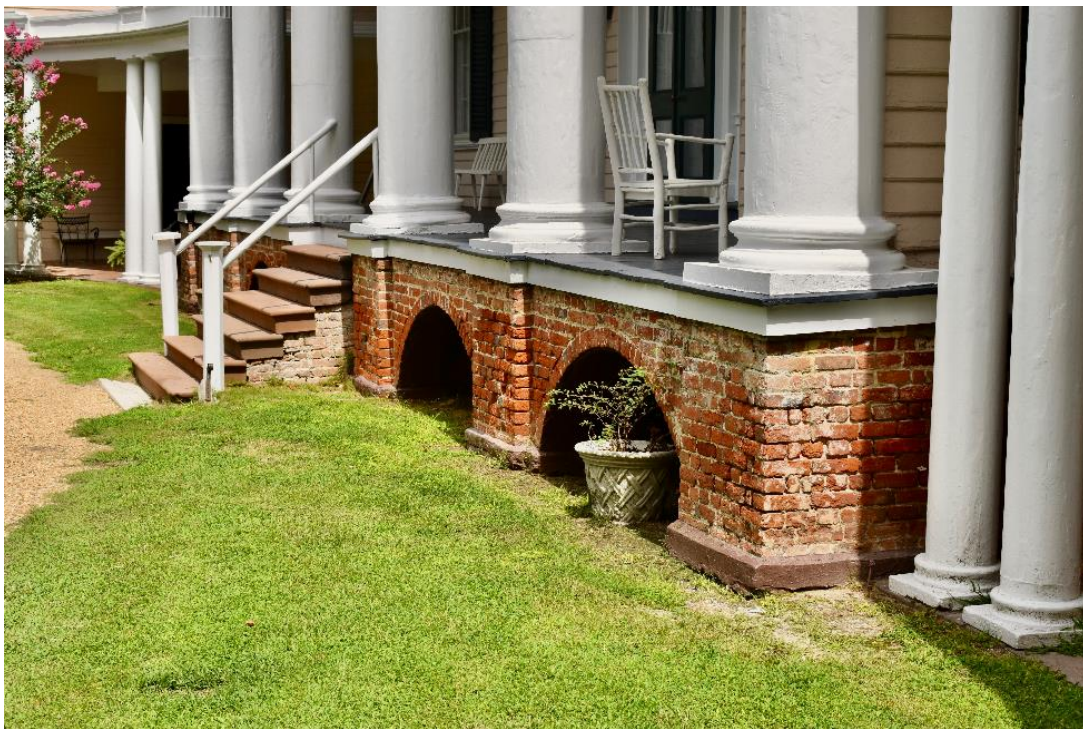
Fig. 25. Erosion at foundation of south porch.

porch (fig. 25). The soil is eroded under the porch and has ripples from ponding that drains towards the foundation. The falling and ponding water also appears to be the cause of foundation mortar and brick deterioration observed in several areas of the foundation.

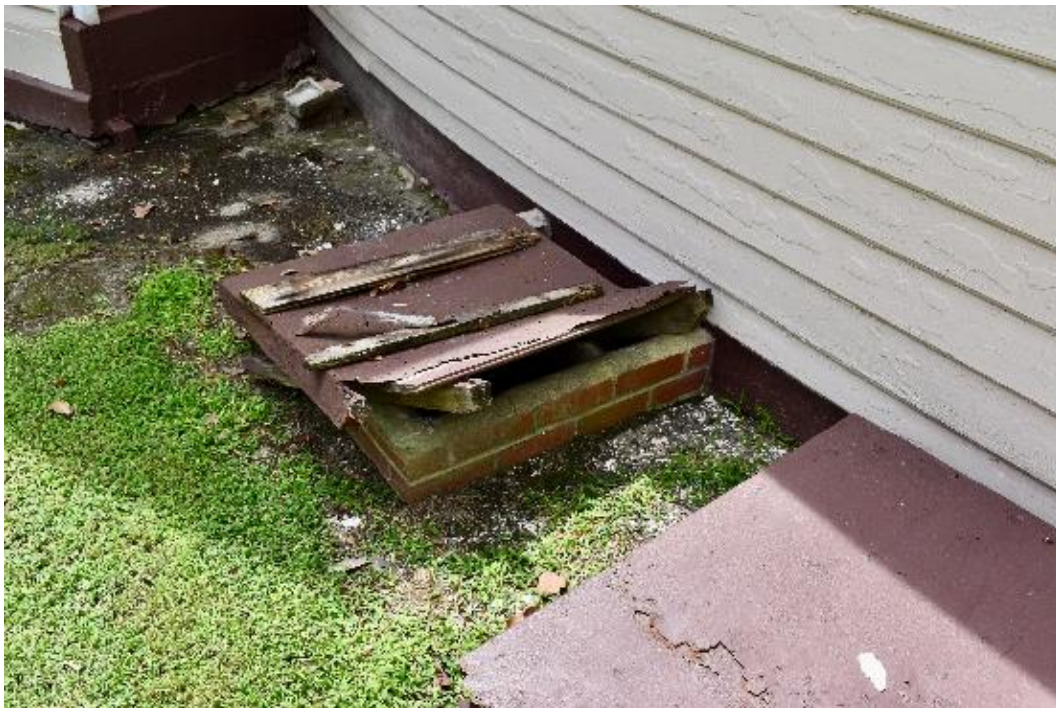
Increasing ventilation in the crawlspace and basement is also recommended. Good cross ventilation will aid in keeping these spaces dryer. Many of the foundation vents and window openings in the basement were covered or blocked. On the north elevation of the hyphens, brick wells were constructed around the foundation vents. These wells have been covered with metal roofs - blocking airflow to the vents (fig. 26). The metal roofs may have been installed to keep the wells from filling up with water - water likely overflowing from clogged or undersized gutters above. (fig. 22).

Fig. 26. Covered foundation vent - north elevation of hyphen

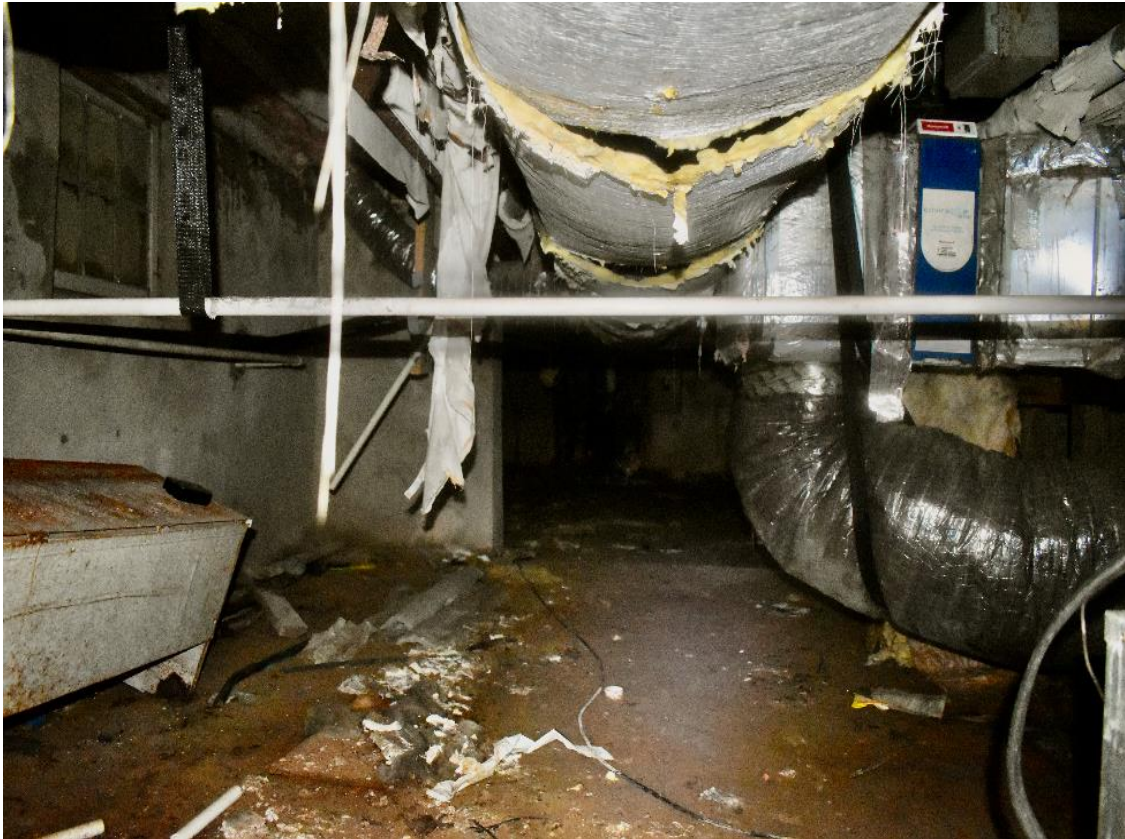
Fig. 27. Basement - note damp floor and damage to ductwork from high humidity levels
