August 30, 22

# Hayes Manor House

*Edenton, Chowan County North Carolina*

## Site Visit Report

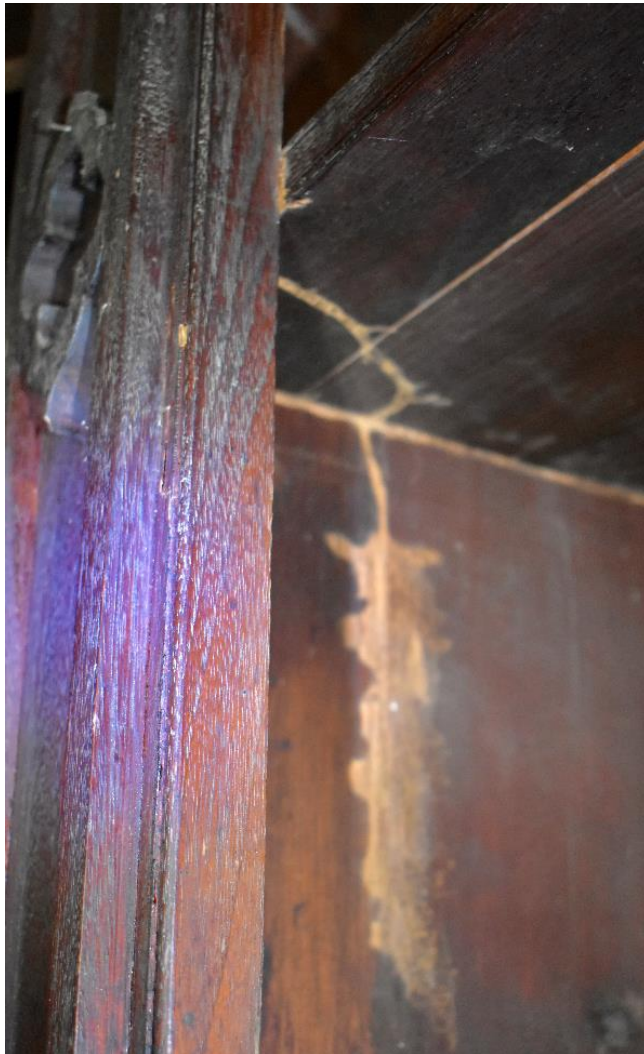
Subterranean termite damage was noticed inside one of the built-in bookcases in the library (fig. 28) – to the left of the main entry door.

Fig.28, Termite damage inside a built-in bookcase in the library.

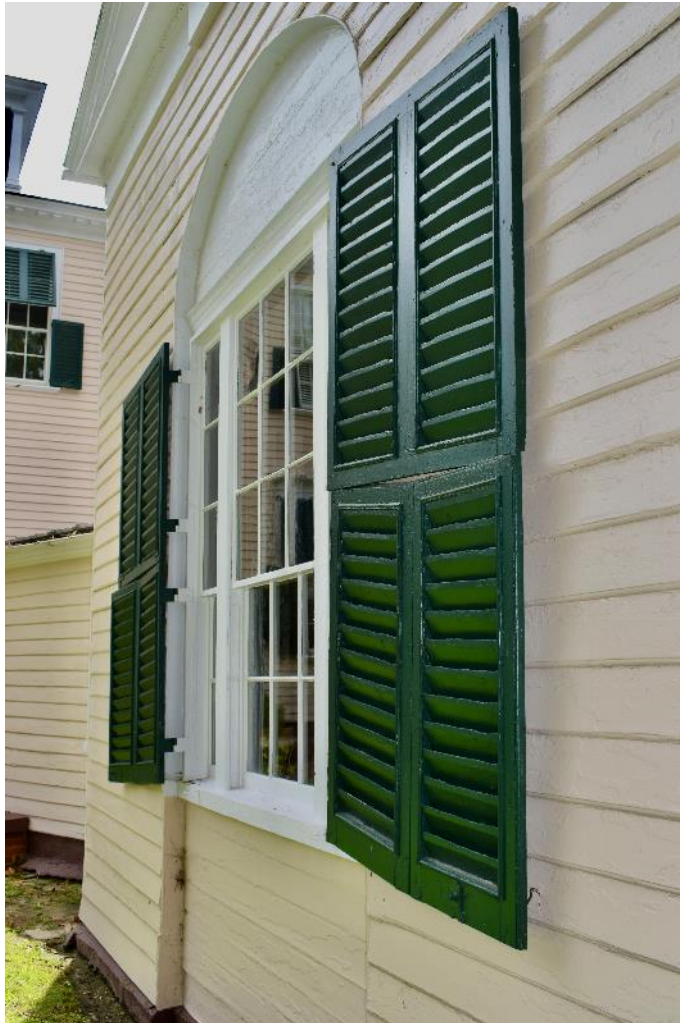
Fig. 29. North elevation, west wing - note sagging blinds.

painted. The blinds and hardware (hinges and hooks) should be checked for structural integrity - or missing components. High wind events such as a hurricane can cause significant damage to shutters that are not properly secured to a building.

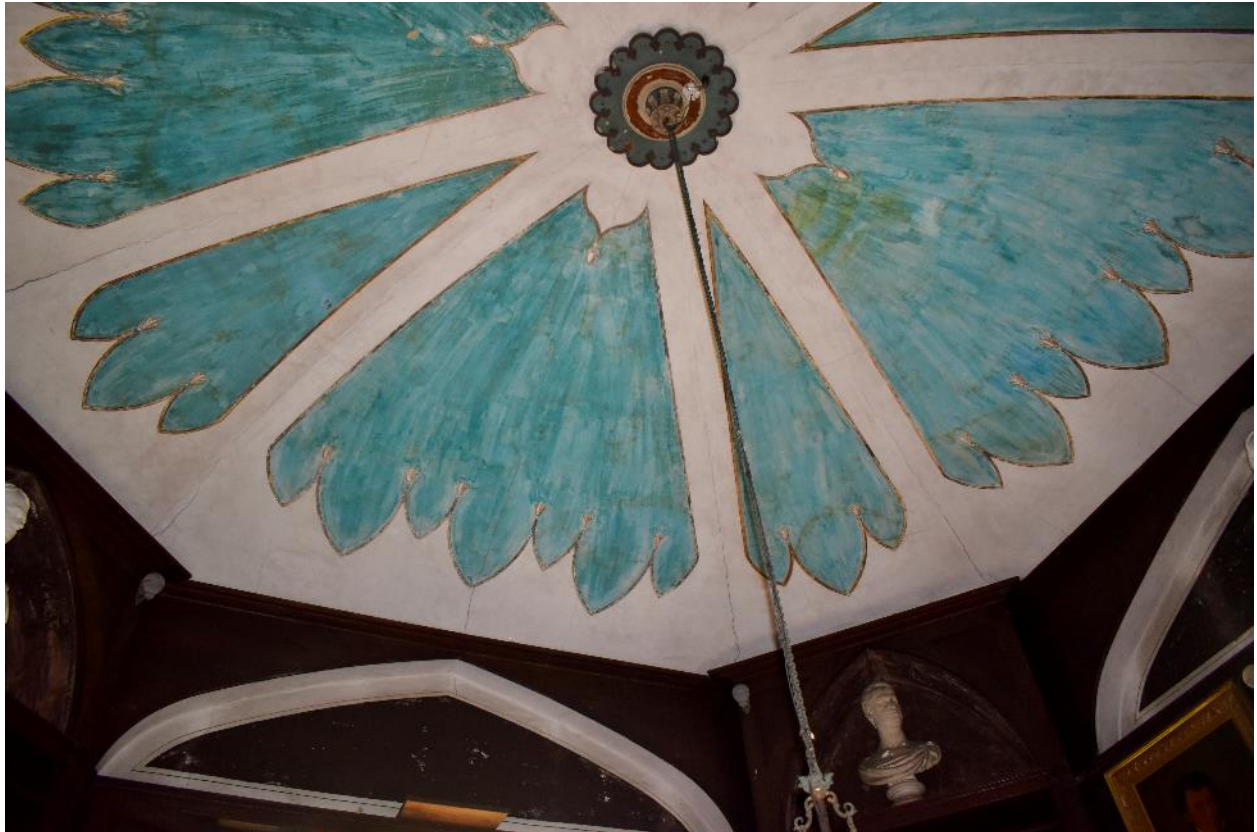
The architecturally and historically significant Gothic library with the paint decorated ceiling (fig. 30) appears to be in stable condition. However, the library felt humid during our visit. We strongly recommend consulting with an architectural conservator who has extensive experience with paint decorated plaster and historic finishes. We do not

Fig. 30. Original paint decorated library ceiling

A qualified conservator should be hired to assess the condition of the historic finishes, plaster, paint decoration, and other features of the room and to offer guidance for any needed conservation work, environmental control, and cleaning.

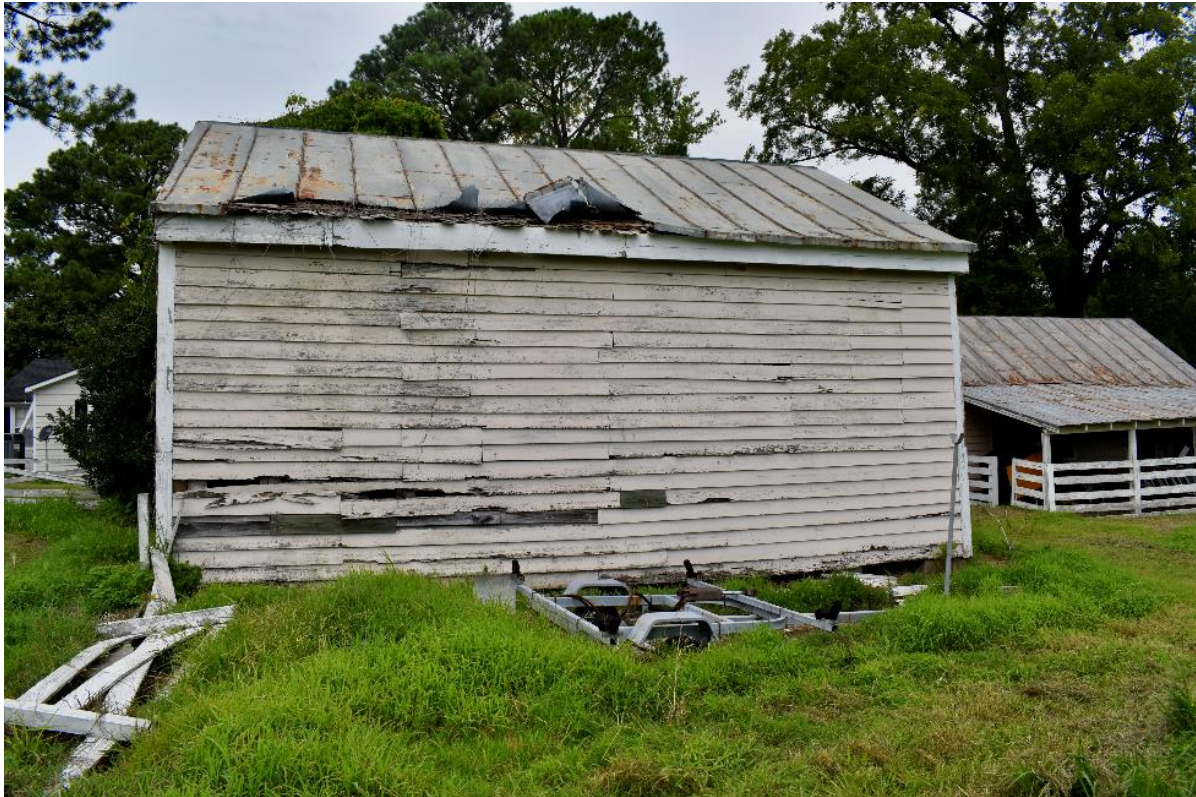
are stored inside the carriage barn (fig.31). We fear that portions of the building are especially vulnerable to failure/collapse during a windstorm.

Fig. 31. East Elevation Carriage House/Barn

The roof has been leaking long enough in the area adjacent to the carriages to cause extensive decay to structural framing members. We recommend that the historic artifacts including the traveling carriages (fig. 32), farm wagons be moved to a secure storage location until the carriage house can be repaired. A restoration contractor/carpenter who has extensive experience with timber-frame buildings, of similar age, should be hired to perform repairs and/or stabilization work to secure this early nineteenth century building.
