## **Lane House Report:**

*A Structural Survey of North Carolina's Earliest Frame Building*

By Andrew Ownbey

*January, 2026*

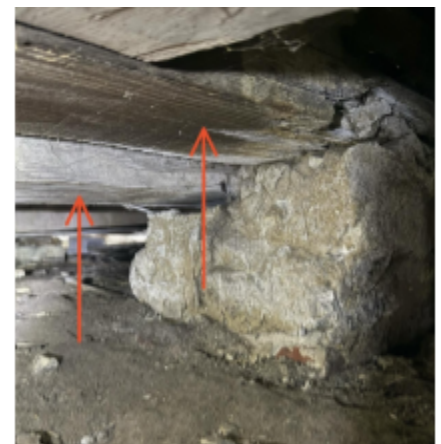
Fig.1. Bermuda stone and brick pier supporting sills for the c1719 core rear sill (r) and 19th c. shed front sill (l).

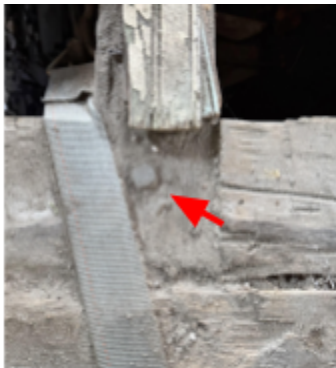
Fig. 2. Pinned lap joint of c1719 floor joists.

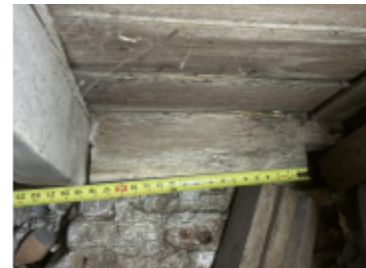
Fig. 4. C1719 trimmer and joist with notches indicating a firebox on the left side.

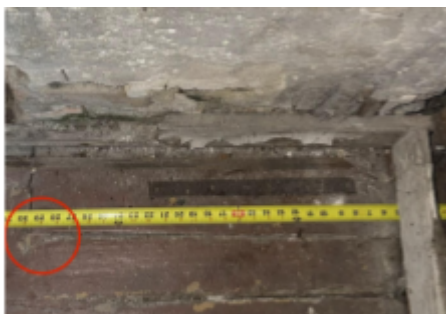
Fig. 5. Early fireplace evidence in flooring, south of chimney.

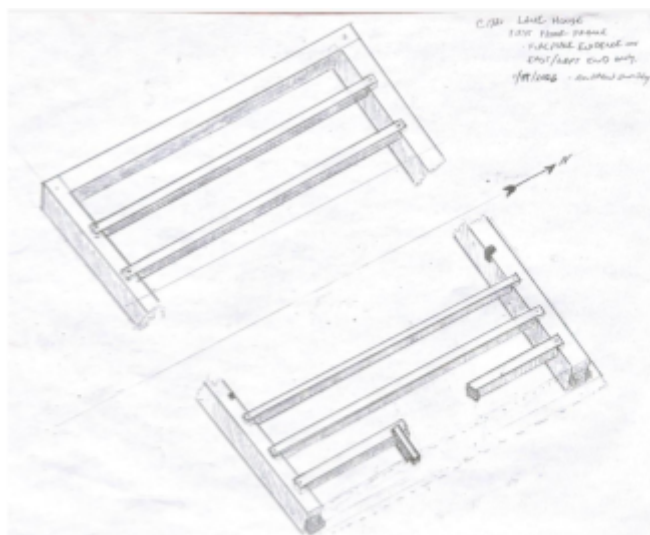
Fig. 6. East vs west first-period subfloor details as seen today clearly showing no fireplace on the west and original fireplace evidence on the east.

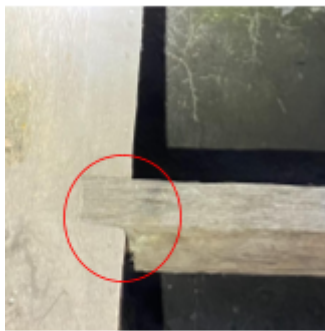
Fig. 7. Shed sill with joist notched with no pins.

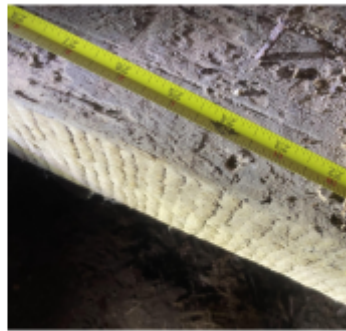
Fig. 8. Shed sill with straight sash saw marks.

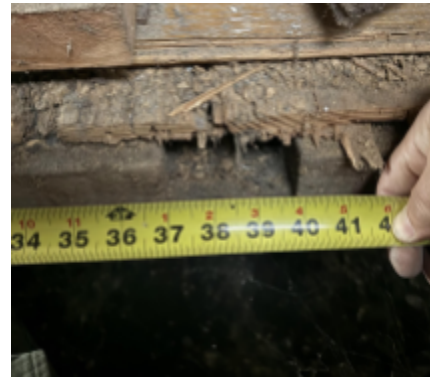
Fig. 9 Notches in shed room for trimmers spaced 37" wide. Note the sill appears to be replaced.

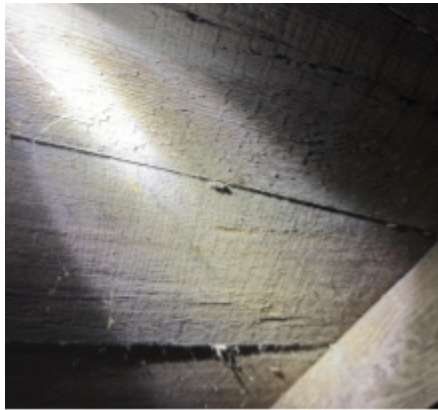
Fig. 10. Bottom side of early, possibly original, pit sawn flooring on west side of core.

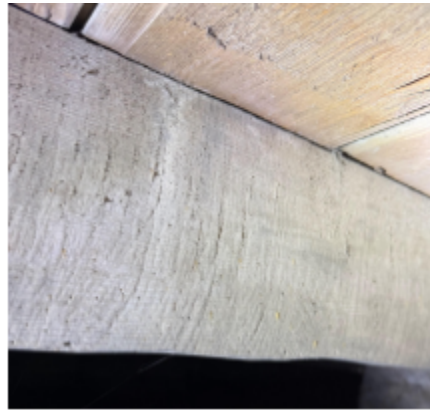
Fig. 11. c1719 pit sawn joist with later sash sawn gauged flooring on east side of core.

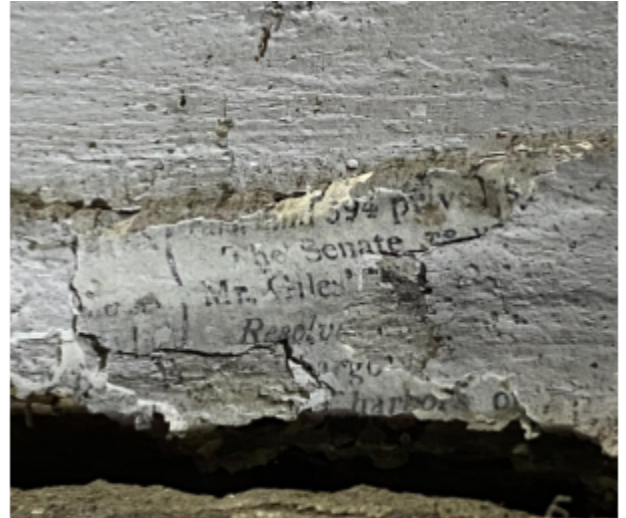
- ❖ The interior framing remained exposed until at least 1804 based on a newspaper fragment found in whitewash mentioning "Mr. Giles", "Senate", and "Resolve..". William Branch Giles (1762-1830) was a Virginia senator from 1804-1815.

Fig. 12. "Mr. Giles" / "Senate" / "Resolve.." typed on paper trapped in lime putty on the interior of siding.

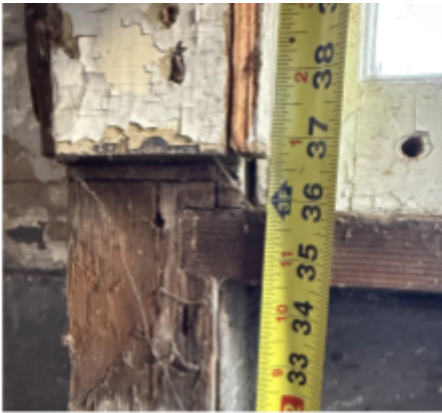
Fig. 13. Sill notch in identified c1719 post.

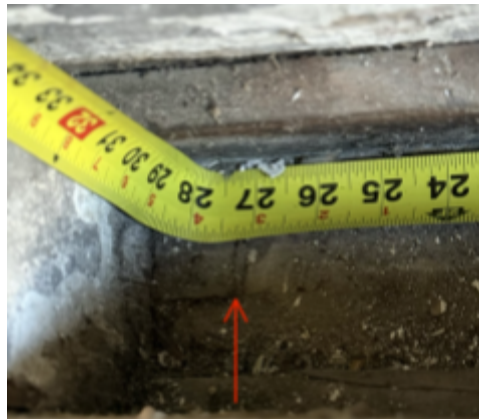
Fig. 14. Original post location with 27" spacing.

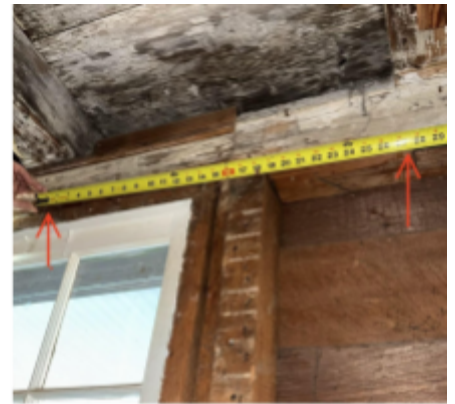
Fig. 15. Mortises with 27" spacing on west side of north wall.

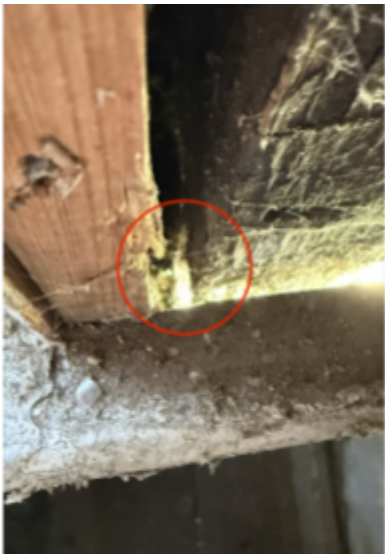
Fig. 16. Sill notch behind chair rail in south post of north window on east gable.

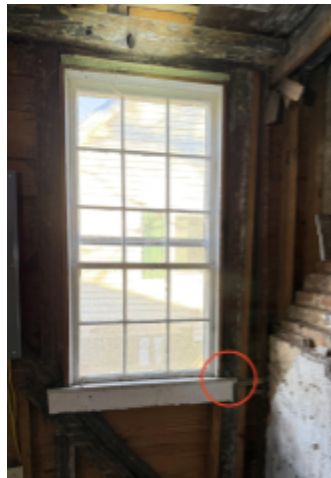
Fig. 17. Notch in post mortised to east gable header to north of fireplace indicating an early window opening.

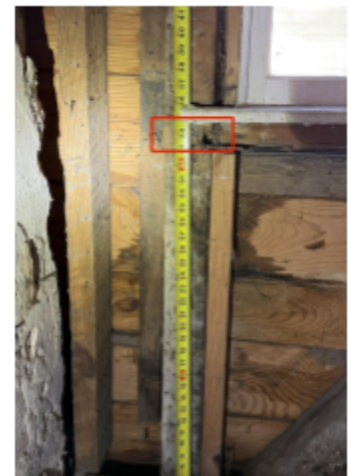
Fig. 18. Notch in post with corresponding mortise in east gable header to south of fireplace indicating an early window opening.

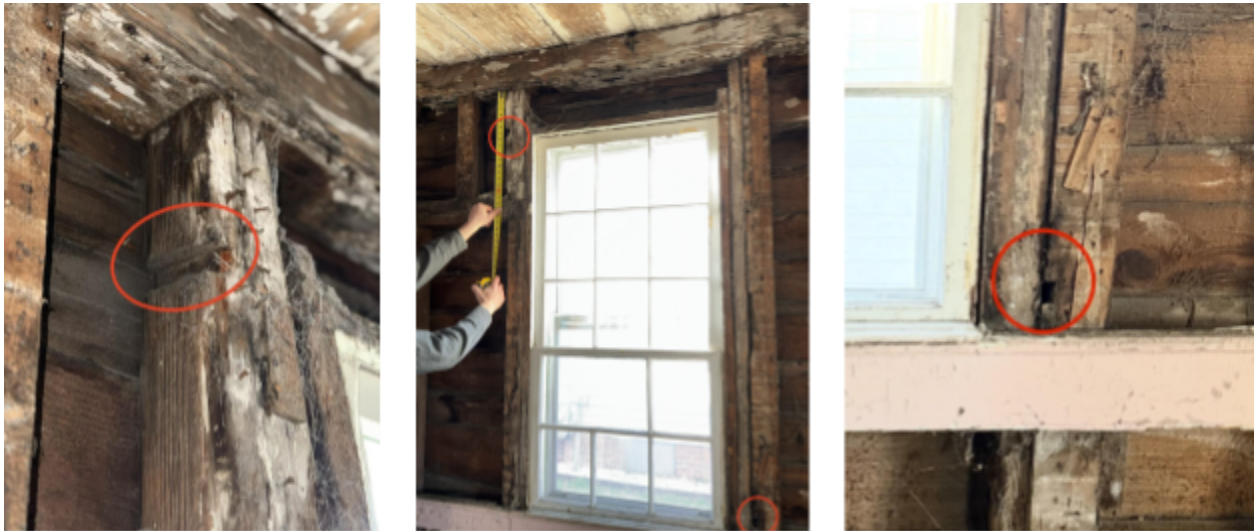
Fig. 19-21. Sill notches on west gable end for previous window, possibly an early modification using lap joints.

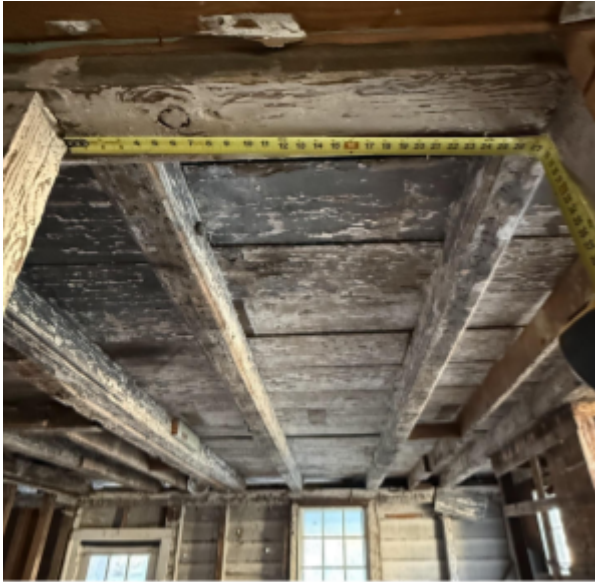
Fig. 22. South studs with 27" spacing mirroring north window location east of door

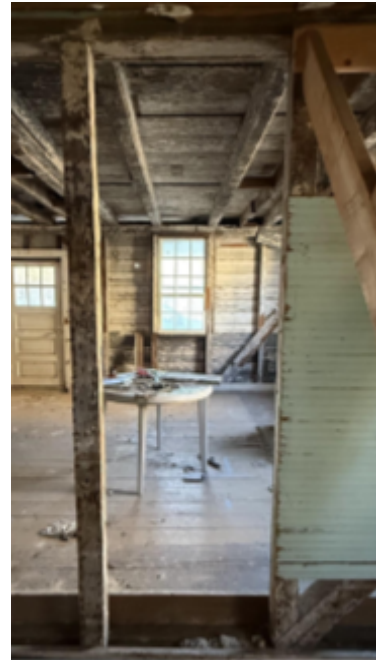
Fig. 23. South wall studs spaced 27" mirroring north window, east of door.

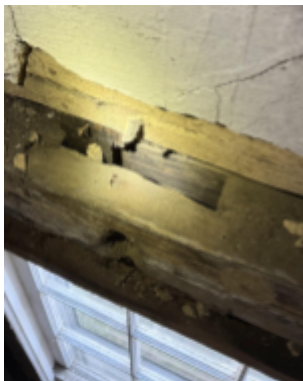
Fig. 24. Large northeast mortise with gable stud tenon inserted.

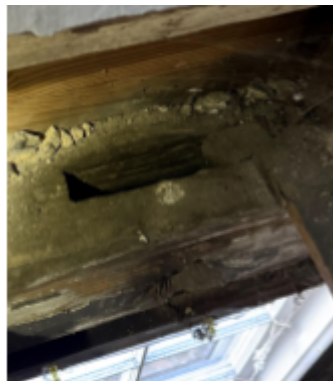
Fig. 25. Large southeast mortise with a possible cut off tenon still inserted.

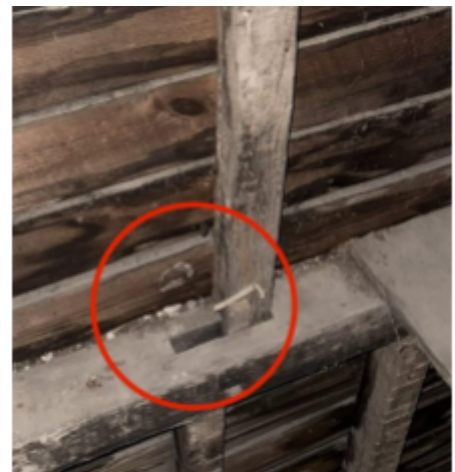
Fig. 26. Northwest large mortise with gable stud from top.

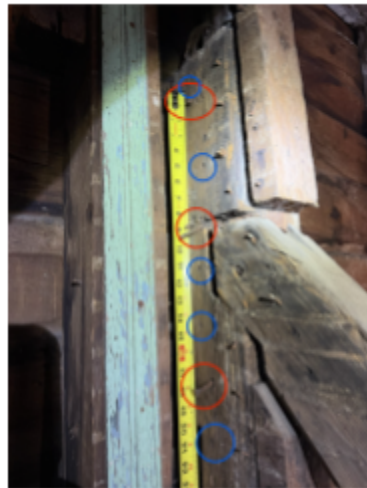
Fig. 27. Southwest corner post south face with siding nails at @ 8" vertical spacing (red) and earlier(?) smaller nails spaced approximately 5" (blue).

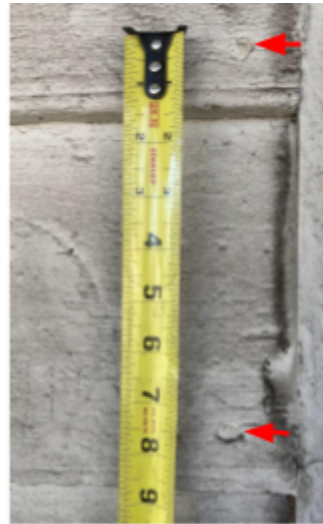
Fig. 28. Northeast siding with wrought nails at @. 8" vertical spacing.

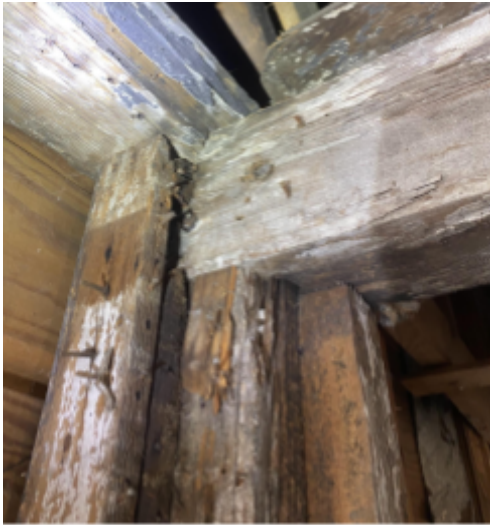
Fig. 29. Southeast post with later nailer for sheathing.

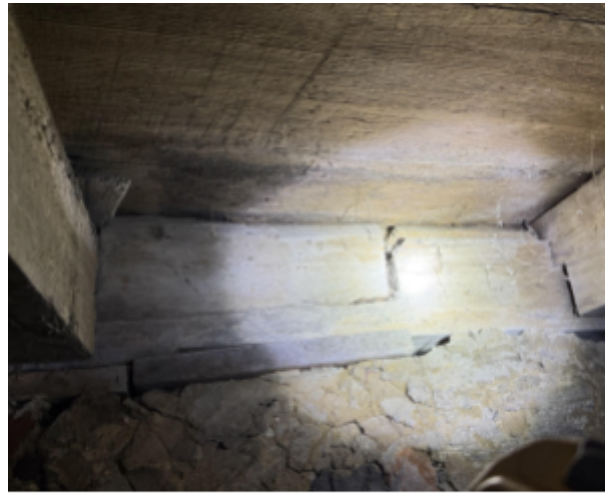
Fig. 30. Lap joint in south sill of c1719 core indicating a possible repair.

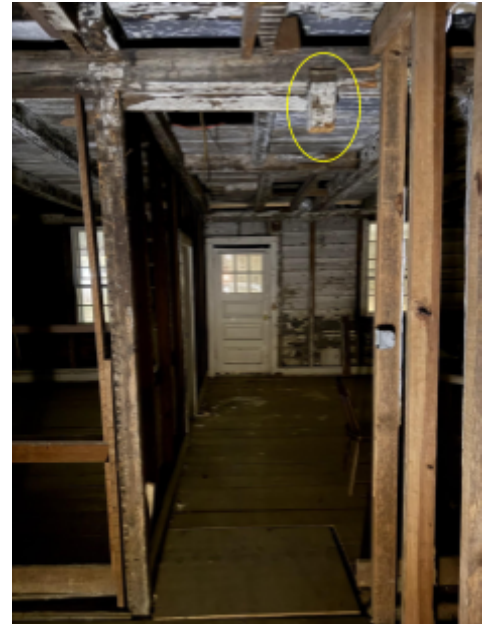
- ❖ The current South door opening is 30" with the left stud showing evidence of being moved to its current location but previously forming a 56" wide door.
- ❖ The top of the post is held on with a beveled lap joint held with wrought nails.
  - Beveled lap joints can indicate a modification of a standing structure otherwise constructed using mortise and tenon joints.
- ❖ As mentioned, the stud spacing at the original window locations on the north are 27" and directly across on the south wall there are studs and empty mortises with the same 27" spacing.
  - This is all evidence of two original window locations flanking an unusually large door on the south wall.
- ❖ There is currently no evidence to prove which side served as the original front of the structure, so it is possible that the large door served as the principal entrance for carrying in large goods.

Fig. 31. Current 30" south door location with lap joint circled in yellow.

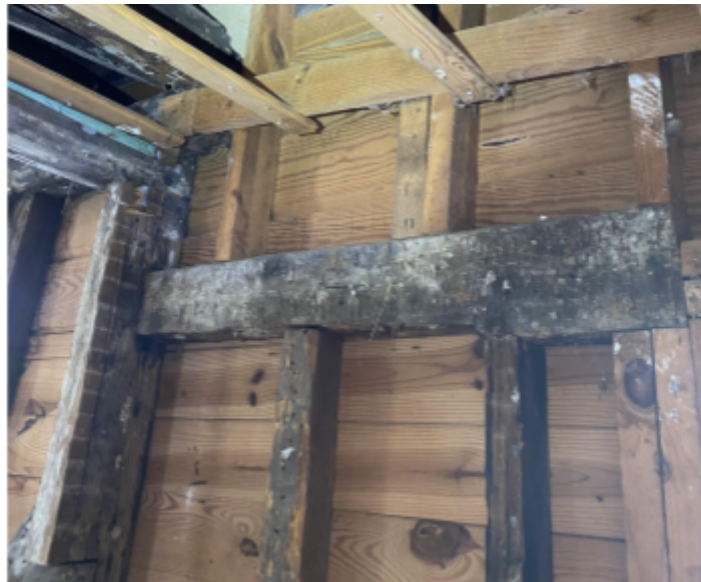
Fig. 32. Heavily modified header mortised into the south face of southeast corner post. Possibly part of an early shed modification.

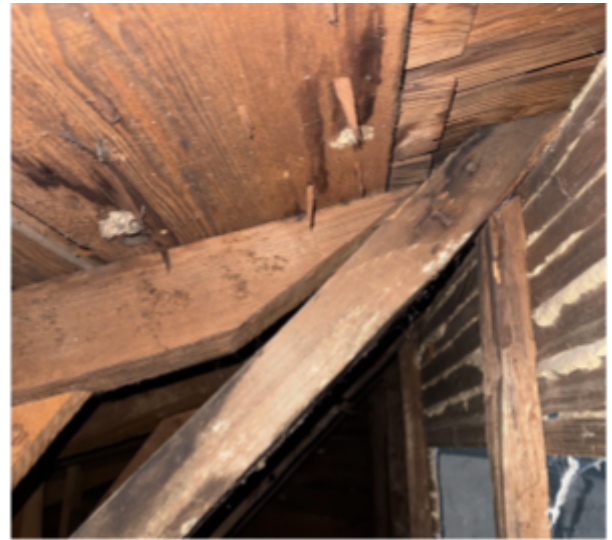
Fig. 33. 19th c. sash sawn shed rafter nailed to the top of c1719 rear rafter.

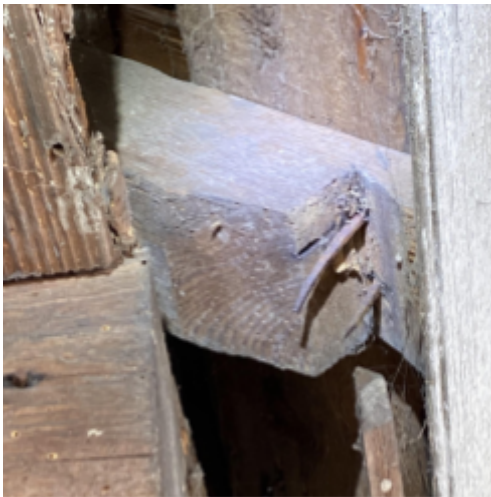
Fig. 34. c1719 notched rafter pulled out of the north false plate. Note wrought nails.

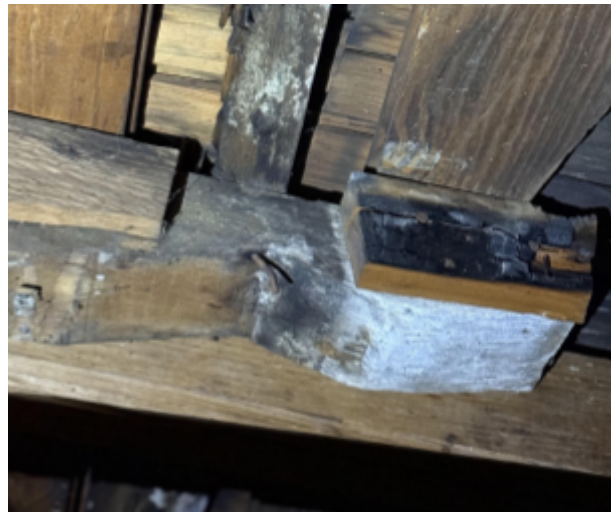
Fig. 35. 19th c. shed rafter tails that once extended over their header. Note original cut nail.

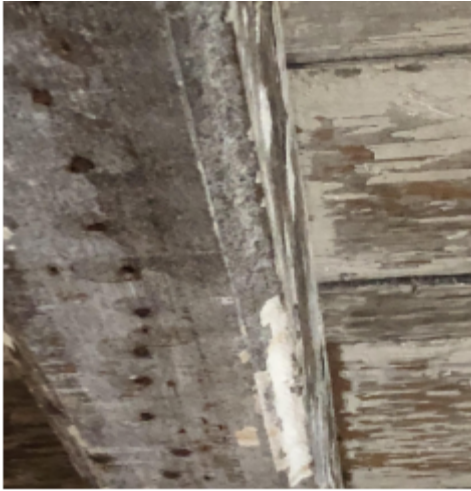
Fig. 36. Ogee molded edge of joists.

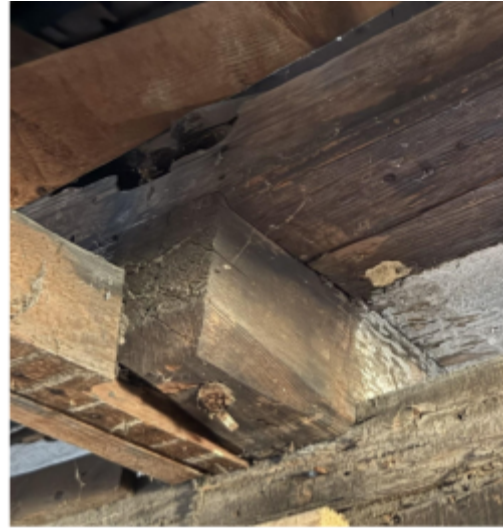
Fig. 37. c1719 south cornice with rafter notched to the thick molded edge pinned false plate.

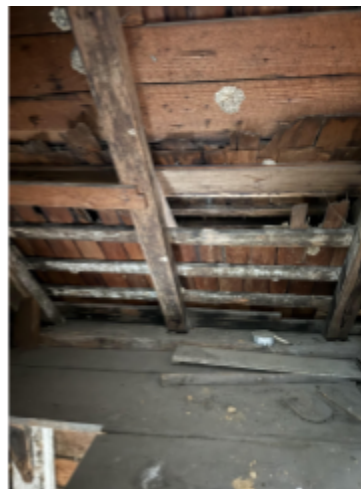
Fig. 38. Core rafters with Later shingles and lath spaced 8" under porch roof.

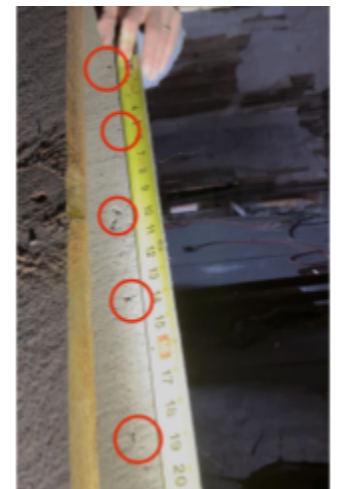
Fig. 39. Top side of core south rafter with 5" nail spacing from original roofing material.

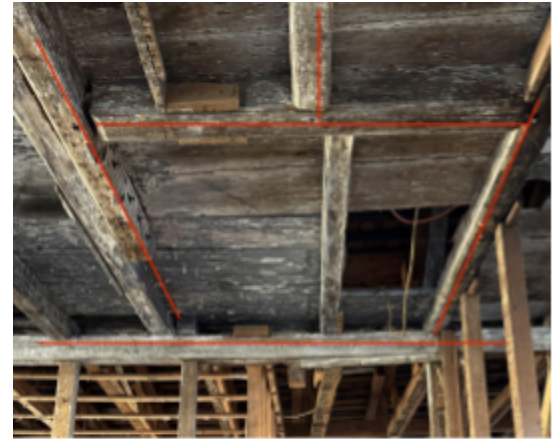
Fig. 40. Loft stair/ladder well.  
Original material marked in red.

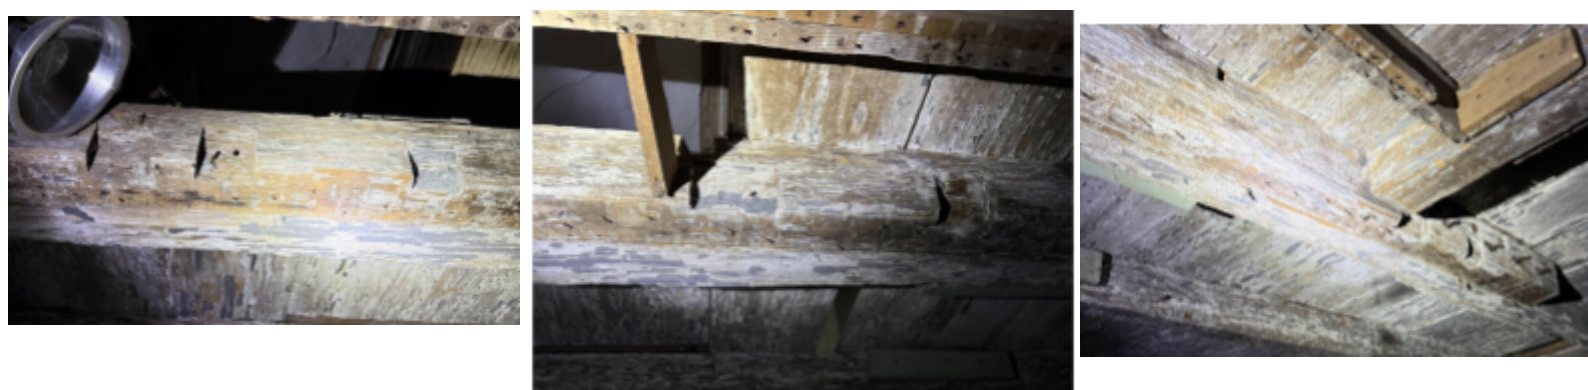
Fig. 41-43. North, center, and south sections of header with  
lap joint notches for early partition wall.  
Note presence of early lime wash inside notches.

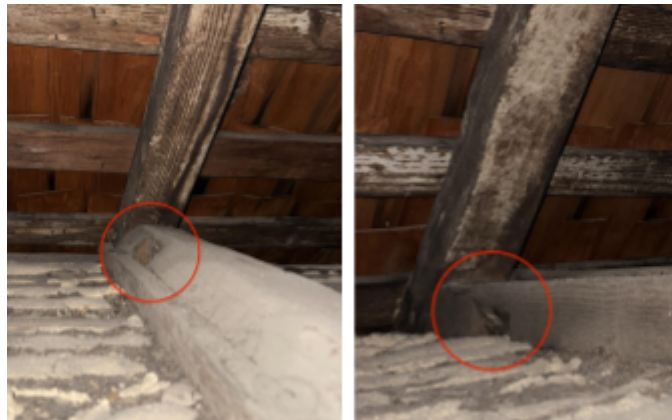
Fig. 44-45. Beveled lap notches in collar ties for loft partitions east and west of access well.

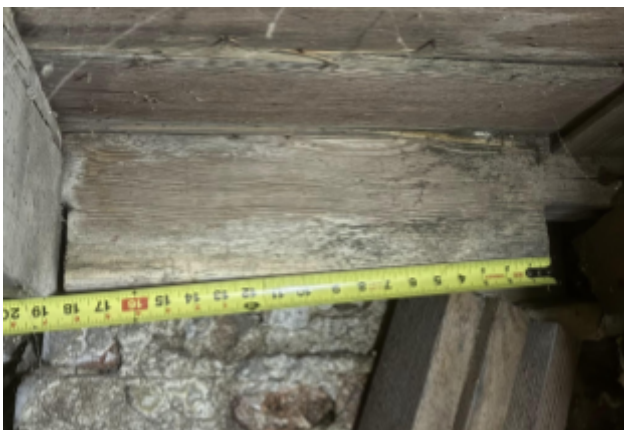
Fig. 46. Hearth trimmer on east wall.

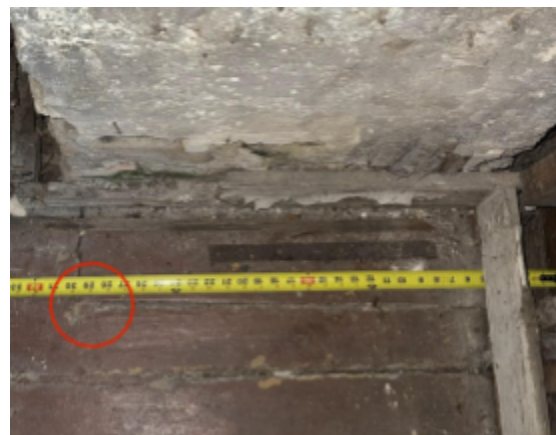
Fig. 47. Early hearth evidence seen in replaced flooring, note miter circled in red.

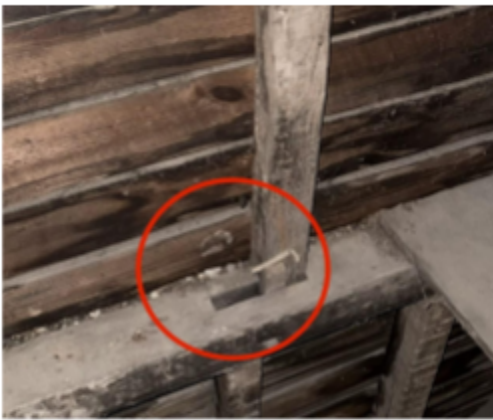
Fig. 48. Northwest mortise in header shown with gable post in situ.

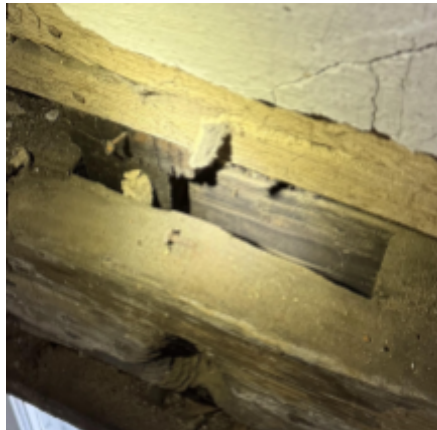
Fig. 49. Northeast large mortise in header with gable stud in situ.

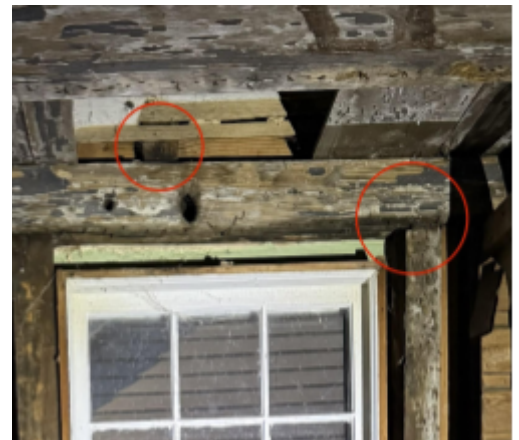
Fig. 50. In situ posts mortised into north end of east header.

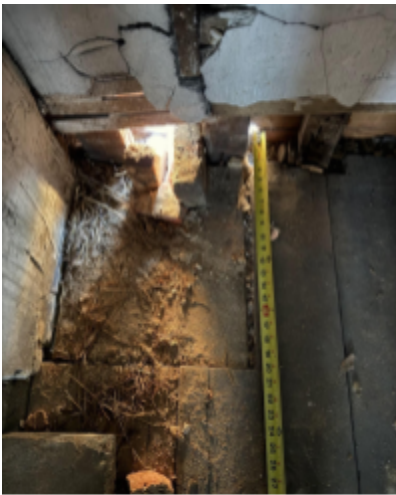
Fig. 51. Loft hearth evidence found in flooring.

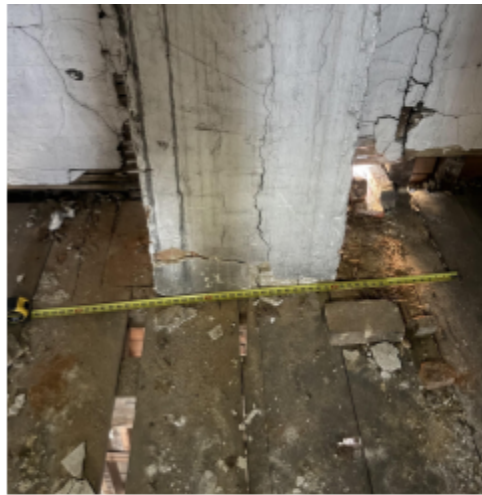
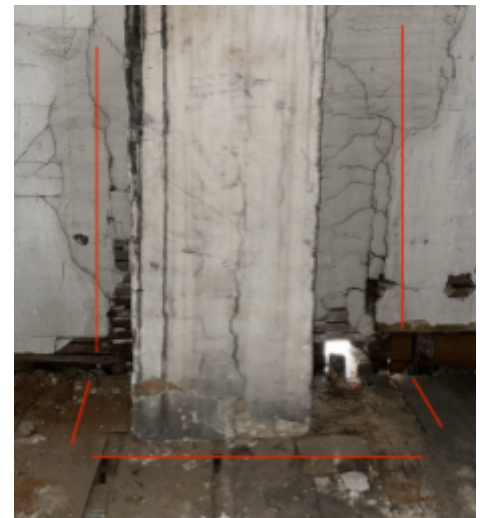
Fig. 52. Loft fireplace location outlined in red.

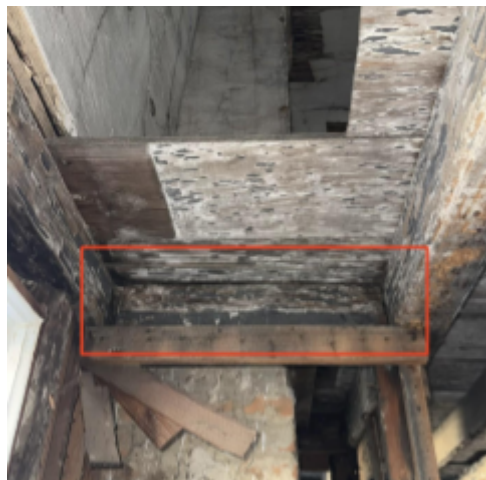
Fig. 53. Possibly original second floor hearth trimmer notched to header and joist.

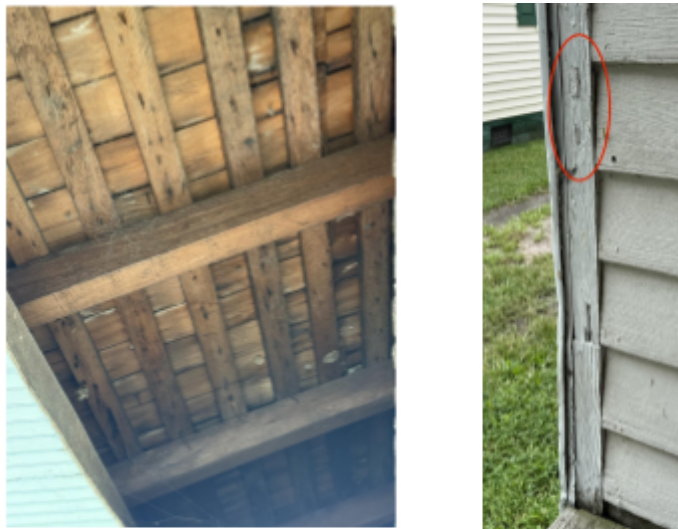
Fig. 54-55. Porch rafters in sash sawn cypress and cut off rail tenon on left post.
