ST PETER'S CHURCH, GRANDBOROUGH

## REPORT ON THE CLEANING AND CONSERVATION OF THE 1849 REREDOS

## Report on the Cleaning and Conservation of the 1849 Reredos

September 2025

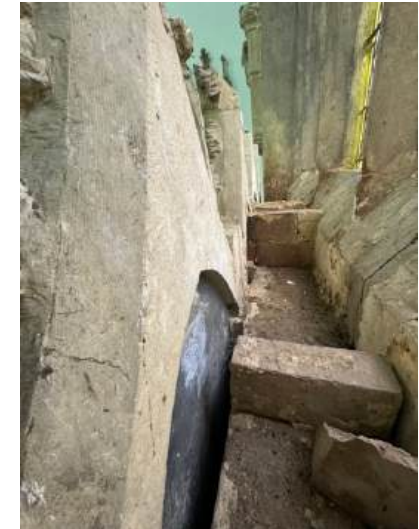
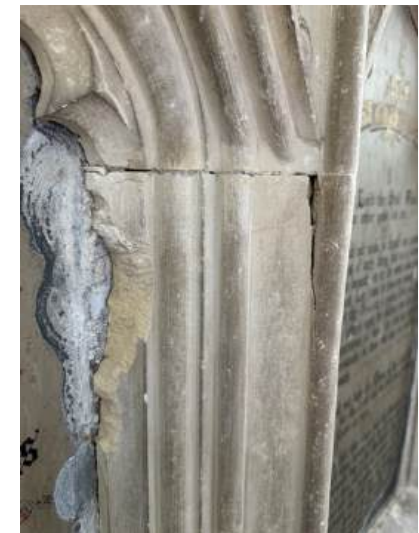
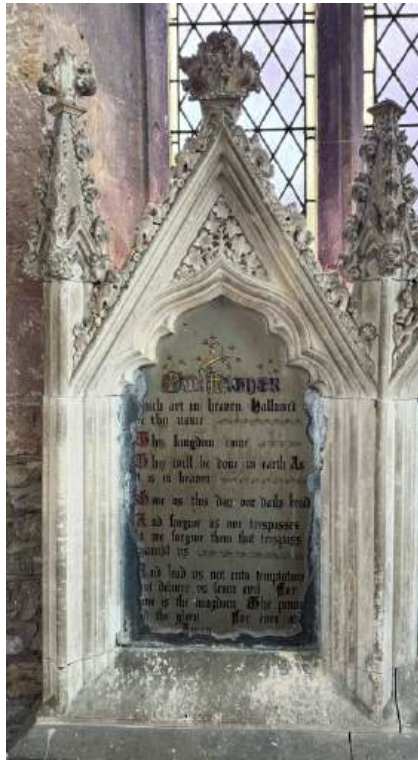
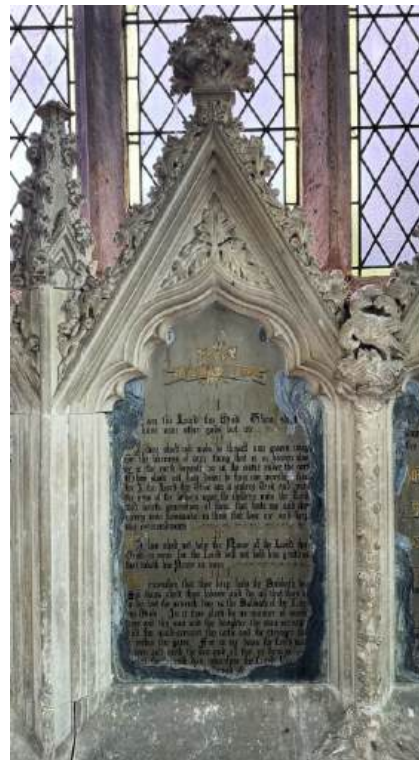
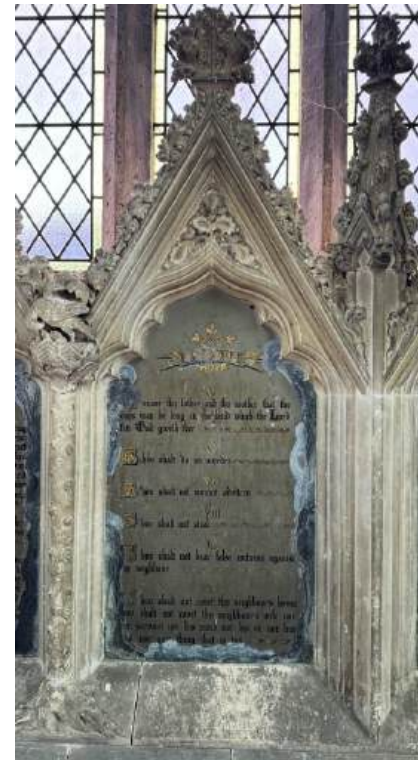
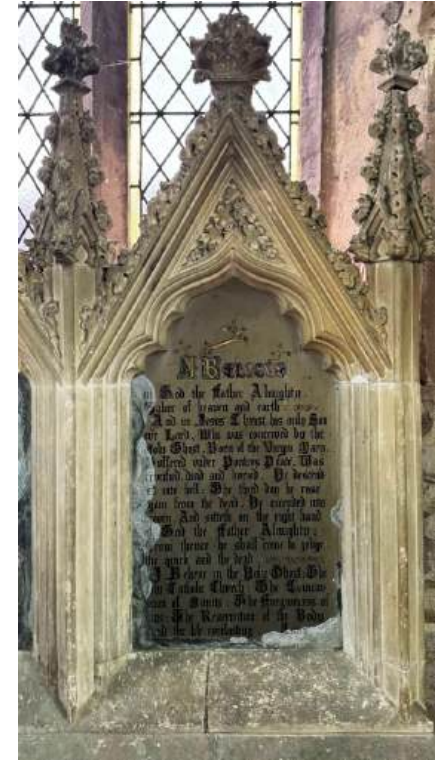
The reredos had suffered damage due to minor localised structural movement, there were cracks beneath both the northernmost and southernmost panels of the east window (see *photo upper right*), and an apparent forward movement at the top had resulted in cracking to the front of the uprights in places (see *photo below right*). The reason for the forward movement was thought to be corrosion of iron cramps within the structure. On dismantling the reredos the cramps became evident, with the expansion of the rusting iron exerting pressure on the stonework of the upper arcade.

The reredos appeared to be partially secured to the east wall up to sill level behind each of the five uprights. The painted panels were loose-fitting, in slots within the stonework, with gaps between them and the earlier wall structure behind. Each was held in place by simply having been wedged at the rear with a brick at the top of each panel (see *photo upper right*).

The humidity had caused soluble salts to mobilise within the wall structure and the resulting surface efflorescence had caused both a whitening of the surface and localised damage to the stonework (see *photo below right*). The humidity and salts had caused significant paint losses around the edges of the panels, but otherwise the surviving paint layer appeared to be relatively stable. The surface was very discoloured and generally dirty and there were obvious urine splash marks as a result from bat activity. High quantities of fresh bat droppings throughout the building indicated the presence of a large and active colony of bats living within the church.

Note the damage had mainly occurred across the central areas of the reredos, at the level of the painted panels, where affected by high humidity and salt efflorescence in the past. The plain stone base and upper arcading, crockets and pinnacles had been less affected but had retained relatively higher levels of surface dirt and grime. The upper elements of the structure making up the pinnacles were loose in many places and one of the acanthus leaf carvings at the top was missing from the pinnacle between the Lord's Prayer and the first Decalogue panel.

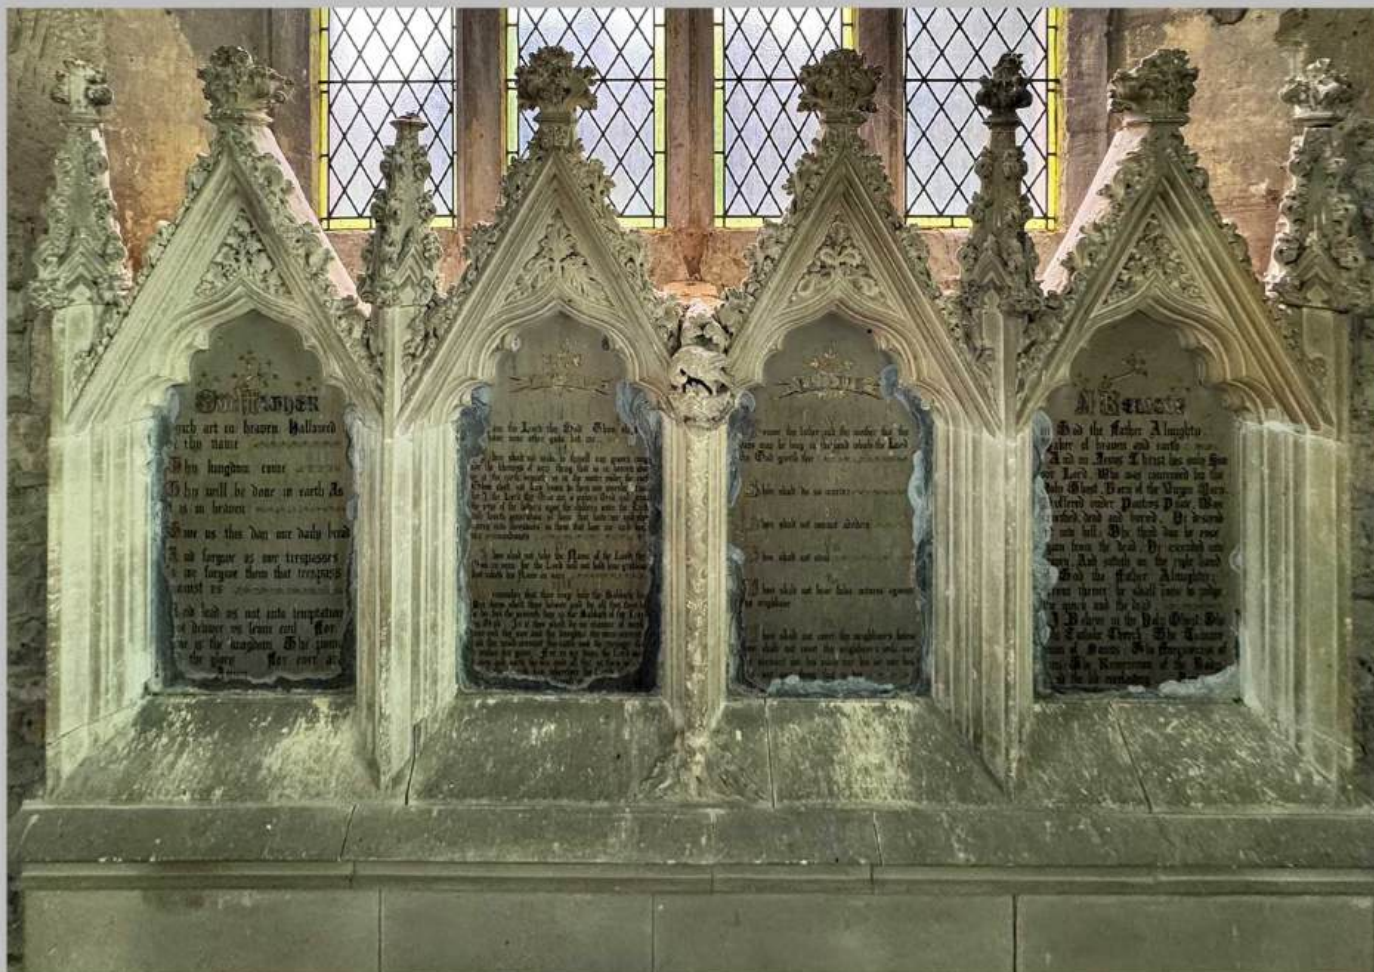
Plate 1 - St Peter's Church Grandborough

The reredos at the east end of the chancel before conservation

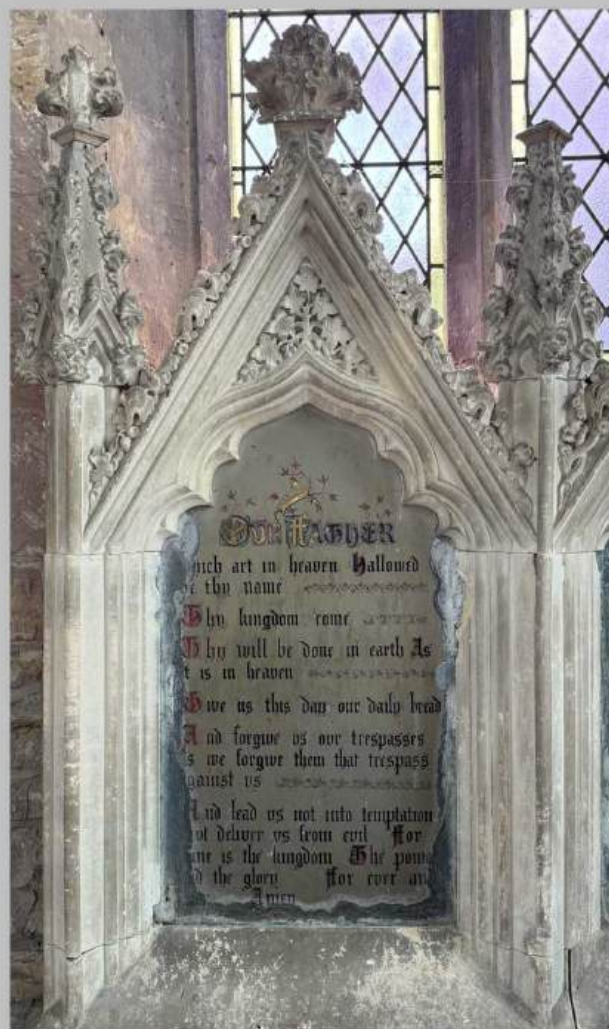
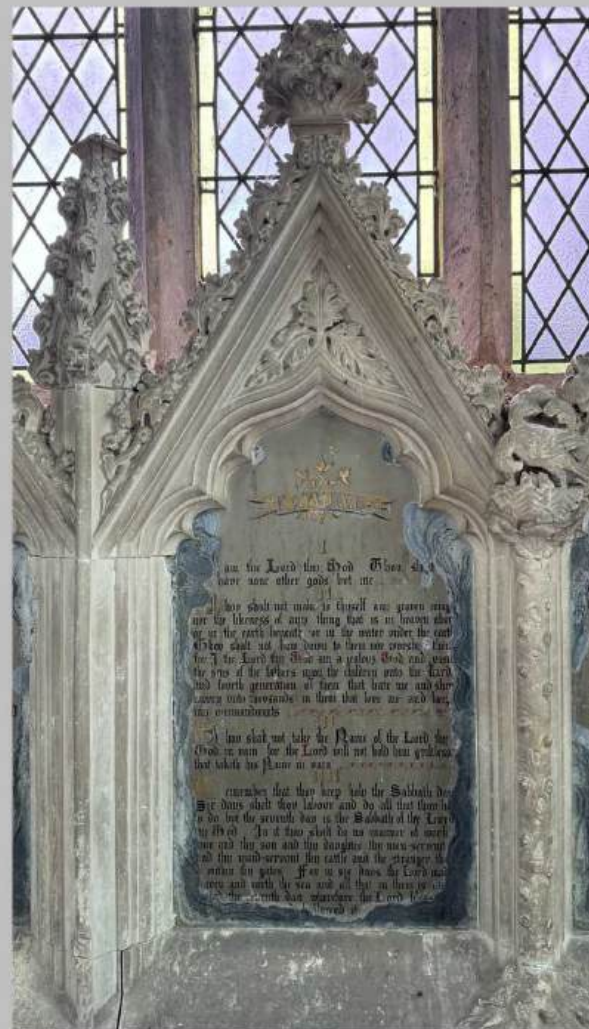
Plates 2-3 - St Peter's Church Grandborough - 1849 Reredos

Details showing the condition of the Lord's Prayer and Ten Commandment panels which have suffered paint loss due to damp where in contact with the Caen stone surrounds

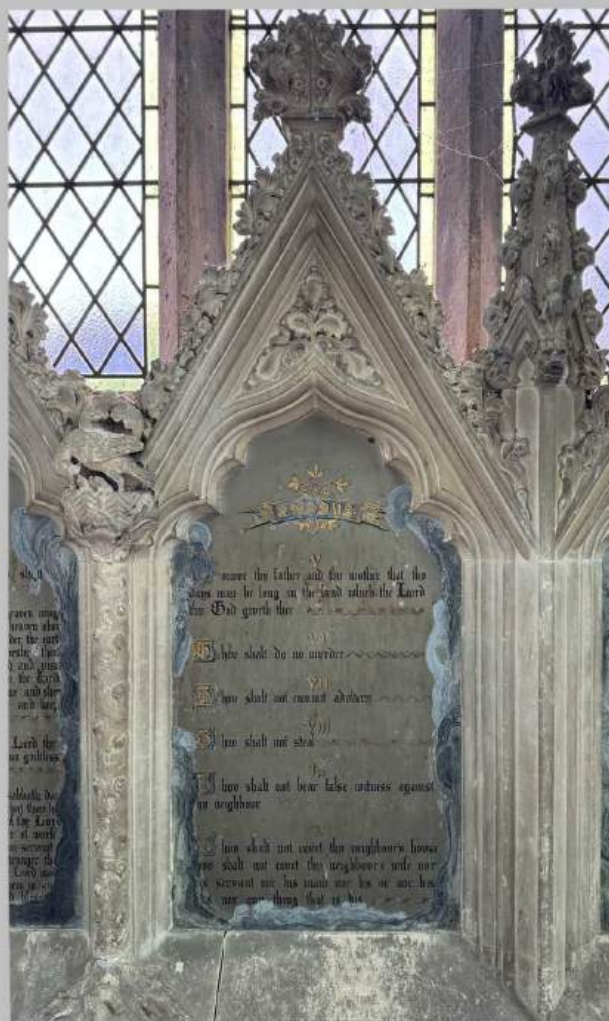
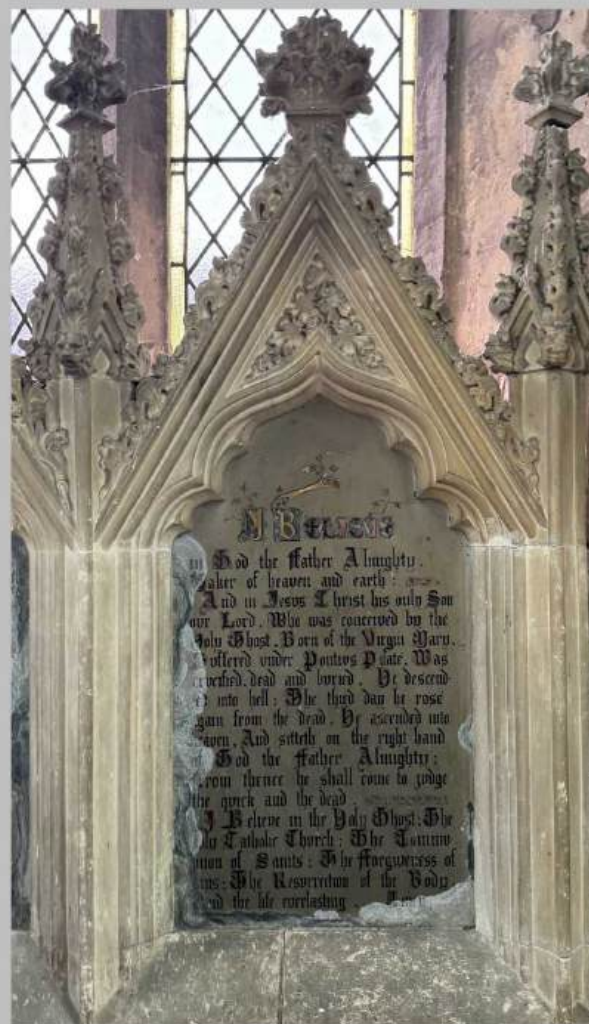
Plates 4-5 - St Peter's Church Grandborough - 1849 Reredos

Details showing the condition of the Ten Commandment and Creed panels which have suffered paint loss due to damp where in contact with the Caen stone surrounds

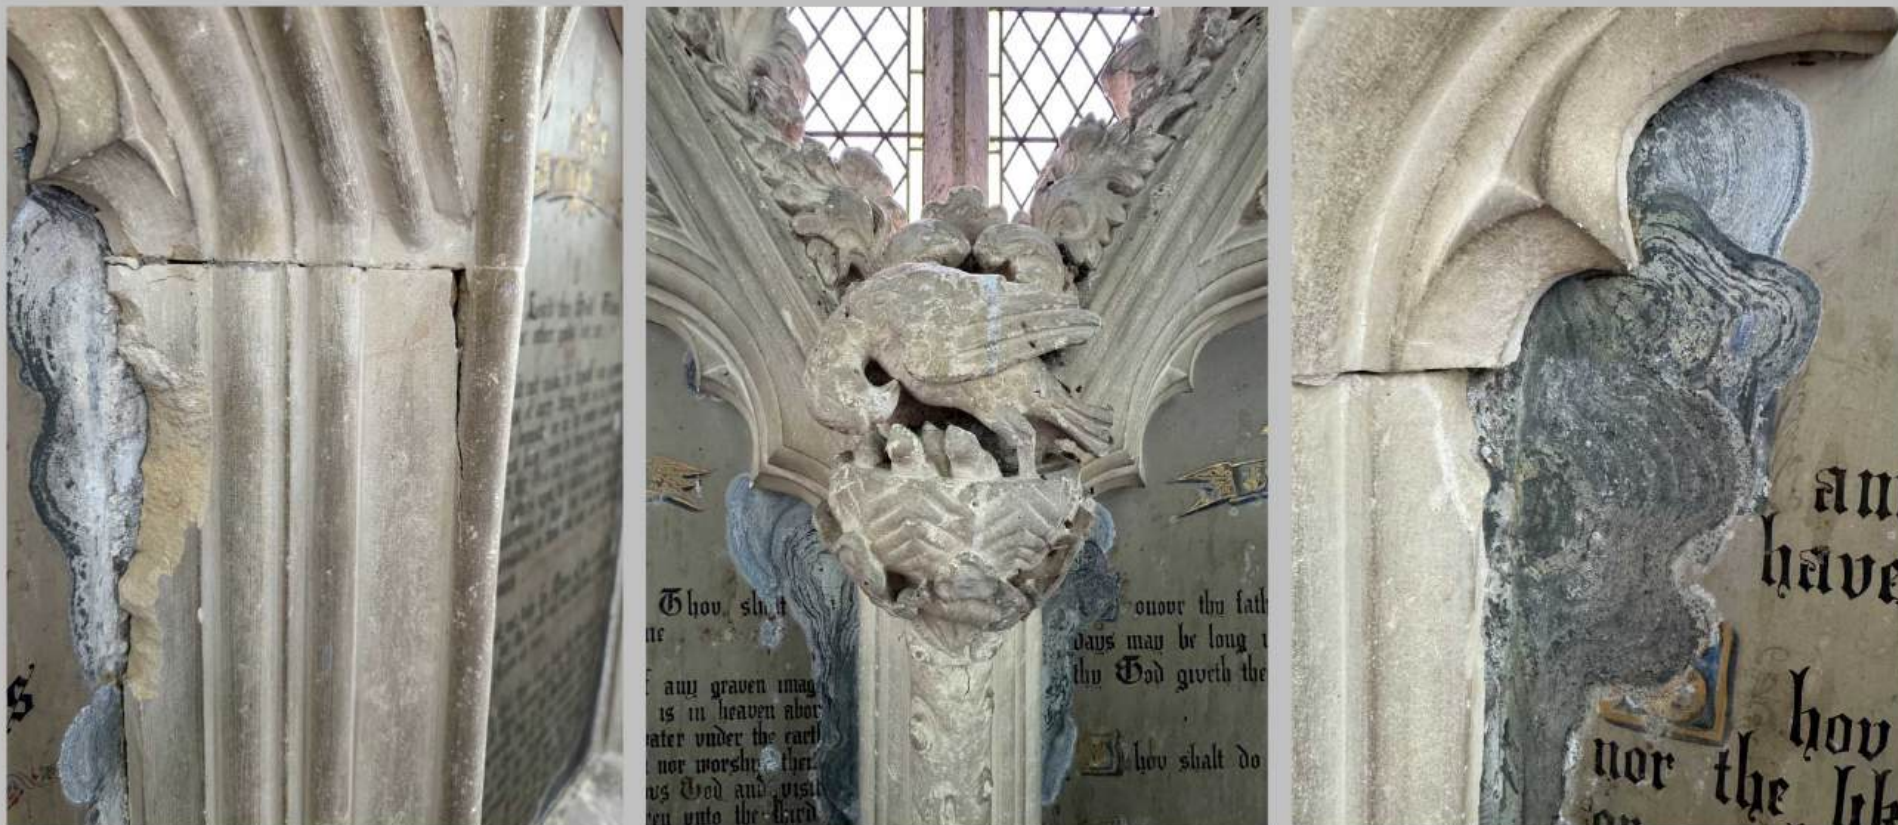
Plates 6-8 - St Peter's Church Grandborough - 1849 Reredos

Details showing the Pelican in her Piety (centre) with localised areas of damage to Caen stone mullions caused by rusting iron cramps within the structure and areas of paint loss at the edges of the panels

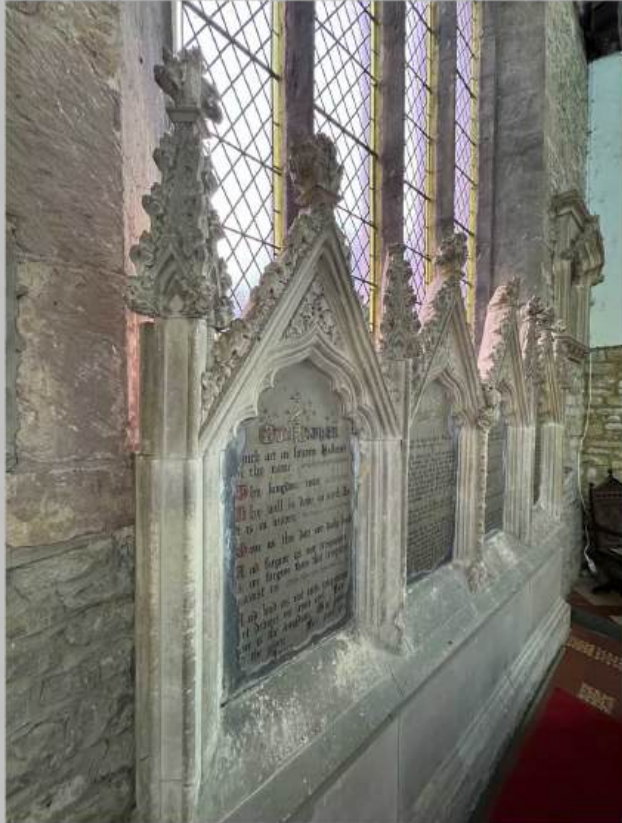
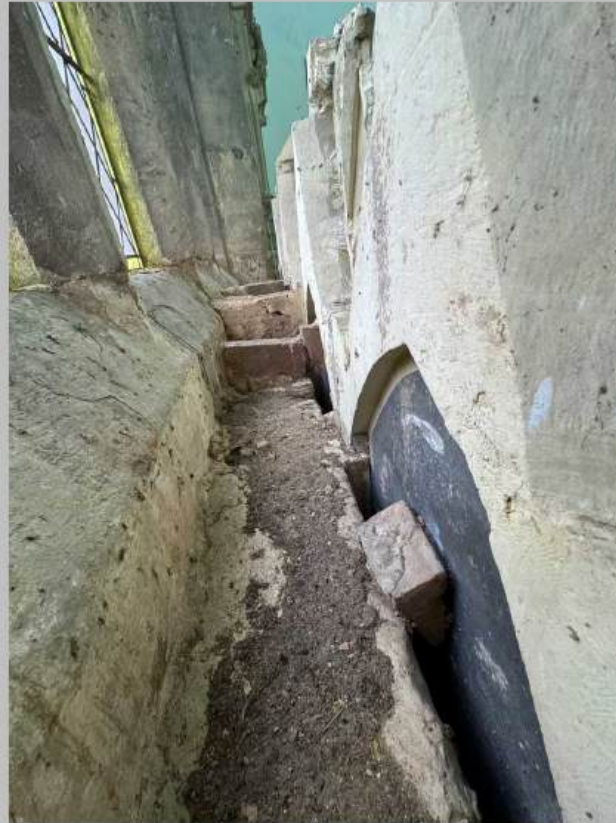
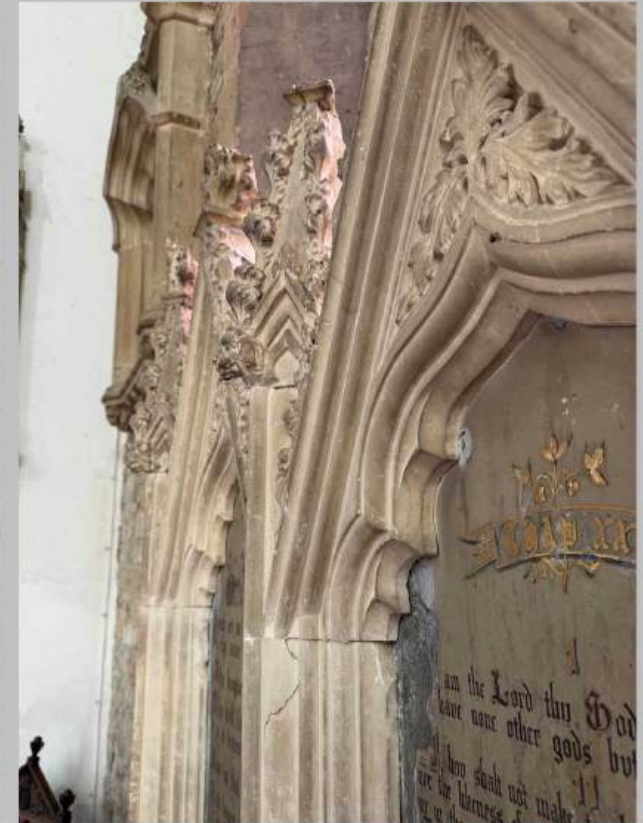
Plates 9-11 - St Peter's Church, Grandborough - 1849 Reredos

The damage to the reredos is centred along the line where it meets the east wall

At the rear the painted panels are held in place with brick wedges  
Where the mullions meet the wall moisture transfer has caused the iron cramps to corrode with expansion tipping the stone arcade forwards

Humidity within the east wall had transferred to the reredos where the two were in contact, primarily where the mullions met the wall across the centre of the structure. It was therefore agreed that the reredos be temporarily dismantled to allow corroded iron fixings to be replaced with a corrosion resistant alternative and for stone repairs to be carried out.

It was agreed that the upper and central portions of the limestone structure be temporarily dismantled to allow the removal of the four painted panels for conservation and restoration at our studio. Once access to the rear of the central structure was possible the condition of the wall behind was assessed and appropriate repairs made to missing areas of pointing, rebuilding areas damaged by the corroded iron fixings and measures taken to minimise future transfer of humidity to the reverse of the reredos. The introduction of a simple damp proof membrane (DPM) behind the mullions was sufficient to isolate the wall from the stone reredos. The corroded iron fixings for the mullions were replaced with stainless steel threaded bar fixing secured with Resapol RBS P400C styrenated polyester resin.

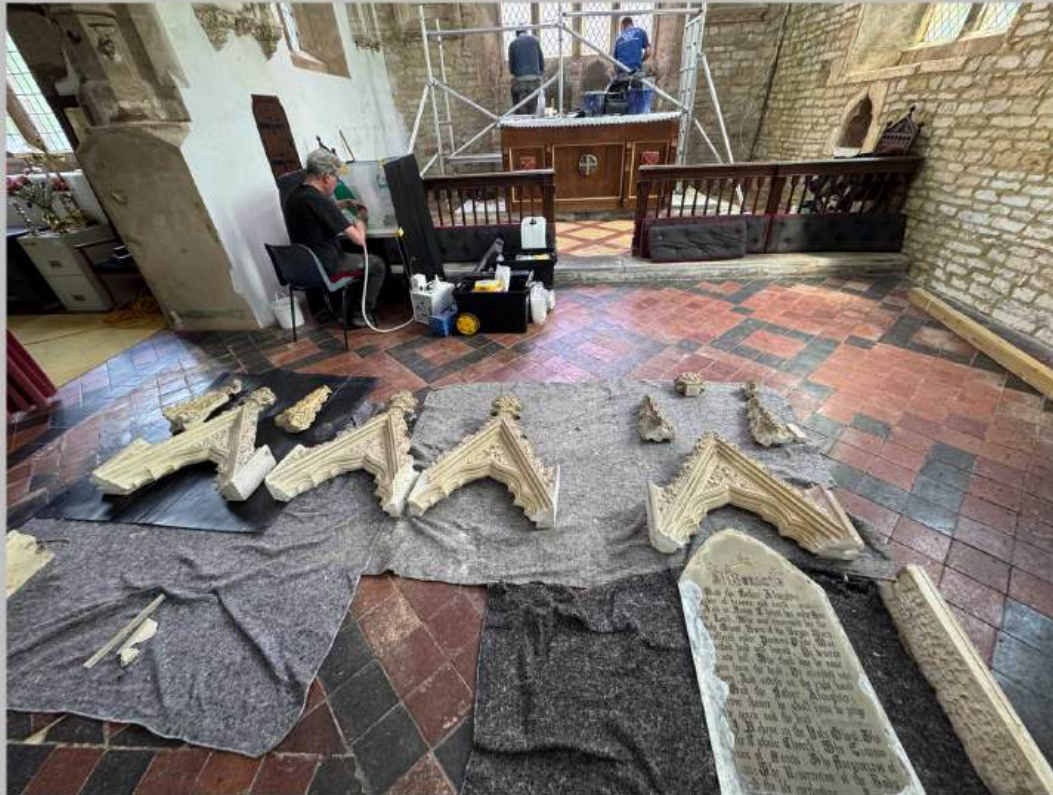
Plates 12-14 - St Peter's Church, Grandborough - 1849 Reredos

During the dismantling of the reredos the upper arches are removed and carefully steam cleaned using a Derator steam generator, the painted panels are gently lifted out and the mullions removed to reveal the loose rubble wall construction behind

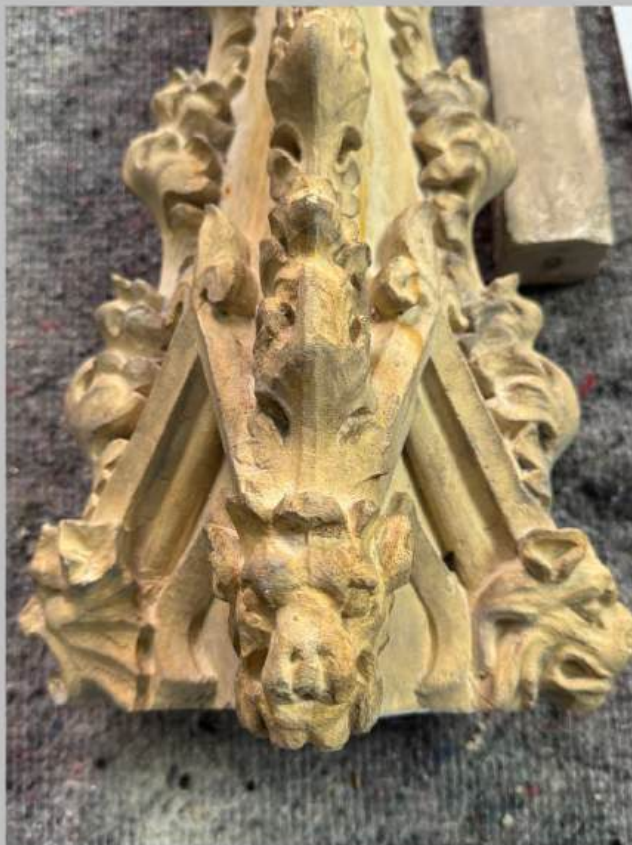
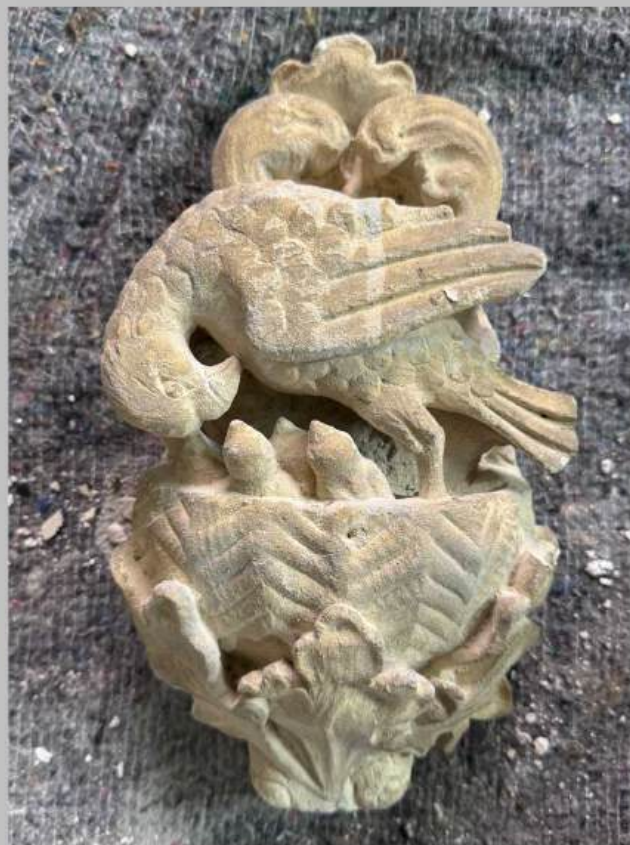
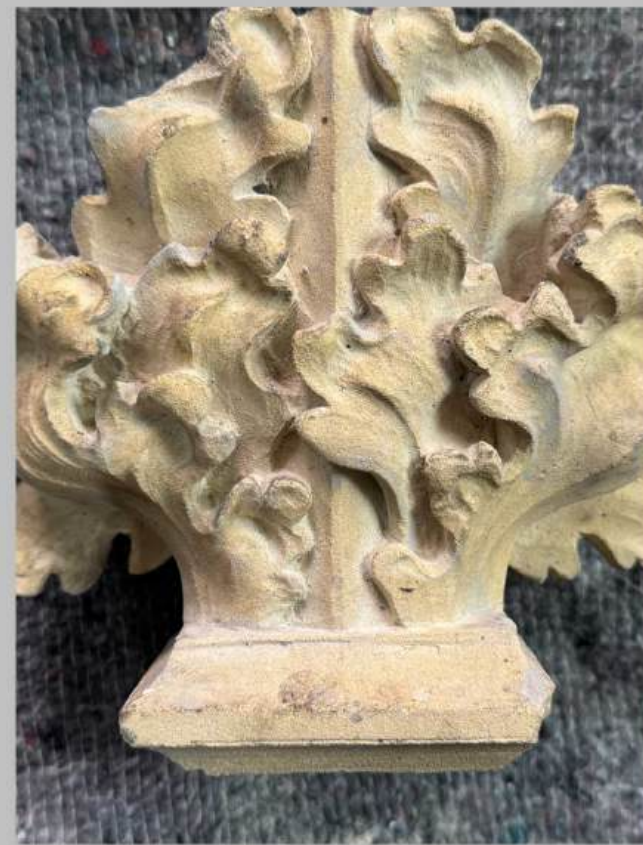
Plates 15-17 - St Peter's Church, Grandborough - 1849 Reredos

After dismantling the reredos each piece is carefully steam cleaned using a Derator steam generator to remove ingrained sooty dirt and waxy deposits from candles

- The limestone structure was carefully cleaned to obtain a more even overall appearance using a Derotor Steam cleaner<sup>6</sup>. This was carried out in advance of the reassembly of the pieces of the reredos so that new lime-based repairs could be matched in to the cleaned surface during reconstruction.

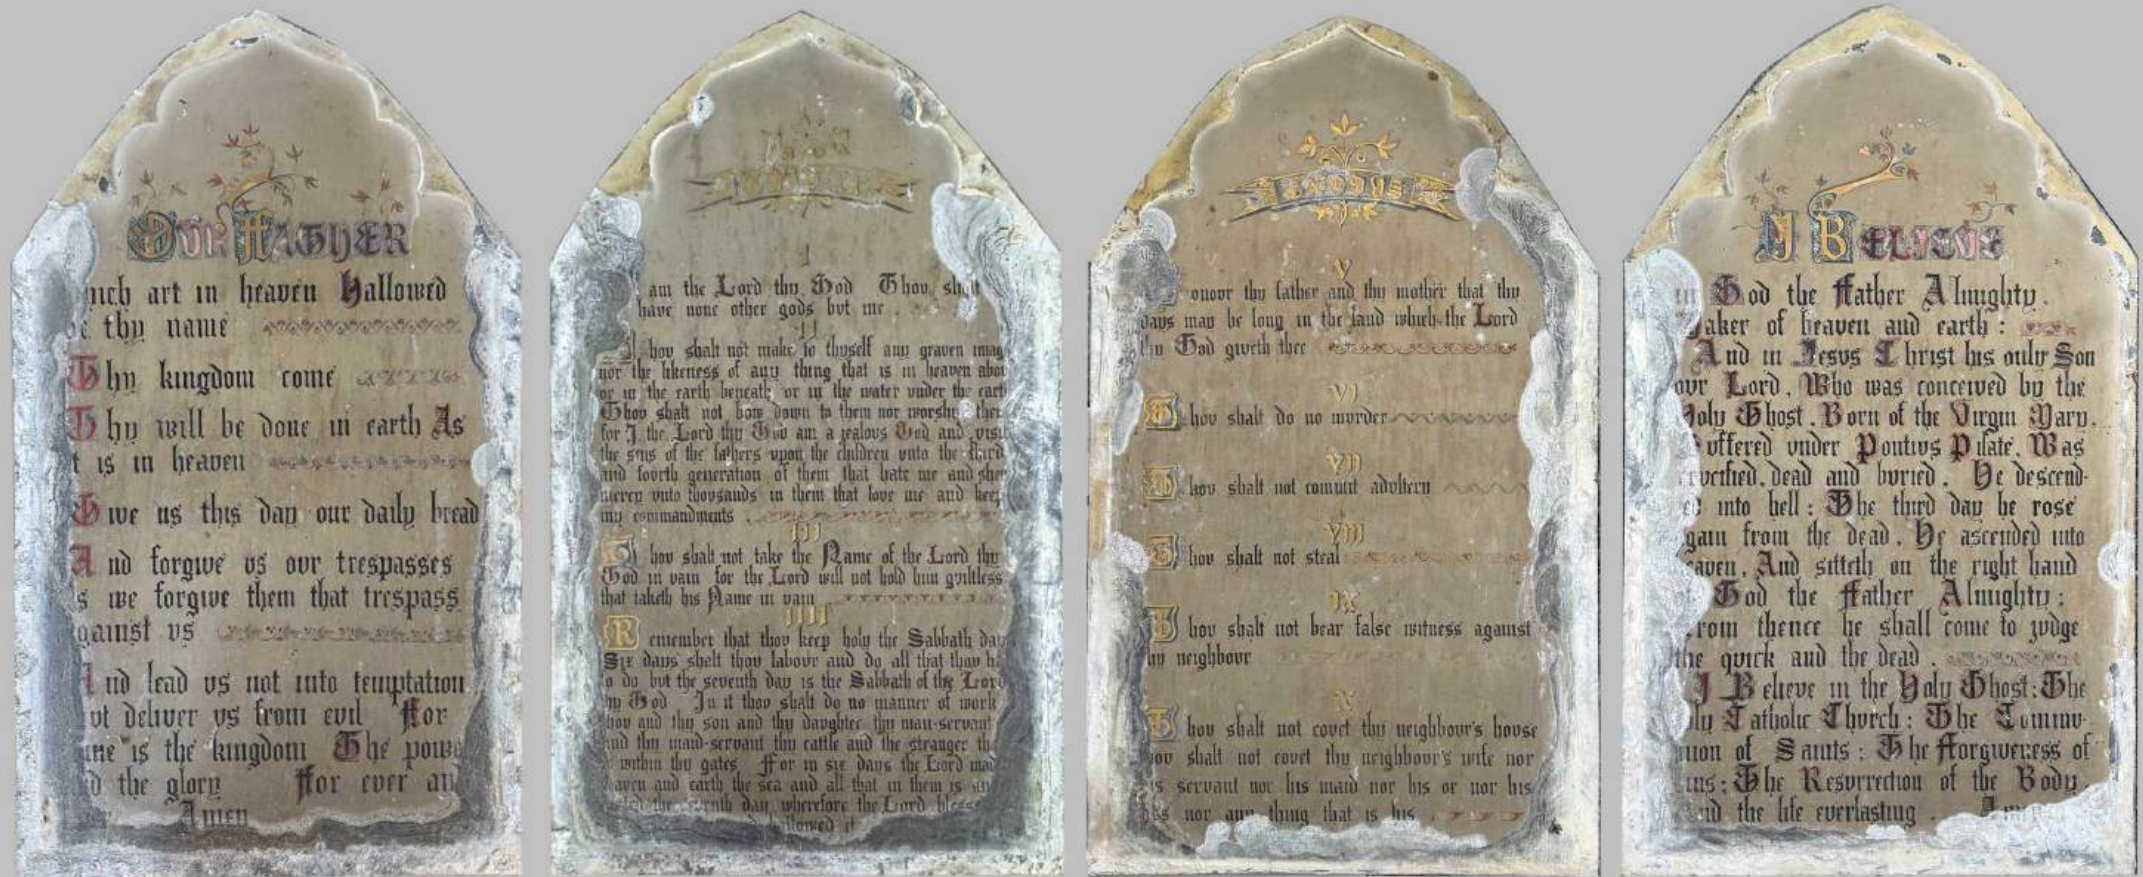
Plates 18-21 - St Peter's Church, Grandborough - 1849 Reredos

The four painted zinc panels at the studio prior to treatment  
 after removal from the reredos

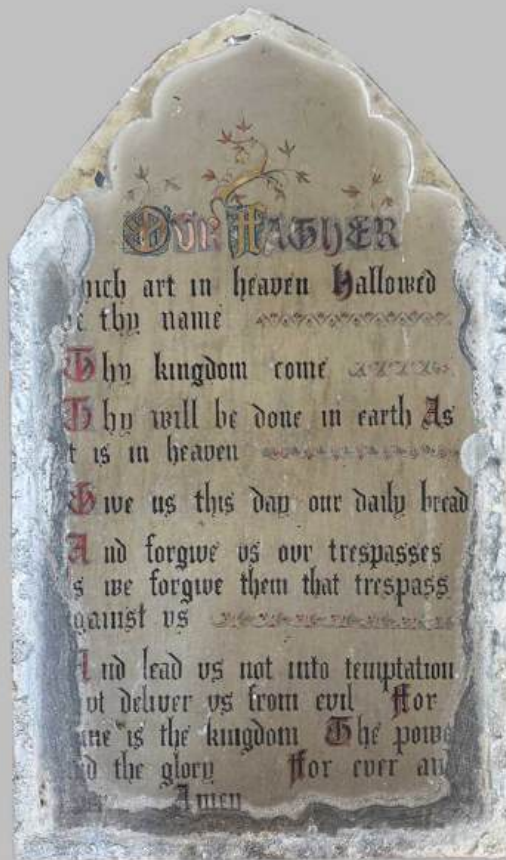
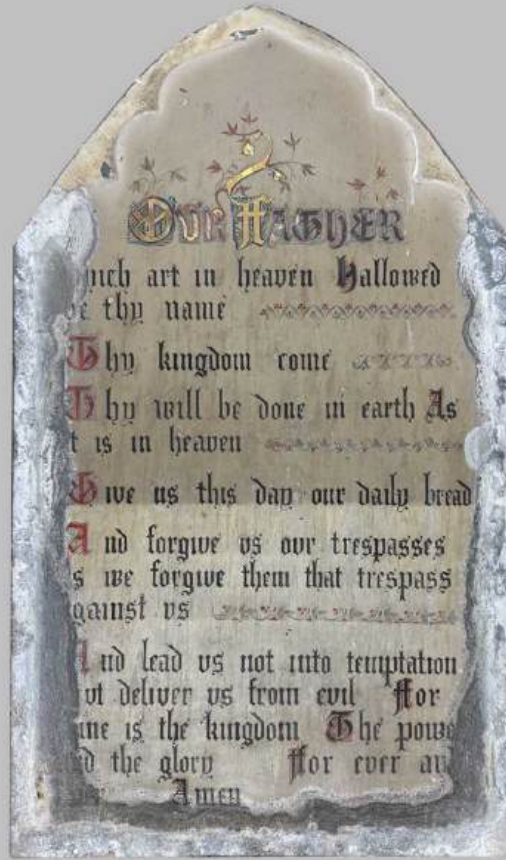
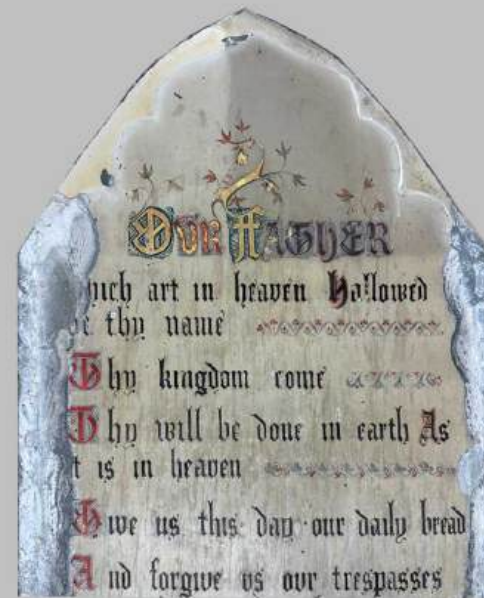
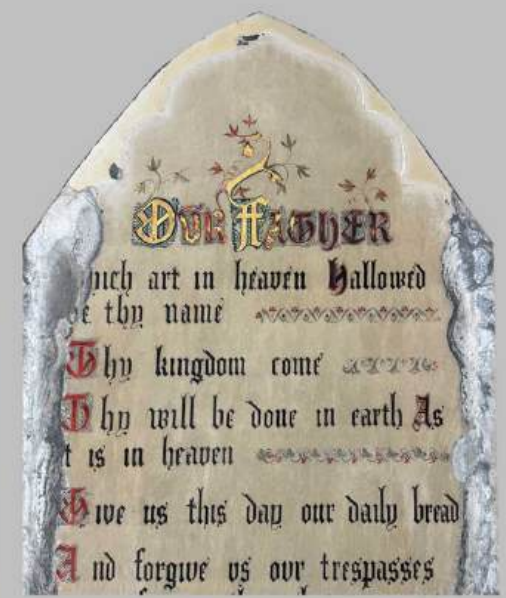
Plates 22-26 - St Peter's Church, Grandborough - 1849 Reredos

The Lord's Prayer during cleaning to remove ingrained dirt, which reveals deep staining and dark splash marks (centre above) within the background colour as a result of bat activity. Further cleaning tests indicate that retouching the background is the only viable option to disguise the dark splash marks (right)

- The painted surfaces were cleaned using deionised water in combination with other cleaning solutions to remove ingrained dirt, bat urine stains, etc. from the decoration on the painted panels. The cleaning mixes included white spirit (to remove wax), tri-ammonium citrate solutions (5% in deionised water) and deionised water with 5% non-ionic detergent Synperonic-A7<sup>5</sup>.

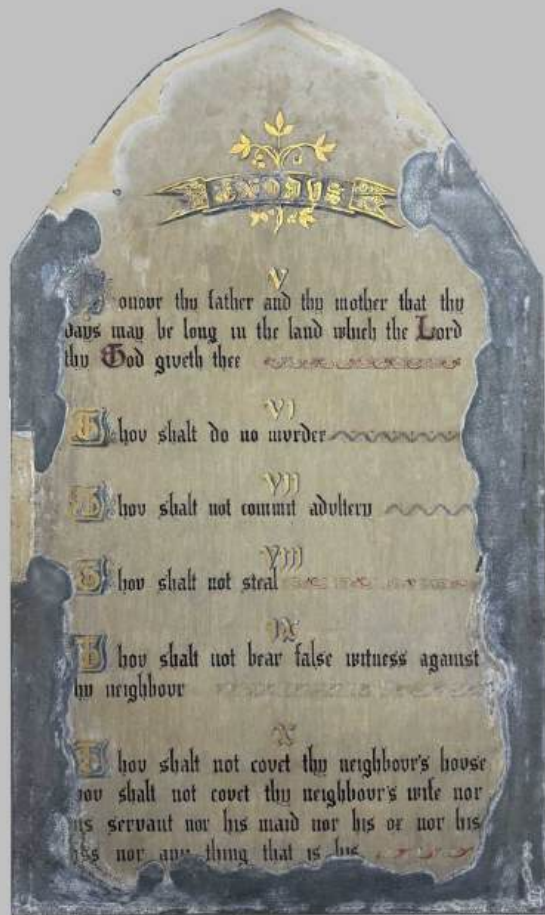
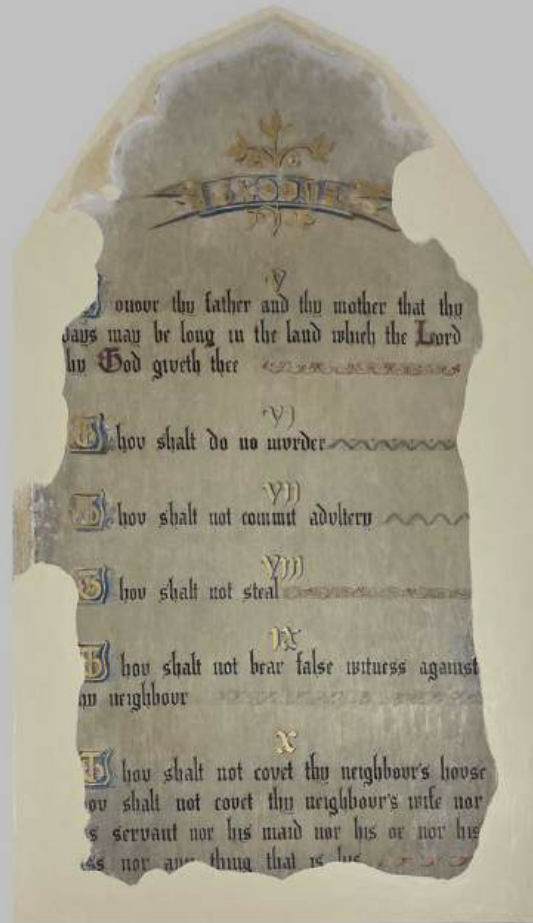
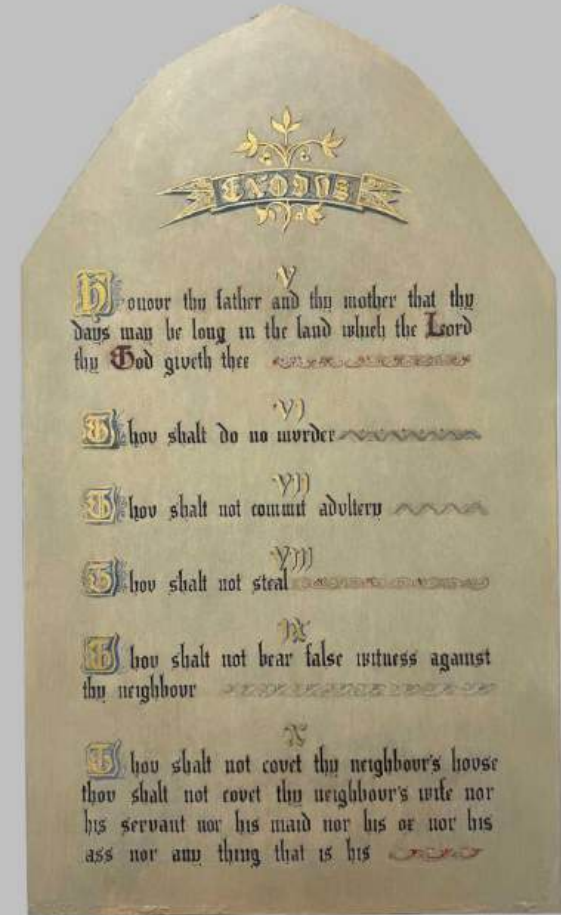
Plates 27-30 - St Peter's Church, Grandborough - 1849 Reredos

The painted zinc panels are cleaned and stripped of corroded material  
holes are filled and a tinted background primer is applied before  
areas of loss are reconstructed, with text copied from the original

- 4.3 Surface repair      Where necessary minor pitting to the surface of the painted panels was filled with Flügger™<sup>7</sup> before priming and retouching

- 4.4 Retouching      Localised retouching of the losses to the painted panels was carried out using Golden™ Artist's Acrylics<sup>8</sup>. Several types of finish are available and appropriate levels of matte or gloss were determined after the surface had been cleaned. .

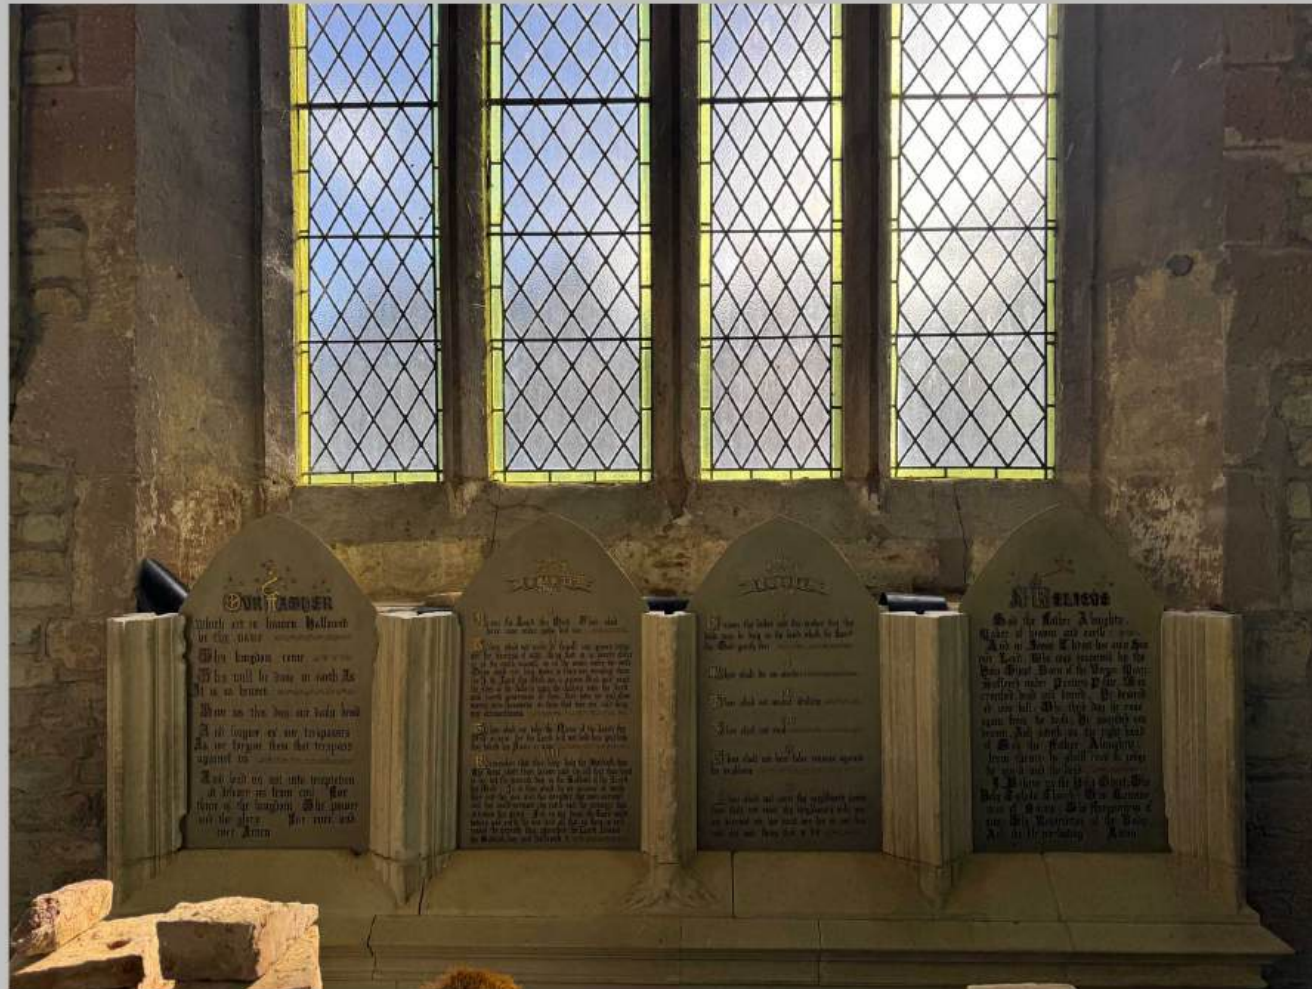
Plate 31 - St Peter's Church, Grandborough - 1849 Reredos

The cleaned and restored panels are placed within the loosely fixed mullions and positions adjusted before securing the stone

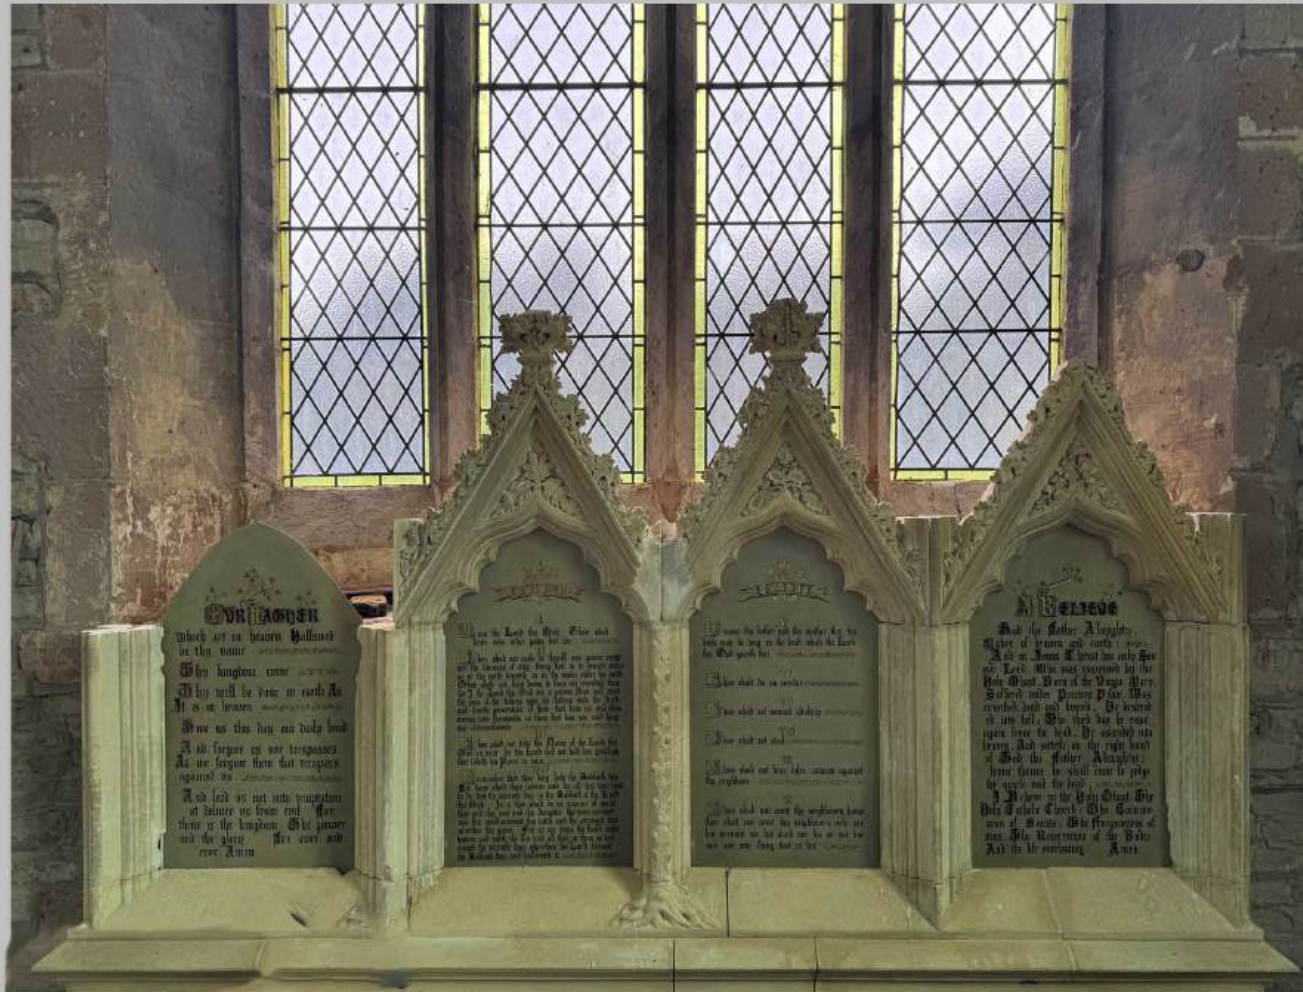
Plate 32 - St Peter's Church, Grandborough - 1849 Reredos

After fixing the mullions securely the stone arches are reinstated

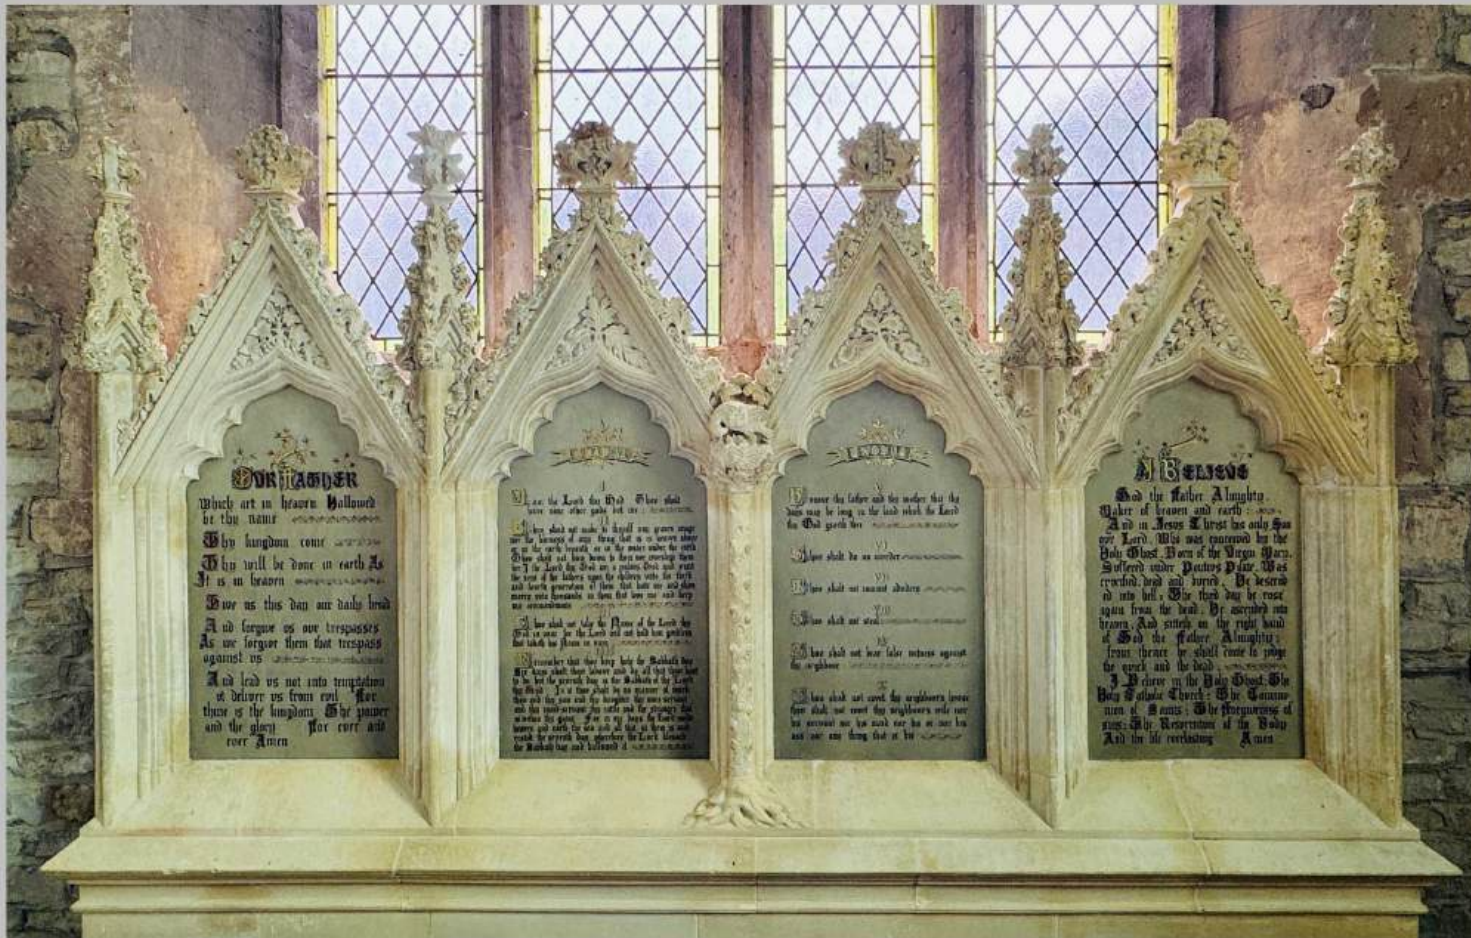
Plate 33 - St Peter's Church, Grandborough - 1849 Reredos

The reredos after cleaning and conservation

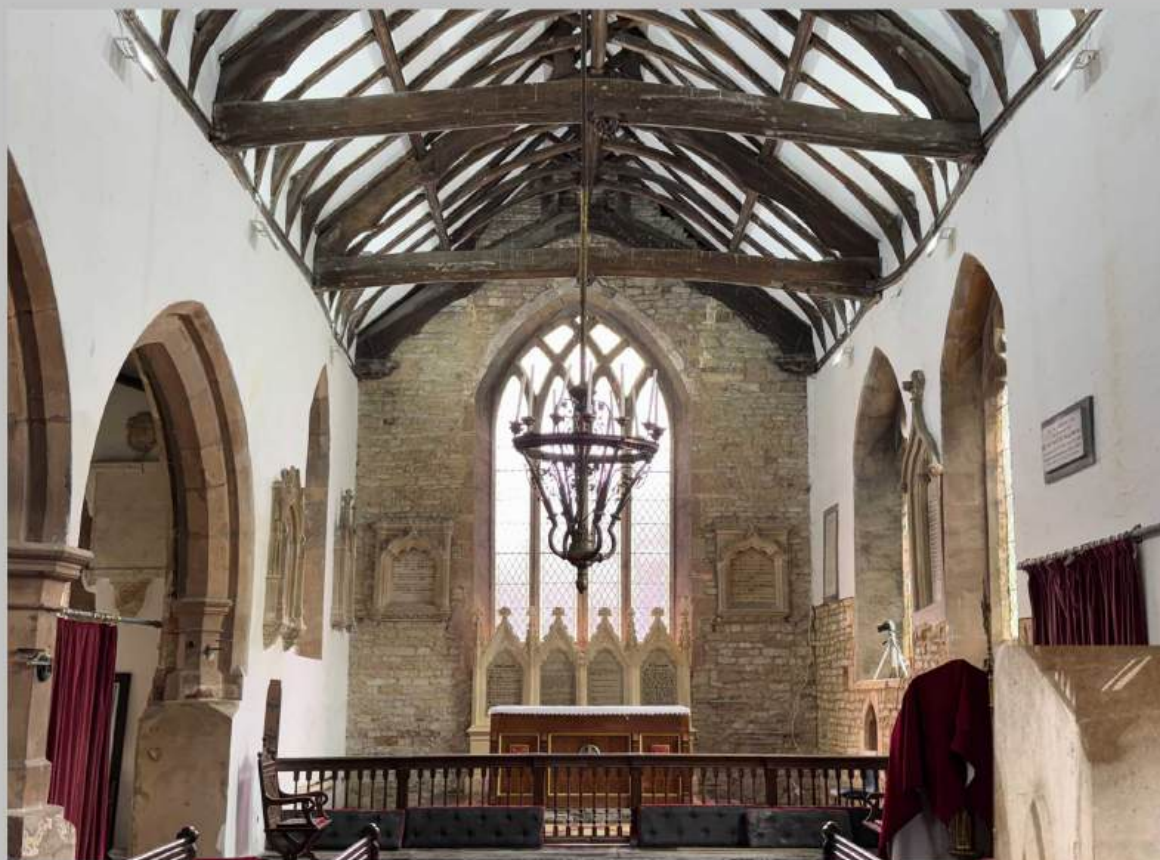
Plate 34-35 - St Peter's Church, Grandborough

The restored reredos and the view circa 1910 (right) when a smaller Victorian altar was in place. The Victorian structure was incorporated into the present 1927 altar
