**9.3 WITHDRAWAL OF FAULT HAZARD AREA – 139, 155 AND 157 TE MAIRE ROAD**

## **Recommendation Report- Withdrawal of Fault Hazard Area – 139, 155 and 157 Te Maire Road**

Fault hazard assessment  
139 Te Maire Rd  
Kahutara

**GEOTECHNICAL DESKTOP PEER REVIEW OF IRBA FAULT HAZARD ASSESSMENT  
139 TE MAIRE ROAD, KAHUTARA, WAIRARAPA**

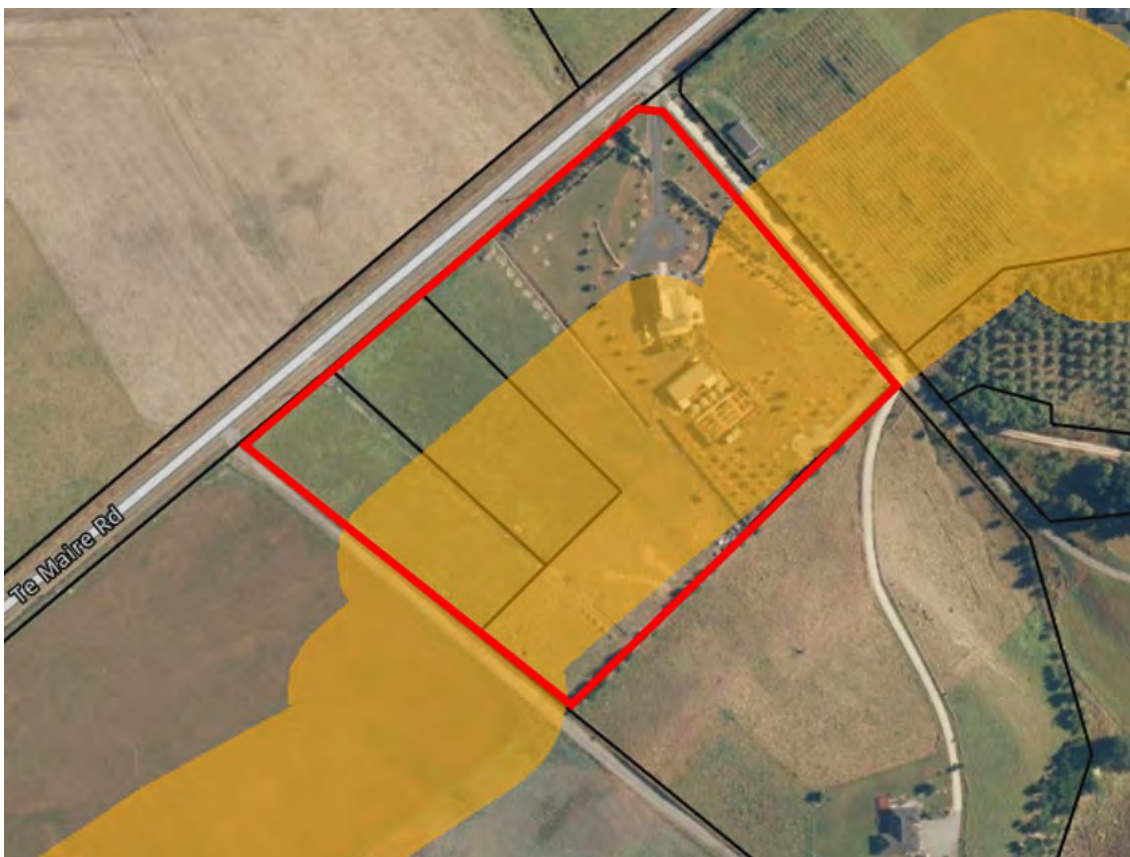
Figure 1: Fault Hazard Area (orange area) on 139, 155 and 157 Te Maire Road (red outline)

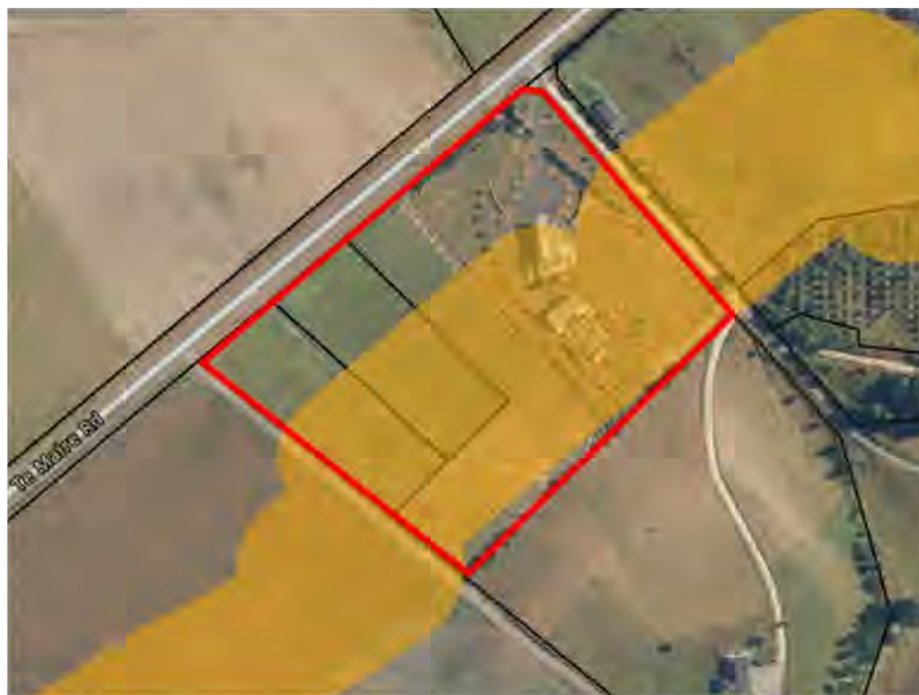
Figure 1: Fault Hazard Area (orange area) on 139, 155 and 157 Te Maire Road (red outline)

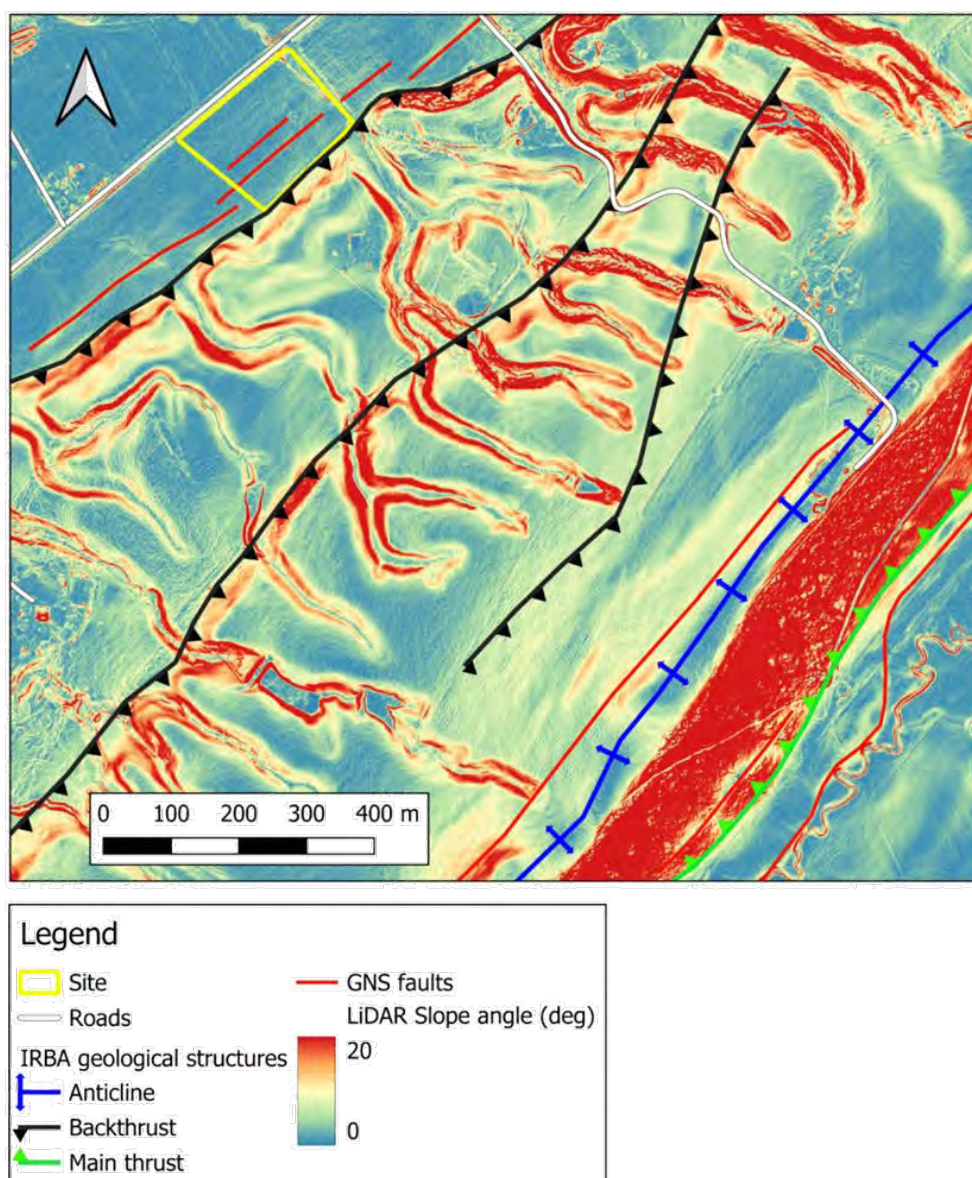
The faulting pattern is well demonstrated by the changes in slope angle across the area (Figure 6). The eastern bounding thrust fault lies at the base of the east-facing scarp 1km southeast of the site. This fault is westwards dipping, and is included in the GNS mapping.

The western margin of the pop-up block is the scarp immediately above the site, and we interpret this to be controlled by a back-thrust fault which dips eastward, likely joining the main bounding fault at depth beneath the ridge. This backthrust is an integral part of the Te Maire Fault system.

Between the bounding faults, there are at least two smaller back-thrust faults, one of which was mapped by GNS. A longer backthrust fault which lies 350m southeast of the site was not included in the GNS mapping, however this feature is clearly evident in the slope angle map, cutting across the numerous eroded gullies (Figure 6).

Figure 6 Geological interpretation for central Te Maire fault zone, overlain over LiDAR slope angle map. Main thrust location taken from GNS.

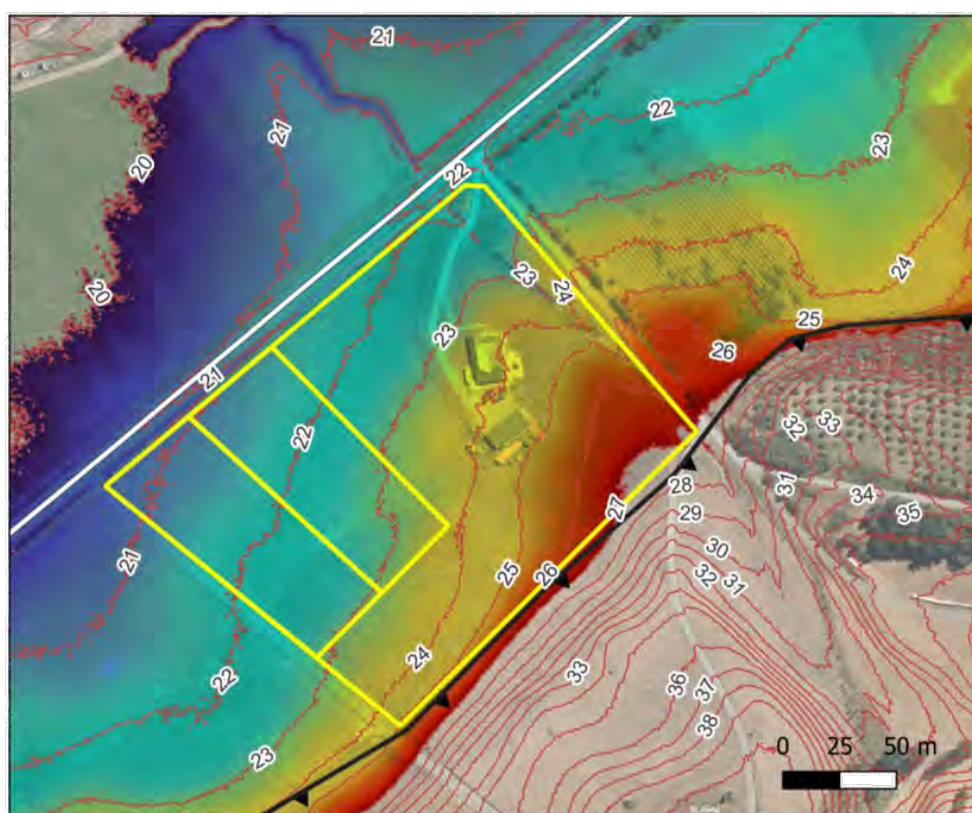
The landform of the site comprises a very low gradient alluvial fan which emanates from the eroded gully at the northeast corner of the site (Figure 7). The fan surface extends from about 27m elevation down to about the 21m contour line, where the surface merges with the regional fluvial surface, eventually draining to Lake Wairarapa about 7km to the west. The drainage follows a linear path through the centre of the fan, and is incised about 1m into the fan surface.

The fan surface appears to be generally uniform, with no indications of scarps cutting across the surface. There is a shallow depression present just south of the centre of the site, indicated by an eastwards bend in the 23m contour line. On the north side of the fan, on the adjacent property, there is a similar shallow depression at the foot of the hill.

Figure 7 Topographic map for site and adjacent areas, 1m contours and colour overlay derived from LiDAR data. The mapped backthrust fault is as per Figure 6.

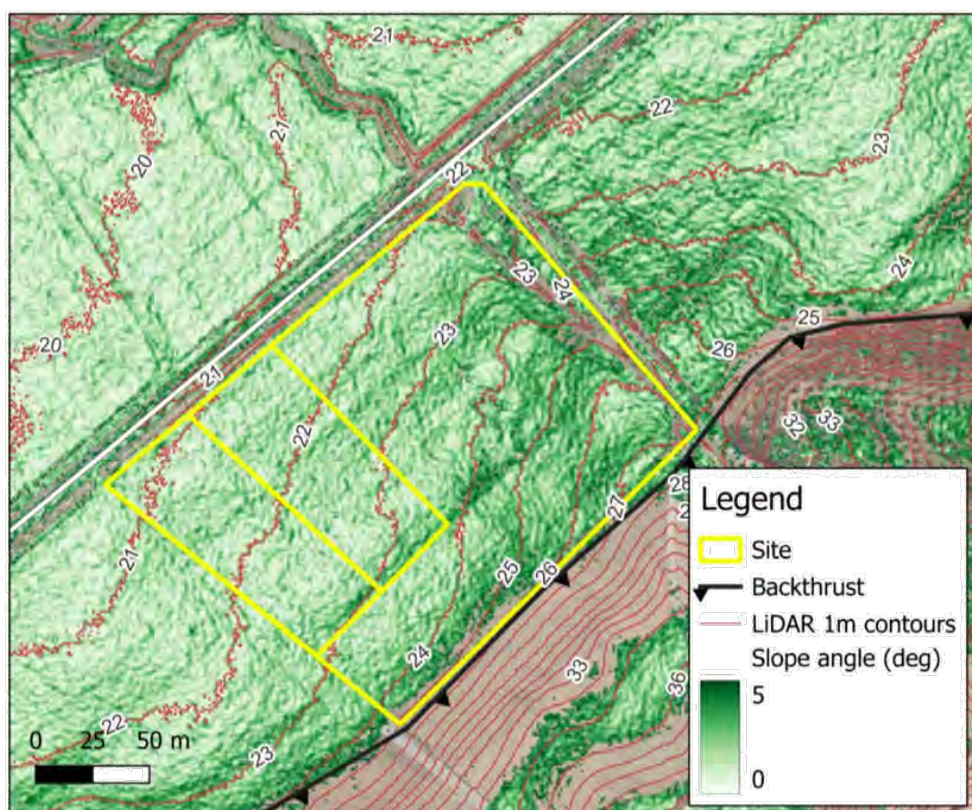
A slope angle map derived from LiDAR data is shown in Figure 8. The colour scale has been set at 0-5° to enhance subtle features of the landscape. There is a persistent NE-SW linear trend evident through the site, with lines being parallel to the road. Some of the linear features appear to be continuous with similar lineaments in adjacent paddocks, and others appear to terminate at the property boundaries. None of the slopes present on the alluvial fan surfaces have slope angles similar to those present on the mapped fault scarps, which are typically 20-25°.

Figure 8 Slope angle map, colour enhanced to show slopes of 0-5°.

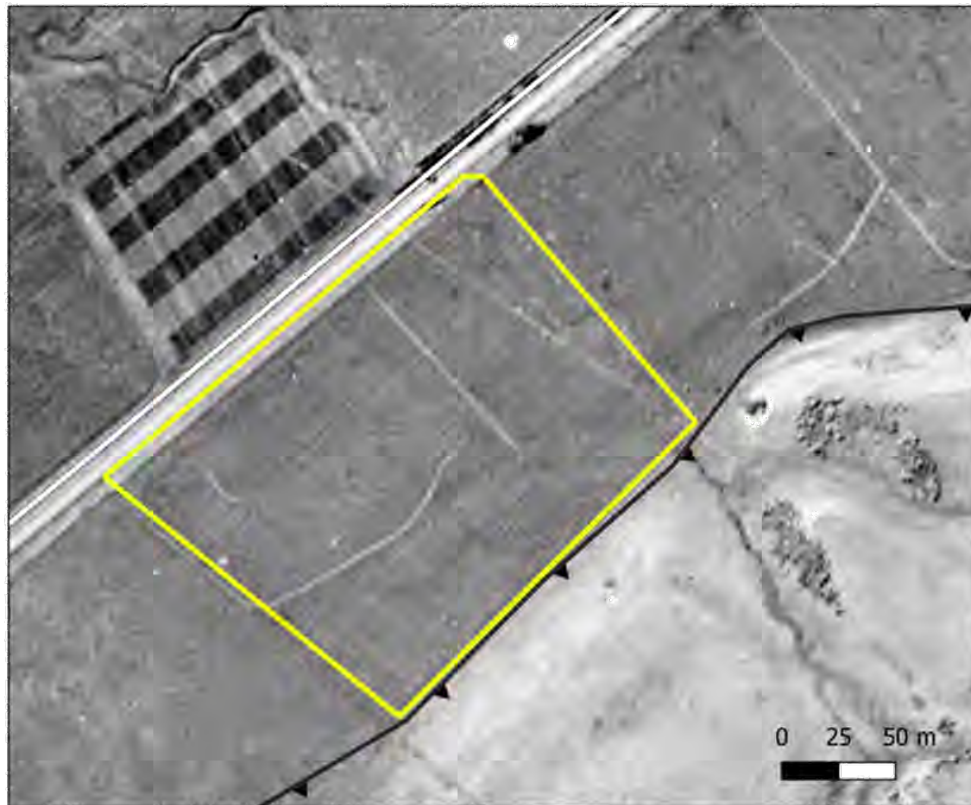
Similar NE-SW linear features are evident on an historical aerial photograph of the site (Figure 9). We interpret these to represent drainage lines, possibly where subsoil tile drains have been installed. The image also shows a farm track accessing the shallow depression south of the site centre. A similar track is evident accessing the area on the adjacent site where a small depression is present. These shallow depressions may indicate former borrow pits where soil has been excavated.

Figure 9 Historical aerial image of site. Source: Retrolens image SH295\_1030\_6 dated 25/8/1944.
