## Slow Shutter Close Corrective Measures (Uniblitz Model CS-65)

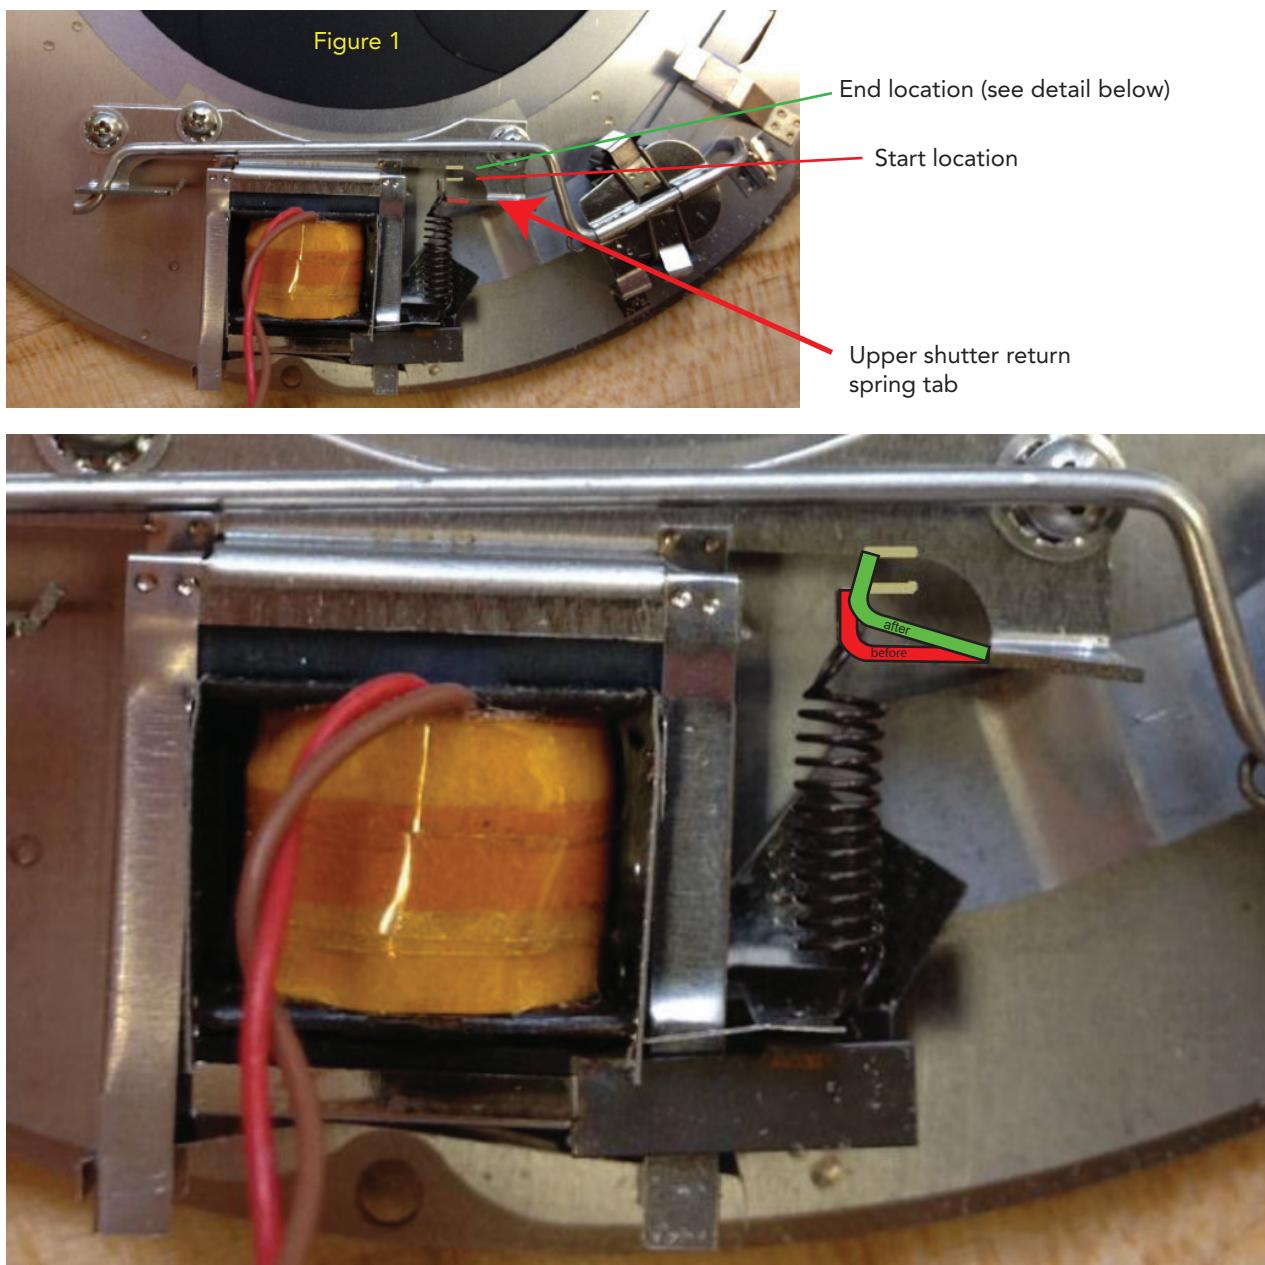
Your camera uses the highest quality shutter available, the Uniblitz 65mm. By design the shutters can be replaced without being returned to FLI in the event of damage or non-functionality. The Uniblitz CS-65mm shutter can become sluggish (closing) over time due to a combination of exposure frequency, age, temperature, and humidity that alter the shutter return spring's tension. If the shutter close time exceeds the camera's shutter delay (set in firmware), streaking will result as the image downloads with light falling on the sensor. The following steps will return your shutter to like-new performance.

The upper spring tab (marked in red below) ends in an 'L' shape.

Note the location of the top of your shutter's upper spring tab 'L' (Figure 1 location indicated by first tan line).

The end of the upper spring tab 'L' should now be at the approximate location noted by the second tan line in Figure 1. This bend increases the shutter spring tension.

Grasp the spring tab at the location marked in red using a suitable pair of needle nose pliers.

Bend the tab by approximately 1mm towards the shutter blades.
