## PROJECT PROFILE

# WL 16

### CATTLE DAMAGED SITE

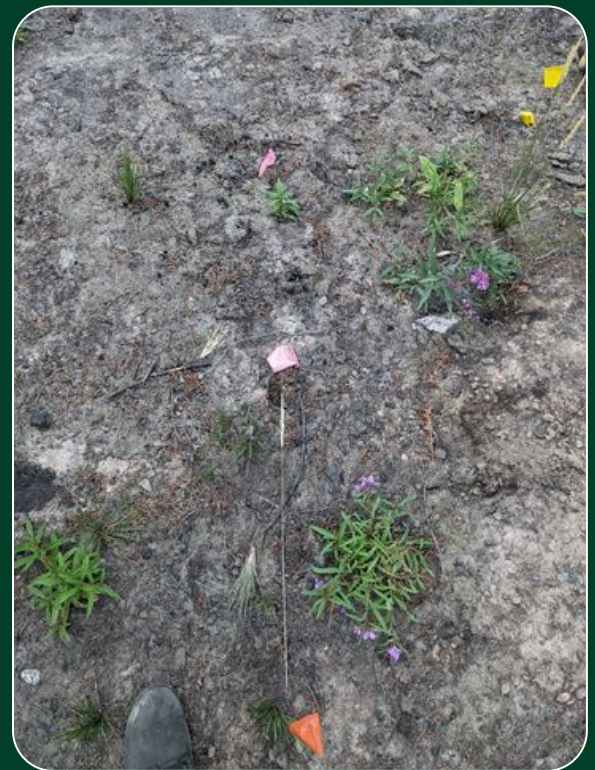
In the second year, zero circular plots were distributed at this site due to the impact of grazing cattle. Our team learned that livestock were allowed to access this site shortly after it was planted, and when the team returned in the fall, many of the permanent plot flags and seedlings had been damaged by trampling. This compromised the data, and after conversations with the landowner it was determined that no further plots (including permanent circular plots) should be established until the cattle issue is addressed.

*Trampling damage at a flagged plot after livestock accessed the site.*

- 06 Any sites with cattle or livestock grazing will be excluded from future operations unless fenced.
- 07 This site was also too dry and hot for commercial operations and would be deprioritized for drone planting in the future.

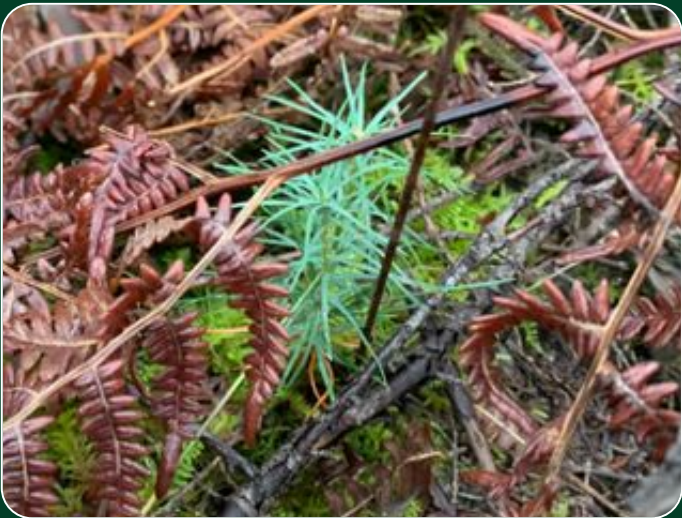
Seedling assessed at 3 months

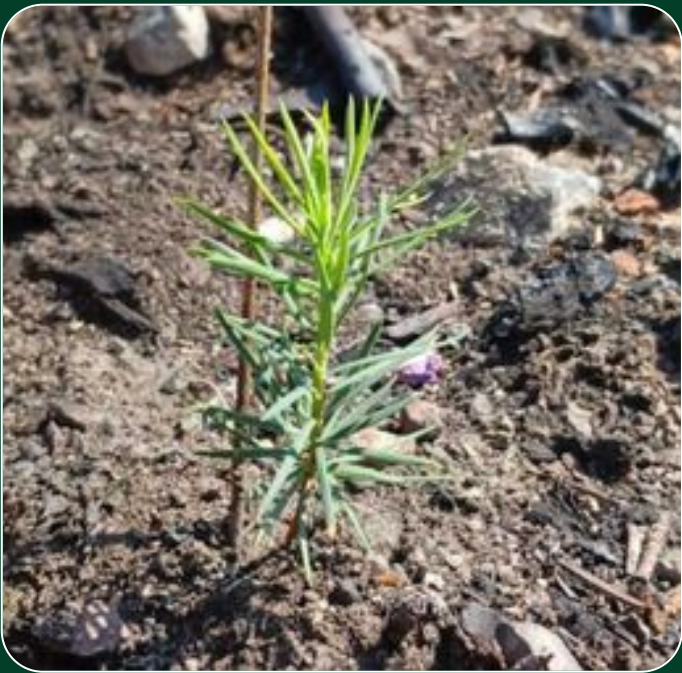
Seedling assessed at 6 months
