## Baseline Assessment – Stream Attributes

**Reach S-F8 (Pipeline ROW)**

**Franklin County, Virginia**

## Profile and Cross-Sections Baseline Survey

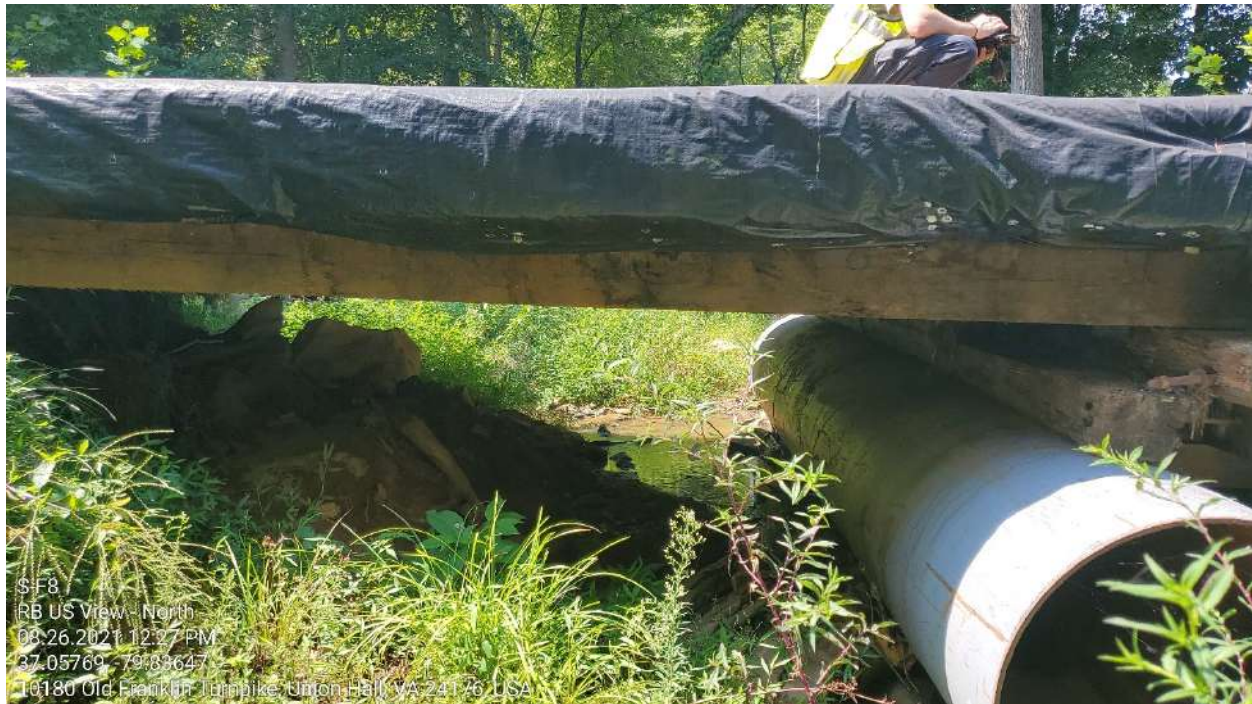
Photo Type: RB US VIEW

Location, Orientation, Photographer Initials: Downstream at ROW/LOD on right bank looking S upstream, DW

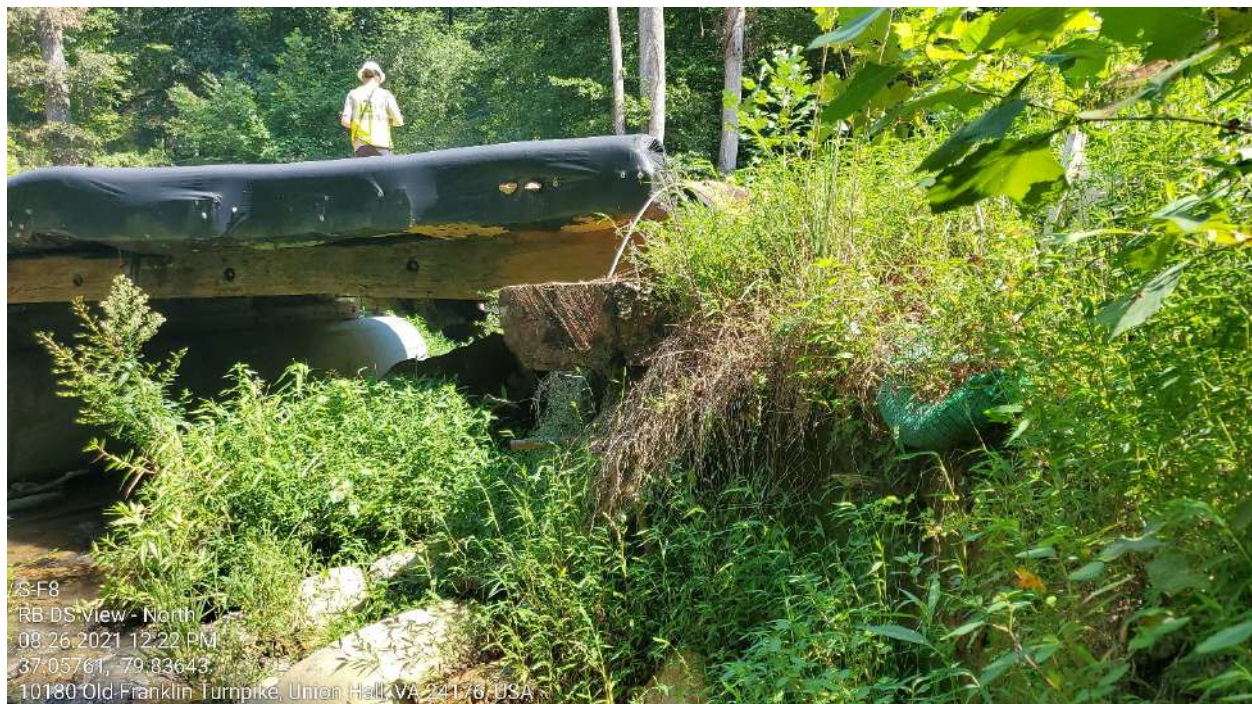
Photo Type: RB DS VIEW

Location, Orientation, Photographer Initials: Upstream at ROW/LOD on right bank looking N downstream, DW

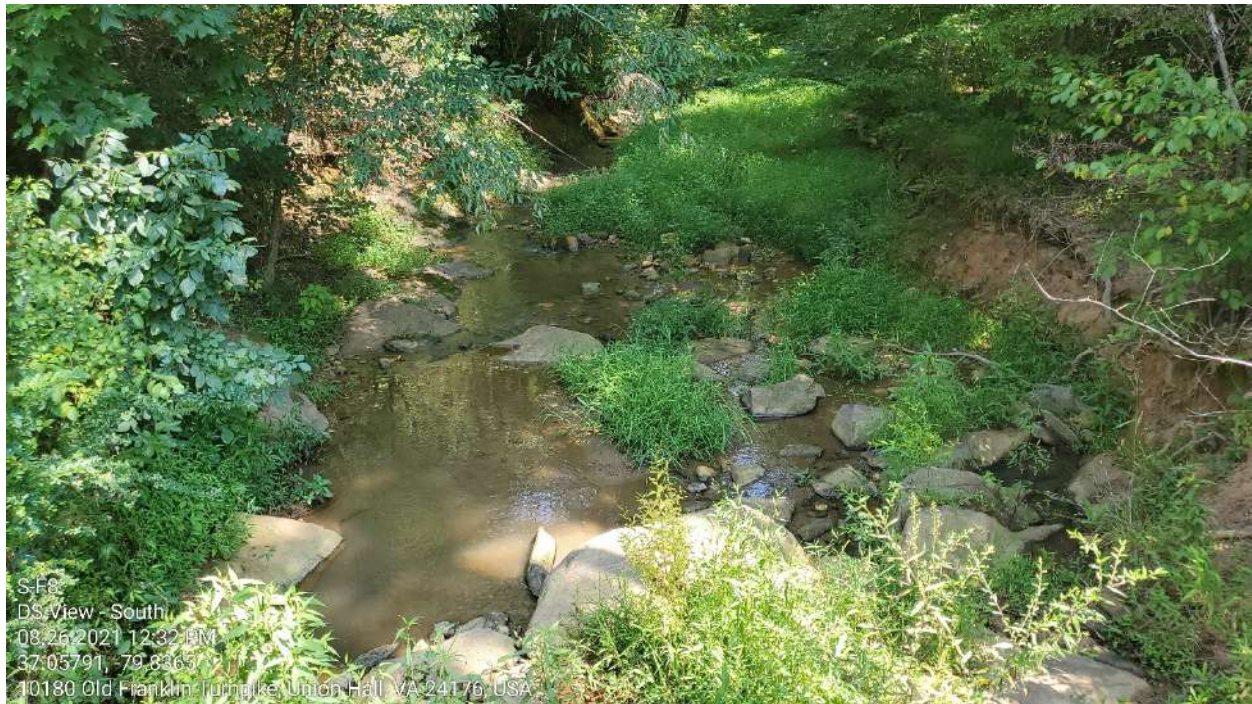
Photo Type: DS COND

Location, Orientation, Photographer Initials: Downstream at ROW/LOD looking N downstream, DW

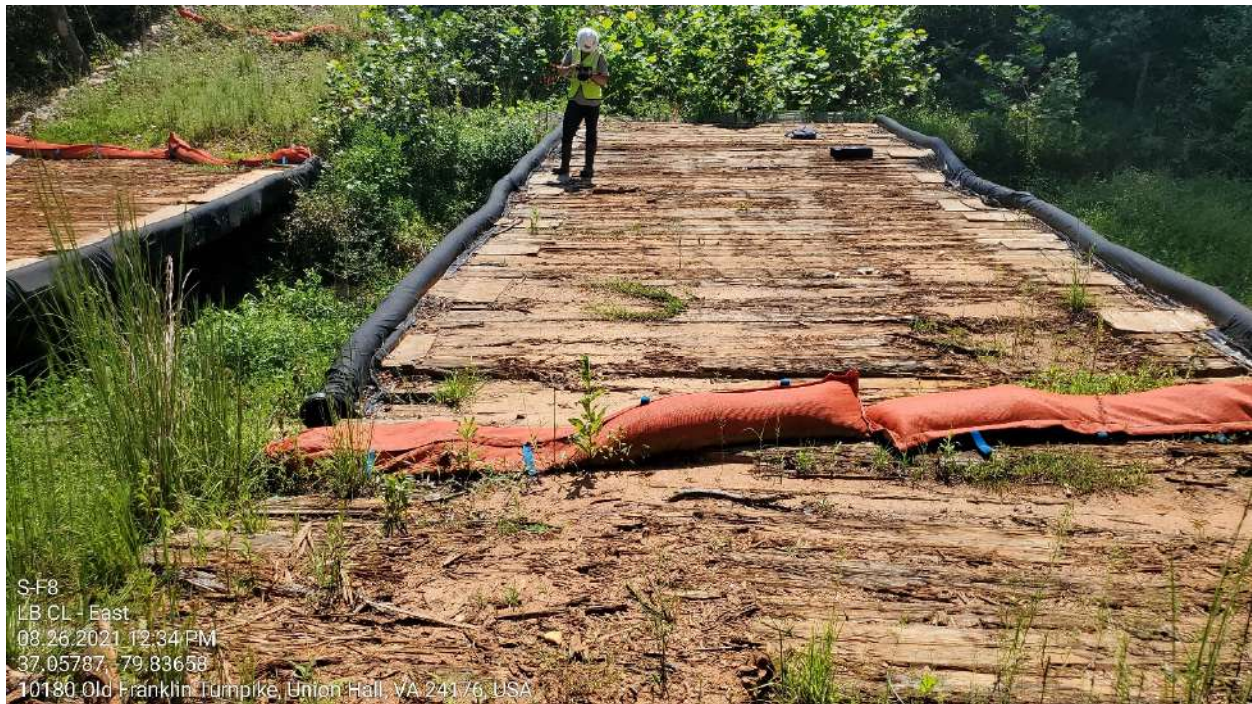
Photo Type: LB CL

Location, Orientation, Photographer Initials: On thalweg at pipe centerline looking E at right streambank, DW

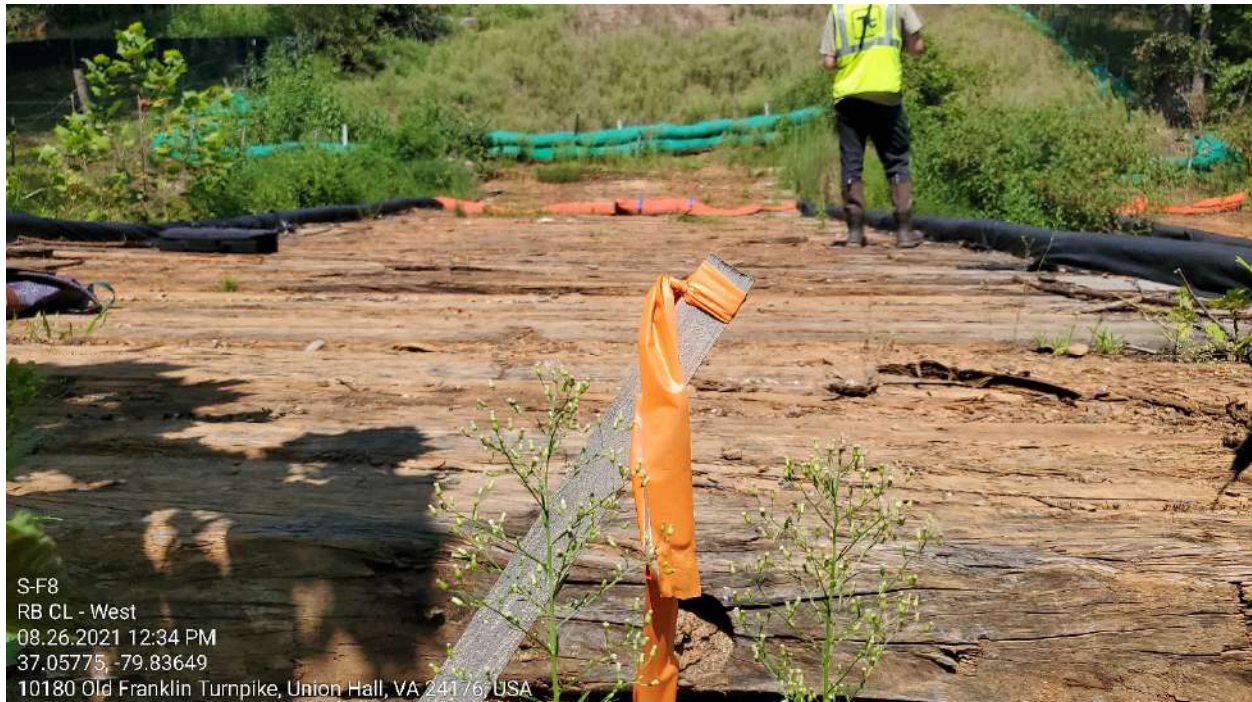
Photo Type: RB CL

Location, Orientation, Photographer Initials: On thalweg at pipe centerline looking W at left streambank, DW

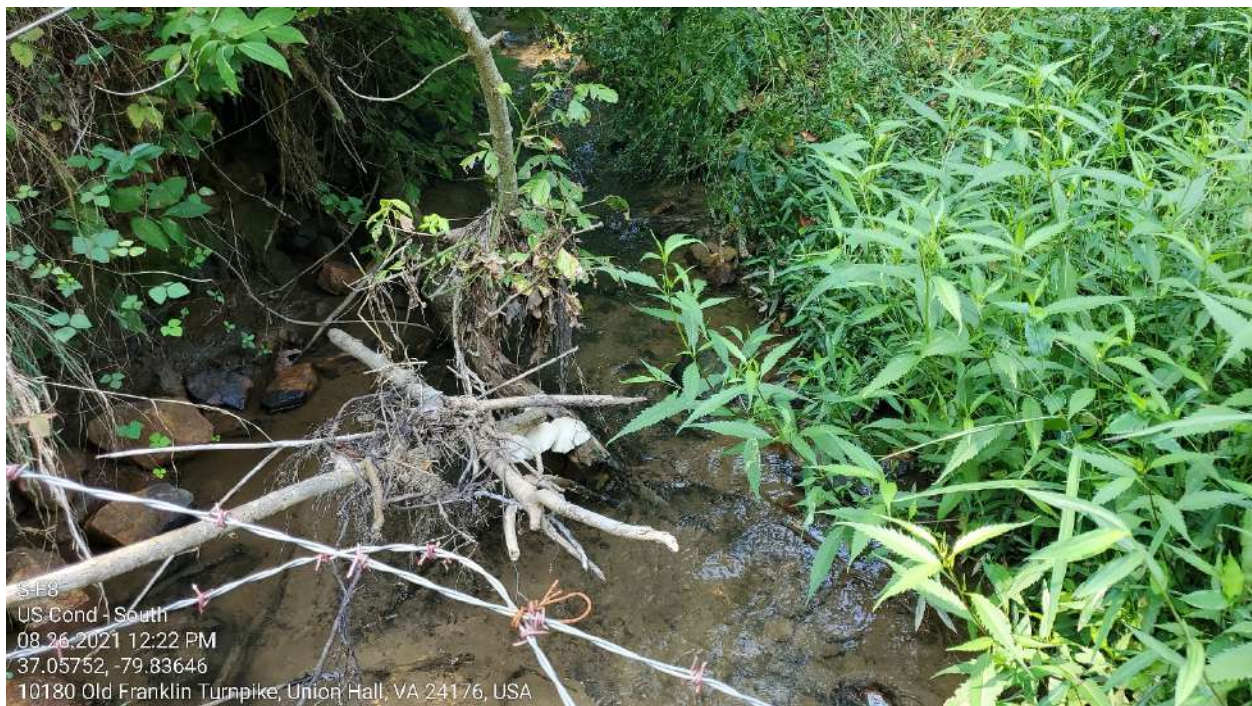
Photo Type: US COND

Location, Orientation, Photographer Initials: Upstream at ROW/LOD looking S upstream, DW

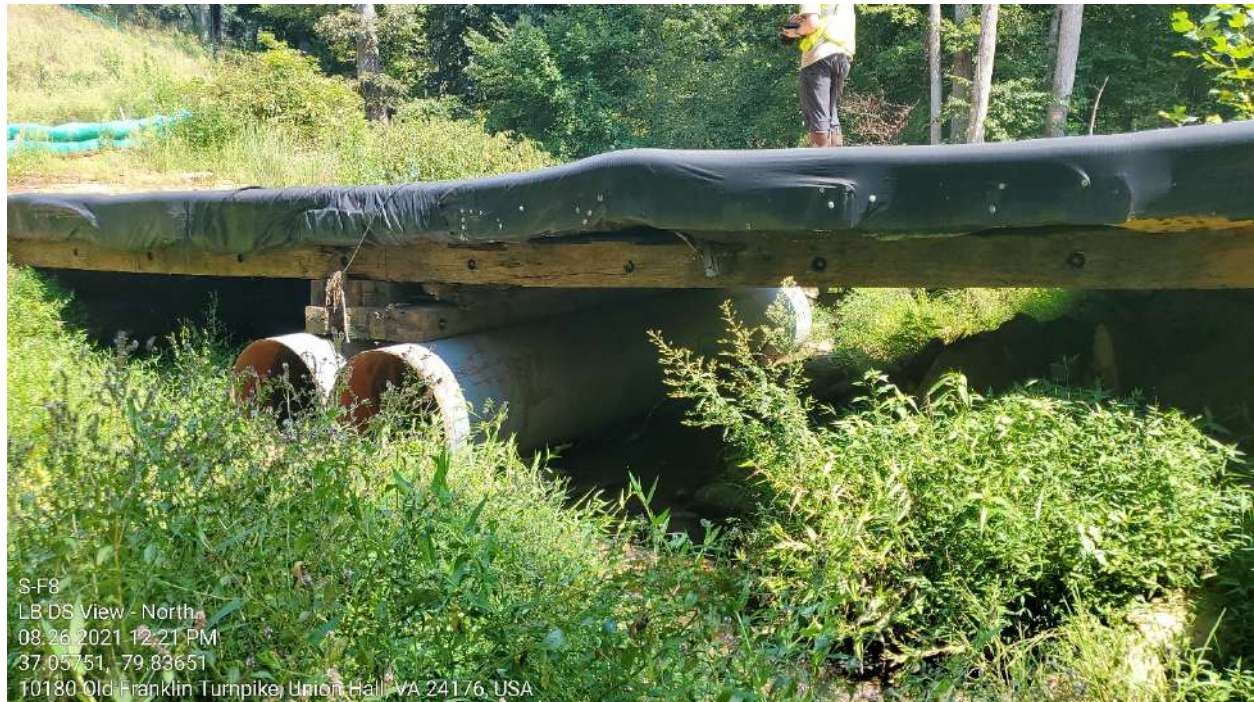
Photo Type: LB DS VIEW

Location, Orientation, Photographer Initials: Upstream at ROW/LOD on left bank looking N downstream, DW

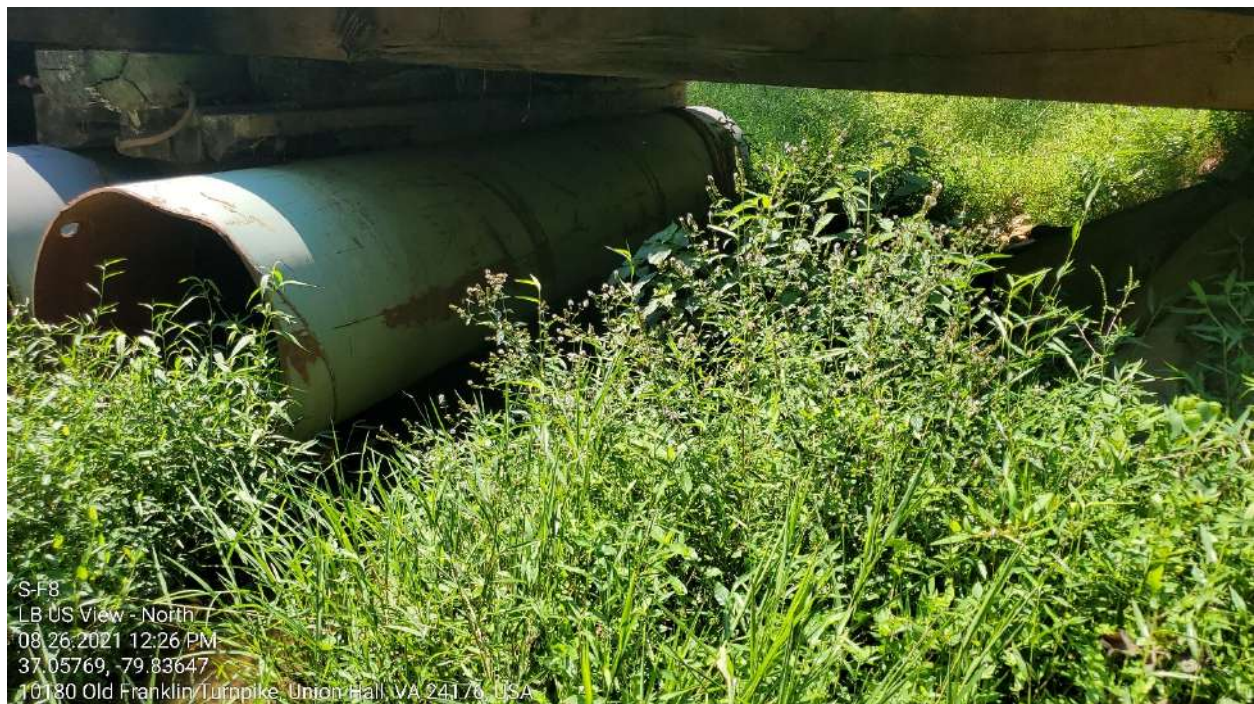
Photo Type: LB US VIEW

Location, Orientation, Photographer Initials: Upstream at ROW/LOD on left bank looking S upstream, DW

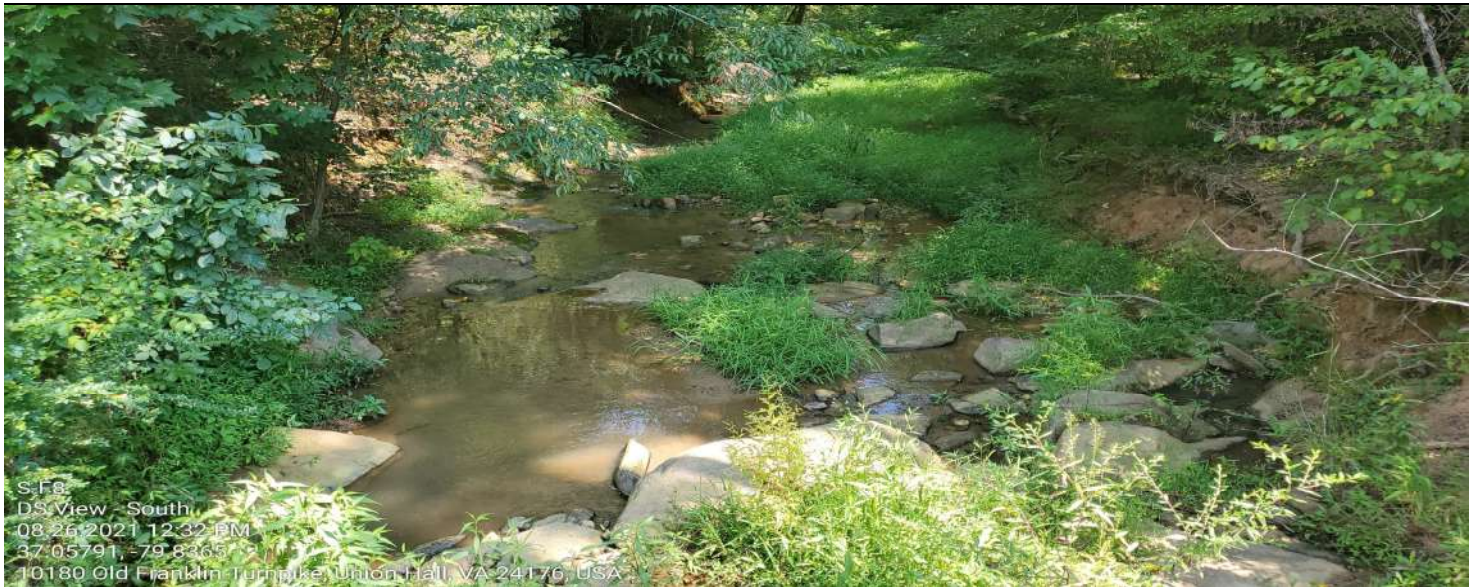
**CAPTION.** Assessment is limited to areas within the temporary ROW.
