## Baseline Assessment – Stream Attributes

**Reach S-H25 (Timber Mat Crossing)**

**Spread I**

**Franklin County, Virginia**

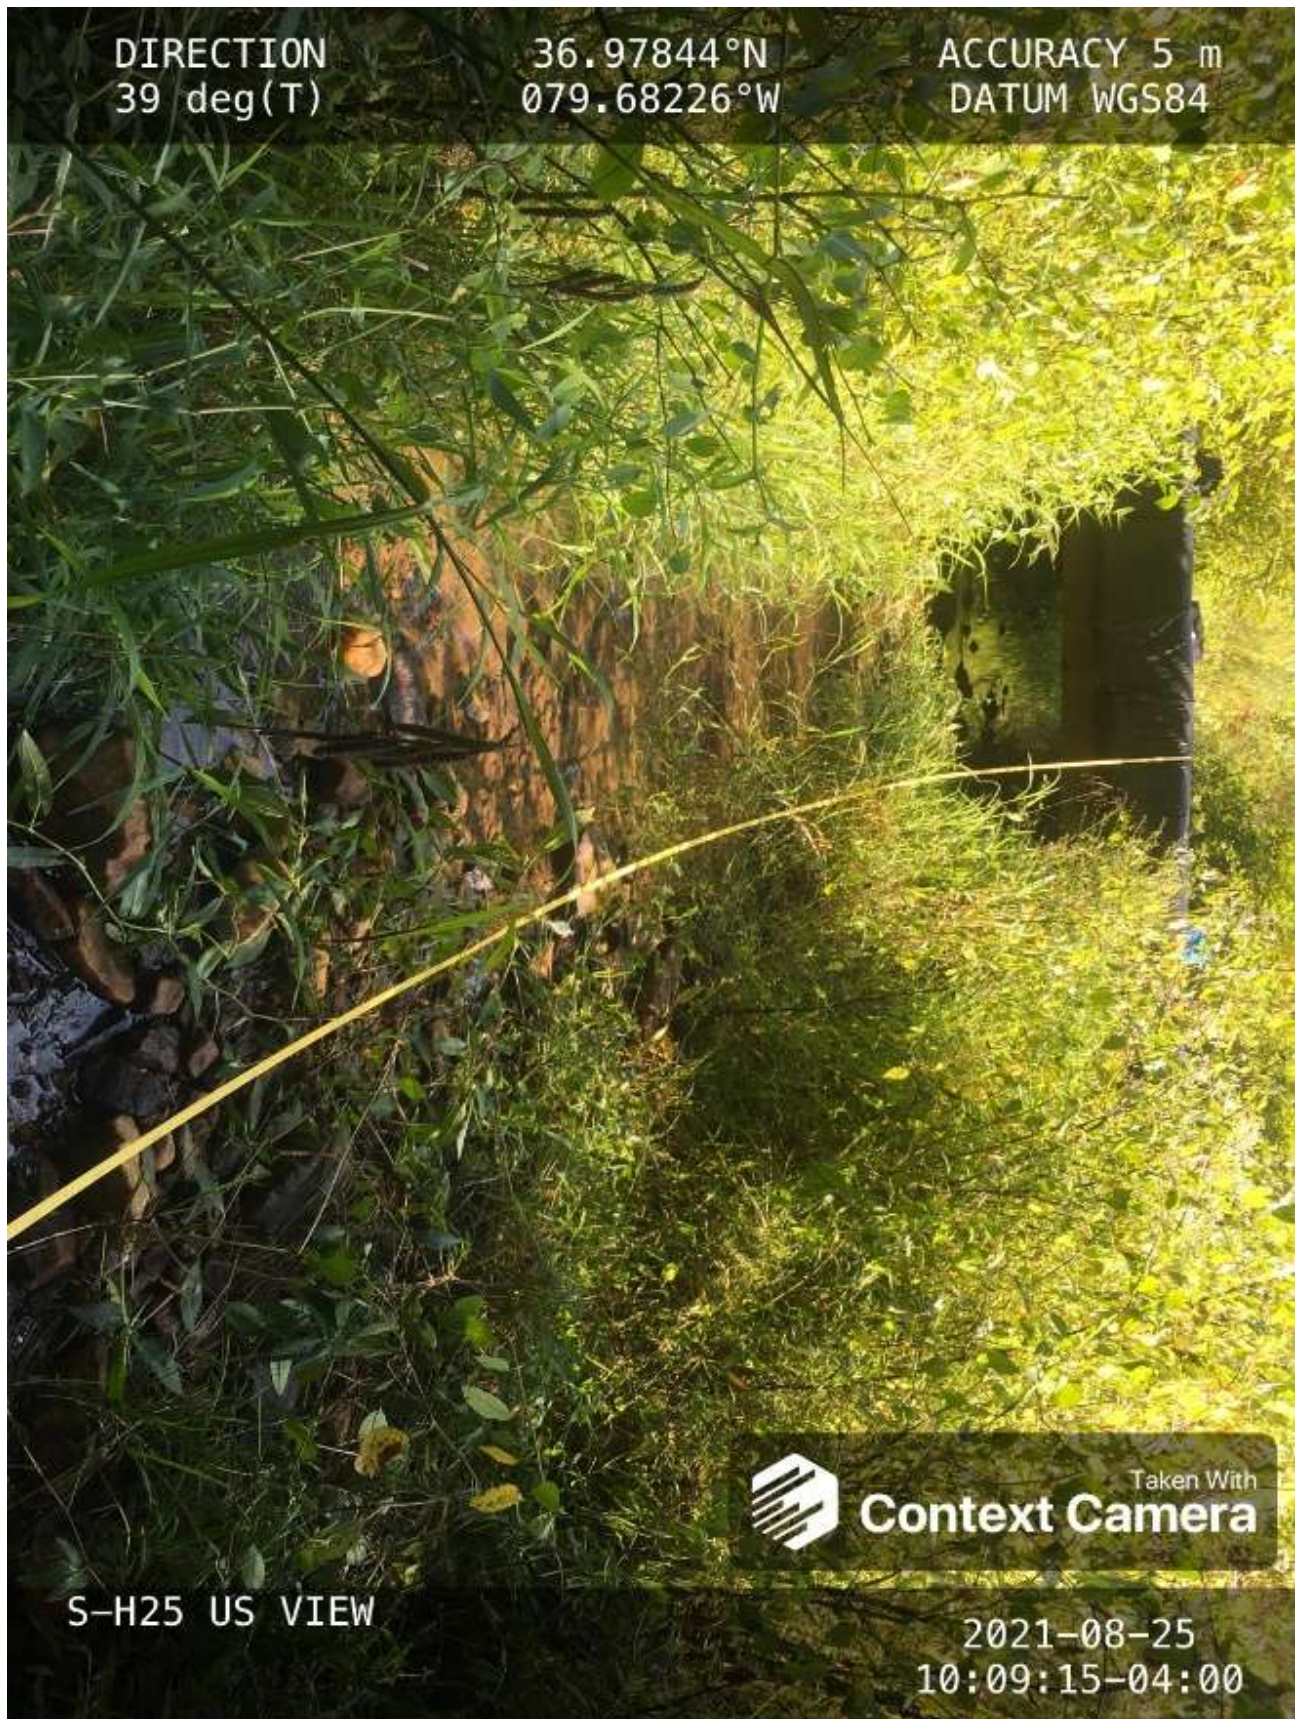
Photo Type: US VIEW

Location, Orientation, Photographer Initials: Downstream at ROW/LOC looking NE upstream, VM

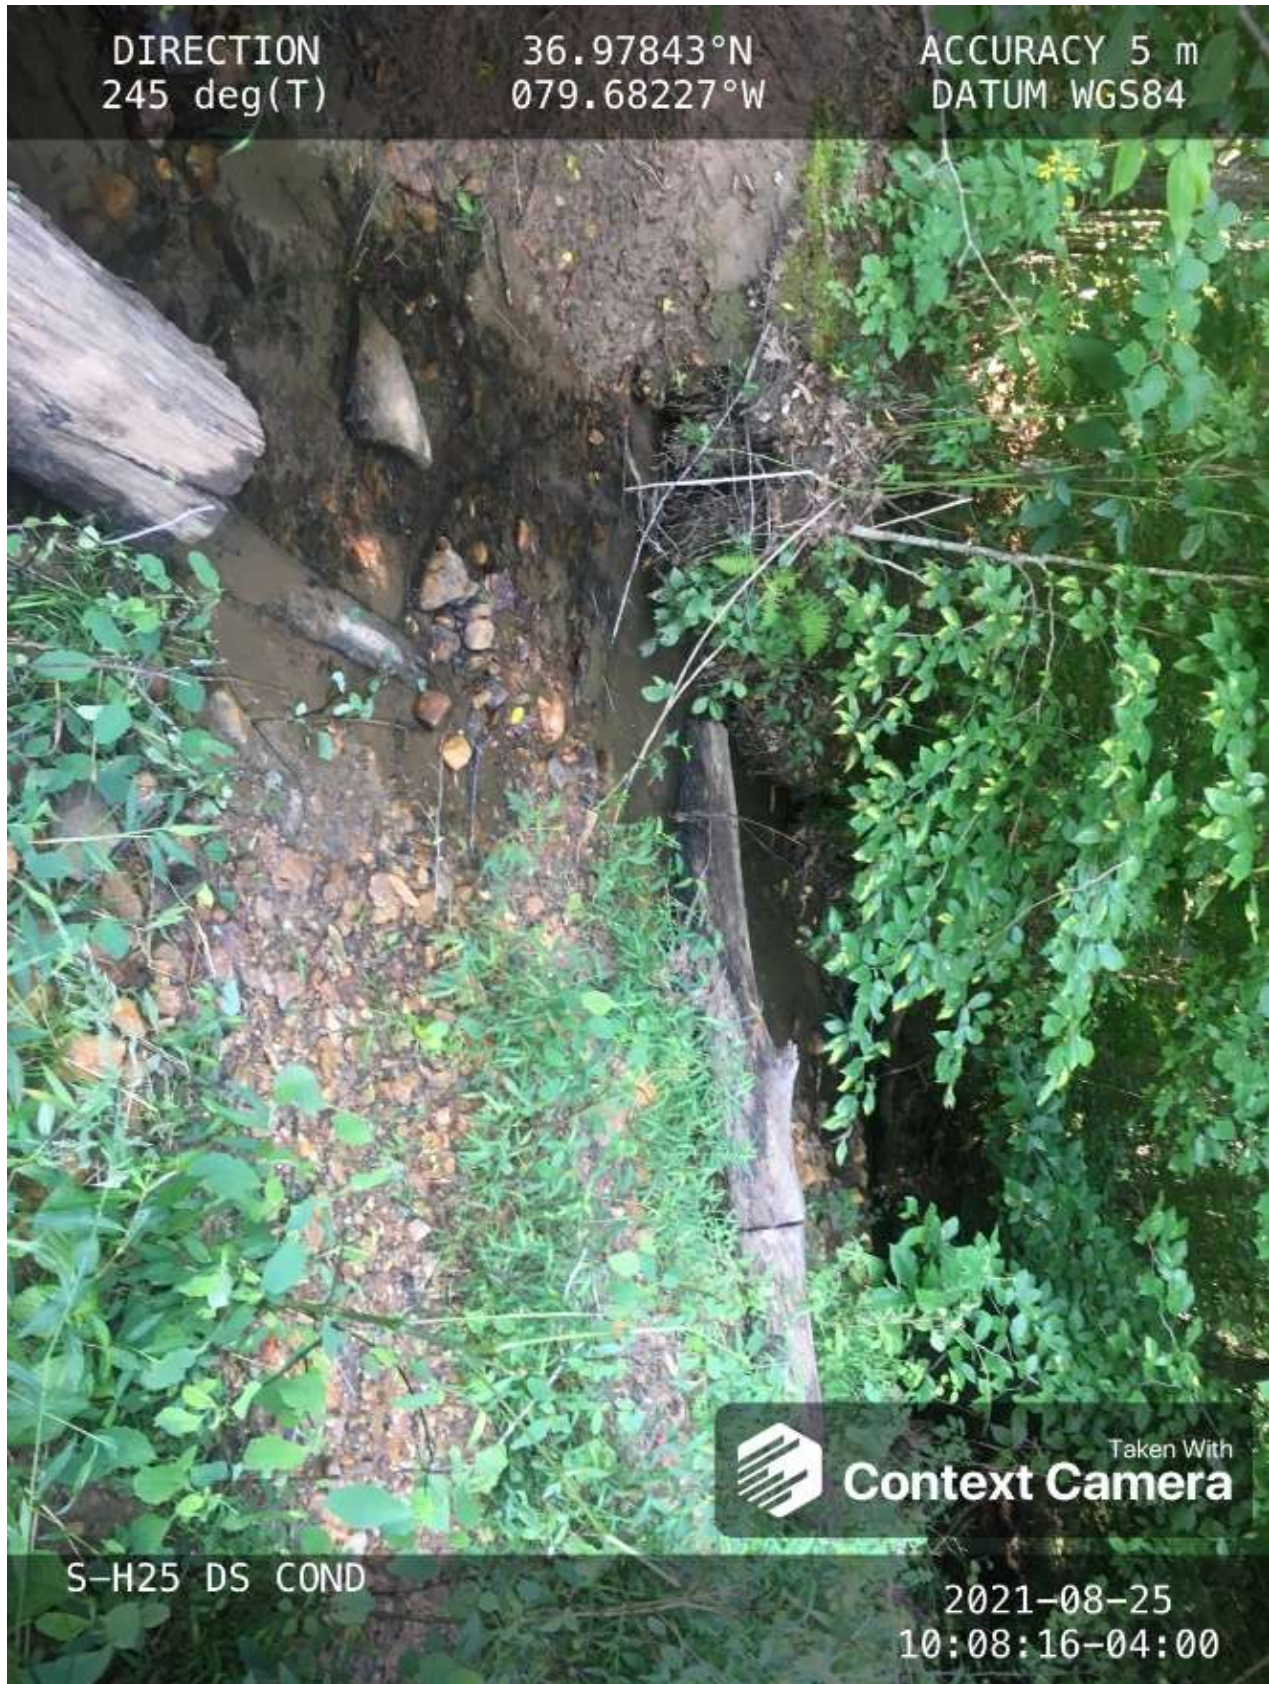
Photo Type: DS COND DS  
Location, Orientation, Photographer Initials: Downstream at ROW/LOC looking SW downstream, VM

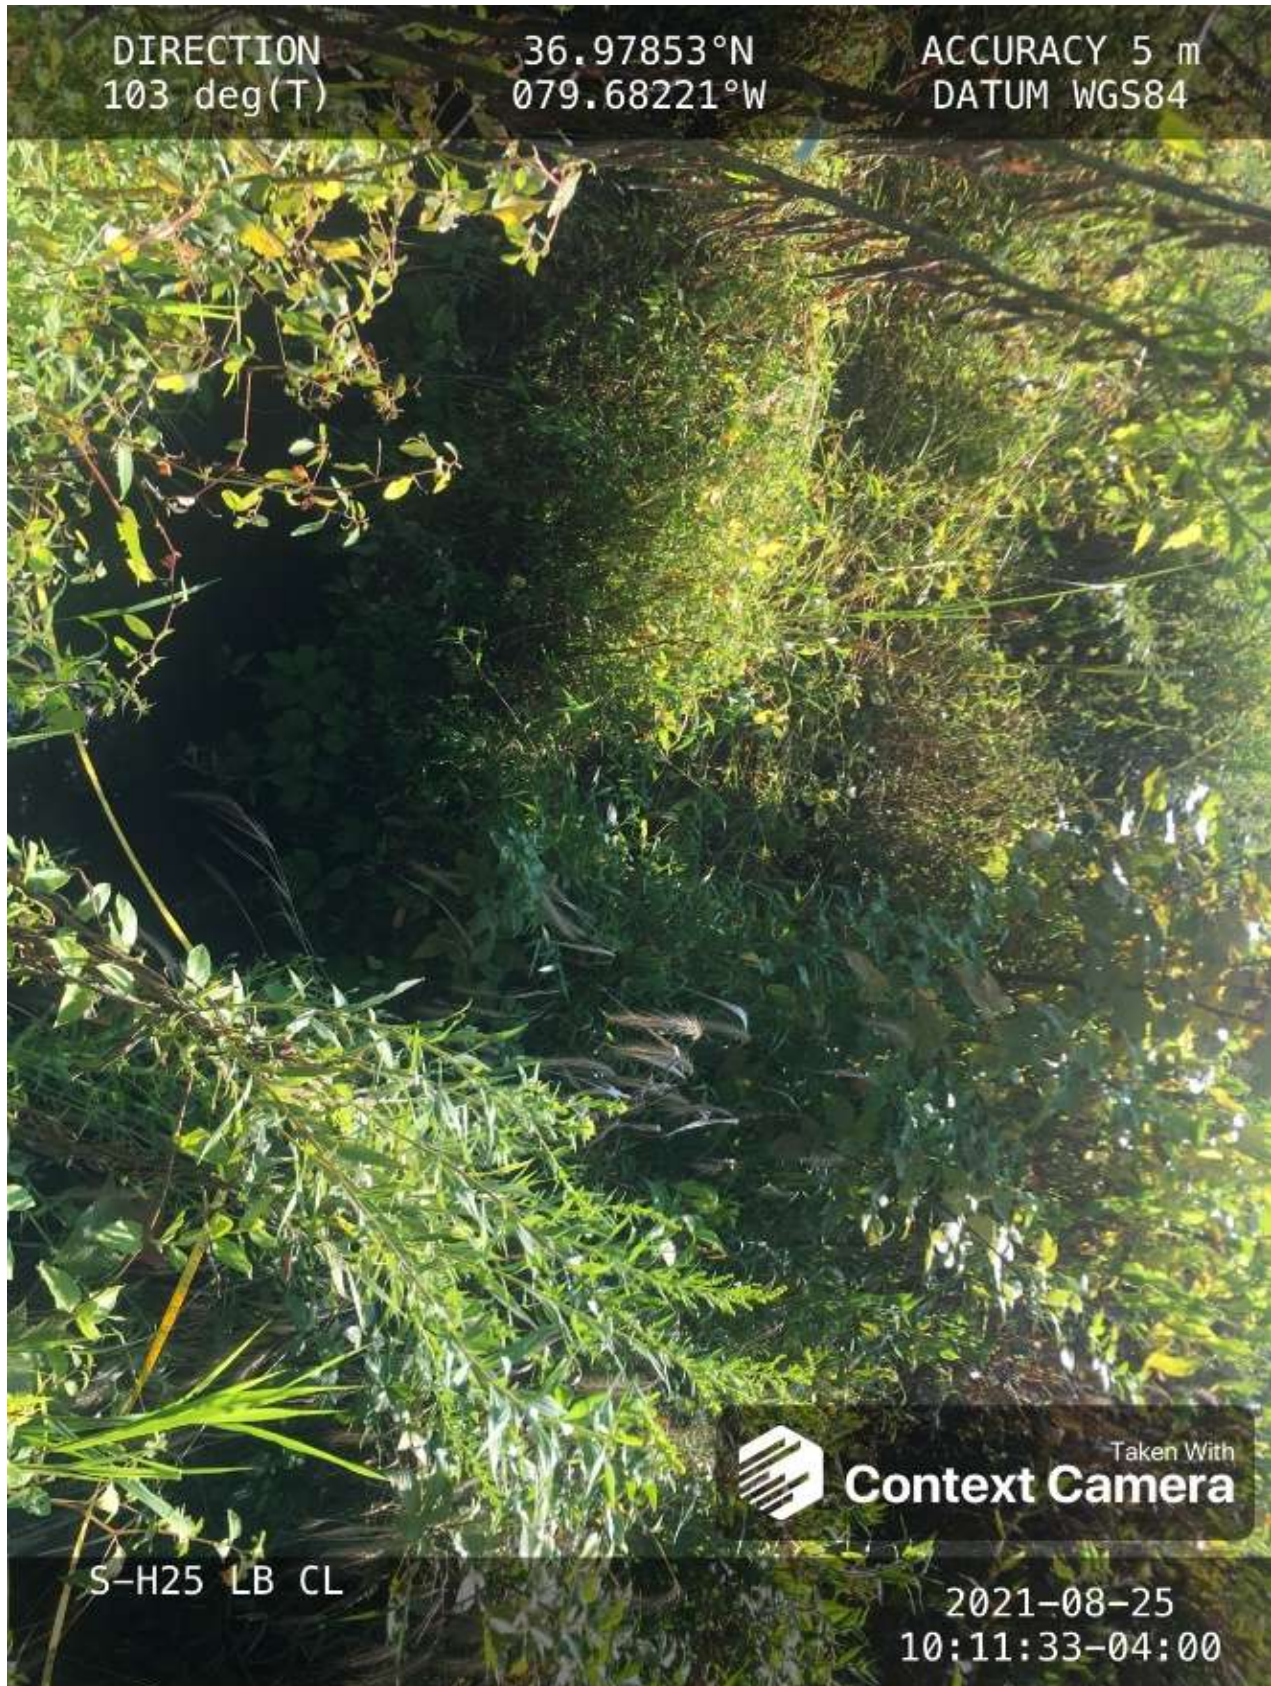
Photo Type: LB CL

Location, Orientation, Photographer Initials: On thalweg at pipe centerline looking SE at left streambank, VM

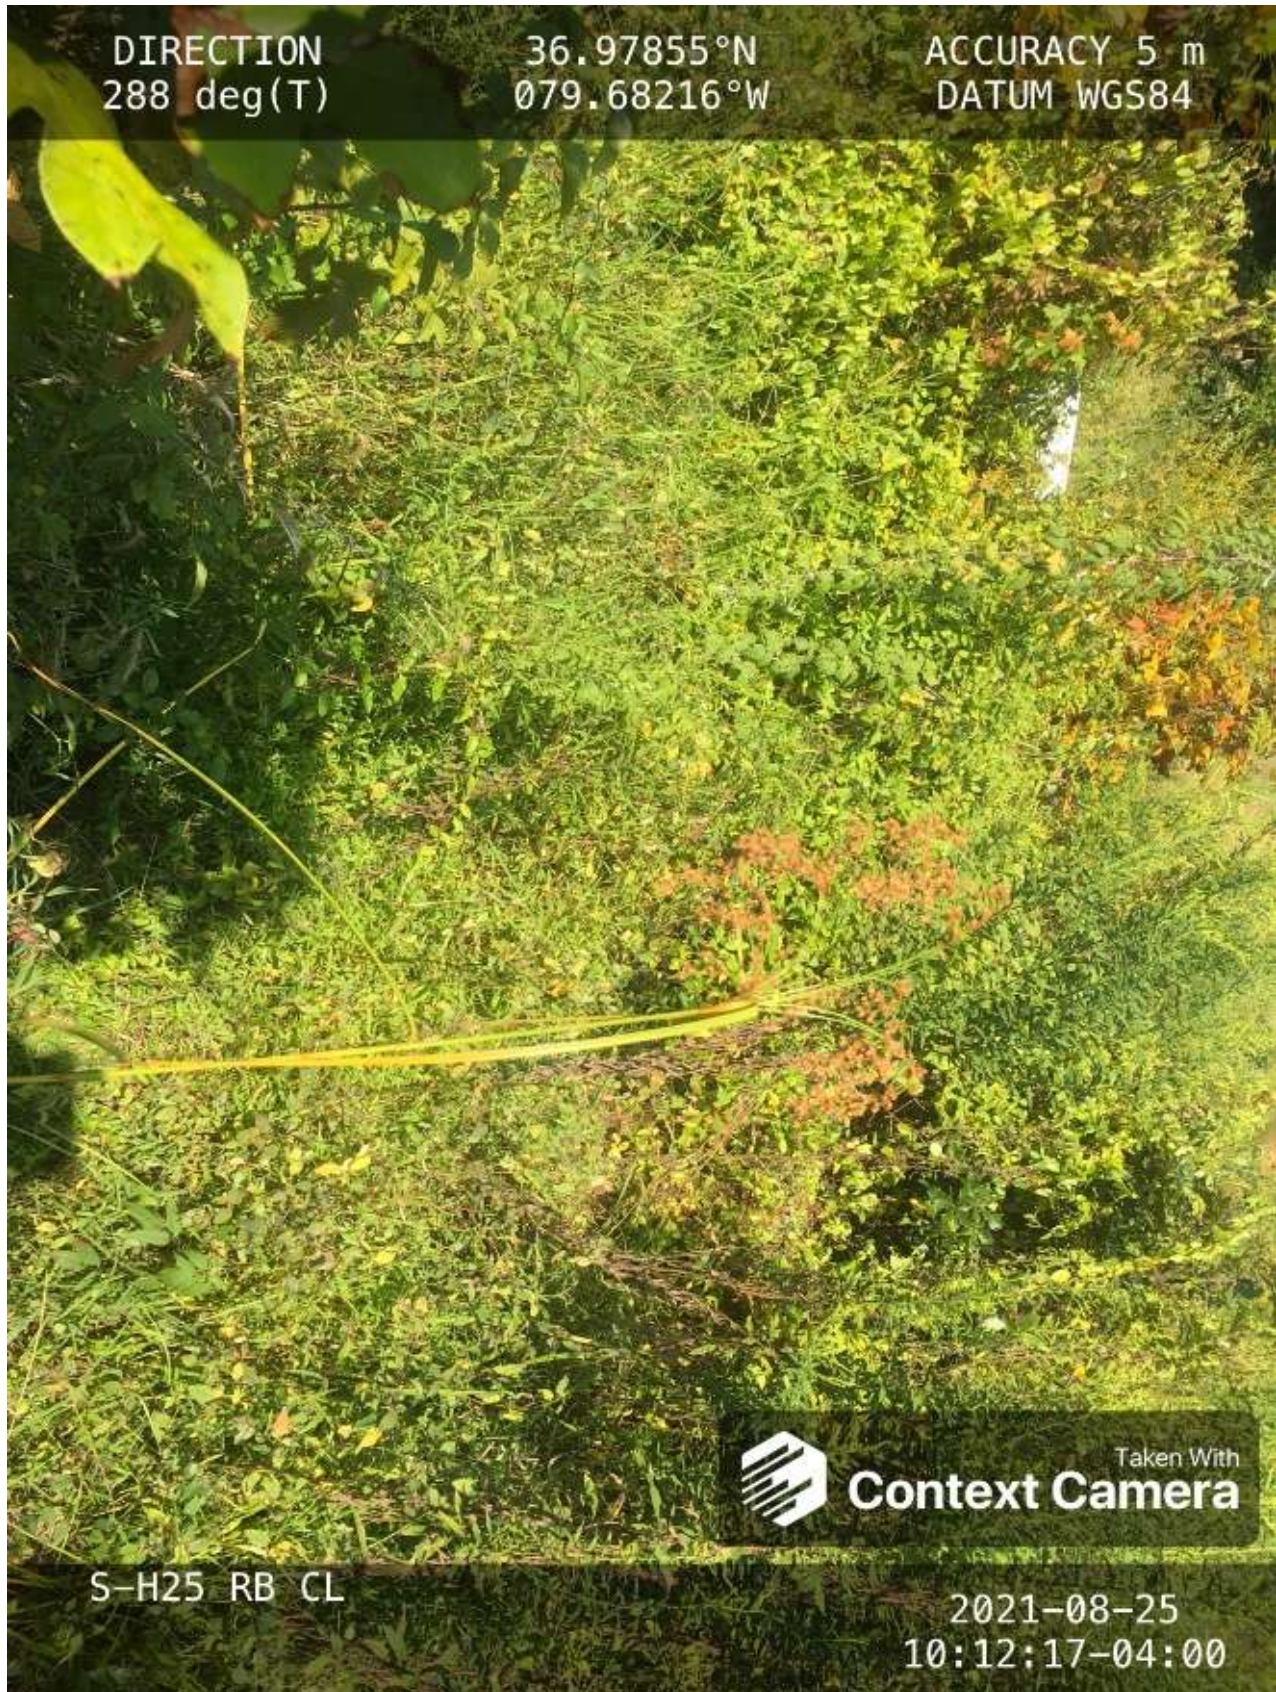
Photo Type: RB CL

Location, Orientation, Photographer Initials: On thalweg at pipe centerline looking NW at right streambank, VM

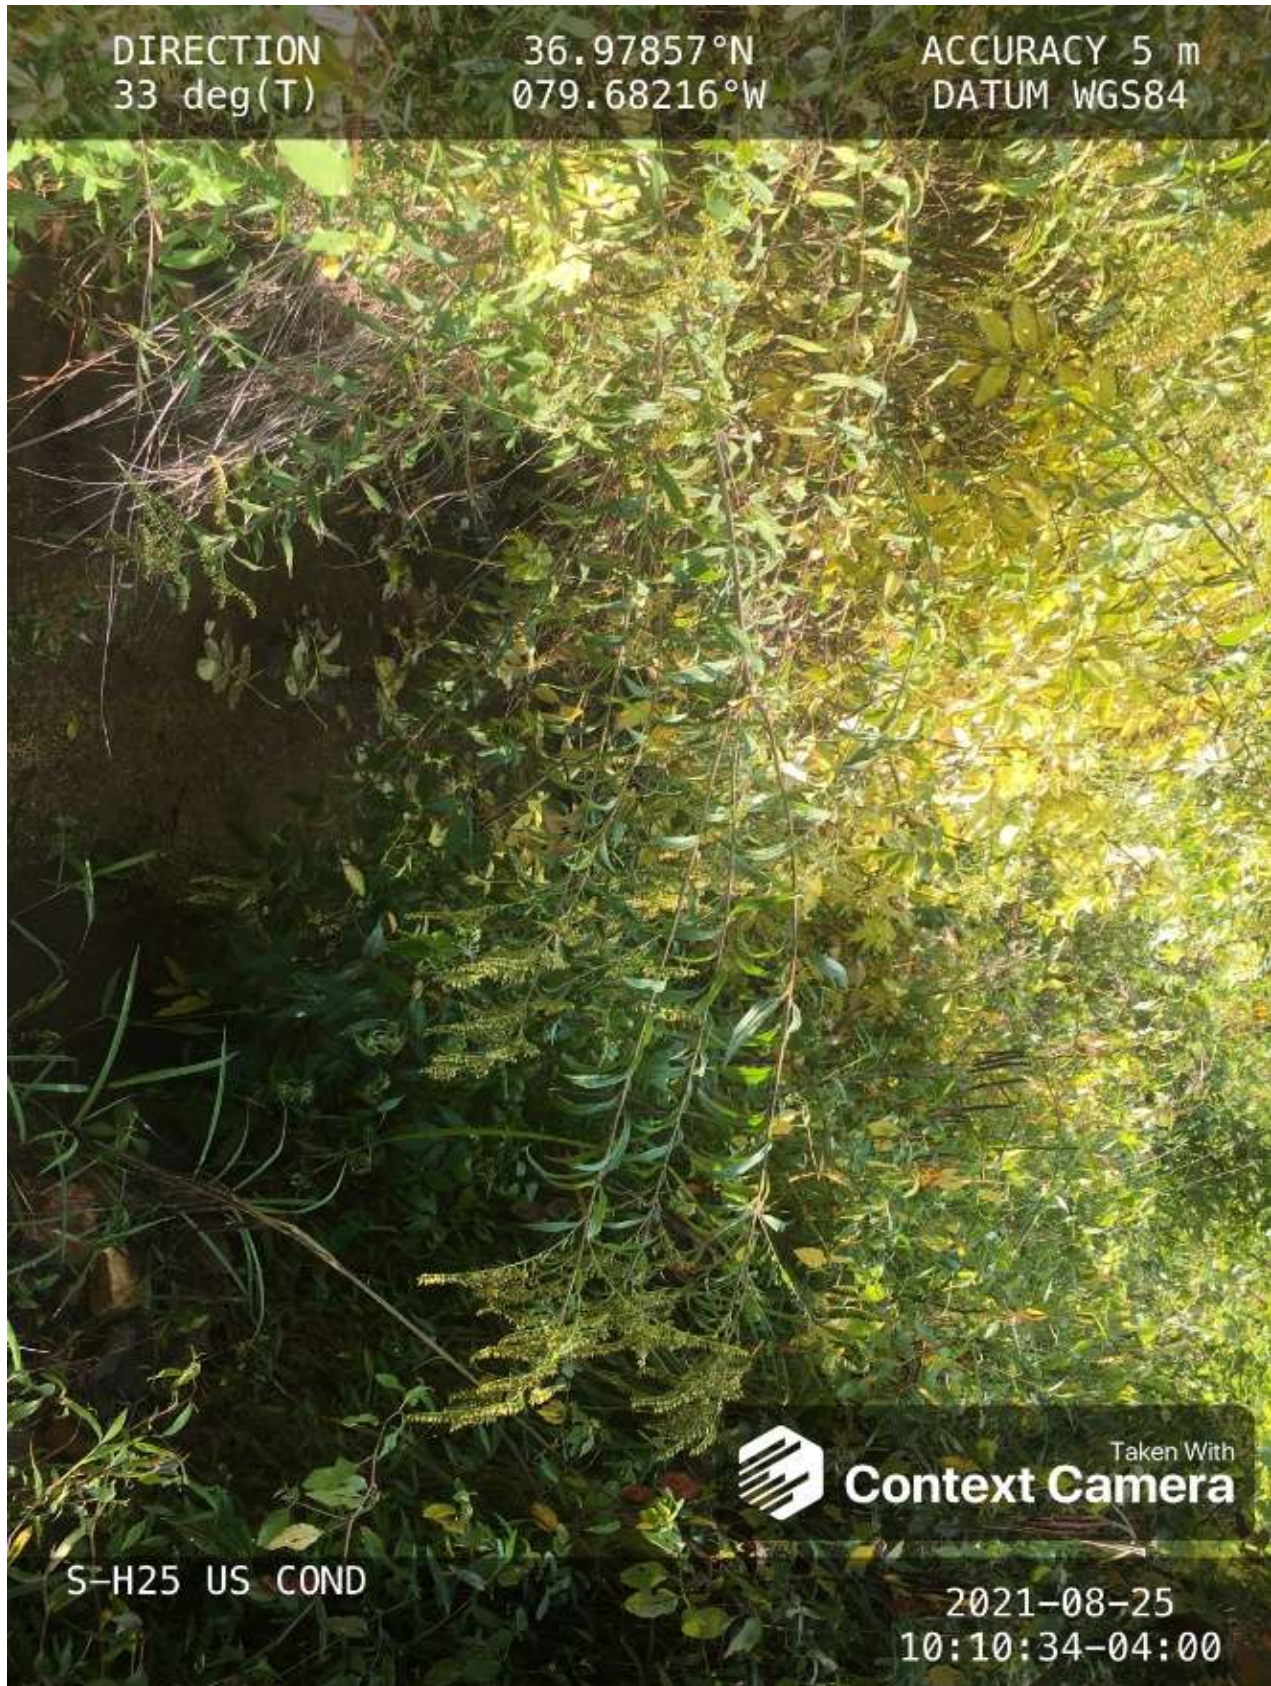
Photo Type: US COND

Location, Orientation, Photographer Initials: Upstream at ROW/LOC looking NE upstream, VM

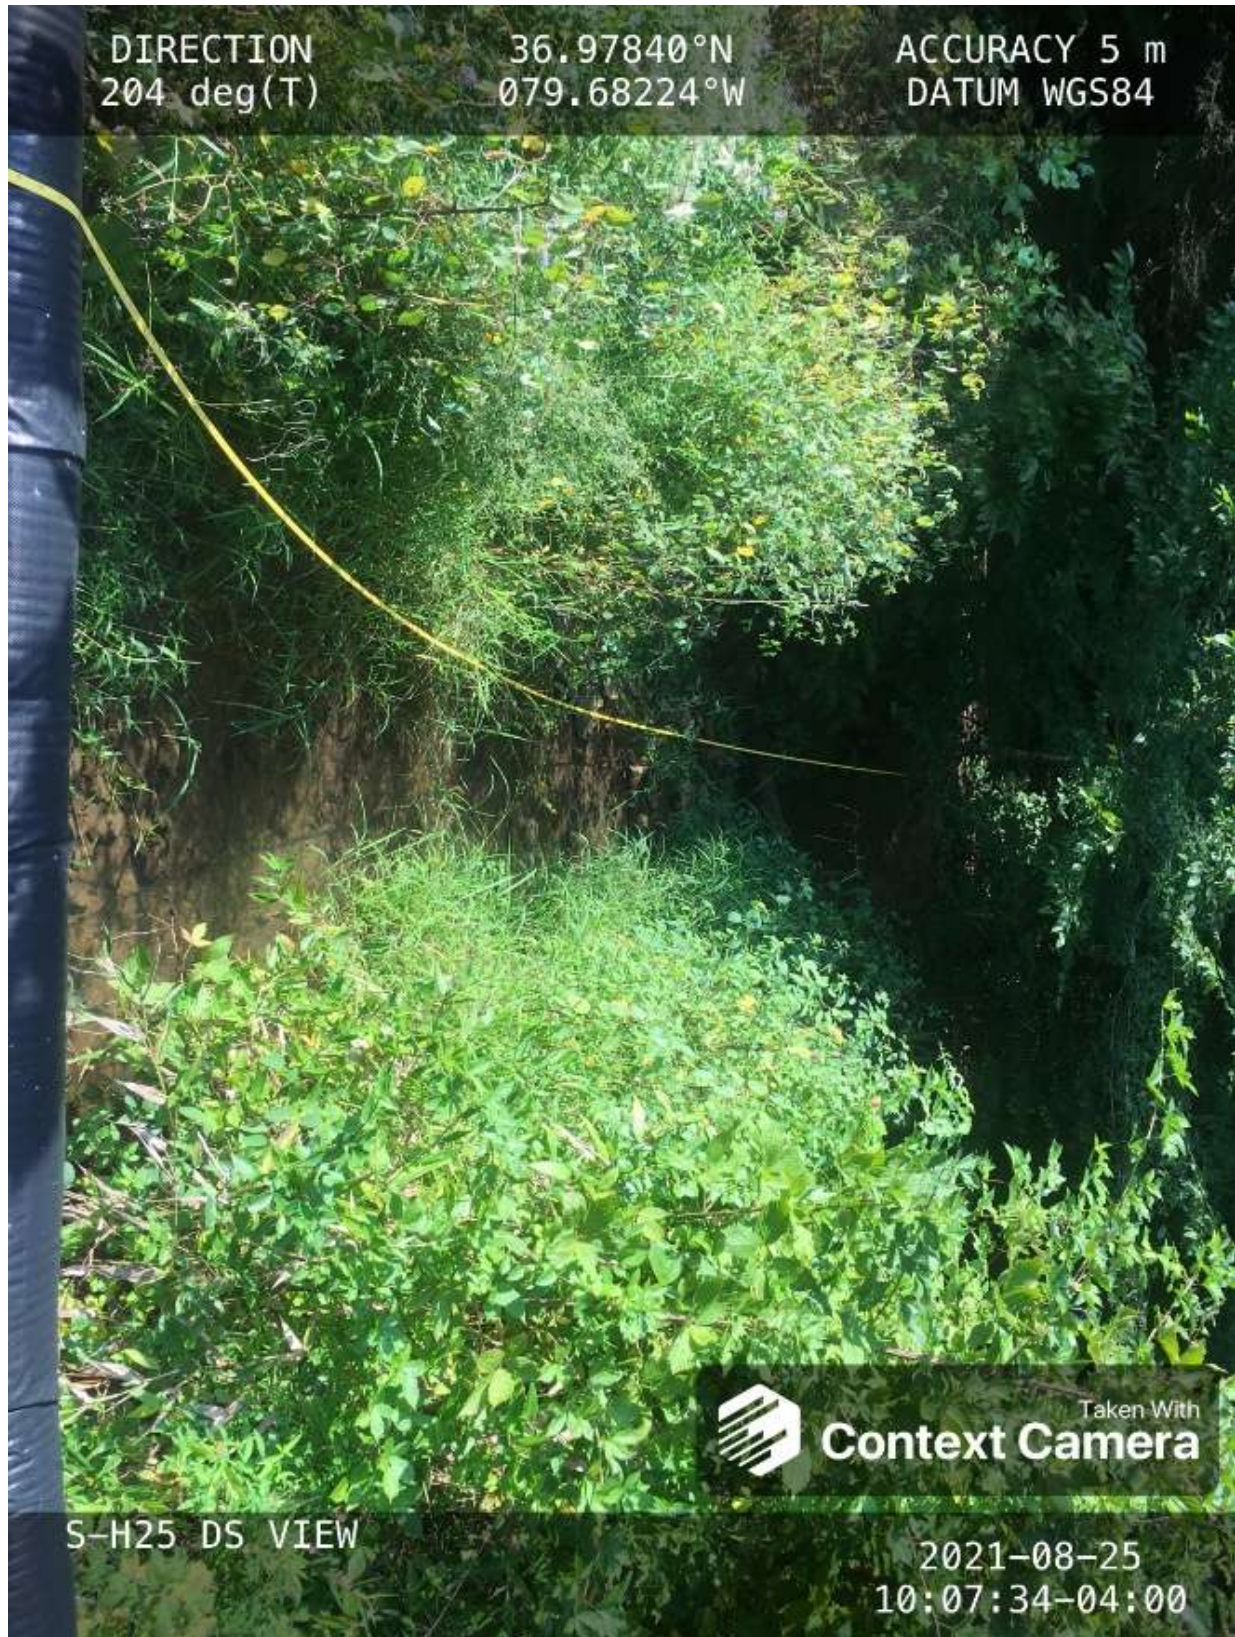
Photo Type: DS VIEW

Location, Orientation, Photographer Initials: Upstream at ROW/LOC looking SWdownstream, VM
