Title: Product wind, water and impact resistance testing of a sample of Aerobrick rainscreen cladding for TI Tiles International Ltd

Report No: N950-18-17536

Customer: TI Tiles International Ltd
Westview House, Devro Campus
Gartferry Road, Moodiesburn G69 0JE

Issue date: 21 February 2018

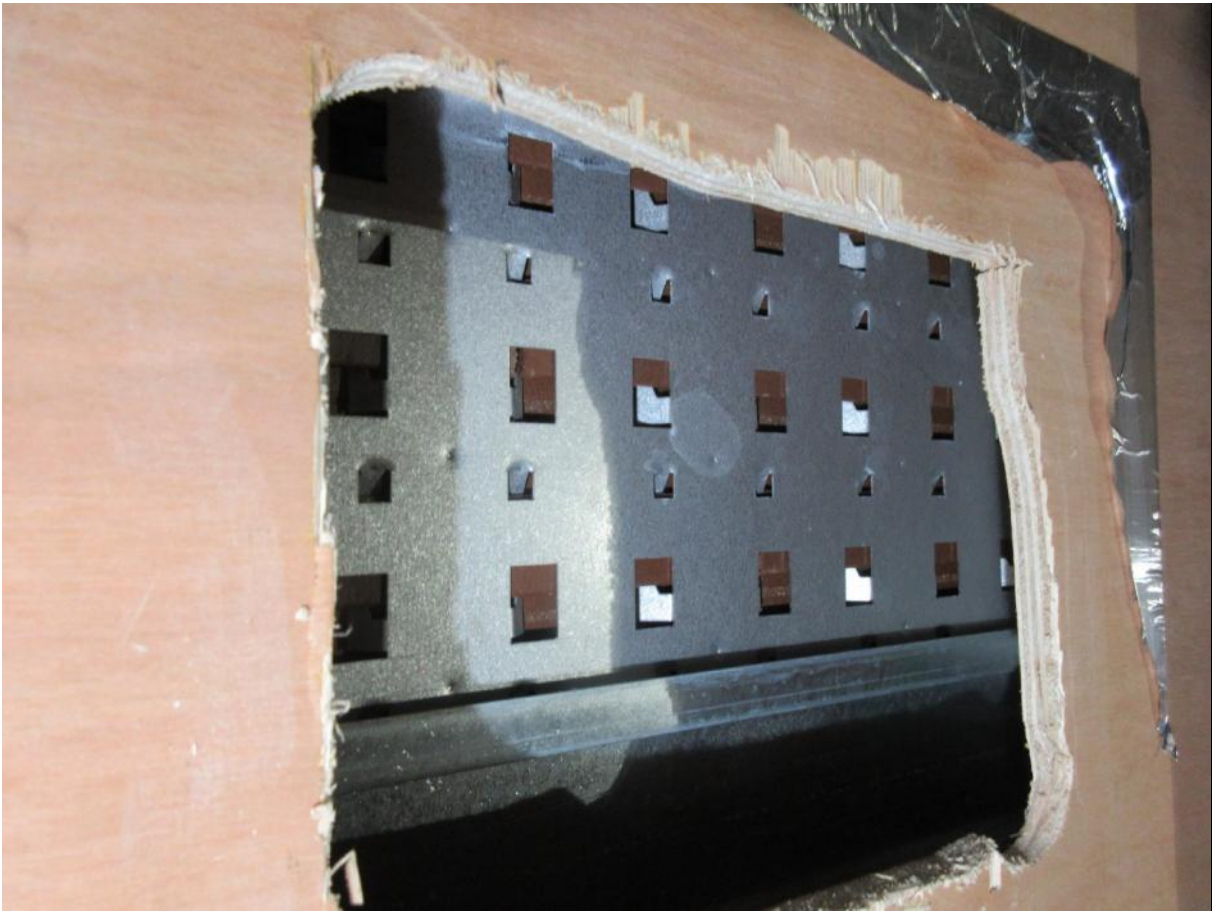
INSPECTION AREA FOR DYNAMIC WATER TEST

No water leakage was observed through the bricks with the mortar joints.

No water leakage was observed through the open jointed bricks with the insulated panels.

Water leakage observed through the open jointed bricks was mainly confined to the support panels and drained out at the base of the cavity during and after testing.

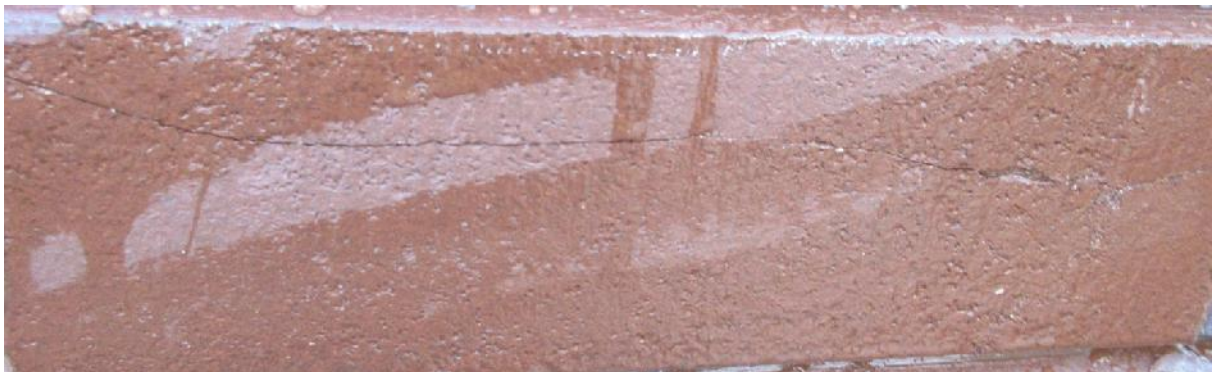
PHOTO 6915

– No damage observed on the bricks with mortar joints. Hairline cracks were observed on the brick face on the open jointed bricks.

6 Nm HARD BODY IMPACT - CRACK IN BRICK WITHOUT MORTAR

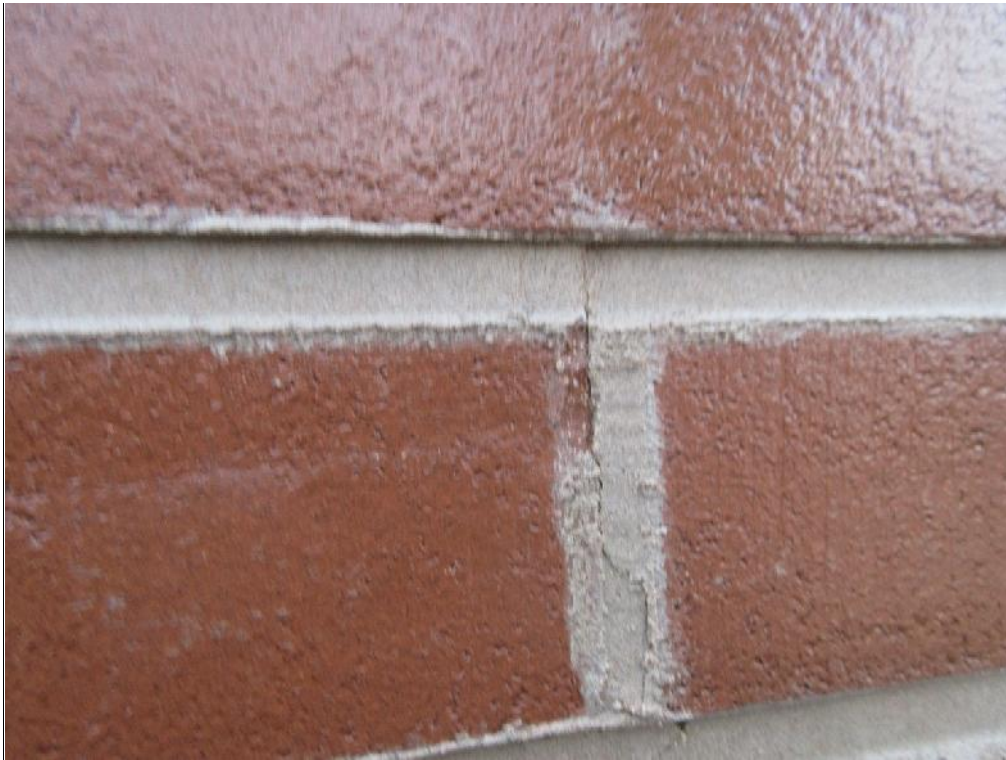
PHOTO 6924

– Minor indent and chip on brick face on bricks with mortar joints and cavity behind. Crack observed along a mortar joint and minor fallout in mortar joint in one location.

10 Nm HARD BODY IMPACT - CRACK IN MORTAR JOINT

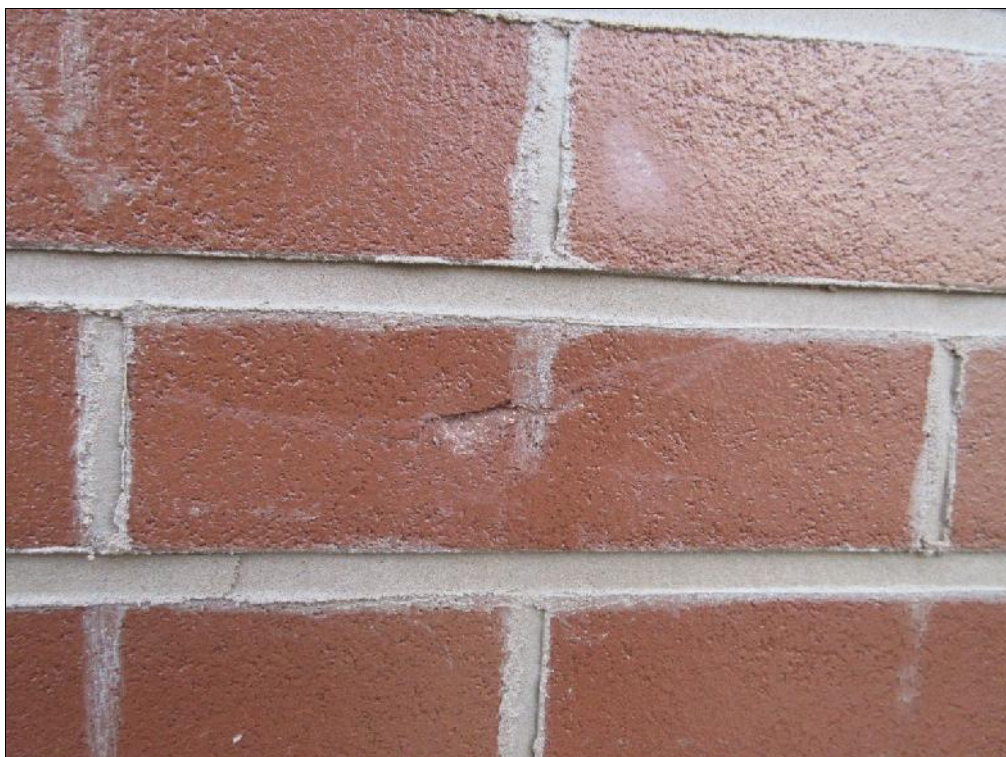
PHOTO 6925

10 Nm HARD BODY IMPACT - SMALL CHIP FROM BRICK FACE

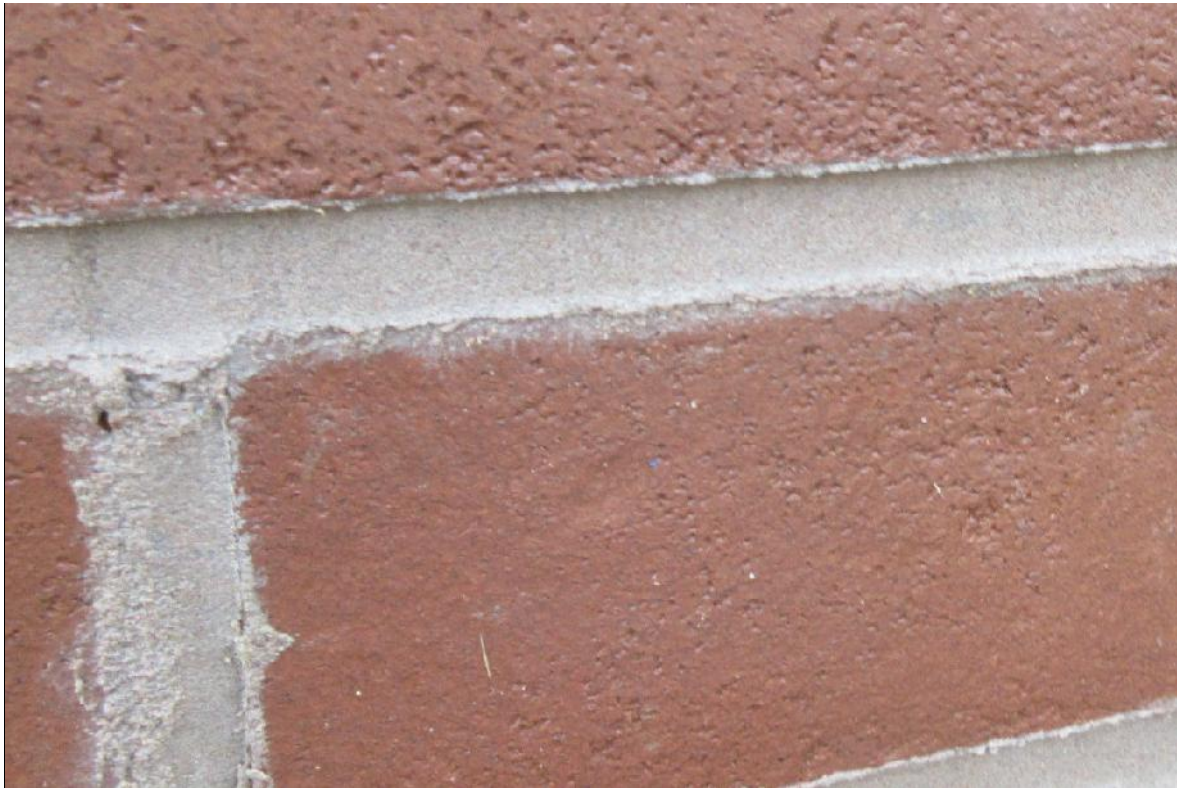
PHOTO 6928

10 Nm HARD BODY IMPACT - SMALL INDENT IN BRICK FACE

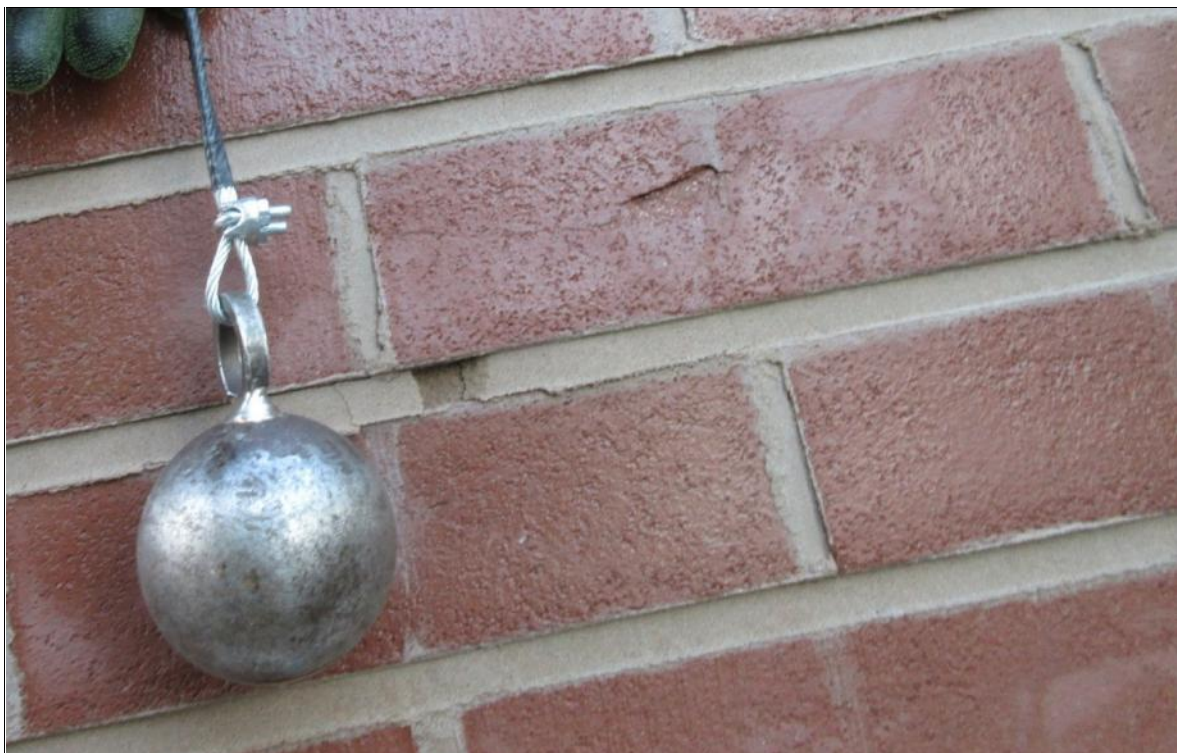
PHOTO 6944

10 Nm HARD BODY IMPACT - SMALL MORTAR JOINT FALLOUT

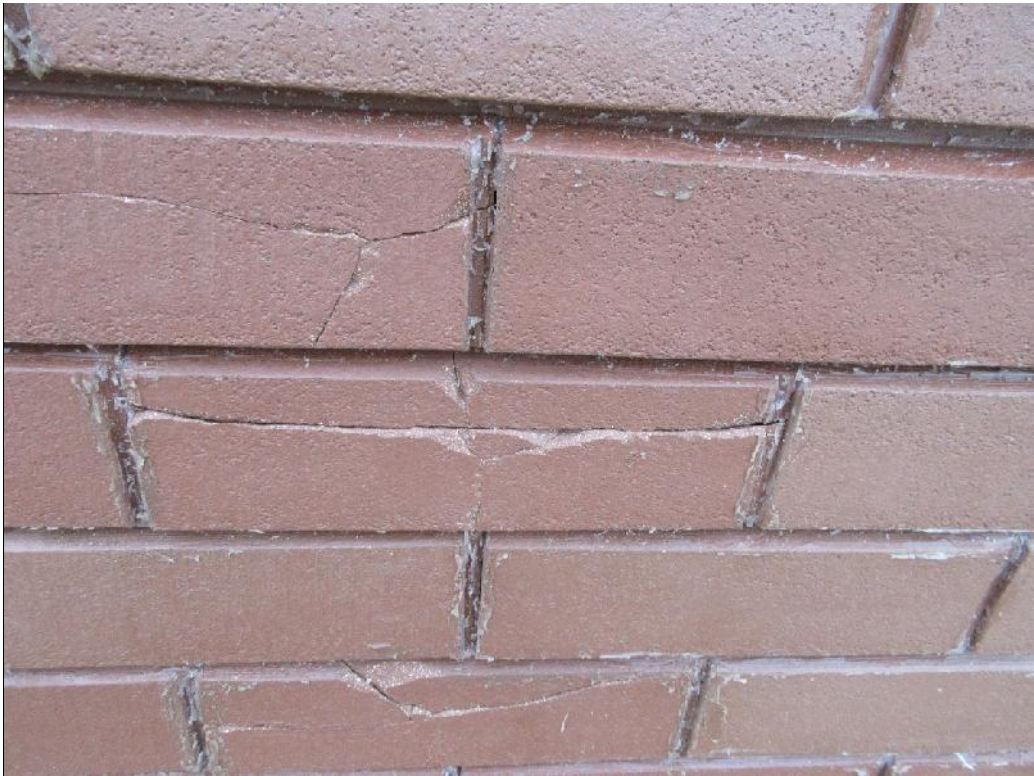
PHOTO 7055

– Cracks and minor fragments from bricks without mortar joints.

10 Nm HARD BODY IMPACTS ON UN-INSULATED WALL

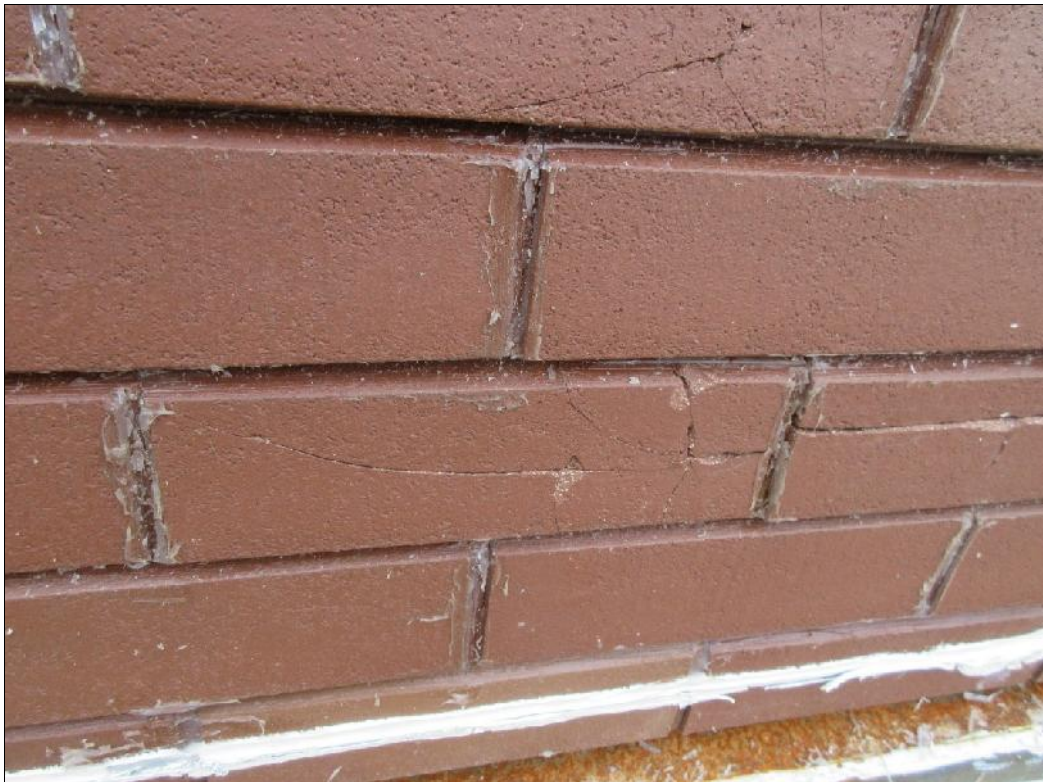
PHOTO 7062

– No damage observed to bricks with mortar joints and insulation behind.

10 Nm HARD BODY IMPACTS ON INSULATED WALL
