**Title: Impact testing a sample of stone cladding for Riverside Drive, Dundee**

**Certificate of Test Number: 30239**

This certificate of test describes impact tests carried out at the request of TI Tiles International on 16/17 March 2021 at VINCI Technology Centre, Leighton Buzzard.

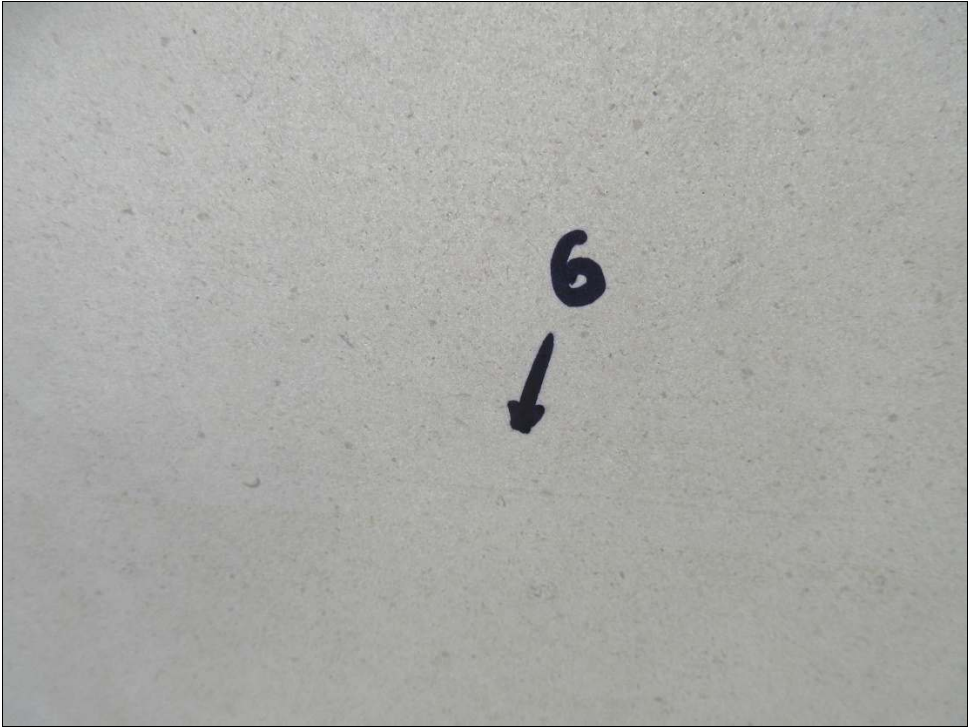
PHOTO 7214

Location	Impact energy (Nm)	Observations	Classification
1	6	No damage	Class 1
2	6	Minor indent	Class 1
3	6	No damage	Class 1
4	6	No damage	Class 1
5	6	Minor indent	Class 1
6	6	Vertical crack – still secure	Class 3
7	10	Vertical crack – 41 g fragment	Low risk
8	10	No damage	Negligible risk
9	10	Minor indent	Negligible risk
10	10	No damage	Negligible risk
11	10	Corner fragment – 42 g	Low risk

HARD BODY SERVICEABILITY IMPACT AT LOCATION 1

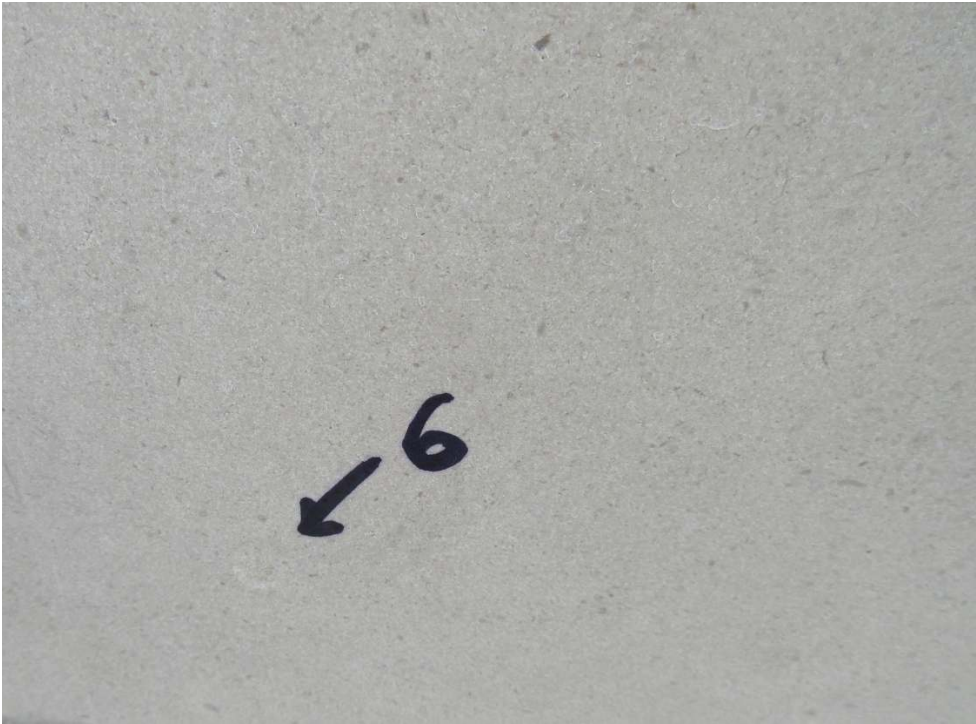
PHOTO 7215

HARD BODY SERVICEABILITY IMPACT AT LOCATION 2

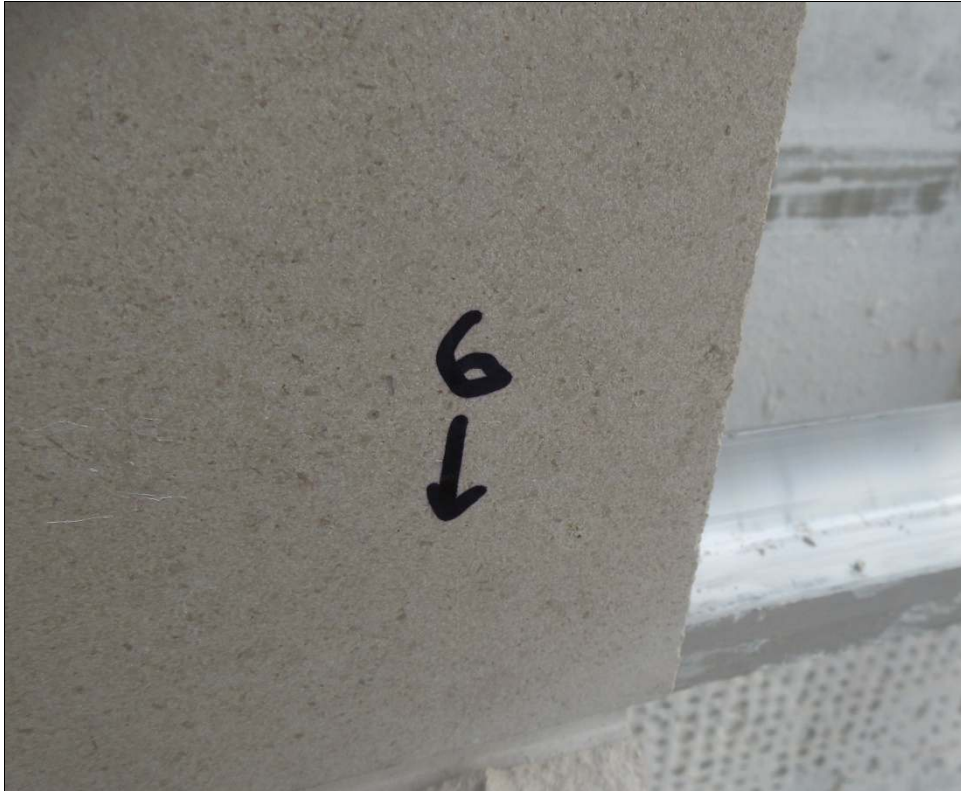
PHOTO 7216

HARD BODY SERVICEABILITY IMPACT AT LOCATION 3

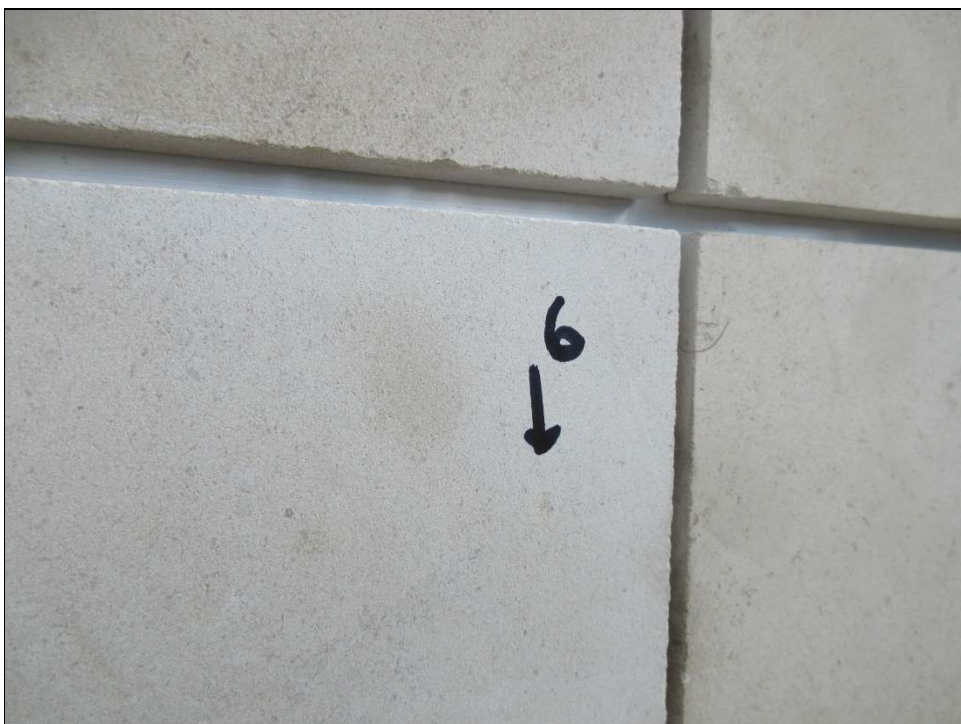
PHOTO 7218

HARD BODY SERVICEABILITY IMPACT AT LOCATION 5

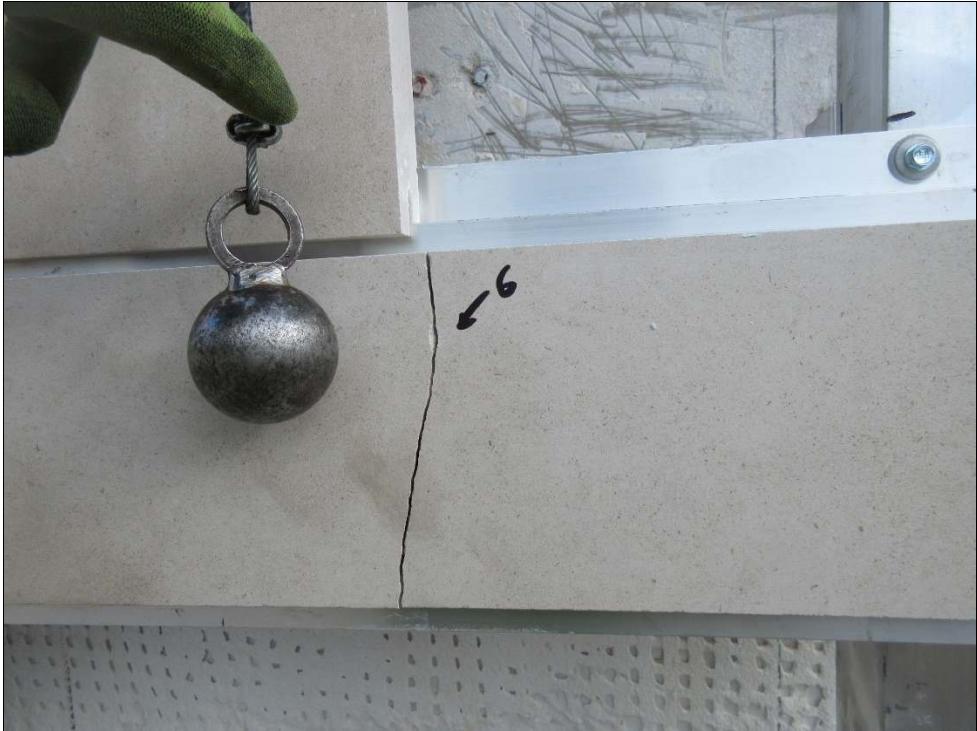
PHOTO 7219

HARD BODY SERVICEABILITY IMPACT AT LOCATION 6

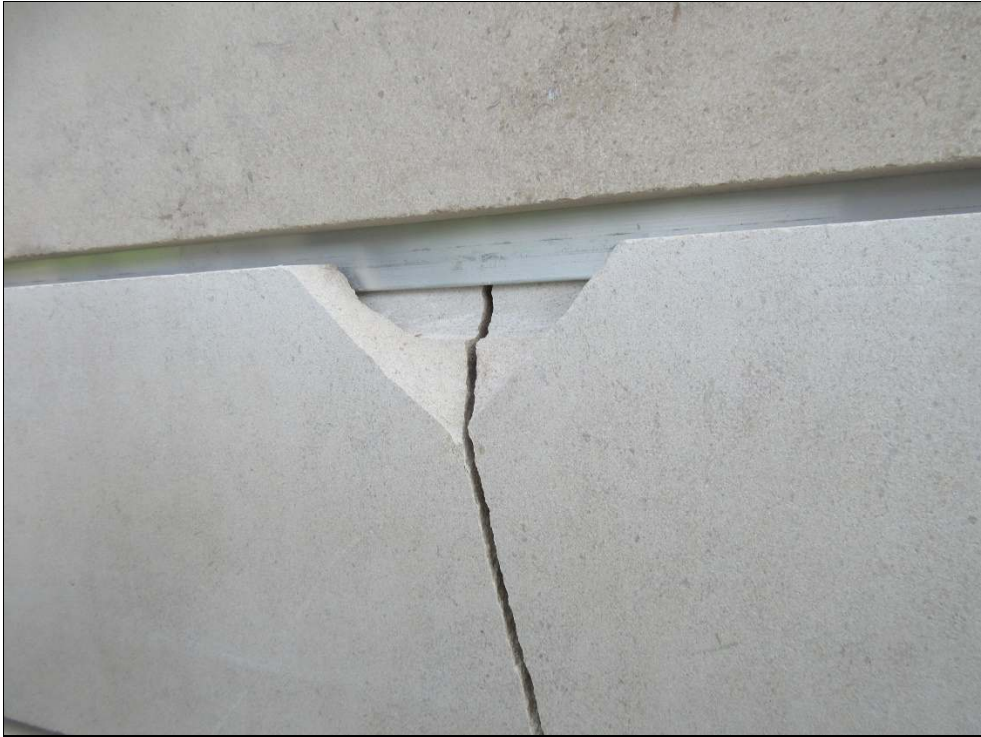
PHOTO 7222

HARD BODY SAFETY IMPACT AT LOCATION 7

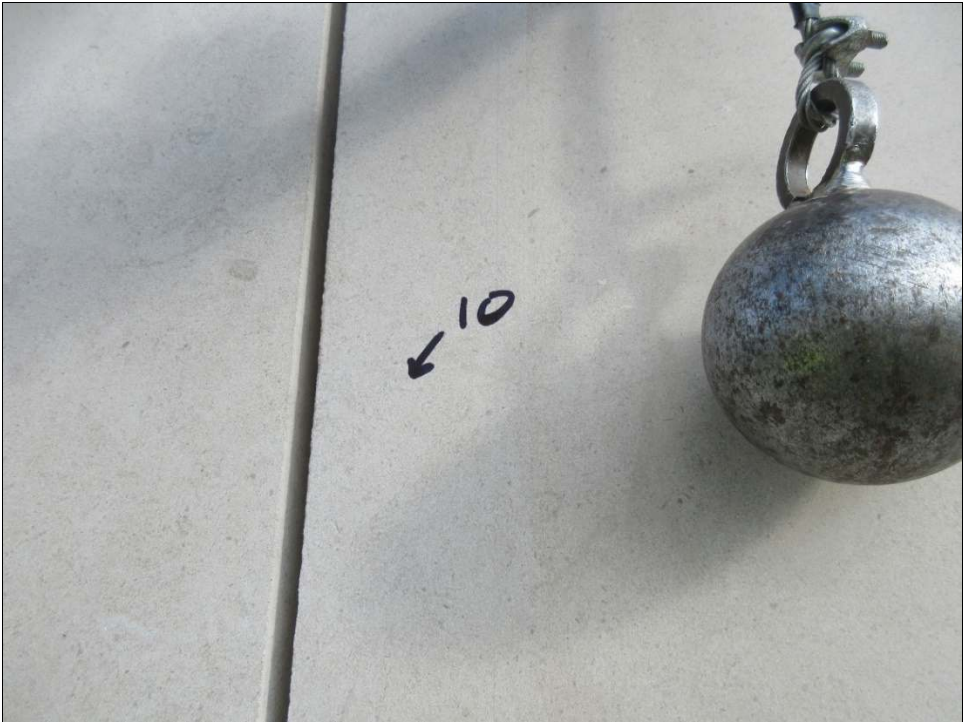
PHOTO 7226

HARD BODY SAFETY IMPACT AT LOCATION 10

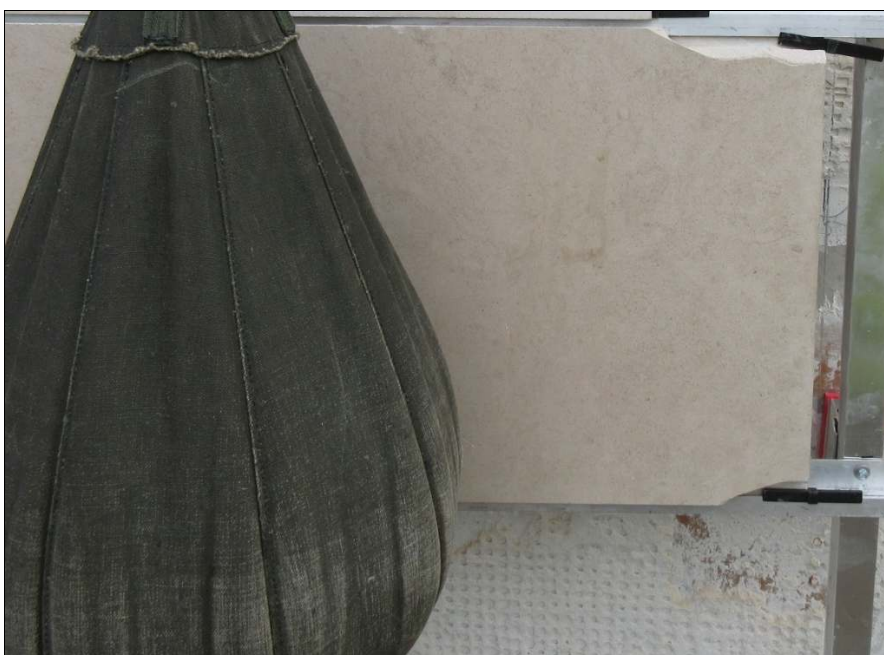
PHOTO 7238

Location	Impact energy (Nm)	Observations	Classification
1	120 x 3	No damage observed	Class 1
2	120 x 3 350	No damage observed 48 g corner fragments	Class 1 Low risk
3	120 x 3	No damage observed	Class 1
4	120 x 3 350	No damage observed Edge fragments 62 g	Class 1 Moderate risk
5	120 x 3 350	No damage observed Vertical crack	Class 1 Low risk
6	350	No damage observed	Negligible risk
7	120 x 3 350	No damage observed 38 g corner fragments	Class 1 Low risk
8	350	No damage observed	Negligible risk

SOFT BODY SAFETY IMPACT AT LOCATION 2

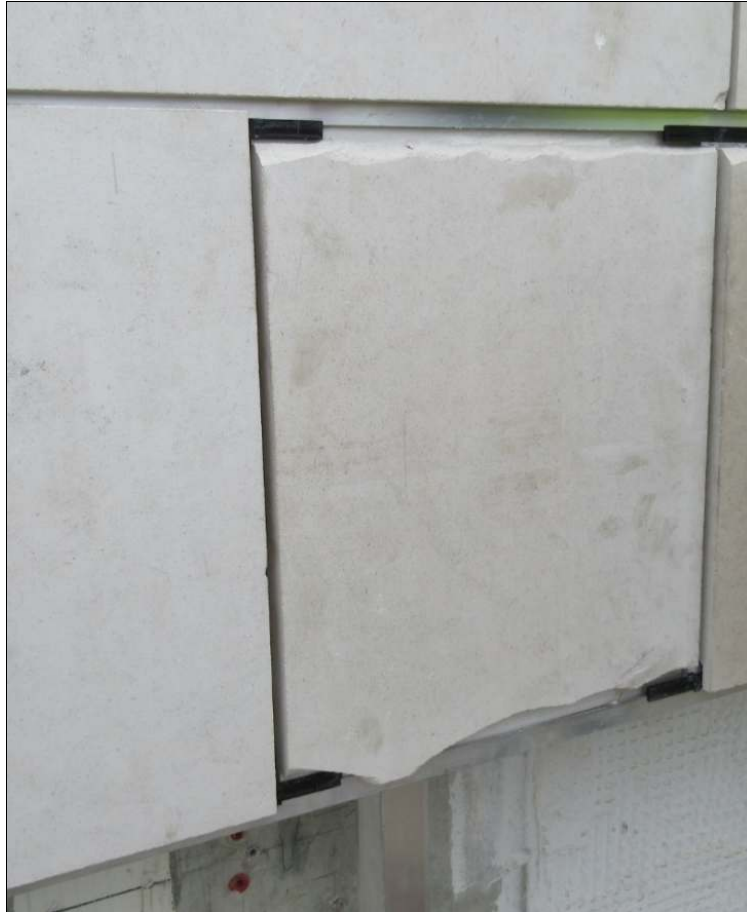
PHOTO 7234

SOFT BODY SAFETY IMPACT AT LOCATION 4

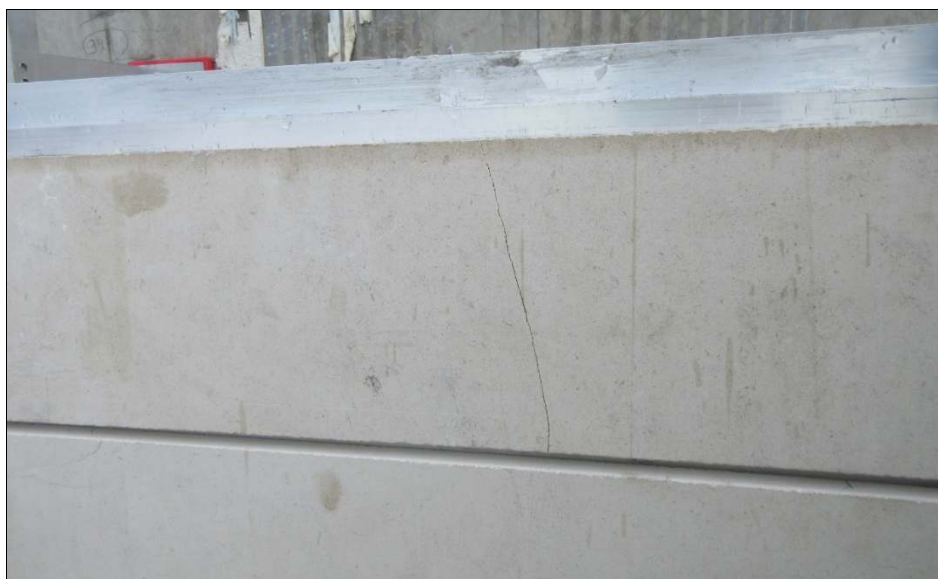
PHOTO 7237

SOFT BODY SAFETY IMPACT AT LOCATION 5

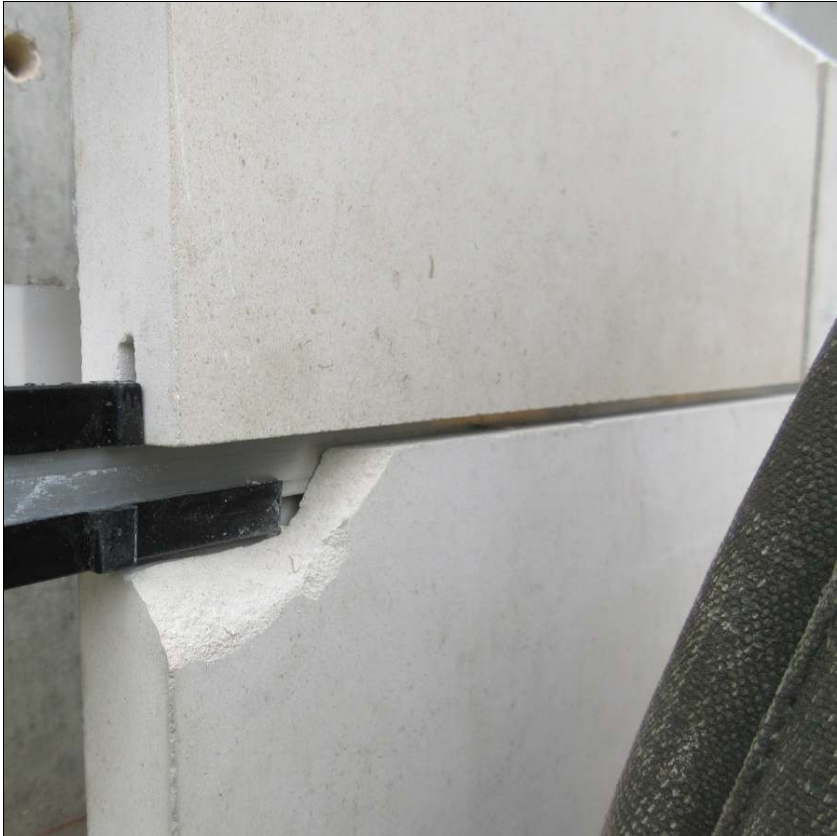
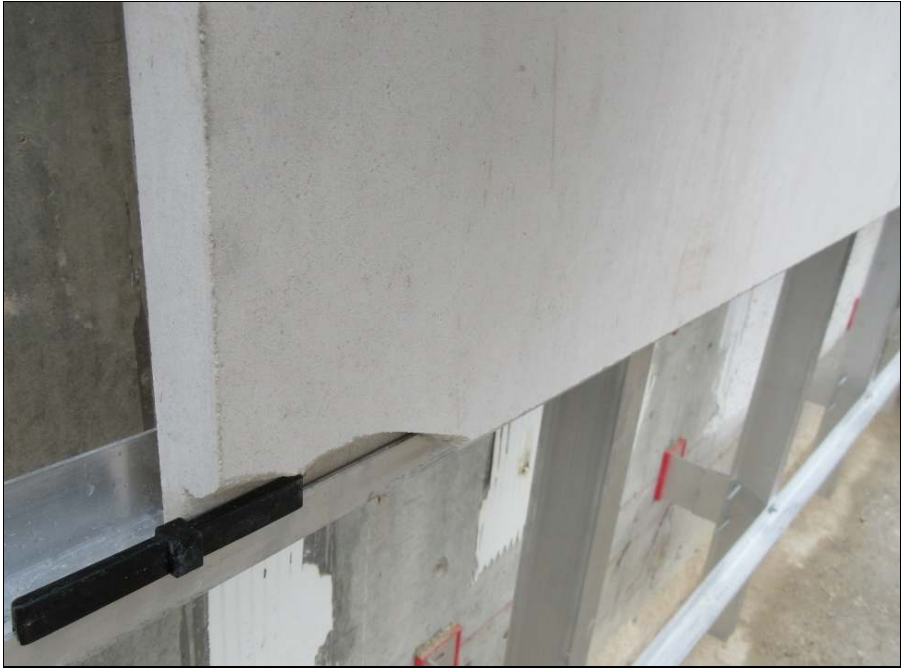
SOFT BODY SAFETY IMPACT AT LOCATION 7

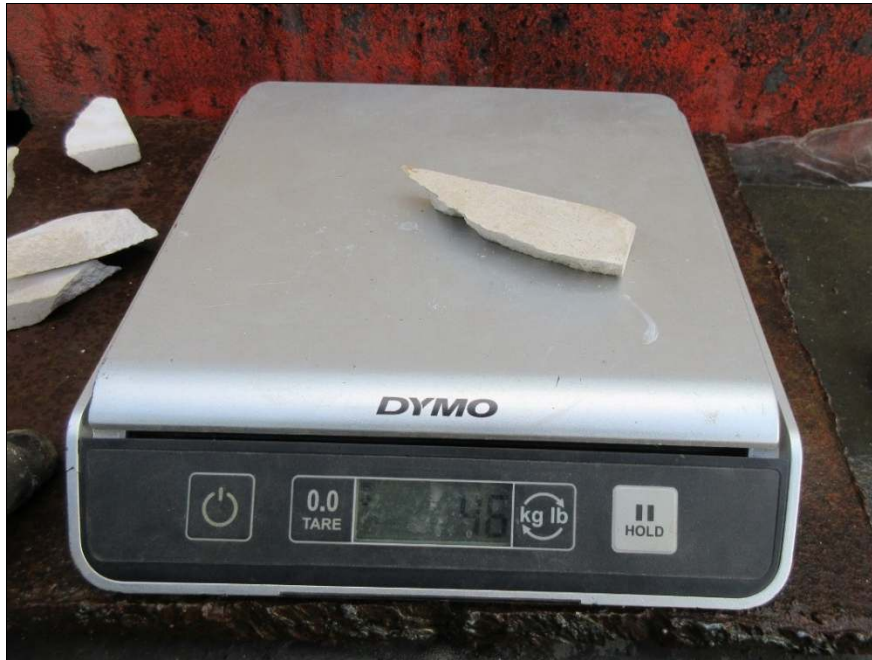
PHOTO 7241

FRAGMENT FROM LOCATION 2

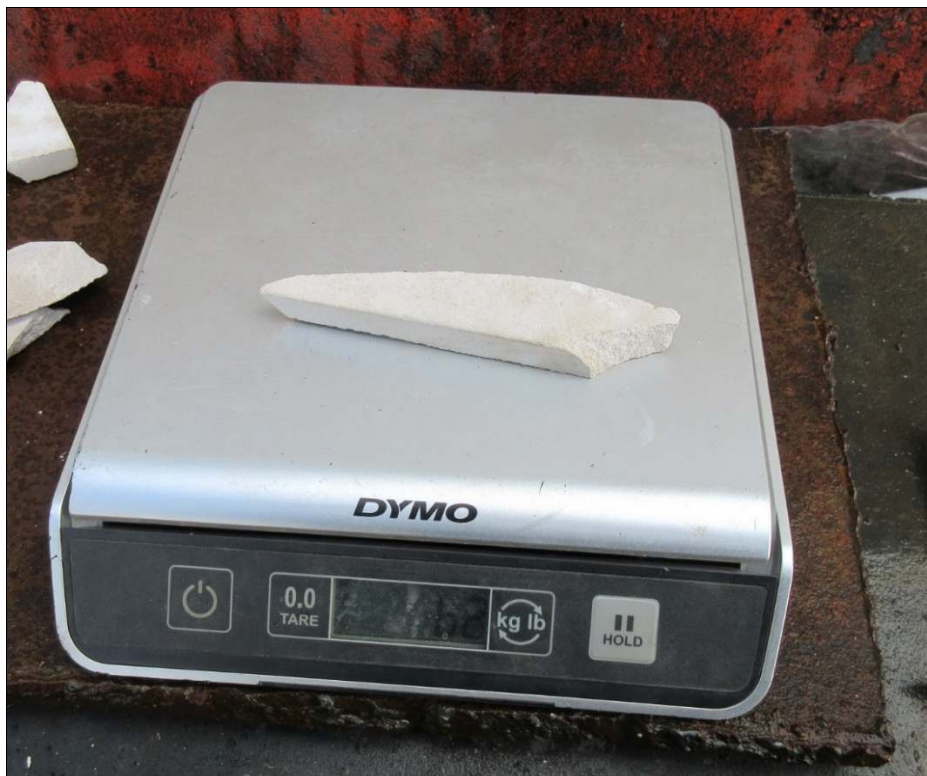
PHOTO 7242

FRAGMENT FROM LOCATION 4

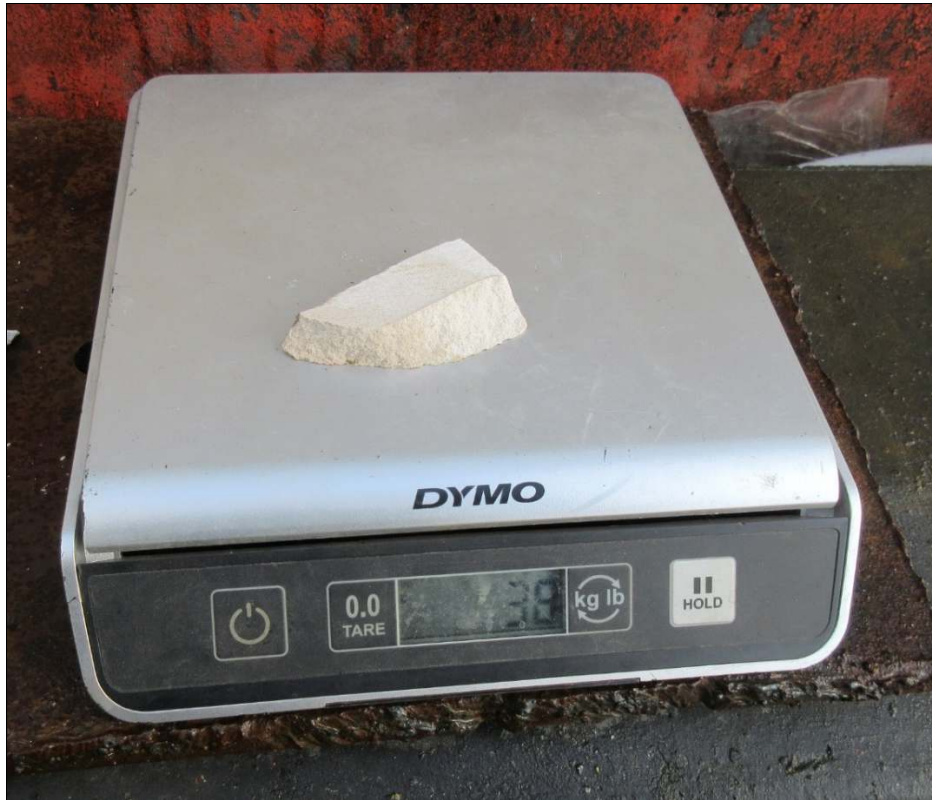
PHOTO 7240

FRAGMENT FROM LOCATION 7
