24FTM20

AGMA Technical Paper

Nanocomposite Coatings for Gears

September 2024

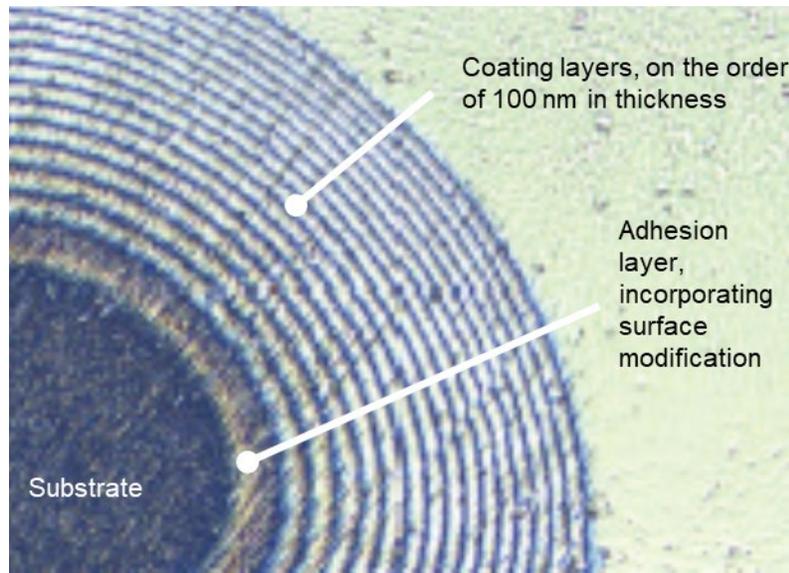
Figure 1 shows the basic structure of a nanocomposite coating. The image displayed shows the layered coating, adhesion layer, and substrate, revealed by the process described in ISO 26423 [4]. A 15 mm diameter steel ball, using diamond paste as an abrasive, is used to grind through the coating to expose a section used to make a thickness measurement. Different coating systems have different numbers of layers and can have different layer mechanical properties and chemical compositions.

Figure 1 – Image of the features of a nanocomposite coating after performing the ISO 26423 coating thickness measurement procedure

Figure 7 shows the result of a coating thickness test performed in accordance with ISO 26423, as discussed in reference to Figure 1. The coating thickness was optically measured to be 3.95 microns.

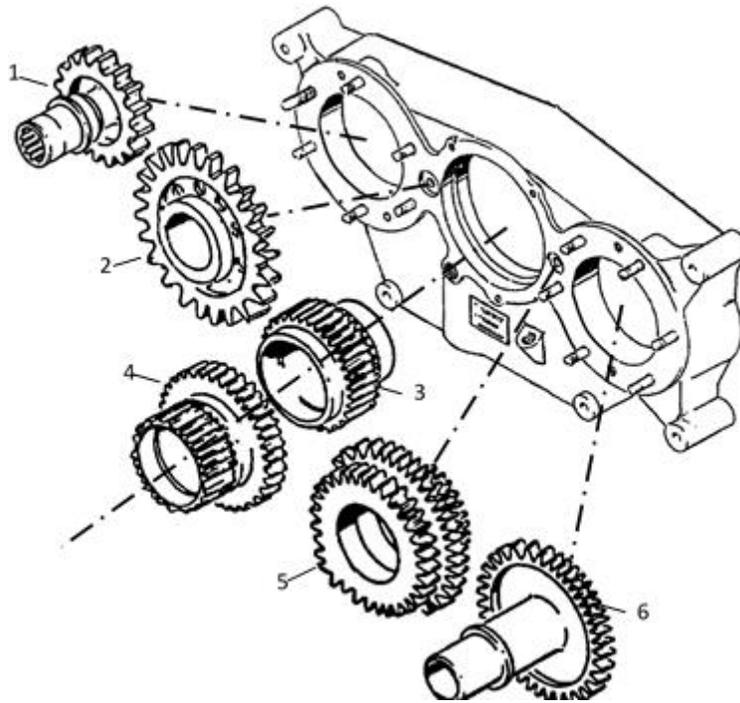
The gears are arranged in series, as shown in Figure 2. All are spur gears, with two gears being of compound configuration. The gears are manufactured from AISI 4620 or AISI 8620 steel, with AISI 8620 being preferred due to market demand and availability limitations. All testing for this project was performed with specimens manufactured from AISI 8620 steel, which was carburized and heat-treated in accordance with the gear drawings.

Figure 2 – Project targeted gearbox exploded view.

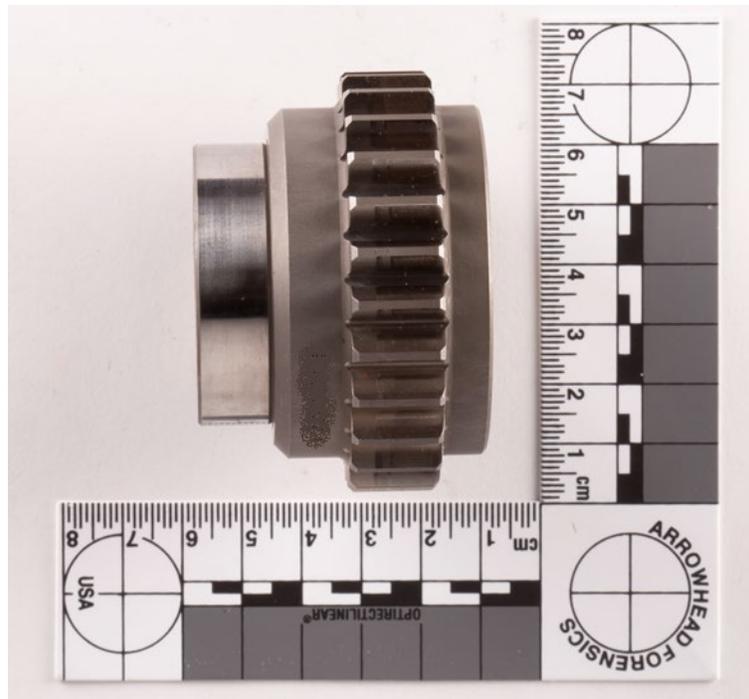
Figure 3 – Sprag Clutch Gear (Gear #3) with scale for reference.

Figures 3-4 show selected gears, with scales for reference.

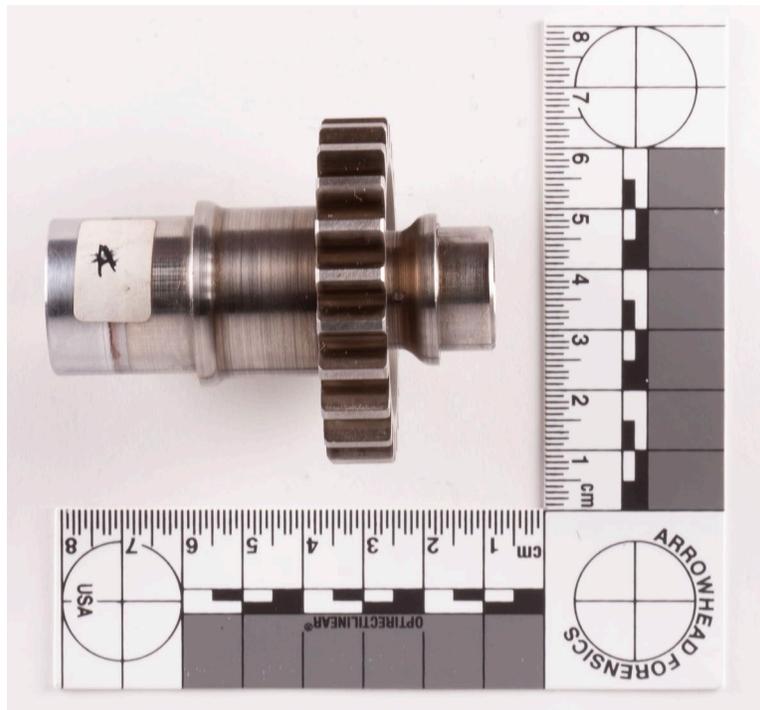
Figure 4 – Generator Spur Gear (Gear #1) with scale for reference.

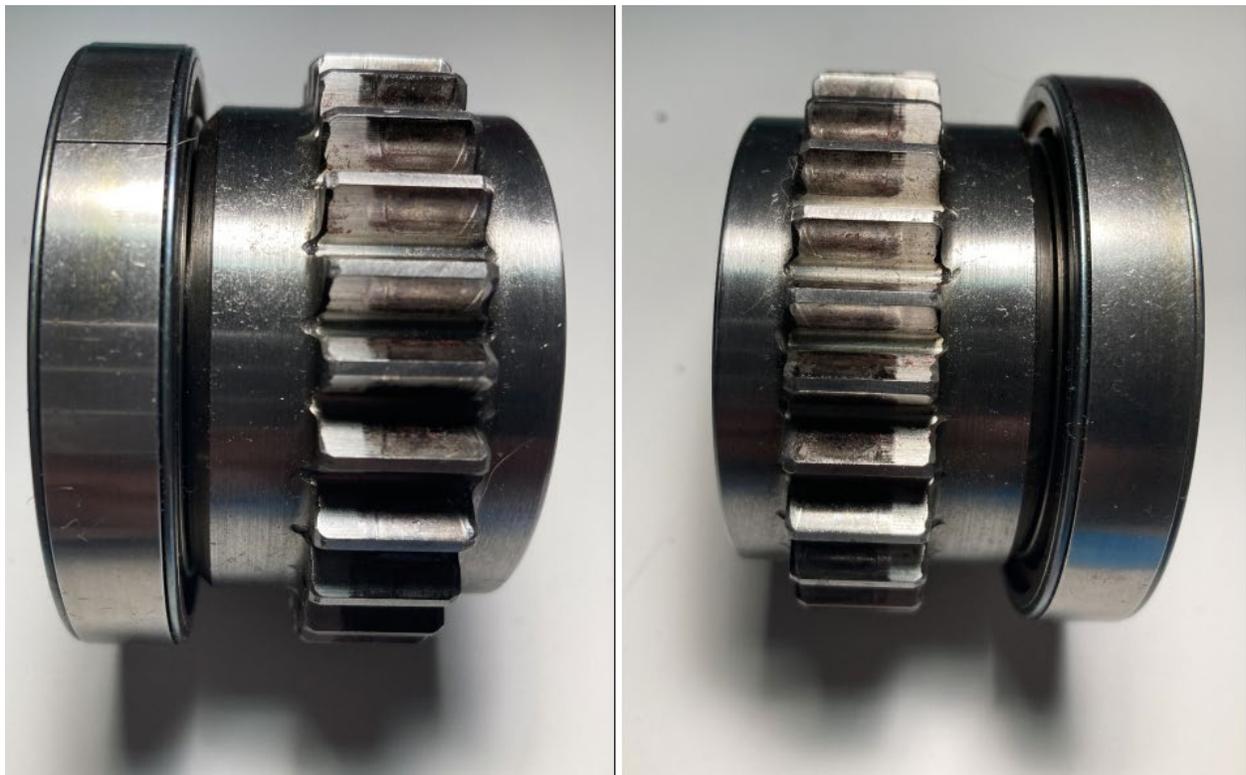
Figures 5-6 show the typical wear and damage seen on gears recovered during overhaul operations.

Figure 5 – Sprag Clutch Gear (Gear #3) pictured with its support bearing in place.

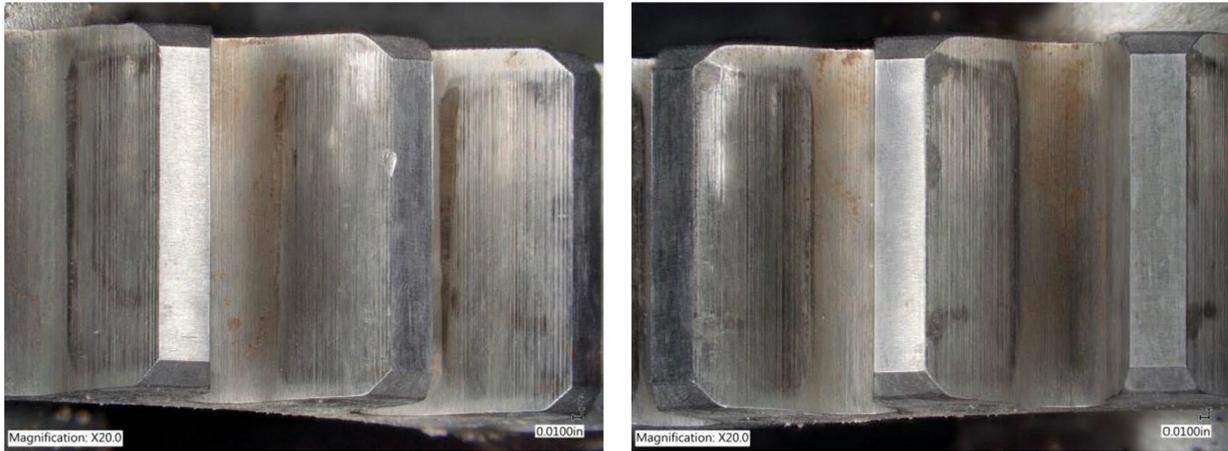
Figure 6 – Generator Spur Gear (Gear #3) showing typical wear seen at overhaul.

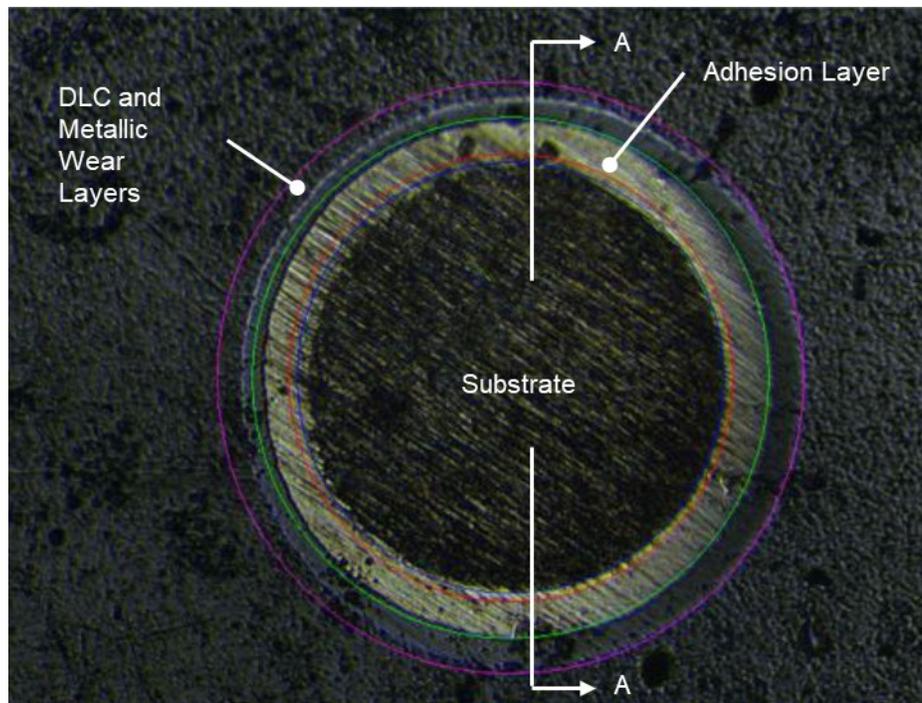
Figure 7 – ISO 26423 Thickness Test on the P51M coating system.

Figure 8 shows a section view, obtained with a scanning electron microscope, of the test crater illustrated in Figure 7.

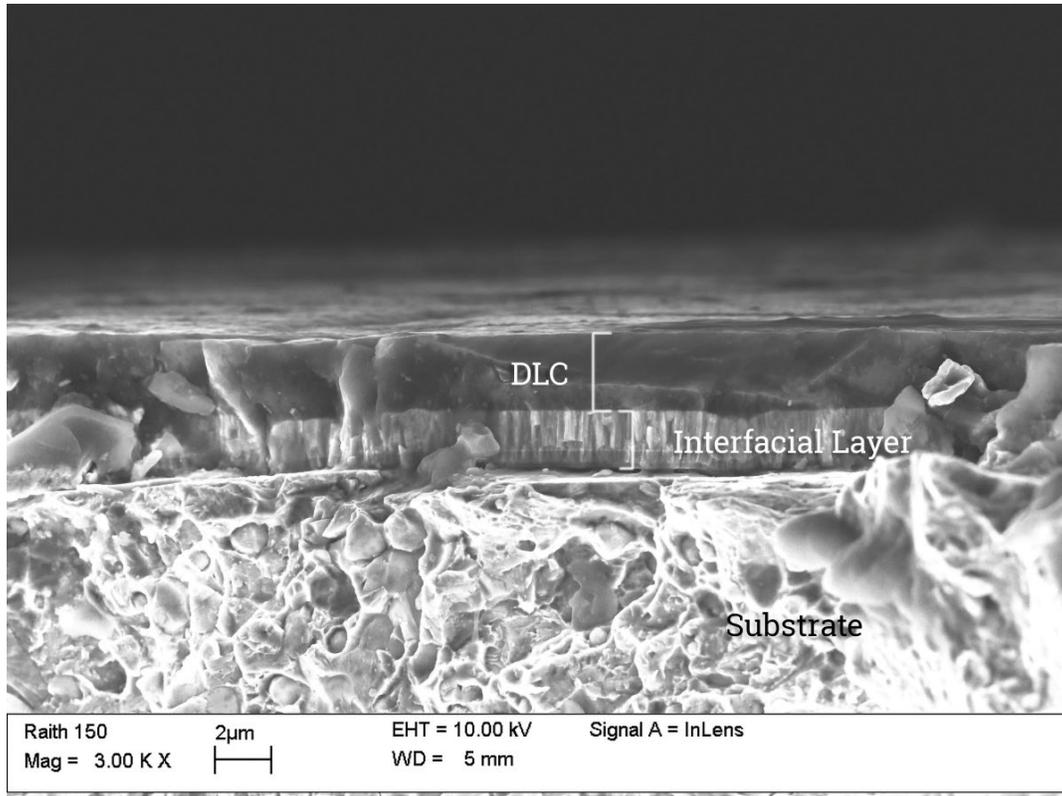
**Figure 8 – ISO 26423 Thickness Test on the coating system.
This image is oriented as Section A-A of Figure 7.**

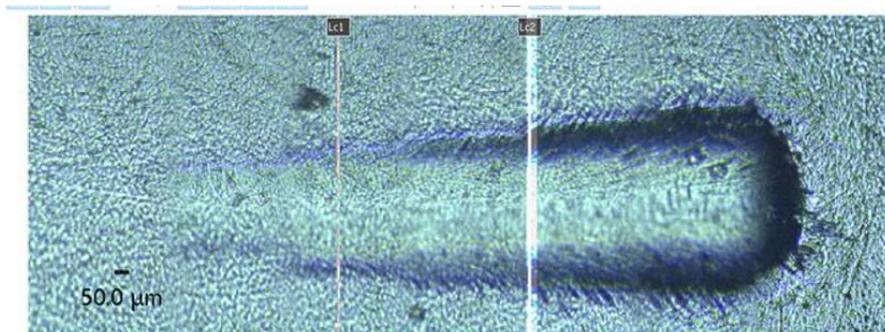
The test used to evaluate coating adhesion, ASTM C1624, [10] uses a stylus with a constantly increasing load to quantitatively characterize the adhesion performance of a coating. The coating is tested with a Rockwell “C” style indenter, with the test terminating when the normal force reaches 100 N. Three critical loads are identified in the standard, representing different levels and types of coating failure. These loads are captured with the help of a machine vision system, identifying the coating failure mode. The first critical load (LC1) is the load where the coating begins to exhibit chevron cracking, indicative of cohesive coating failure or failure of the coating to adhere to itself. LC2 is said to occur when the coating exhibits chipping failure, indicative of an adhesive failure of the coating, or where the coating begins to spall away from the substrate at the edges of the damage zone. LC3 is the final metric, where the coating freely spalls away from the substrate.

Figure 9 – Image of ASTM C1624 Scratch Test results on P51M Coating. For this test, LC1 was detected at 33.3 N, LC2 was detected at 63.27 N, and no occurrence of LC3 was detected.

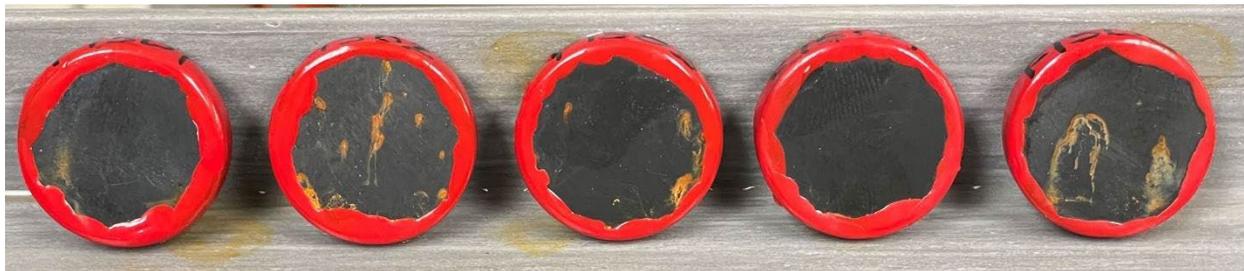
Figure 11 shows the coupon test articles after 24 hours of exposure.

Figure 11 – Test coupons from Figure 1 after 24 hours of salt fog exposure.

Normal testing is terminated after 48 hours of exposure in the procedure defined in MIL-STD-810G 509.6. The coupons that showed corrosion were analyzed under magnification. The corrosion present was attributed to holidays/pinholes [11] in the coating, which can occur when the surface preparation for the material is inappropriate, when the coating application process is not fully developed, or when the adhesion layer and associated surface modification design are not fully tailored to the chemistry of the substrate. The coupons that did not show signs of corrosion were returned to the salt fog chamber for long-term exposure.

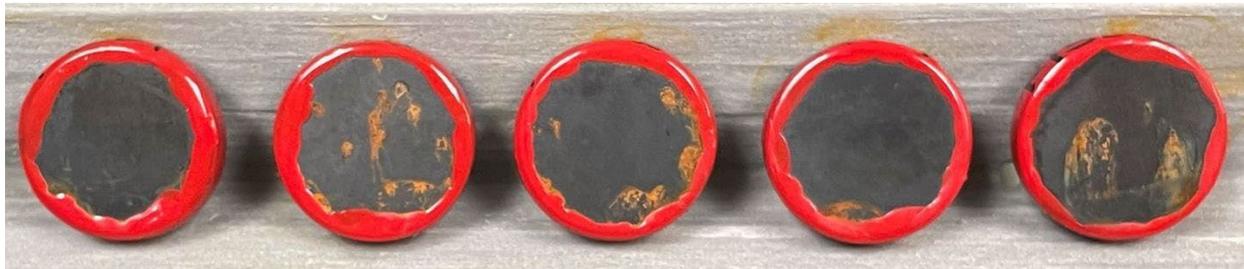
After the initial 24-hour exposure was complete, the test articles were returned to the chamber for an additional 24 hours (48-hour total exposure). The results of that test are shown in Figure 12.

Figure 12 – Test coupons from Figure 1 after 48 hours of salt fog exposure.

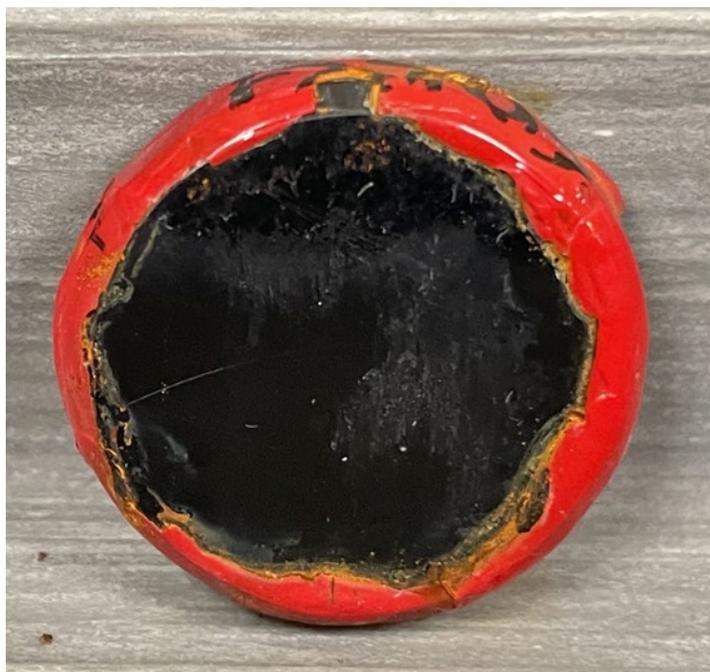
Subsequent development of the adhesion layer and surface modification used with this coating recipe has yielded significant, consistent corrosion resistance performance for the coating system. Figure 13 shows a coupon manufactured from AISI 4140 steel. This coupon was removed from long-term testing to clear the chamber for new work. Based on the latest test results, the coating is rated for 1000+ hours of salt fog exposure.

Figure 13 – Test coupon F2703 after 1341 hours of salt fog exposure.

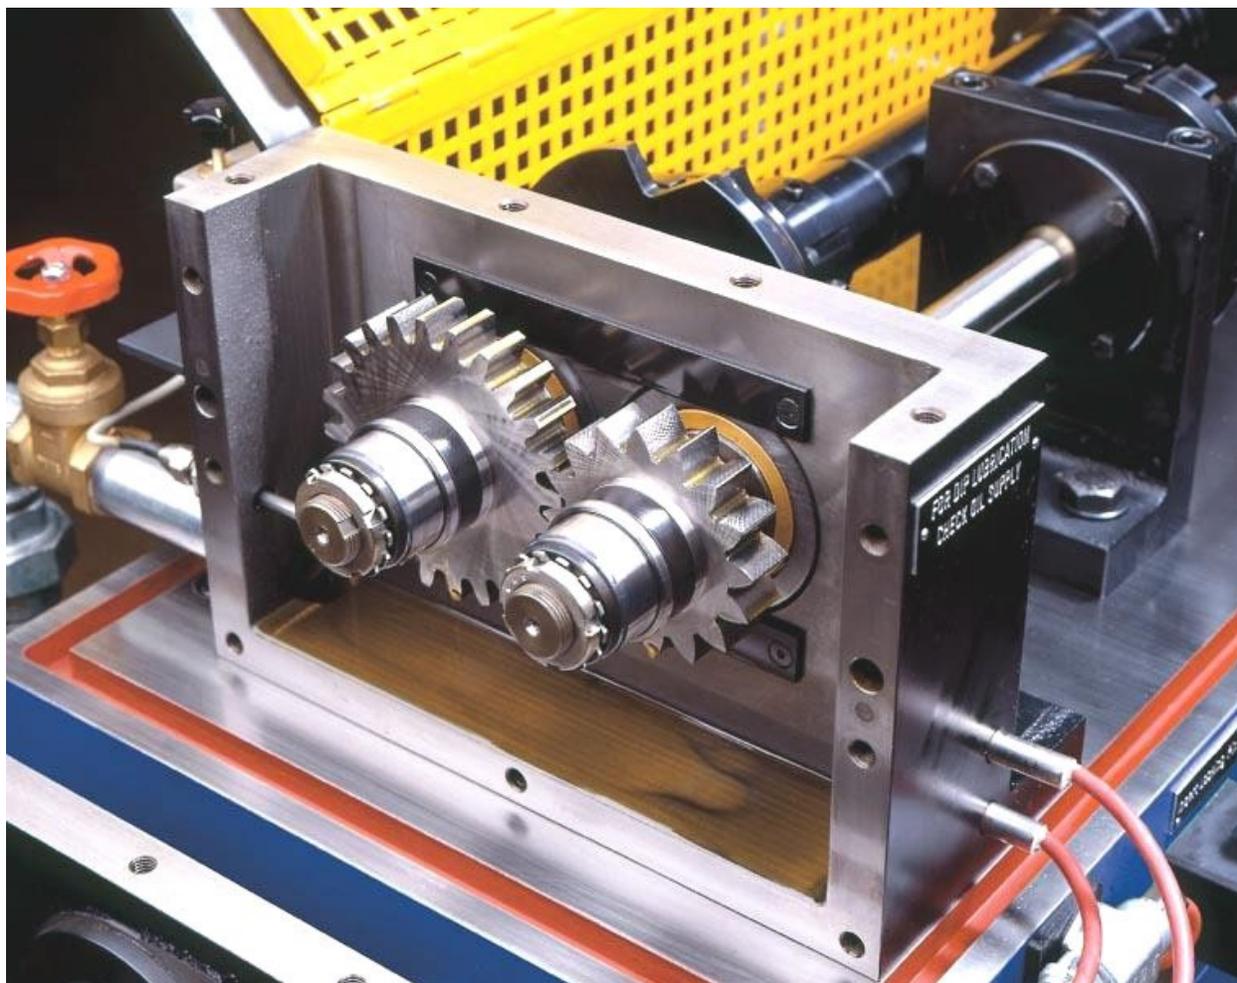
also weighed prior to testing so that a material loss figure can be provided at the end of the test. Figure 14 shows a commercially available test machine with standard test gears mounted.

Figure 14 – Open test cell in a standard FZG-type test machine, shown with a standard set of test articles with equal flank widths. The gear wheel has 24 teeth, and the pinion has 16 teeth. [14]

This setup uses the pinion as the drive input for the system. Previous experience and analysis of the results of tribological testing indicated that a more severe test was appropriate if coating failure was to be observed. A more severe version of this test is defined in ISO 14635-2: FZG test procedures Part 2: FZG step load test A10/16, 6R/120 for relative scuffing load-carrying capacity of high EP oils [15]. In this test, the gear wheel drives the system in reverse. Additionally, the pinion has a flank width of 10 mm (half of the gear wheel flank dimension), increasing the contact stress between the test articles. The independent test lab performing this work suggested that Mobil DTE Light Oil of ISO grade 32 [16] be used as a test lubricant, as it would offer minimal protection to the gear surfaces itself, minimizing any occlusion of results attributable to the coating. This is the test that was performed to evaluate the scuffing performance of the coating.

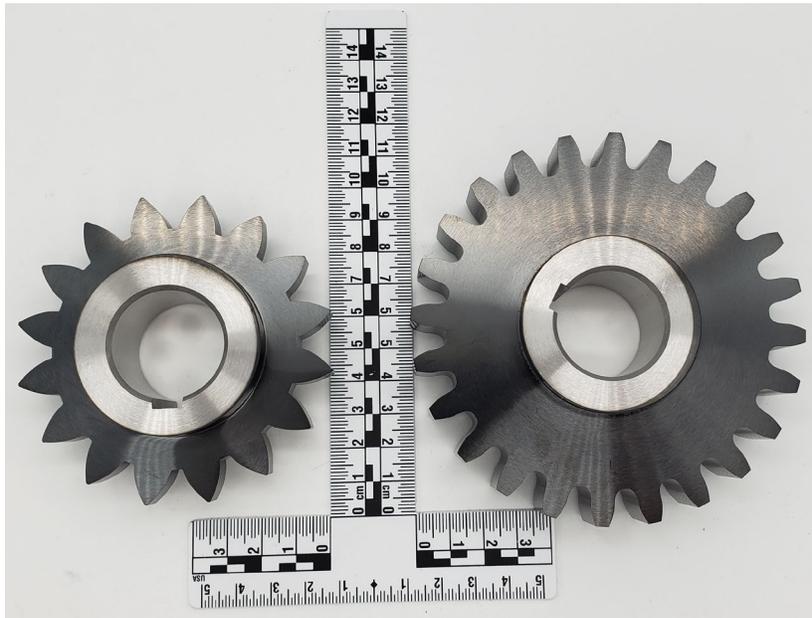
Figure 15 shows a set of test gears after application of the coating. Figure 16 shows a close-up of the test surfaces of an uncoated gear, with the checked pattern visible. This is a visual aid for the test operator when assessing failure. Due to the small coating thickness, this pattern was still visible after coating application.

Figure 15 – FZG test gears with P51M coating applied.

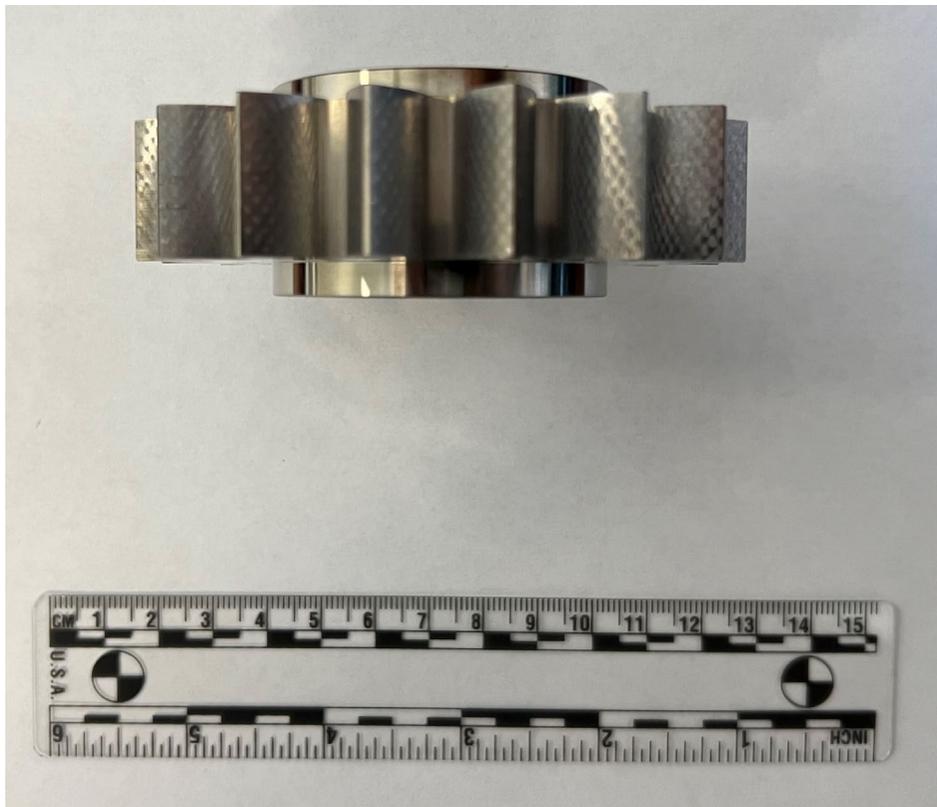
Figure 16 – FZG test gear view of flanks showing the checked pattern used to highlight the appearance of surface scratches.

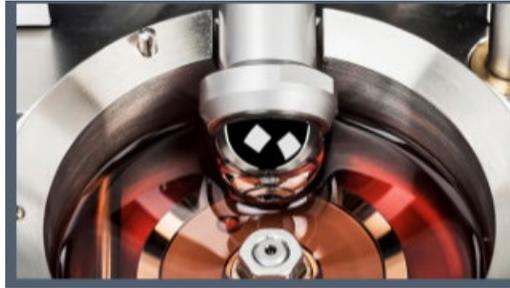
Additional testing was done with an alternate method. A ball-on-disc method was employed to better control the contact surfaces' relative velocity. This test allows the user to specify the amount of sliding present at the contact interface where both sliding and rolling occur. In involute gear teeth, the contact is perfect rolling at the pitch diameter, with varying amounts of sliding in the rolling direction and in opposition to the rolling direction during every tooth contact event. A commercially available ball on disc scuffing test cell is shown in Figure 17.

Figure 17 – Commercially available ball on disc test cell. [17]

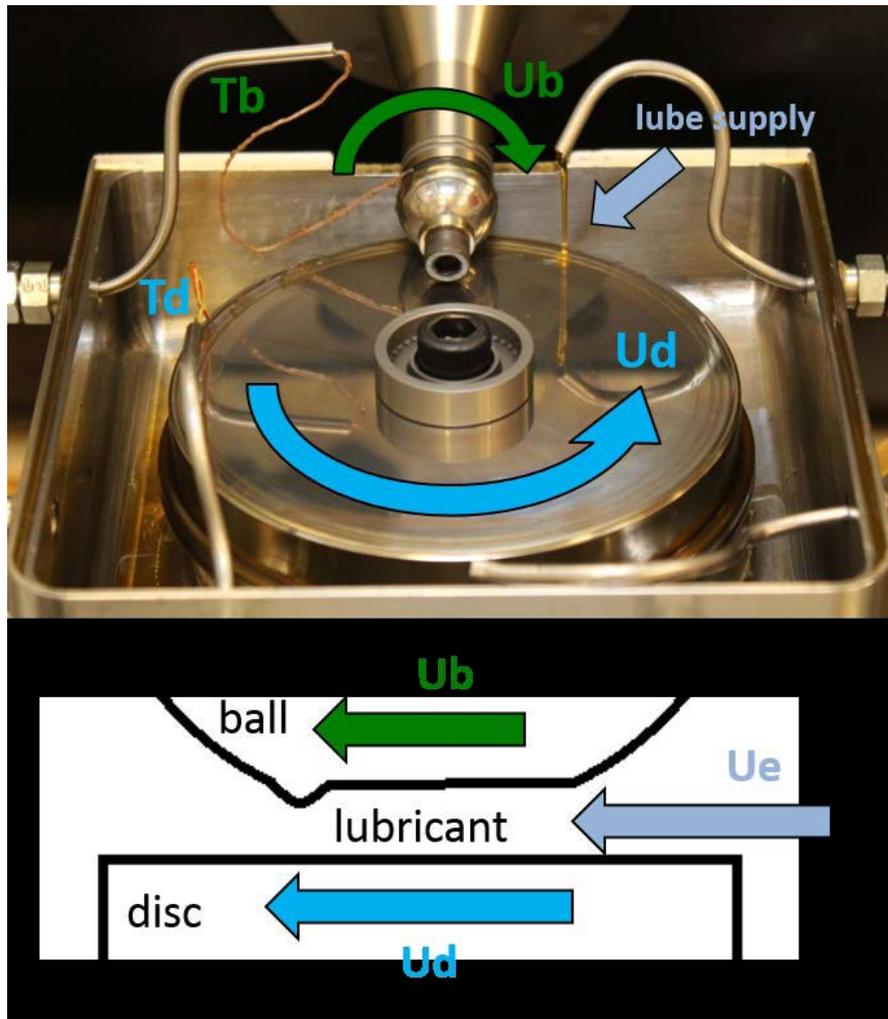
Figure 18 provides a general schematic of the various velocities. T_b and T_d refer to the temperatures of the ball and disc test articles, which are also shown in the data plots presented.

Figure 18 – Schematic of forces in ball on disc testing. [18]

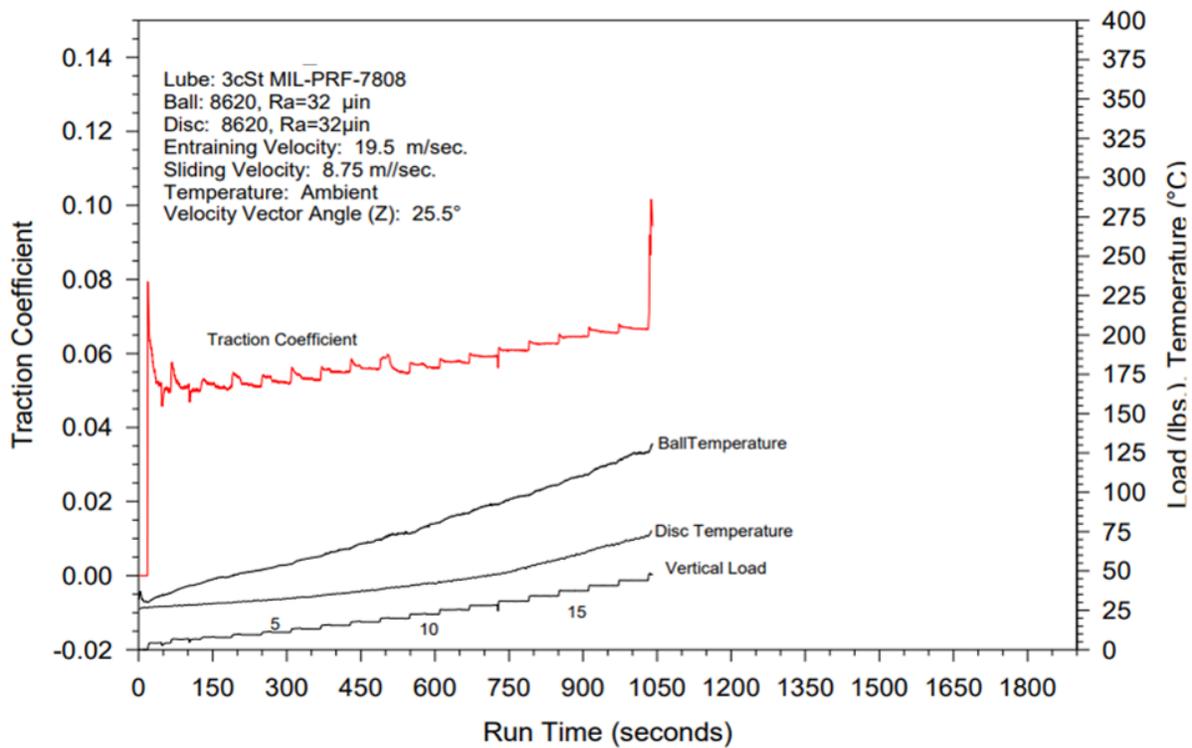
Figure 19 – Data plot for the uncoated and unimproved surface finish ball on disc test articles with surface finishes representative of the gears under study.

Table 11 provides the test configurations and results for the various combinations of surface treatments evaluated. Figures 19-21 plot the test data.

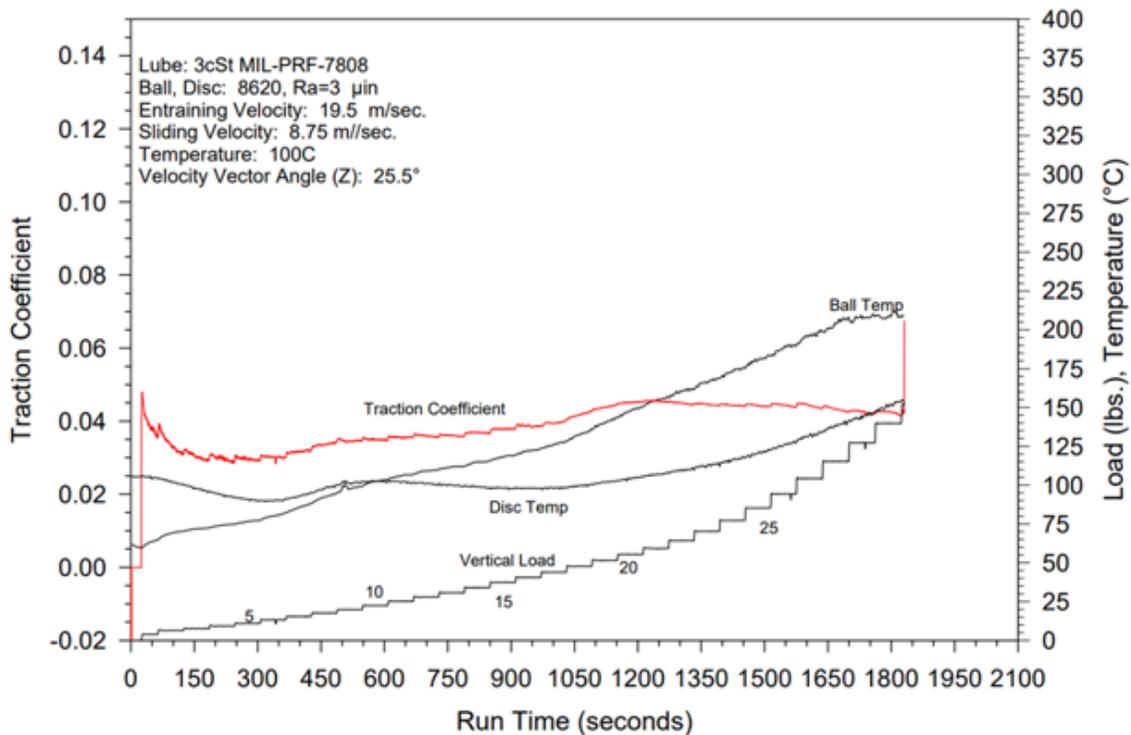
Figure 20 – Data plot for the uncoated ball on disc test of test articles with improved surface finish. Note the scuffing event indicated by the traction coefficient data-trace at around t = 1800 s.

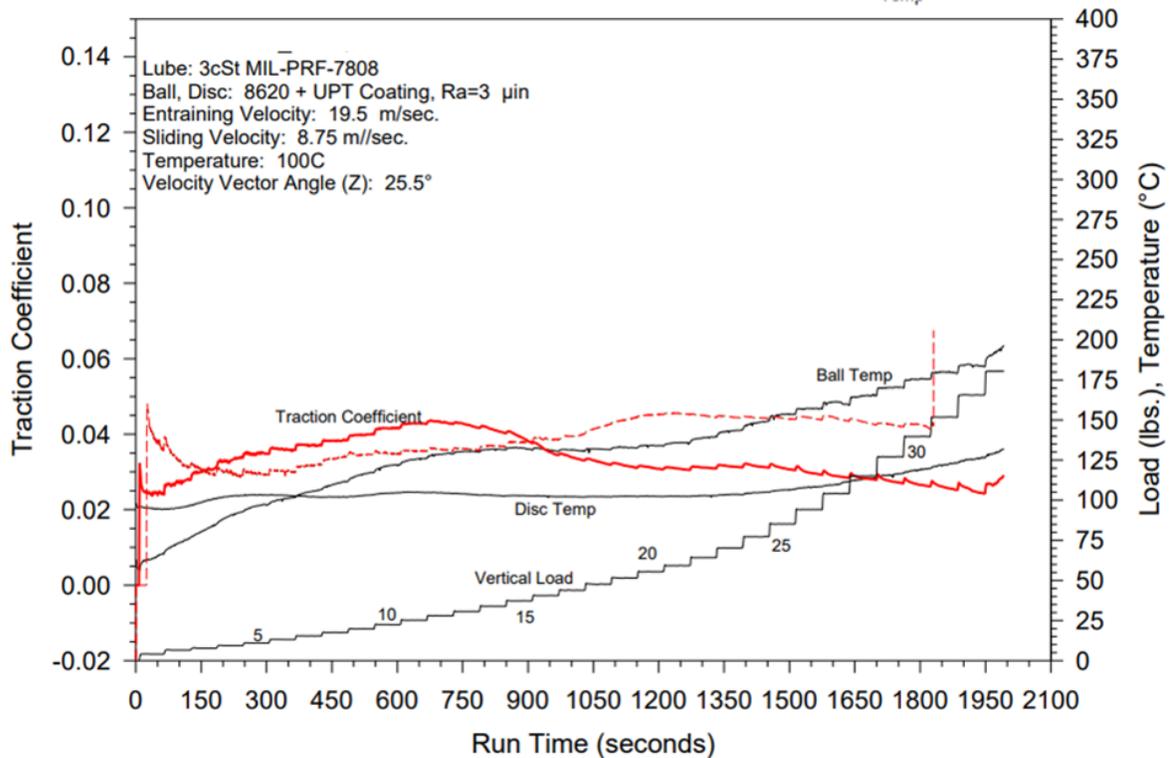
Figure 21 – Data plot for the ball on disc test of P51M coated test articles. Note the lack of a spike in traction coefficient. The red dotted trace is the traction coefficient of the uncoated ball on disc test, shown for reference.

The differences illustrated in Figure 21 are the reduction in traction coefficient, reduction in ball and disc temperatures, and the higher load capacity when comparing the test articles with an improved surface finish and test articles with both an improved surface finish and the coating system applied. At stage 30, these are 0.04 compared to 0.02 for the traction coefficient, 225 °C compared to 175 °C for the ball, and 150 °C compared to 120 °C for the disc. The load capacity increased from stage 30 to stage 33. The increase in contact stress is shown in Table 11.

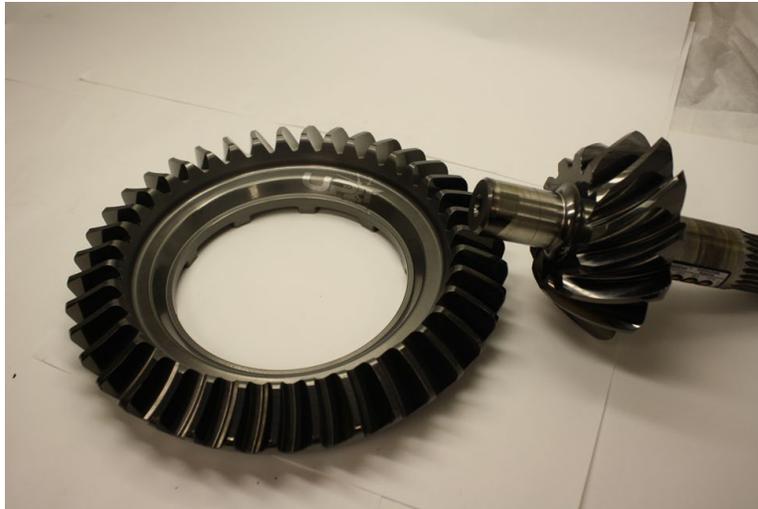
This project was inspired by work done for a competitive racing team operating in an environment where any edge in performance is valuable and where significant engineering effort is expended to obtain such performance advantages. The ring and pinion for this project are shown in Figure 22.

Figure 22 – Ring gear and pinion from a competitive racing team, coated with the predecessor of the P51M coating system.

While the authors are constrained by a non-disclosure agreement with this racing team to release detailed data, the results obtained from dynamometer testing showed an average increase of 0.5% of operating torque available at the vehicle brake.
