CHELAN COUNTY

18-Month Pilot Summary

Drone-Installed Wireless Powerline Sensors

Wireless Movement Sensors Successfully Installed and Tested On 115kV Transmission Lines

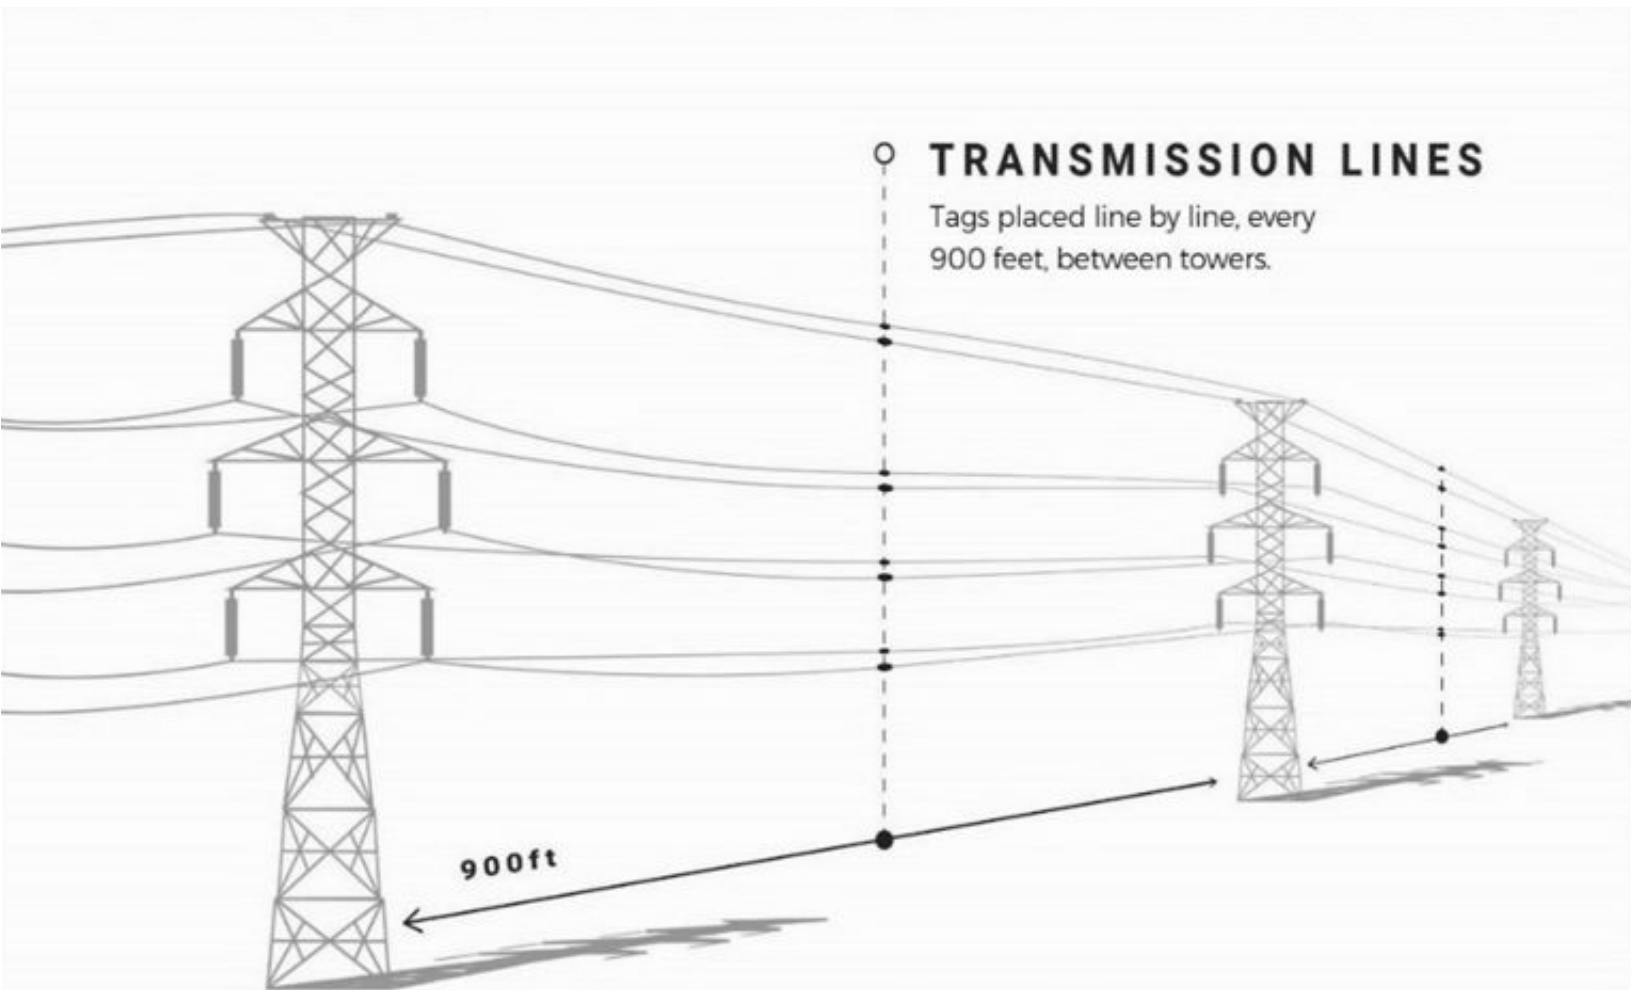
Installation Challenges Met by Shielded Drone Technology

Installation of the Linebacker Sensors presents logistical and scientific challenges. Hand installation, while reliable, may be slow, expensive and comparatively dangerous. In addition, localized electric field near energized components and conductors can produce an electric discharge known as a "Corona." Until now, it was thought that using electronics near the corona was nearly impossible. However, to increase speed and efficiency, Recon has created a shielded drone that successfully operates in the Corona and installs Linebacker tags at an average flight time of only 32 seconds per tag.

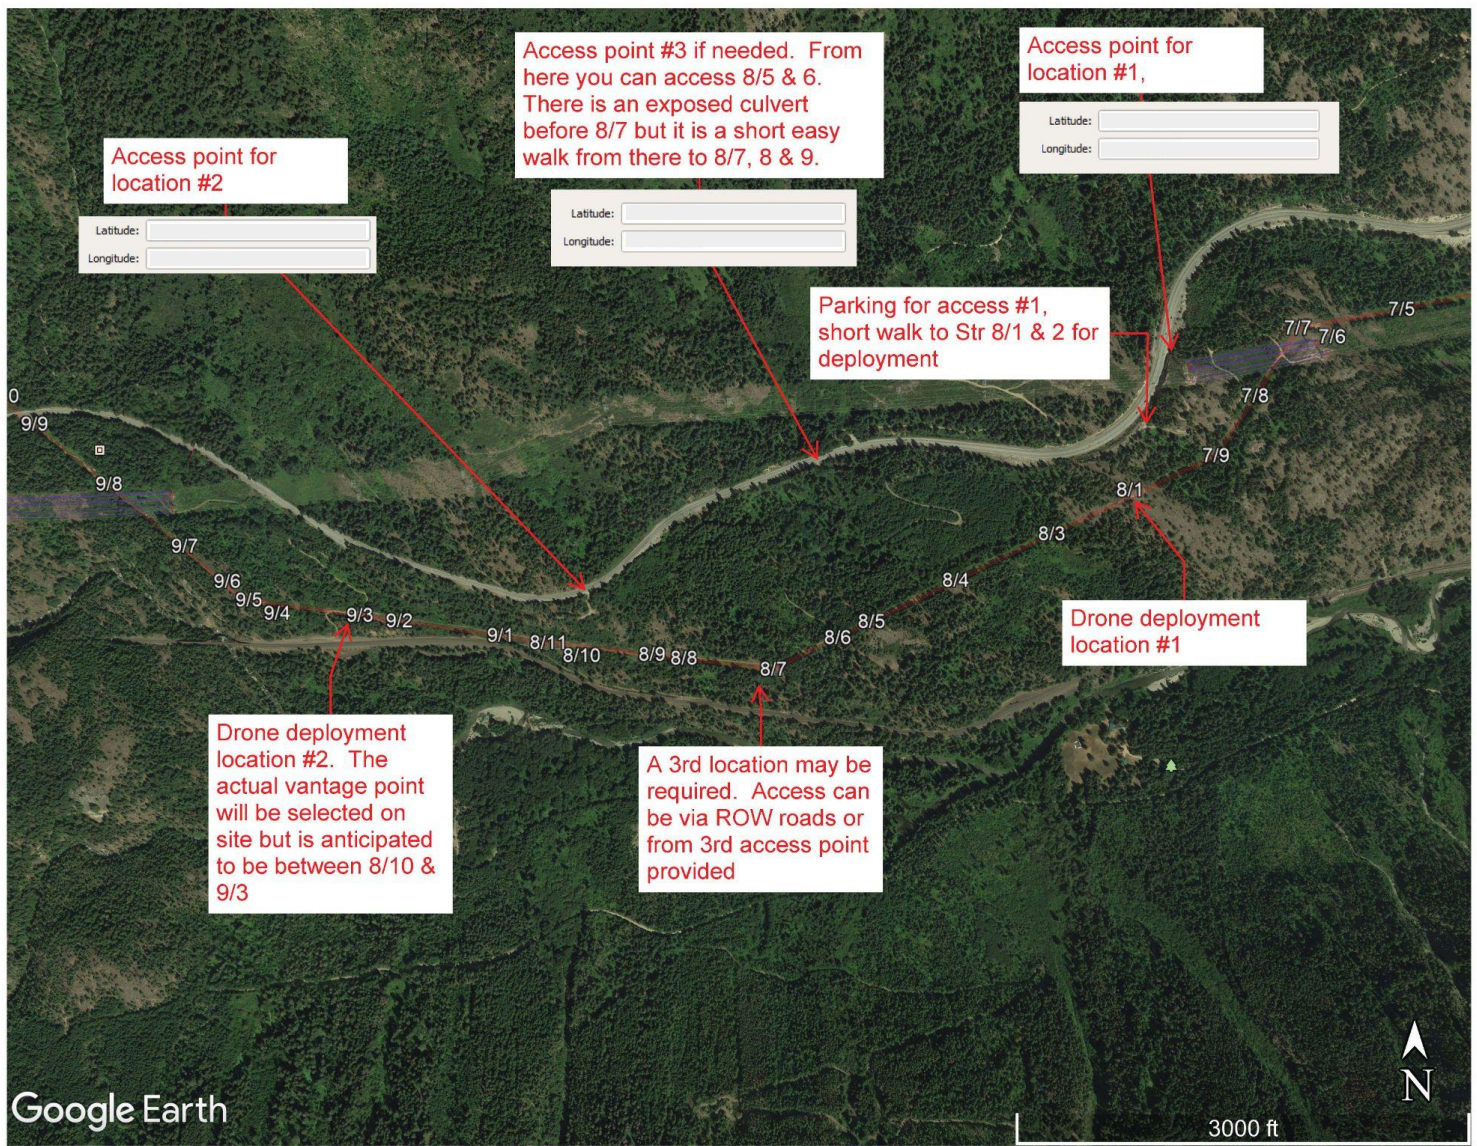
July 2020 Pilot Started Near Wenatchee, Washington

Recon Dynamics successfully installed 25 Recon Linebacker™ Powerline Sensor Tags, 4 solar-powered Recon Proxboxes, and a solar-powered weather station on lines and poles near Wenatchee, Washington.. Only Access Point 1 and 2 were used.

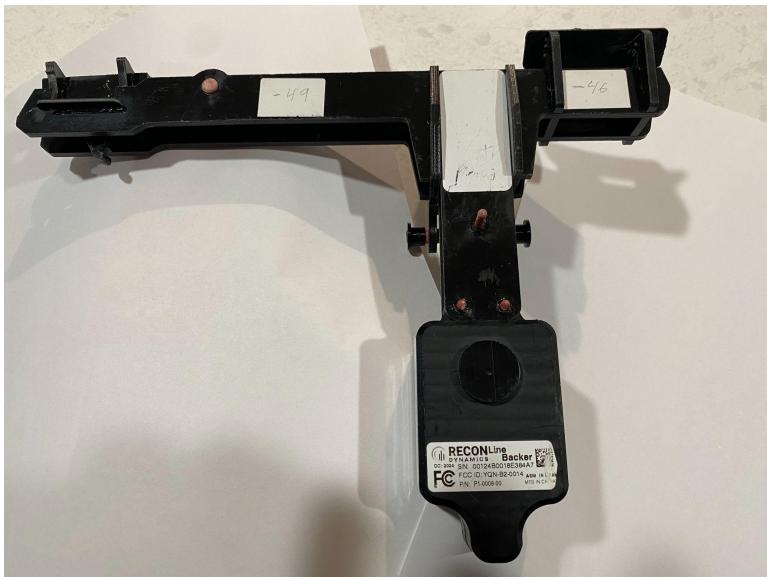
QUICK FACTS

- 5-10+ year battery life
- Automatic data transfer
- Motion sensor
- Temperature sensor
- Over-the-air programmable
- Industrial strength
- Location tracking via install location

- Standard: **802.15.4**
- RF Rx Sensitivity: **-97dBm**
- Tx Output Power: **+5.6 dBm**
- Standard Transmit Interval: **5 minutes**
- Transmit Count: **1M+**

- Motion: **Internal 3-axis accelerometer**
- Temp: **± 3% over operating range**

- Dimensions:
 - 10 x 8.5 x 3.5 in**
 - 243 x 215 x 83 mm**
- Weight: **9.625 oz, 271g**
- Environmental Rating: **IP68**
- Operating Temp Range:
 - 40 to +140°F**
 - 40 to +60°C**

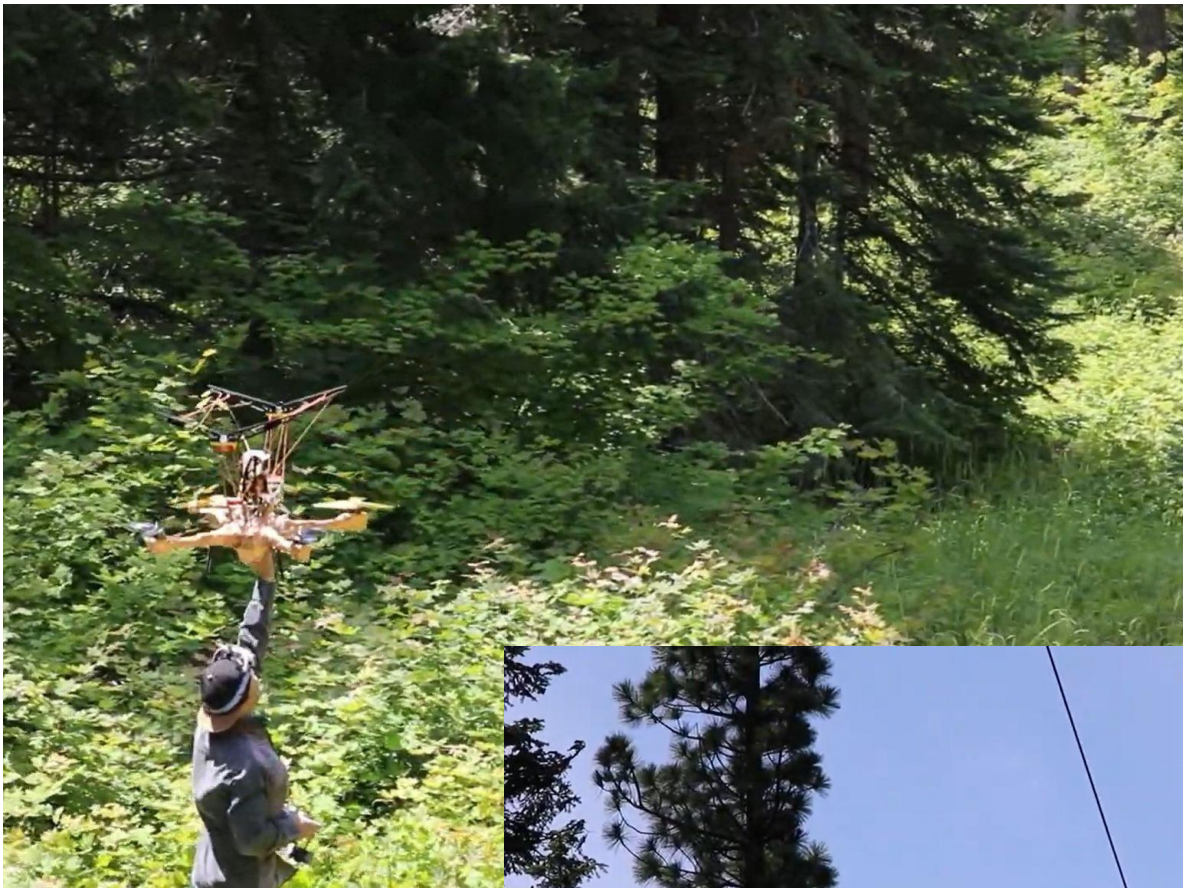
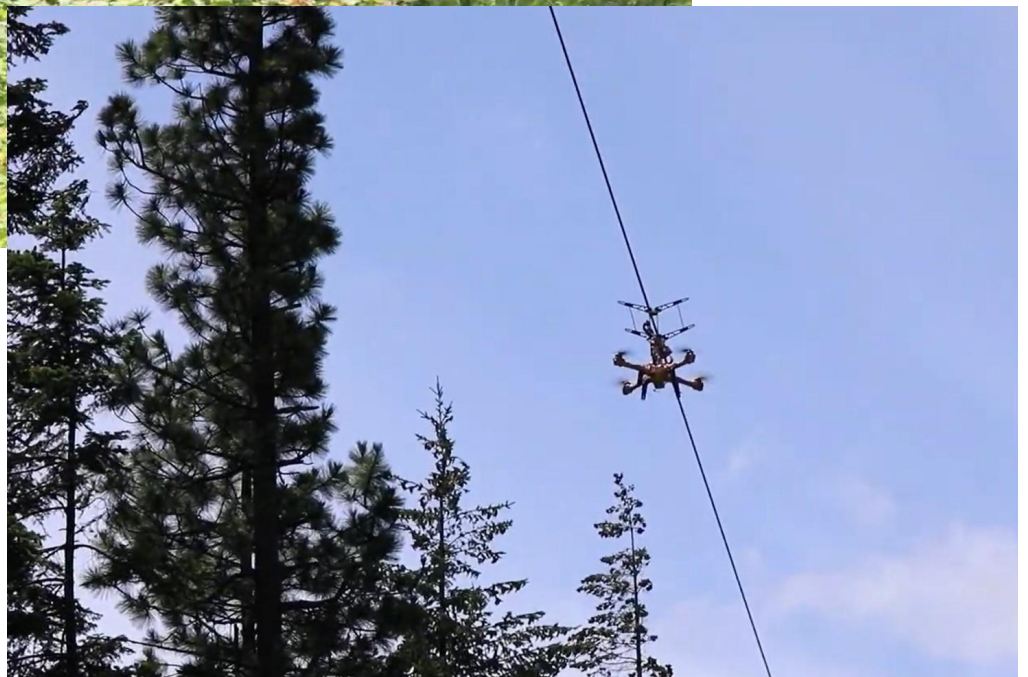
Drone Installation

32 Seconds Per Tag

After 9 months of testing various drone shielding methodologies, on July 8th 2020, Recon successfully installed 25 tags at an average flight time pace of 32 seconds each without incident.

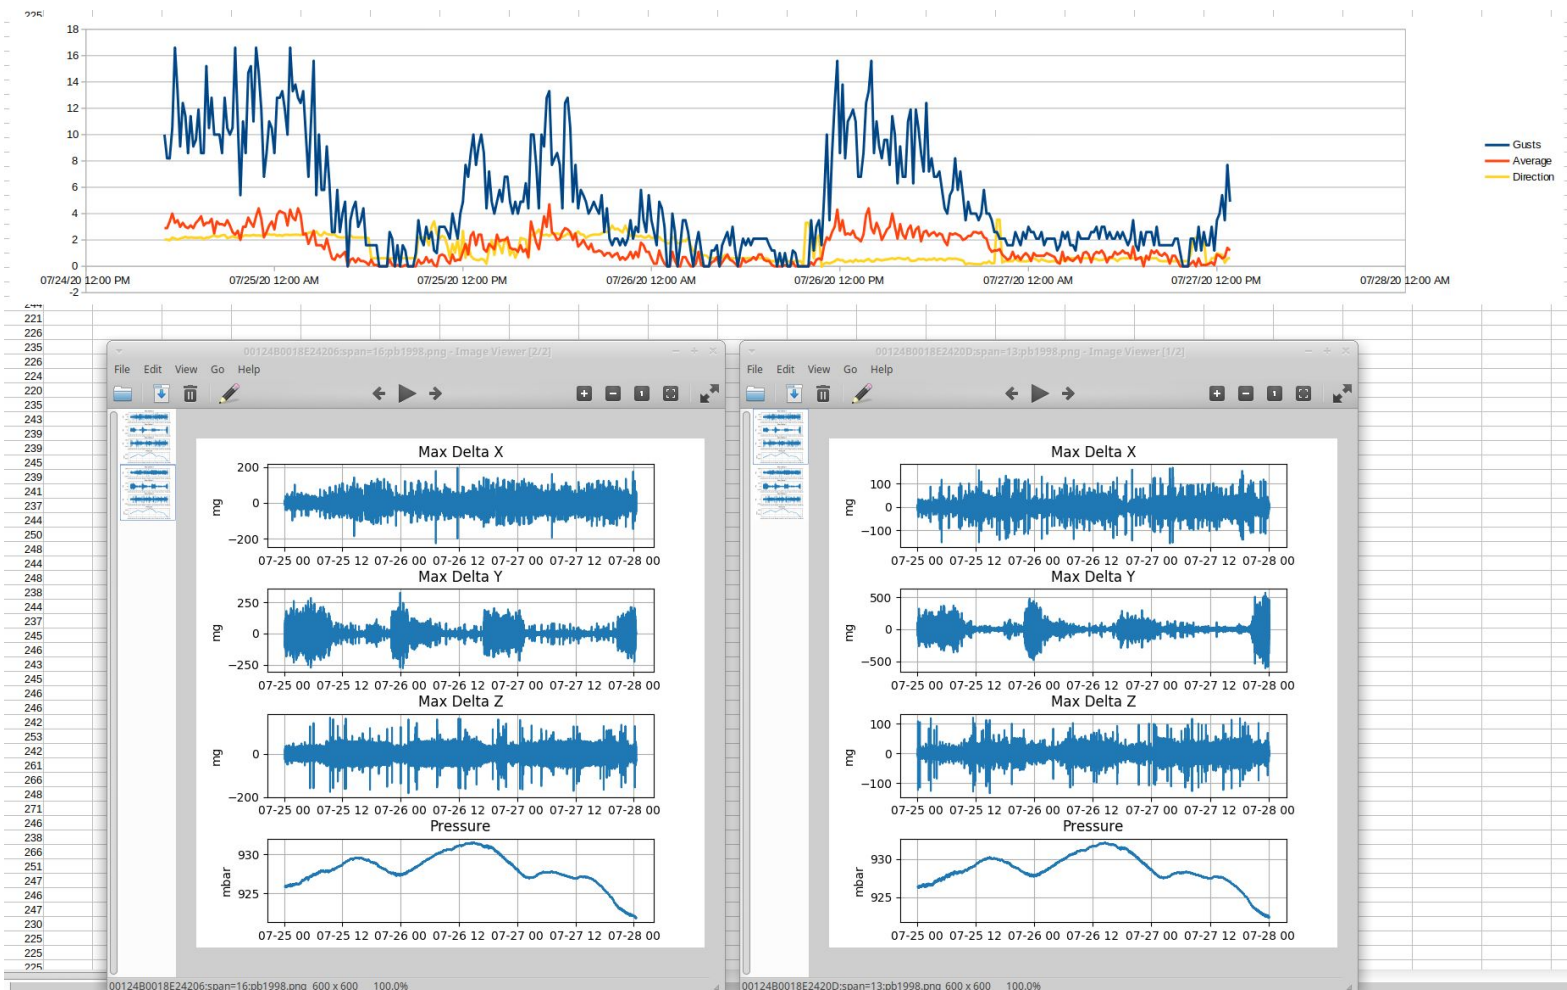
Sensors Function

Wind data matched control

During the weeks following the installation Recon engineers successfully downloaded wind data from the Linebacker tags.

This wind data correlated with a wind station installed at the same site for the purpose of acting as a control.

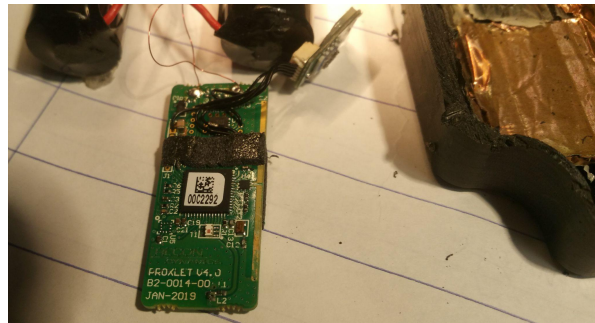
In November 2021, after nearly 18 months, power surging up to 115,000 Volts and temperature swings from -9 degrees F to 109 degrees F. Potelco Inc. employees removed all the linebacker tags from the Chelan PUD 115kV powerlines.

All 25 tags were still installed, and were recovered.

Upon detailed inspection by Recon engineers all 25 tags were still fully operational and showed no signs of any deterioration from the corona of the 115kV transmission line.
