Surface and tap water quality in Cerro de Pasco and surrounding areas

Report on water contamination • July 2024 campaign

Cerro de Pasco, Peru

Version 1 • Released on 20 November 2025

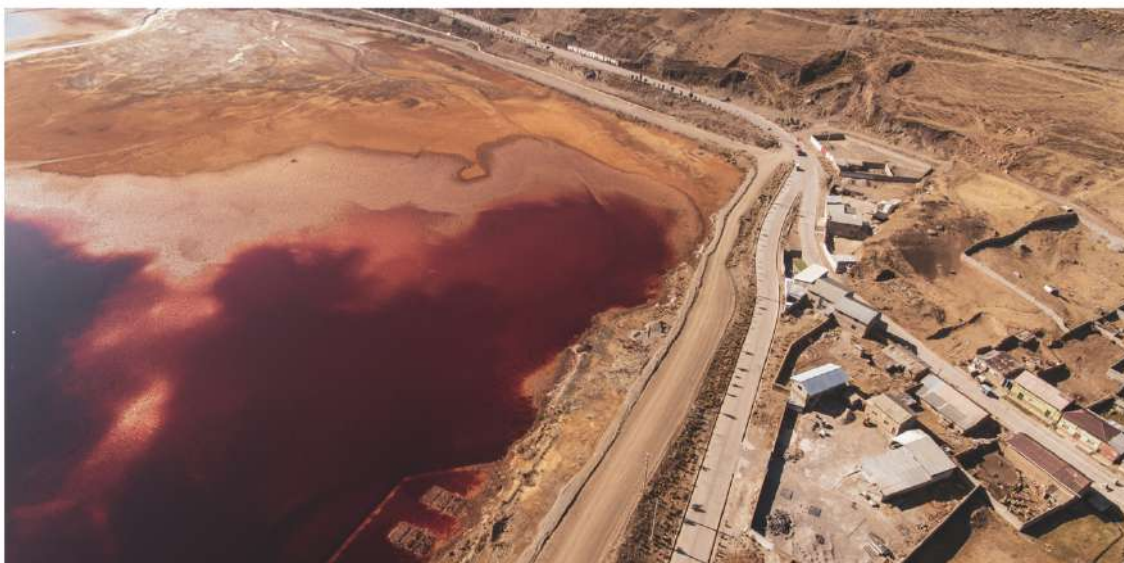
Figure 2. Aerial view of Lake Quiulacocha’s blood-red waters from close to the eponymous community. Photo credit: Stefano Sbrulli for Source International, 2019.

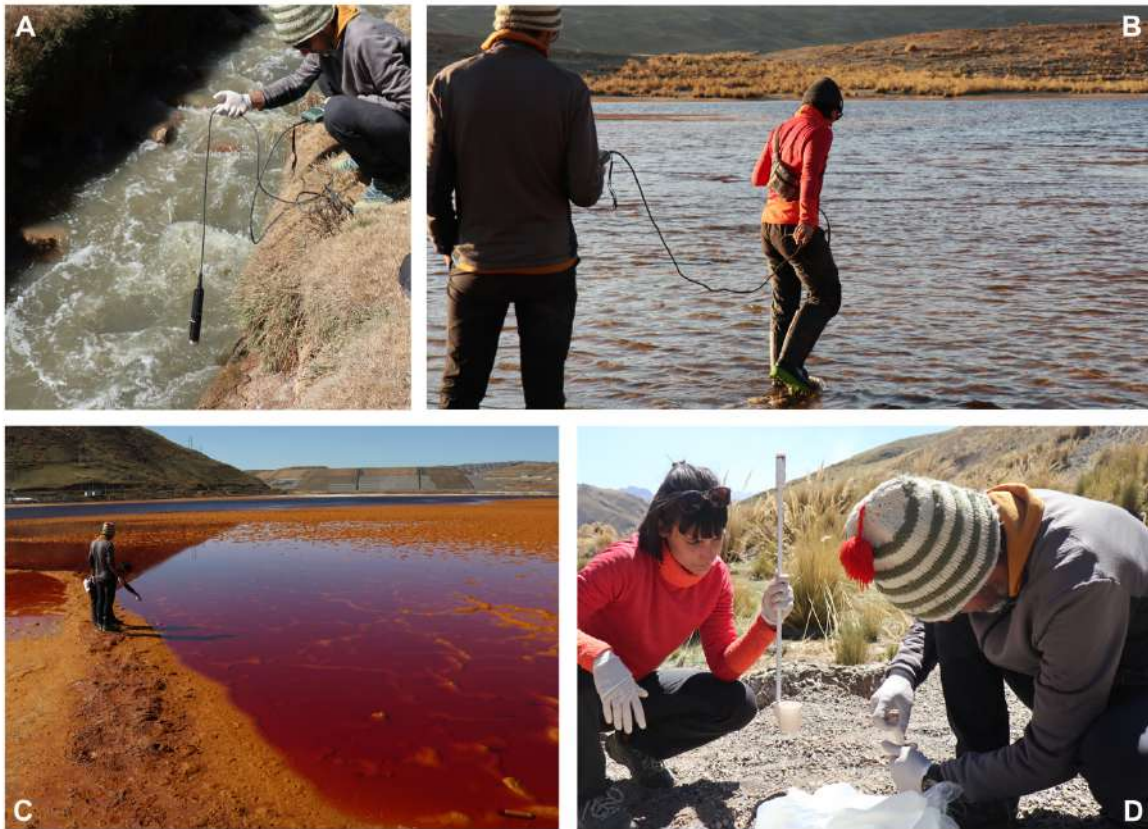
Figure 4. Overview of sampling activities and tools. Panels A and B show the use of the multiparametric probe in the Tingo River and Lake Yanamate. Panels C and D show how we collected surface waters using the Teflon sampler at the Lake Quiulacocha and the Tingo River.

At each site, we recorded the GPS position with a Garmin Fenix 7 watch and measured general water quality parameters with a multiparametric field probe (Hanna, HI 98194). The probe's pH and conductivity sensors were calibrated prior to sampling with new standard solutions (i.e., commercial buffers at pH 4 and 7 for pH and a 1413 $\mu\text{S}/\text{cm}$ standard solution for conductivity). The temperature probe was used uncalibrated. For measurements, we placed the multiparametric probe in running water (Figure 4A-B) and recorded temperature, pH, and conductivity values after stabilization. We then rinsed the probe thoroughly with deionized water and stored it in its case. For tap waters, we placed the liquid sample into a container and recorded the same parameters after stabilization.

We collected surface waters using a teflon sampler equipped with a 50 cm stick (Figure 4C-D). The sampler was rinsed thoroughly with surface water, then we syringe-filtered (0.45 μm) the water directly into a new 50 mL falcon tube. We added 4 drops of concentrated nitric acid (70%), mixed,

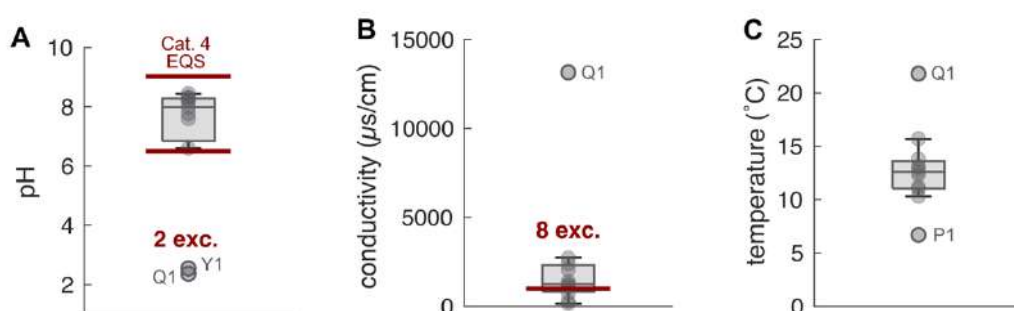
Figure 5. Overview of general water chemistry parameters ($N = 11$). The red line in panels A and B indicate the category 4 Peruvian Environmental Quality Standard (EQS), while the red text clarifies the number of exceedances (exc.). Raw data are in the Appendix (Table A2).

Water pH ranged from 2.4 to 8.4, although most values were between 6.5 and 8 (Figure 5A and Table A2). Lake Quiulacocha (Q1) and Lake Yamamate (Y1) had pH values well below any regulatory limit (Table 1). Both sites have a well-documented history of acidic contamination from mining residues and consistently exhibited strongly acidic conditions in past campaigns.^{3,5,12}

Conductivity spanned from 154 to 13150 $\mu\text{S}/\text{cm}$ (Figure 5B and Table A2). Except for the two tap waters, which were below all normative limits, **8 of 9 surface waters exceeded the EQS for the protection of aquatic ecosystems** (Table A2). Q1 had the highest conductivity of the dataset and was clearly identified as an outlier in the boxplot analysis (Figure 5B). Likewise, Y1 showed elevated conductivity (2740 $\mu\text{S}/\text{cm}$), ranking second overall and exceeding the EQS for more permissive classes (e.g., cat. 3). These two sites had conductivity above 4000 $\mu\text{S}/\text{cm}$ also in 2022,¹² in agreement with the known contamination.

Water temperature was between 6.7 and 21 °C (median of 13 °C), consistent with climate conditions in Cerro de Pasco. The boxplot analysis identified two outliers: Lake Quiulacocha (Q1) and the Paragsha tap water (P1), which were respectively warmer and colder than the rest of the samples. We suspect Lake Quiulacocha's higher temperature may be caused by the oxidation of pyrite by oxygen, iron, and microbes – a process that is known to release heat.^{17,18} Indeed, pyrite, a mineral made of iron and sulfur, constitutes approximately 50% of Lake Quiulacocha's tailing residues.¹⁹

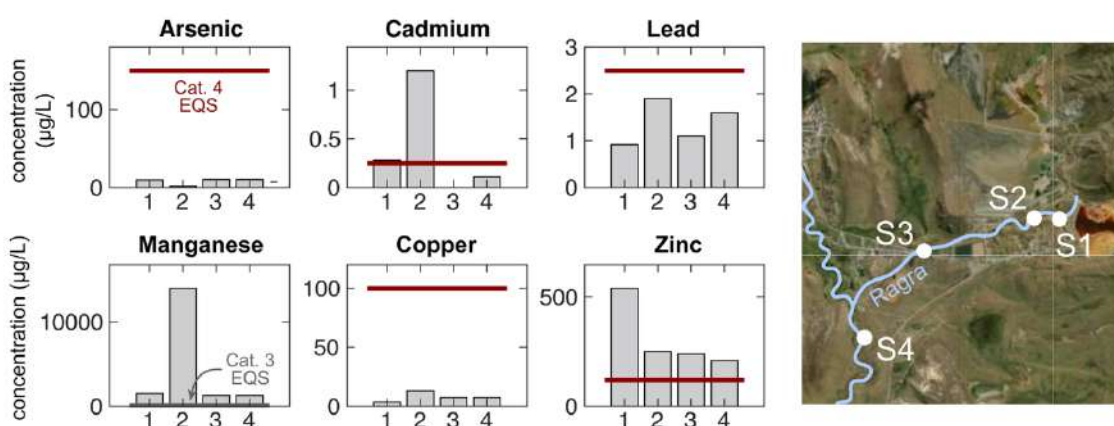
In this area, we observed **7 exceedances of the national EQS for the protection of aquatic ecosystems** (Figure 9 and Table 3). While all sites exceeded at least twice the cat. 4 EQS for zinc (210

– 540 vs. 120 µg/L), S1 was also slightly above the EQS for cadmium (0.28 vs. 0.25 µg/L), while S2 was above the EQS for both cadmium (1.2 vs. 0.25 µg/L) and thallium (3 vs. 0.8 µg/L). Overall, **S1 and S2 were the most polluted sites**, in agreement with their proximity to mining activities and the Ocroyoc tailing dam (Figure 9 and Figure 3). The exploratory principal component analysis further revealed a subtle difference between S2 and the other samples (Figure A1), which we also noticed in the higher concentration of specific metals – i.e., cadmium, cobalt, manganese, selenium, and thallium. S2 was collected in an effluent of the Ocroyoc tailing dam *before* it joined the Ragra River, which likely explains the slight difference in chemical composition.

Figure 9. Exceedances of selected heavy metal exceedances in the San Juan River watershed. The color code is the same as in Figure 6. Raw data are in Table 3.

Sites S1 and S3 were also included in the past two campaigns,^{12,13} revealing an **overall decrease in pollution throughout the years**. For example, in 2022, S1 had 4 exceedances of the cat. 4 EQS (i.e., cadmium, lead, thallium, and zinc) and 1 in cat. 3 (i.e., manganese); in 2023, we observed 3 exceedances of cat. 4 (i.e., cadmium, thallium, and zinc) and 2 of cat. 3 (i.e., iron and manganese); and in 2024, we had only 2 exceedances of cat. 4 (i.e., cadmium and zinc) and 1 of cat. 3 (i.e., manganese). **Cadmium, zinc, and manganese were consistently the most problematic elements at these sites**, followed by lead and thallium. Conductivity has also been constantly above the cat. 4 EQS at the 2 sites from 2022 until now.

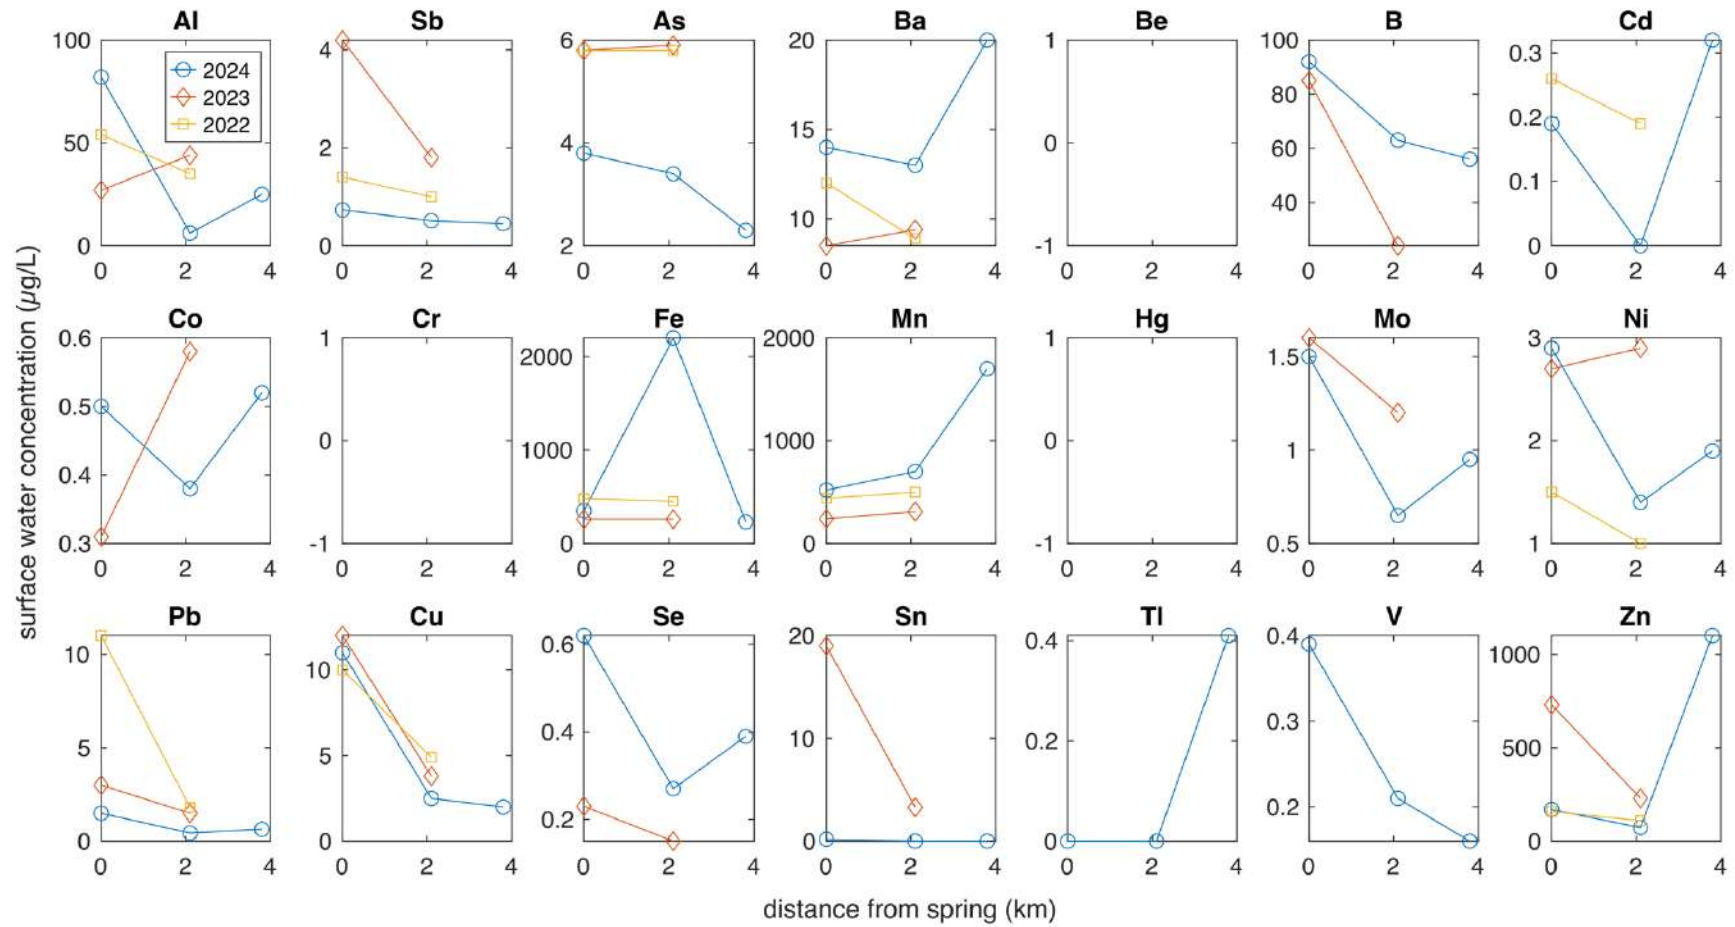
Figure A2. Changes in the concentration of dissolved heavy metals along the Tingo River from 2022 to 2024. Distances from the spring are estimated using the measuring tool in Google myMaps. Previous year data are taken from the Reports of the 2022¹² and 2023¹³ sampling campaigns. Beryllium, mercury, and chromium were never detected.

While TR3 was not sampled in the past two campaigns (Table 2), **the other 2 sites showed overall similar water chemistry throughout the years** (Figure A2).^{12,13} Zinc always exceeded the cat. 4 EQS at TR1 and, in 2023, was above this value also at TR2. Likewise, manganese was always above the cat. 3 EQS at the two locations. Of the other metals regulated under the D.S. N° 008-2017-MINAM, in 2022, cadmium slightly exceeded the cat. 4 EQS at TR1, while lead showed a constant decrease over time – in 2022, it was above the cat. 4 EQS at both sites; in 2023, it was above the EQS only at TR1; and in 2024, it was below the EQS at both locations (Figure A2).
