Surface and tap water quality in Cerro de Pasco and surrounding areas

Report on water contamination • July 2024 campaign

Cerro de Pasco, Peru

Version 1 • Released on 20 November 2025

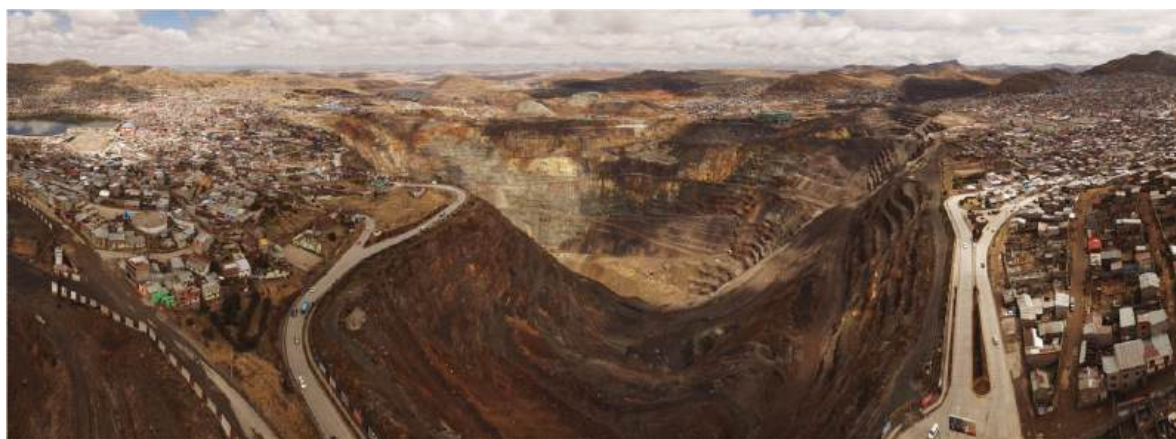
Figure 1. Aerial view of “El Tajo”, the large open-pit mine around which Cerro de Pasco has grown. Photo credit: Stefano Sbrulli for Source International, 2019.

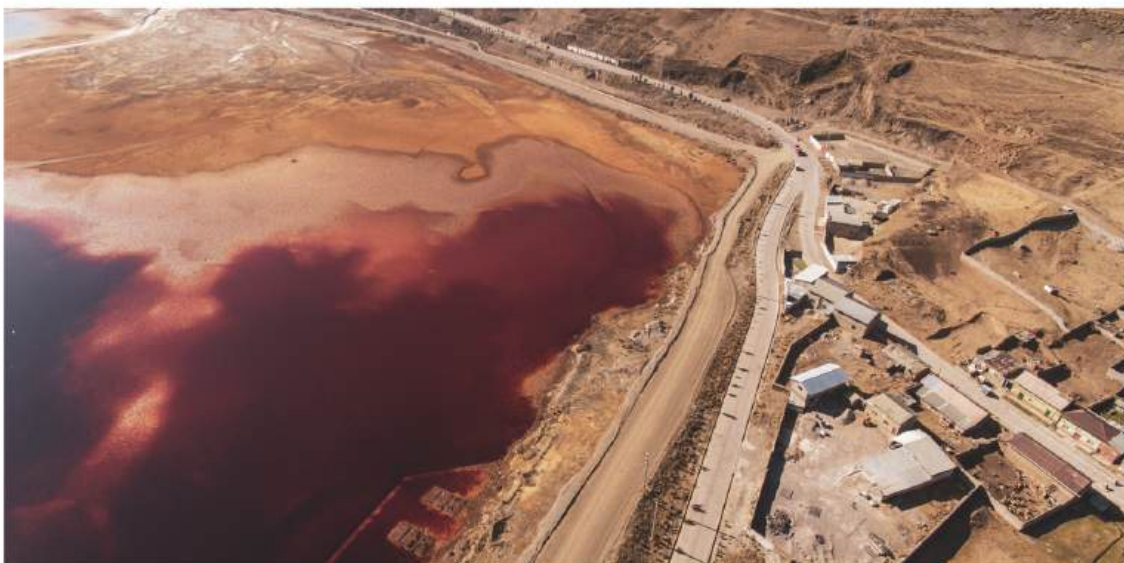
Figure 2. Aerial view of Lake Quiulacocha’s blood-red waters from close to the eponymous community. Photo credit: Stefano Sbrulli for Source International, 2019.

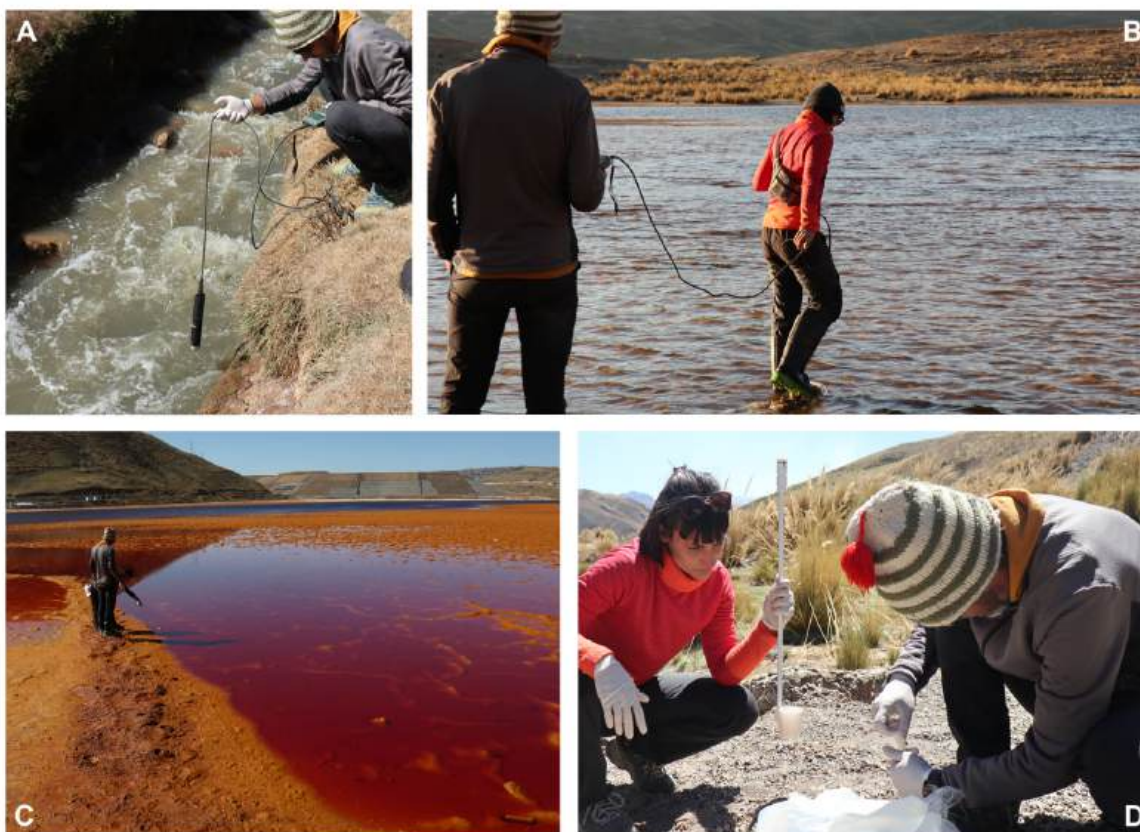
Figure 4. Overview of sampling activities and tools. Panels A and B show the use of the multiparametric probe in the Tingo River and Lake Yanamate. Panels C and D show how we collected surface waters using the Teflon sampler at the Lake Quiulacocha and the Tingo River.

We collected surface waters using a teflon sampler equipped with a 50 cm stick (Figure 4C-D). The sampler was rinsed thoroughly with surface water, then we syringe-filtered (0.45 μm) the water directly into a new 50 mL falcon tube. We added 4 drops of concentrated nitric acid (70%), mixed,
