Kauai is one of the wettest places on Earth - and by 2018, years of heavy rain had taken its toll on The Kauai Village Shopping Center.

Identifying the Problem

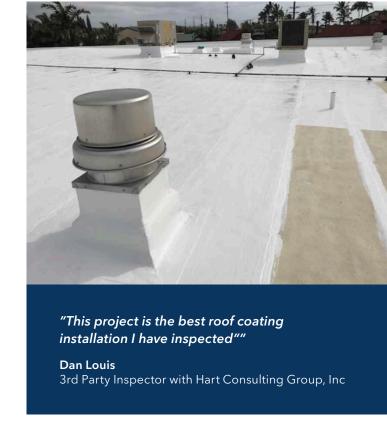
A thorough inspection of the structure revealed a multitude of problems that were all contributing to the water intrusion. The metal coping was severely corroded and the metal flashings were rusty, while improperly sealed laps were allowing water to seep through the roof and walls. Dozens of field repairs to the roof had blistered and were failing, with water trapped below the surface in several areas around the roof. Multiple laps across the roof and on the walls were also compromised.

The Beachside Roofing Hawaii team got to work, starting with the walls. They first removed all of the severely corroded metal coping. Walls were repaired and coated with Enduris high solids Roof Coating to seal them. After this, new metal coping was installed, seated in places and sealed using Enduris Liquid Flashing for maximum protection.

After taking on the walls, they began work addressing the multitude of field blisters. The team used a moisture meter to identify areas of trapped water under the roof - before tearing open the wet areas to assess the damage.

Affected areas were then thoroughly heat dried and sealed water tight using a new modified bitumen granulated cap sheet. The final step was to check every single lap in the roof and the walls before thoroughly resealing every compromised lap prior to applying the Enduris Roof Coating.
