NEW DECK
for MR & MRS BUNGARD
at 3 PEARSE STREET - BRIGHTON

3 Pearse Street Lot 2

This Site Validation Report (SVR) has been prepared to address Conditions 3 through 6 of Land Use Consent LUC-2024-329 for the property located at 3 Pearse Street, Brighton, specifically Proposed Lot 2.

3 Pearce Street, Brighton Site Validation Report

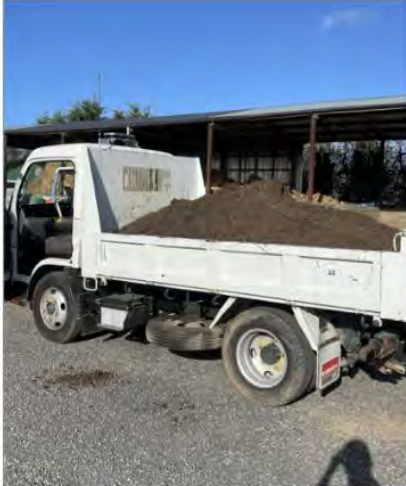
Imported Top Soil from Wals Plant Land, Mosgiel

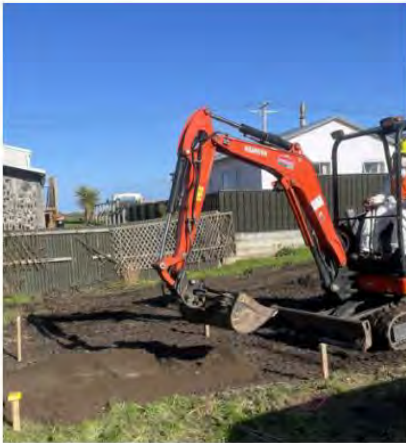
Imported Top Soil being blended with contaminated soil in a 2m square radius around site location 3P5 as per CSMP and RAP

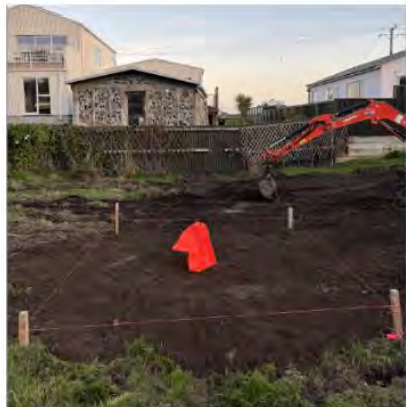
Remediated site location 3P5, Flag indicating remediation sampling location, noted on Hills Laboratory report as 3P5 (B)

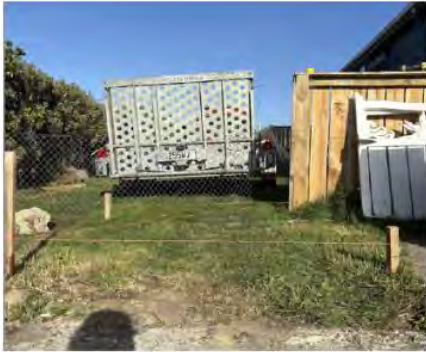
Site Location 3P1 prior to remediation works

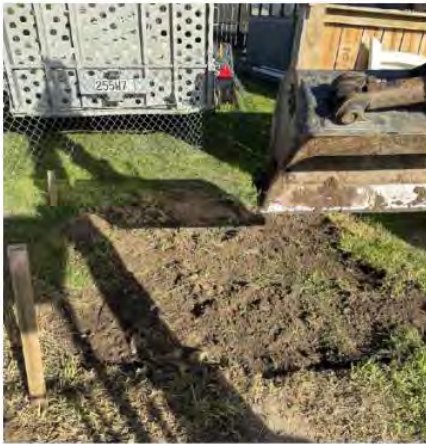
Site location 3P1 with soil being exposed to blend in new clean top soil as per CSMP and RAP

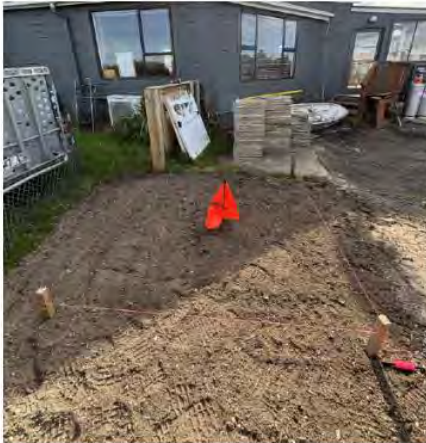
Site location 3P1 after soil remediation works, flag indicating remediation sampling location, noted on the Hills Laboratory results as 3P1 (B)

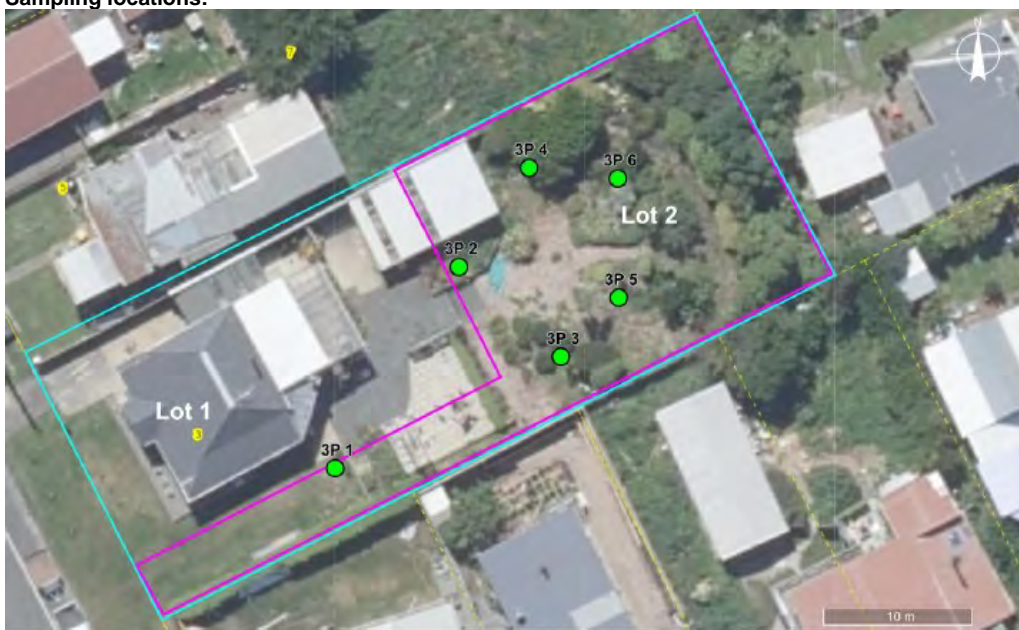
Sampling methodology:	Comments: • Surface samples (0 – 0.15 m depth) were collected from each location.		
	Comments: Not included in this report	<input type="checkbox"/>	<input checked="" type="checkbox"/>
Analyte selection:	<input checked="" type="checkbox"/> Metals <input type="checkbox"/> TPH <input type="checkbox"/> PAH <input type="checkbox"/> BTEX <input type="checkbox"/> OCP's <input type="checkbox"/> ON/OP's <input type="checkbox"/> VOC's <input checked="" type="checkbox"/> Asbestos <input type="checkbox"/> Other:	<input checked="" type="checkbox"/>	<input type="checkbox"/>
	Comments: • All samples were analysed individually for heavy metals, as the primary contaminants of concern associated with the long residential history of the site. • No analysis was conducted for asbestos, as no evidence of asbestos was observed during the site investigation.		
Sample Location Plan from Report	Sampling locations:

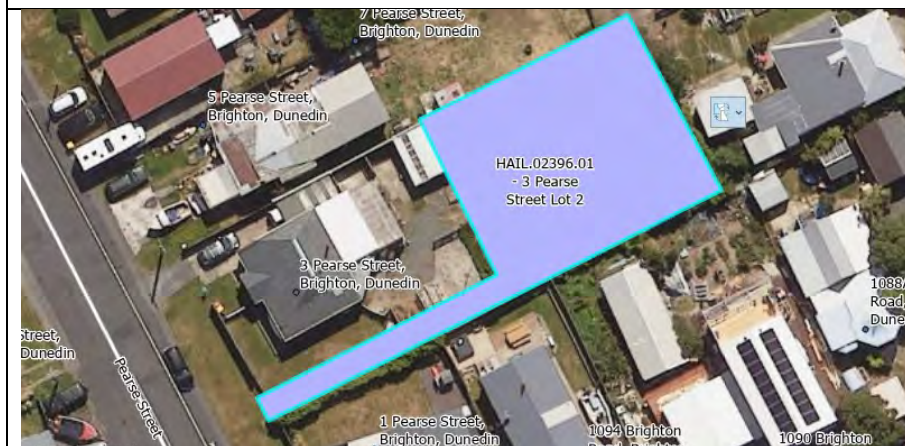
GIS Map Excerpt

Site Number:	HAIL.02396.01
Site Name:	3 Pearse Street Lot 2, Dunedin
HAIL Status:	Verified HAIL
HAIL Category 1:	I: Any other land that has been subject to the intentional or accidental release of a hazardous substance in sufficient quantity that it could be a risk to human health or the environment
Contamination Status Human Health:	Contaminated for Residential Land Use
Mitigation Status:	Not Completed
Contamination Status Environmental Health:	Contaminated
Mitigation Status:	Not Completed
Summary:	Lead concentrations exceed the residential human health guidelines at two out of six locations. These results indicate that portions of the site may present a potential risk to human health. The Remedial Action Plan and Contaminated Site Management Plan notes that the depth of contamination in the site has not been characterised, and all soils should be considered contaminated unless additional sampling and analysis have been performed to confirm otherwise. Additionally, if asbestos is present on the exterior of any buildings, specifically the shed on the proposed Lot 2 portion which is intended to be demolished, additional sampling and analysis for asbestos is required.

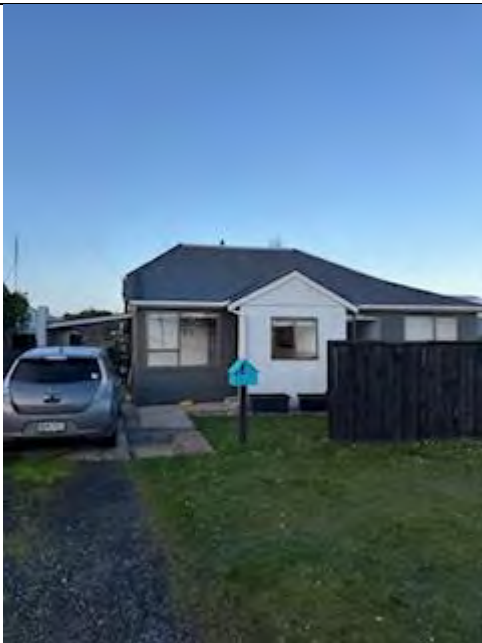
Client Name: Phil Wilson		Client Site Location: 3 Pearce Street, Brighton, Dunedin 9035	
Photo NO: 01	Date: 8 July 2025

Image location: Front of property			
Photo NO: 02	Date: 8 July 2025

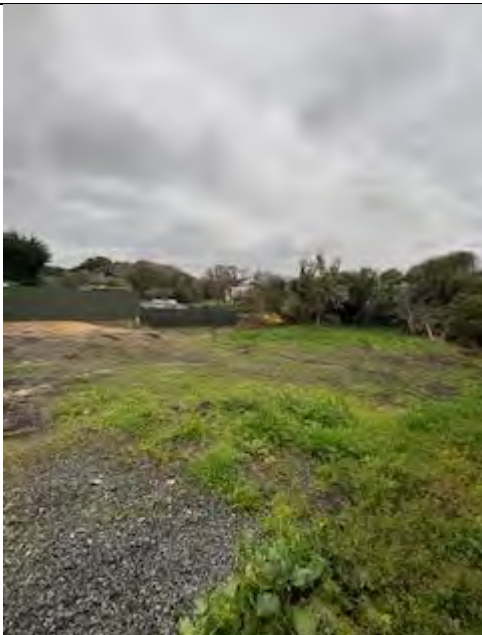
Image location: Sampling area of property

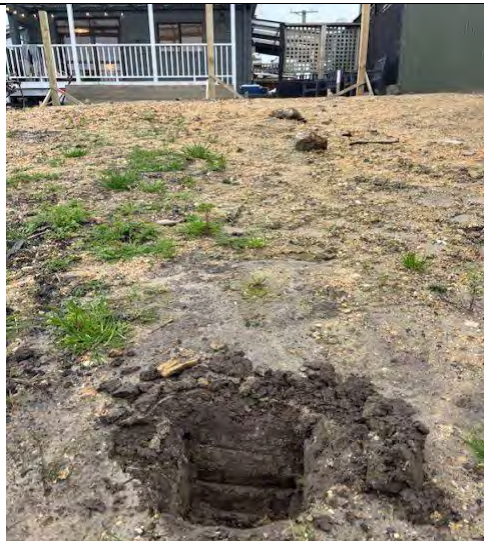
Client Name: Phil Wilson		Client Site Location: 3 Pearse Street, Brighton, Dunedin 9035	
Photo NO: 03	Date: 8 July 2025

Sample Number: 3P1			
Depth: 0-300mm

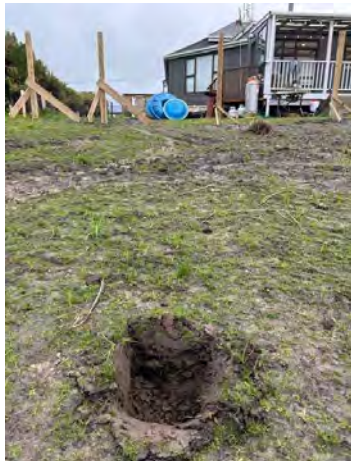
Sample Number: 3P5		
Depth: 0-350mm

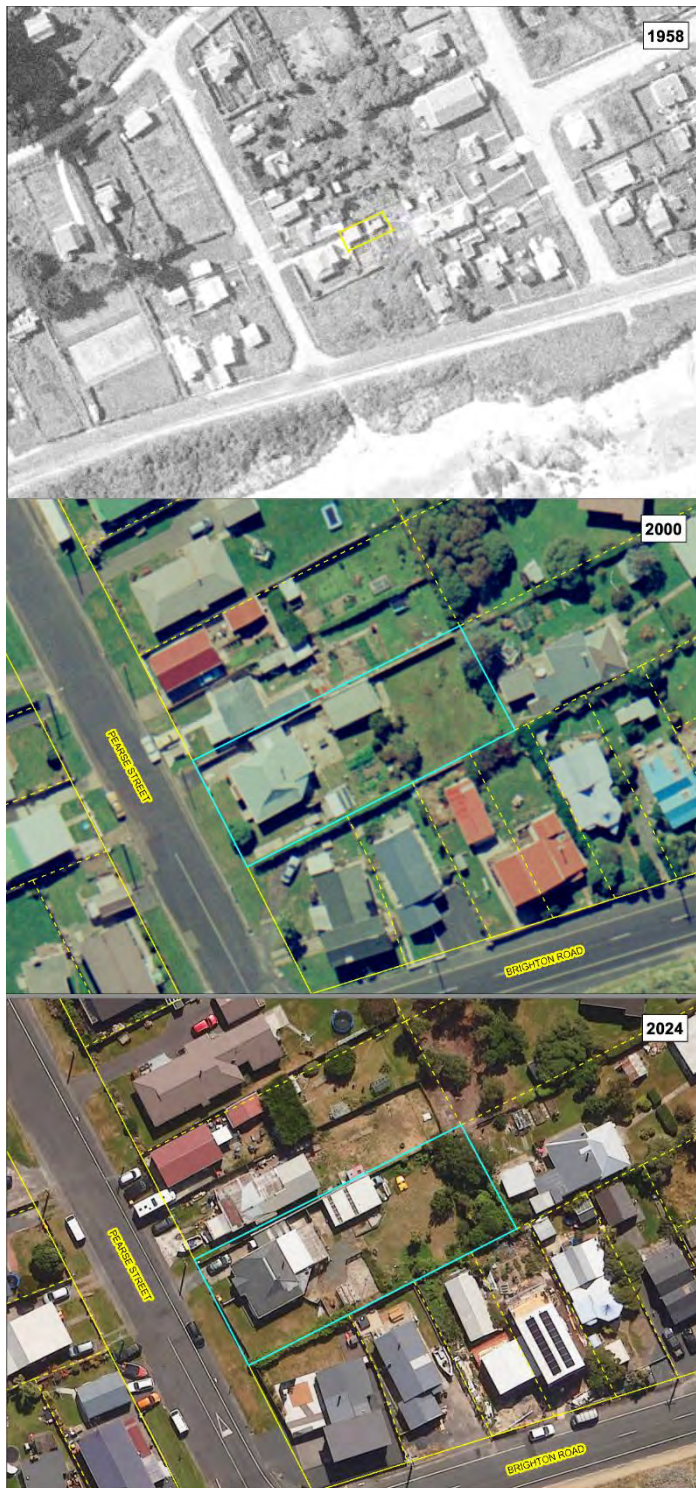
Historical aerial imagery obtained from the DCC HAIL Report (HAIL-2024-95) indicates the presence of the shed structure, which is highlighted in yellow in the 1958 photograph.

Historical aerial imagery dating from 1958 to 2024 (Appendix 4) confirms the property has remained largely undeveloped aside from the shed structure. The area has been vegetated with typical garden plantings and minor charcoal like fragments observed in initial soil samples suggest historic domestic burning, *but* no significant HAIL activities. This is consistent with typical residential land use.

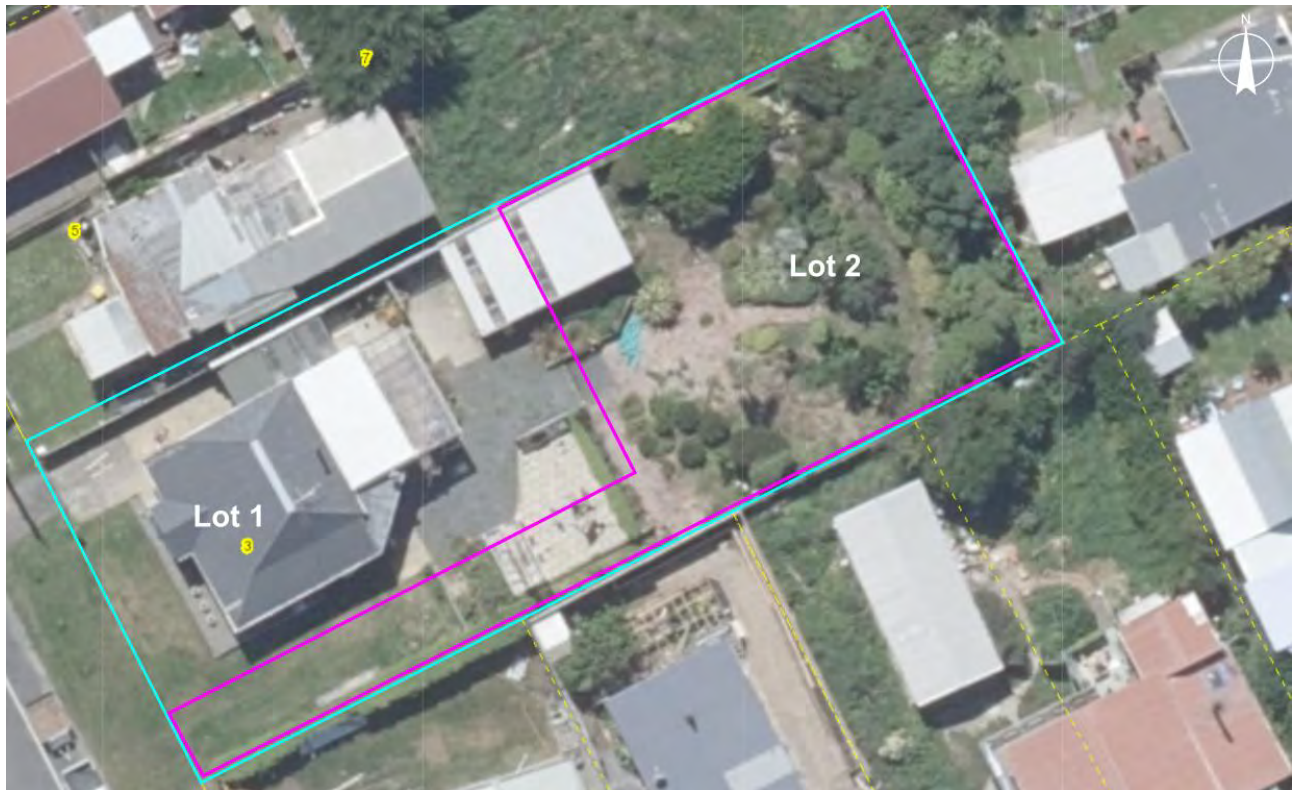
Figure 1: The property at 3 Pearse Street outlined in turquoise, with the site extent (Proposed Lot 2) outlined in magenta (DCC GIS, 2023-2024. Copyright DCC/ORC, CC BY 4.0).

The relevant property details are provided in Table 1. For the purposes of this report, the site is defined as the area of proposed Lot 2, approximately 560 m² of the total 0.1012 ha property, as outlined in magenta in Figure 1.

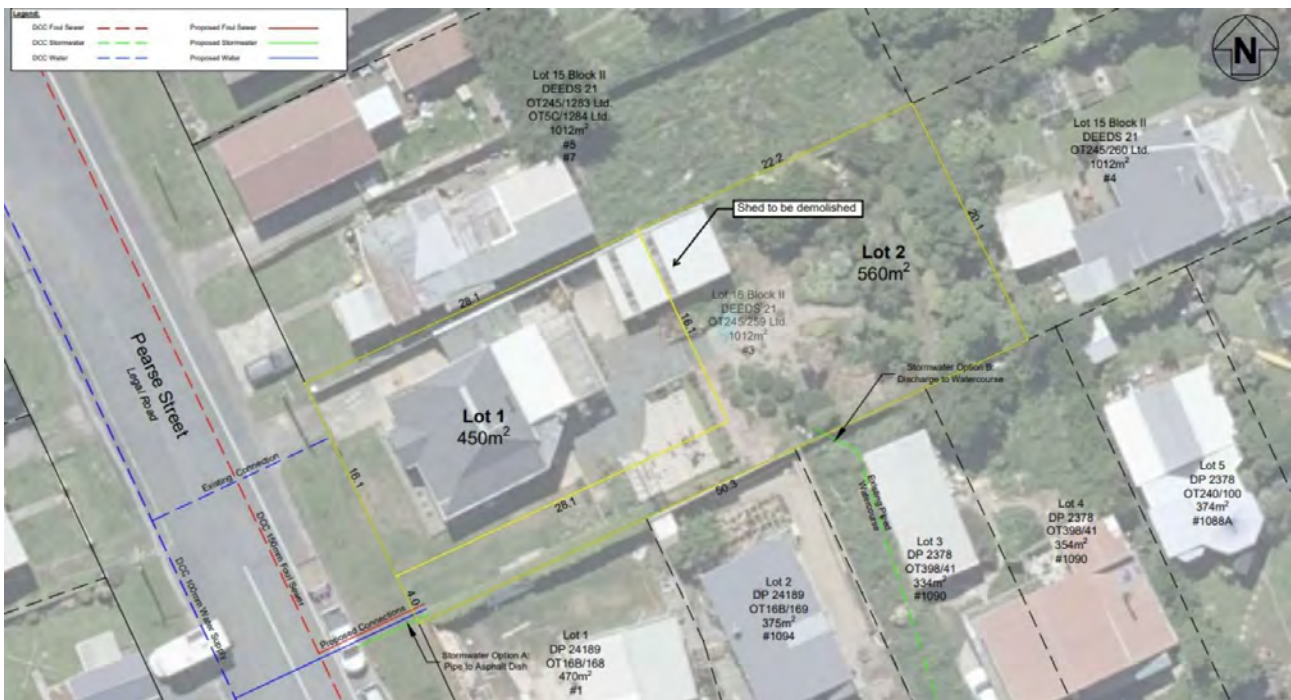
Figure 2: The proposed subdivision of 3 Pearse Street (dated 26 June 2024, TL Survey Services Limited).

The property at 3 Pearse Street is proposed to be subdivided into two lots, with the existing dwelling remaining on proposed Lot 1 (450 m²), the existing shed demolished and a new dwelling constructed on proposed Lot 2 (560 m²), as shown in Figure 2. No detailed plans for the proposed residential development on Lot 2 have been provided. However, it has been advised that the new dwelling is proposed to be of dimensions approximately 13 m by 6 m, constructed on the western half of Lot 2. The dwelling is proposed to have a pile foundation, requiring minimal disturbance of the existing site soils.
