# Ting Signaltape® Case Study

## Third Party Excavation Damage

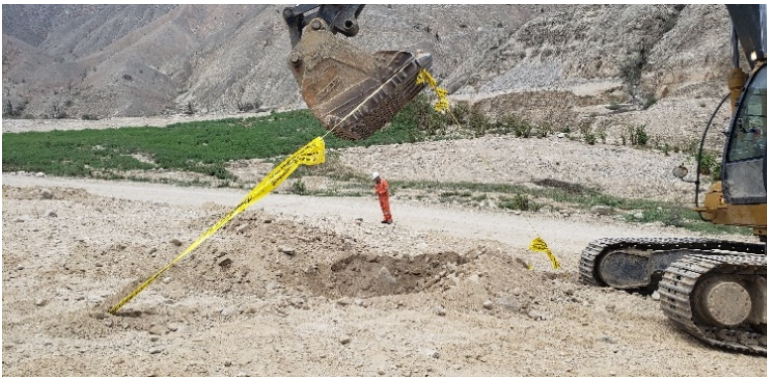
Signaltape was specifically engineered to address these two gaps in damage prevention. By pulling out of the ground when encountered by excavation equipment, it directly alerts the operator, and does not require additional proactivity or compliance to do so. It consists of a 3,000lb tensile strength aramid fiber core material laminated between two pieces of film. This core material is woven in a sine wave within the tape to not only provide protection at any angle of approach, but also to create high strength slack needed to pull the tape to the surface. This performance is unique for marker tapes which historically sheer underground and get lost in the slag pile.

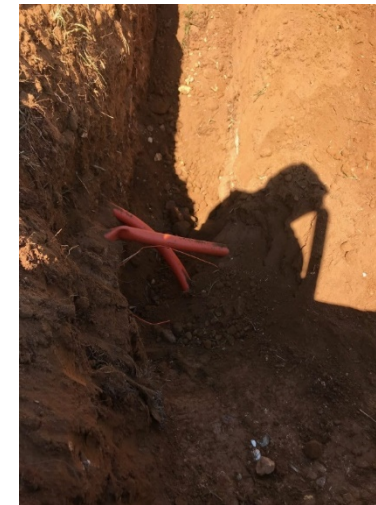
Figure 2: No Signaltape installed above Ting Conduit

One year after installation, the New Belvedere subdivision had a total of two strikes where the signaltape was NOT installed. In both cases, the conduit was damaged near turn up points in a handhole. There were two additional cases where the signaltape pulled up to the surface, warned the operator, and successfully protected the utility. The Fiber Construction Manager discovered that signaltape had prevented these two strikes when he arrived on site and found the ground disturbed and the tape on the surface.

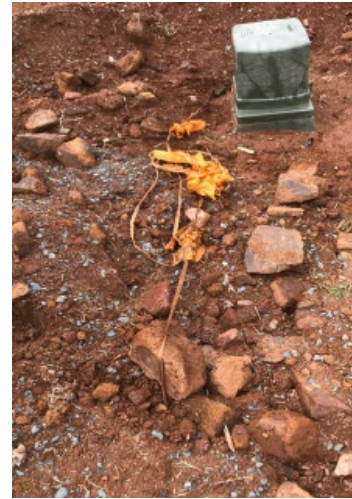
Figure 3: Signaltape Prevented Damage #1

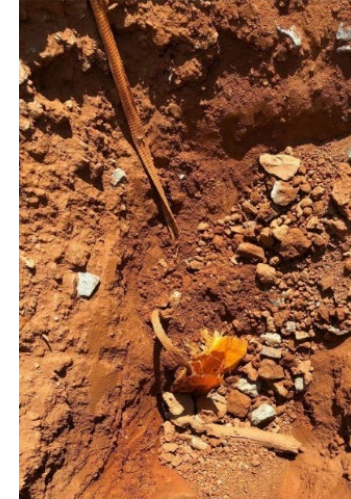
Figure 4: Signaltape Prevented Damage #2
