## CASE STUDY

# Remedying Mismatch and Shading with Tigo's Monitoring & Optimization Functionalities

Connected in March 2011, the Jessolar PV plant is an integrated PV system that is compliant with the second edition of the Italian Feed-In Tariff ("Secondo Conto Energia"). It consists of 8,610 solar modules with a total power of 1,980kWp.

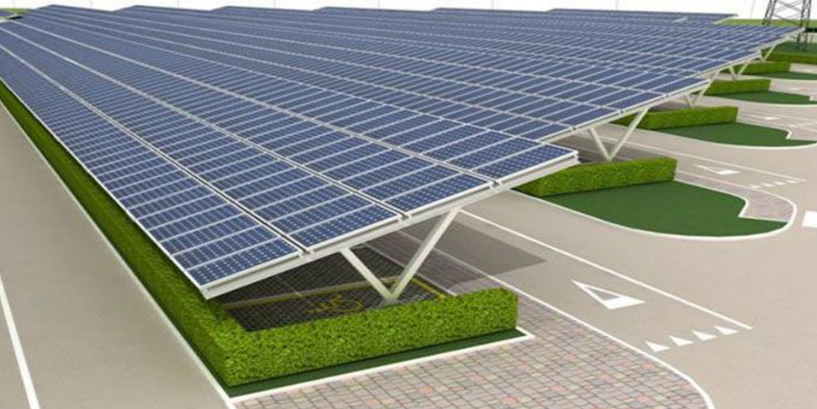
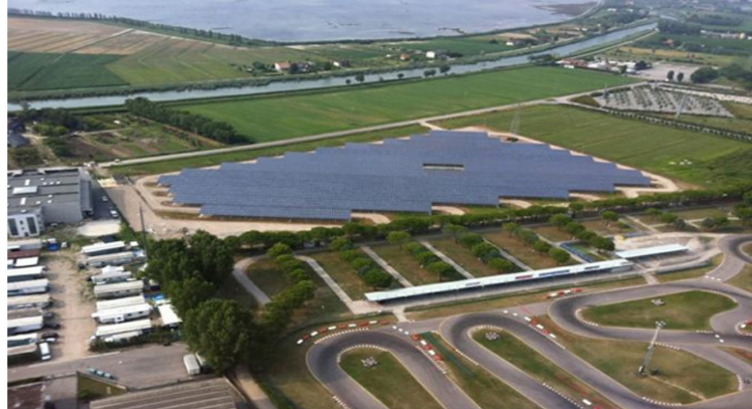
## Optimization Impact Over Time

Comparing PV production data between H1-2016 and H1-2017, there is a clear 14.2% performance improvement. This result improved even more after the scheduled substitution of the 210 damaged solar modules (the optimization feature helped contain the issue at the time).
