CASE STUDY

Outshining the Shade with Tigo TS4: Mitigating Mismatch, Maximizing Yield

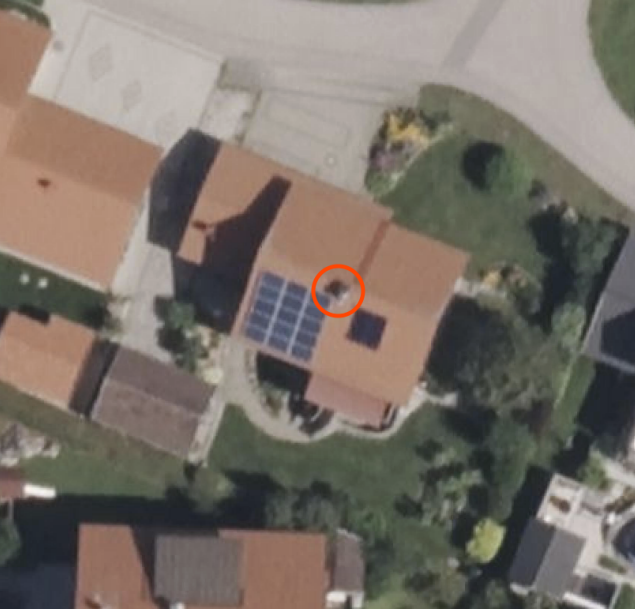
LEFT: Aerial view of the installation site. The 15 PV modules installed in landscape orientation are clearly visible in the center of the image. Inside the red circle, the chimney that casts its shadow on 4 modules during the morning hours.

The system is composed of 15 Canadian Solar modules rated at 265Wp each, installed on the south-facing slope of the roof. Given the favourable orientation and the presence of only one MPPT in the original inverter, this system was configured as a single string. A chimney cast a pronounced shadow over 4 of the 15 modules during the morning hours, noticeably impacting energy production.
