Spokane Conservation District

LTPBR for Lazy A Farms (Little Hangman Creek Tributaries) Planning and Design

Randy Baker and Eric Allen

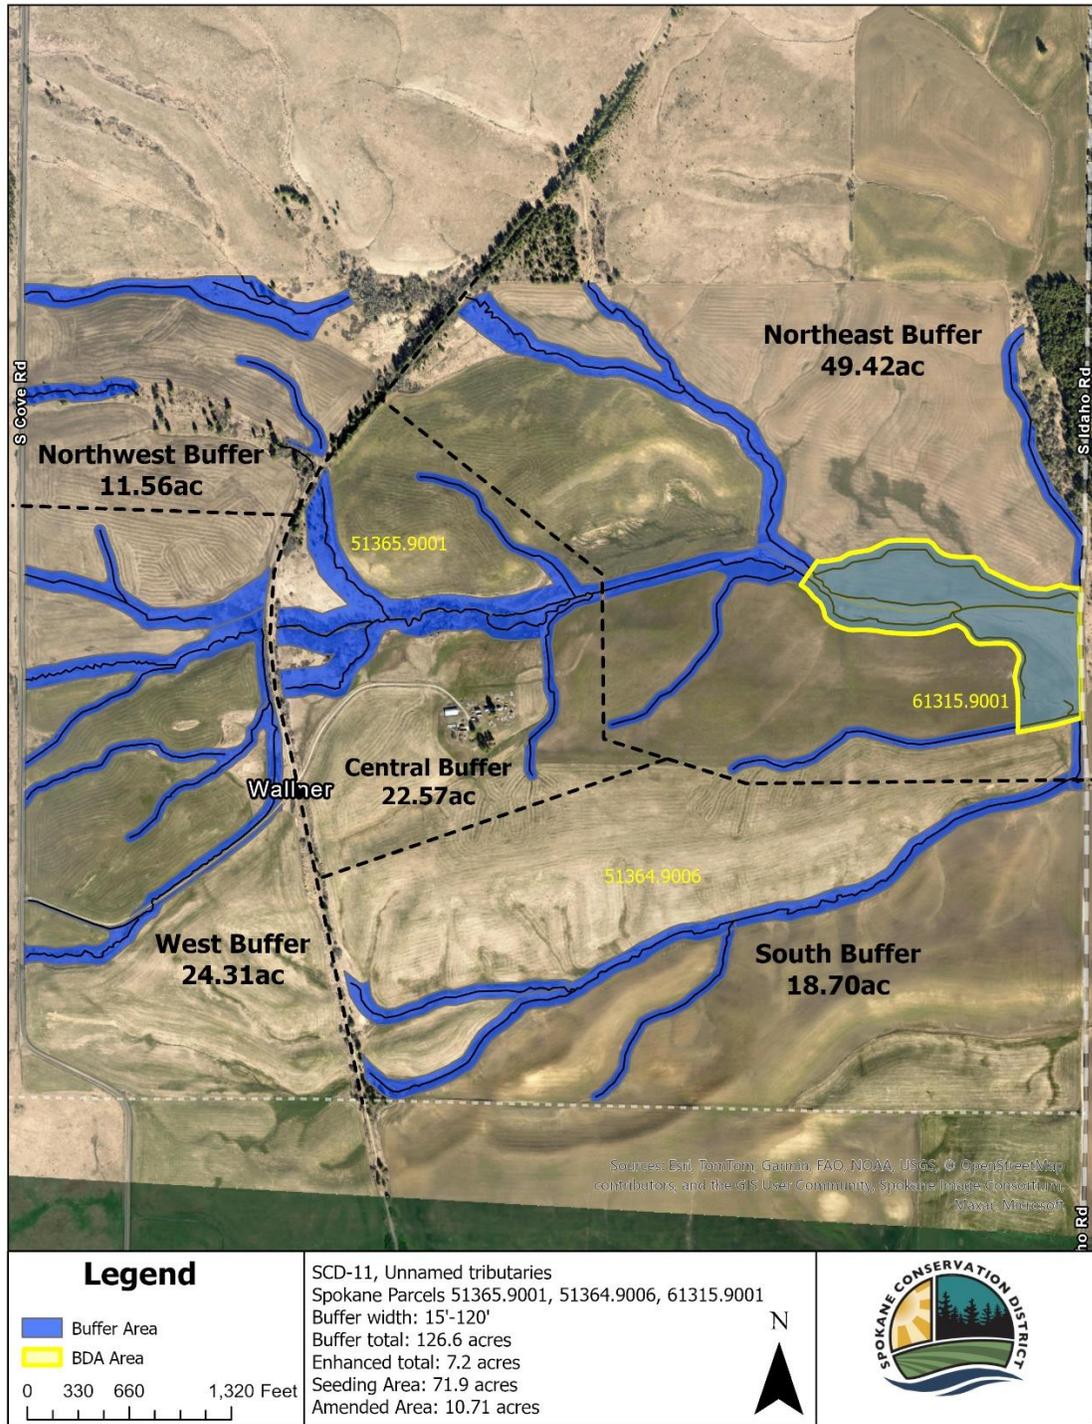
Figure 1. Project Location. Unnamed tributaries flow in a generally eastward direction through the site.

This project is located within the headwaters of Little Hangman Creek the eastern side of Tekoa Mountain in southeastern Spokane County. All of the land is owned by Lazy A Farm and included in the riparian planting project implemented by the Spokane Conservation District. The primary purpose of this project is to increase groundwater availability for the riparian plantings and capture suspended sediment as a means of reducing turbidity.

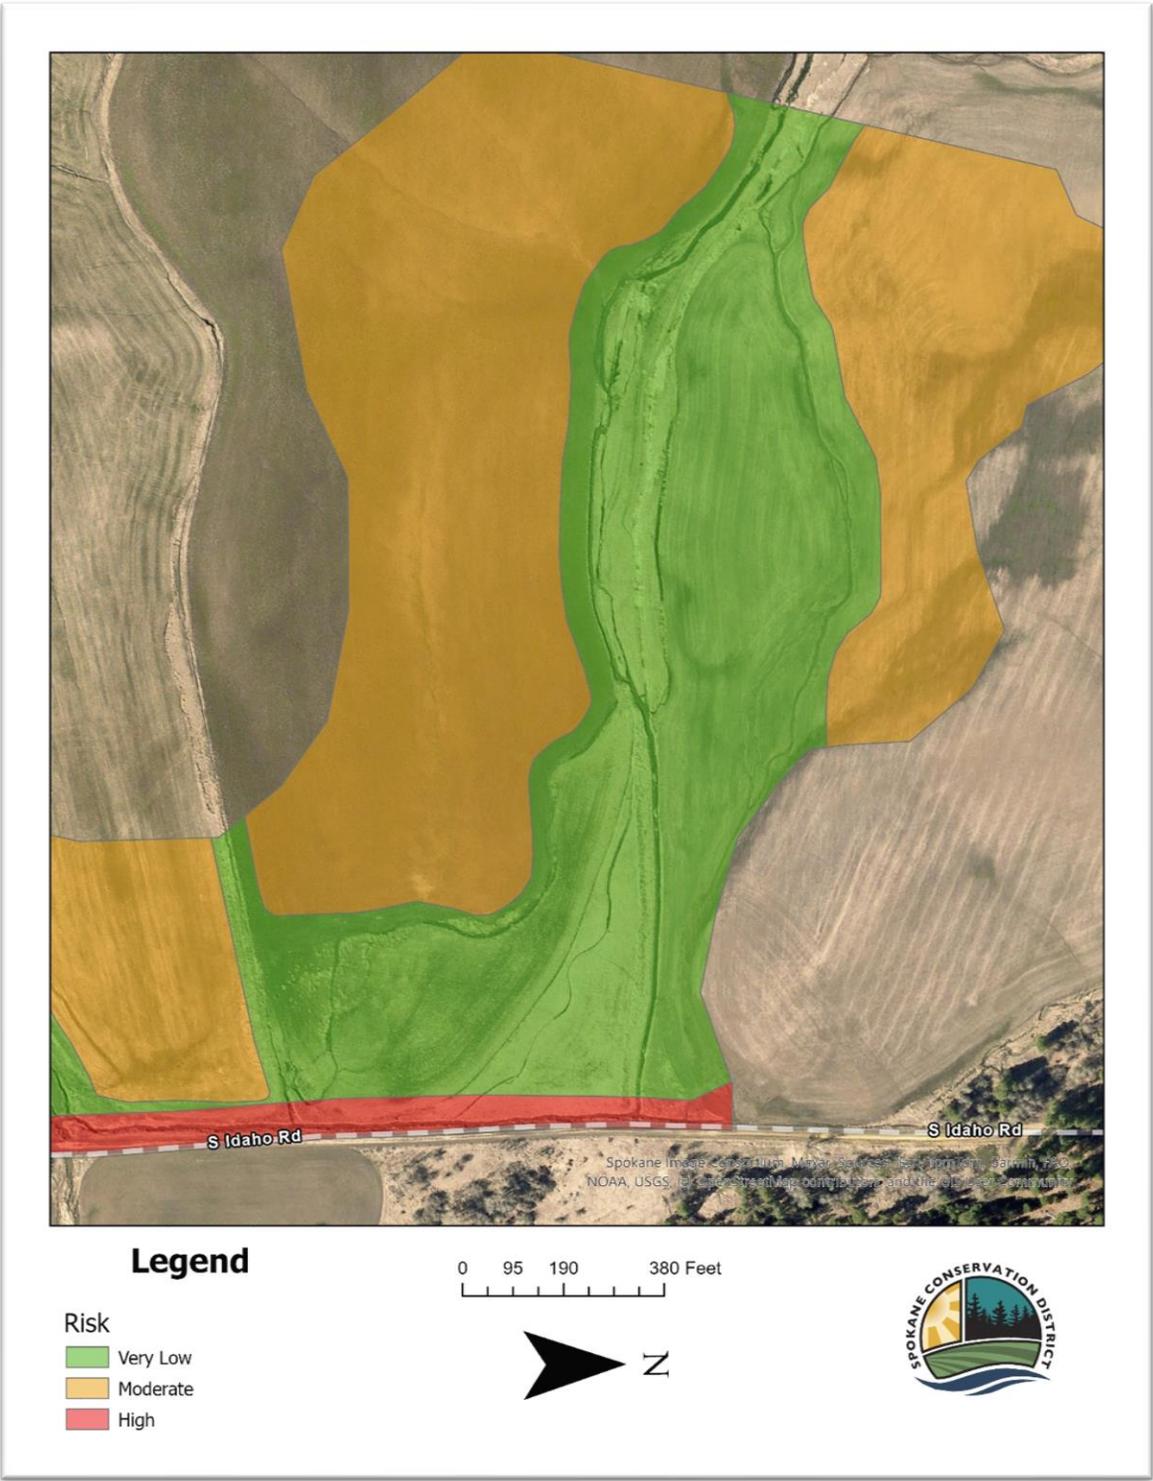
Figure 2. Risk Assessment Map. A Valley Bottom Estimation Tool was used to assess the potential stream valley and likelihood the stream would pose a risk to infrastructure or crops. Isolated to lower risk area to be targeted with treatment.

Risks within the project site were evaluated based on infrastructure and agricultural land (Figure 2). The agricultural land use requires consideration of the potential for crop loss due to channel migration into productive lands. This loss of crop is a financial loss to the producer and landowner as well as loss of trust. BDA's are not known to be implemented in Hangman Creek and a new project such as this could quickly develop a poor reputation both for the SCD and the LTPBR.

With these considerations, risk is described in three general categories: low, moderate, and high described below and identified in Figure 2.

Low. These areas are far from infrastructure and have at least one or more confining features that prevent channel migration.

Moderate. These areas are where the buffer, the limit of allowable channel migration, are less than the modeled valley width or where there are few confining features. Although channel migration would restore geomorphic function to the system, the potential for such migration to induce crop loss is considered a risk here.

High. These areas are either near infrastructure, such as the house at the north of the site, or there is significant likelihood of the channel migrating out of the buffer into fields, such as the middle of the site.

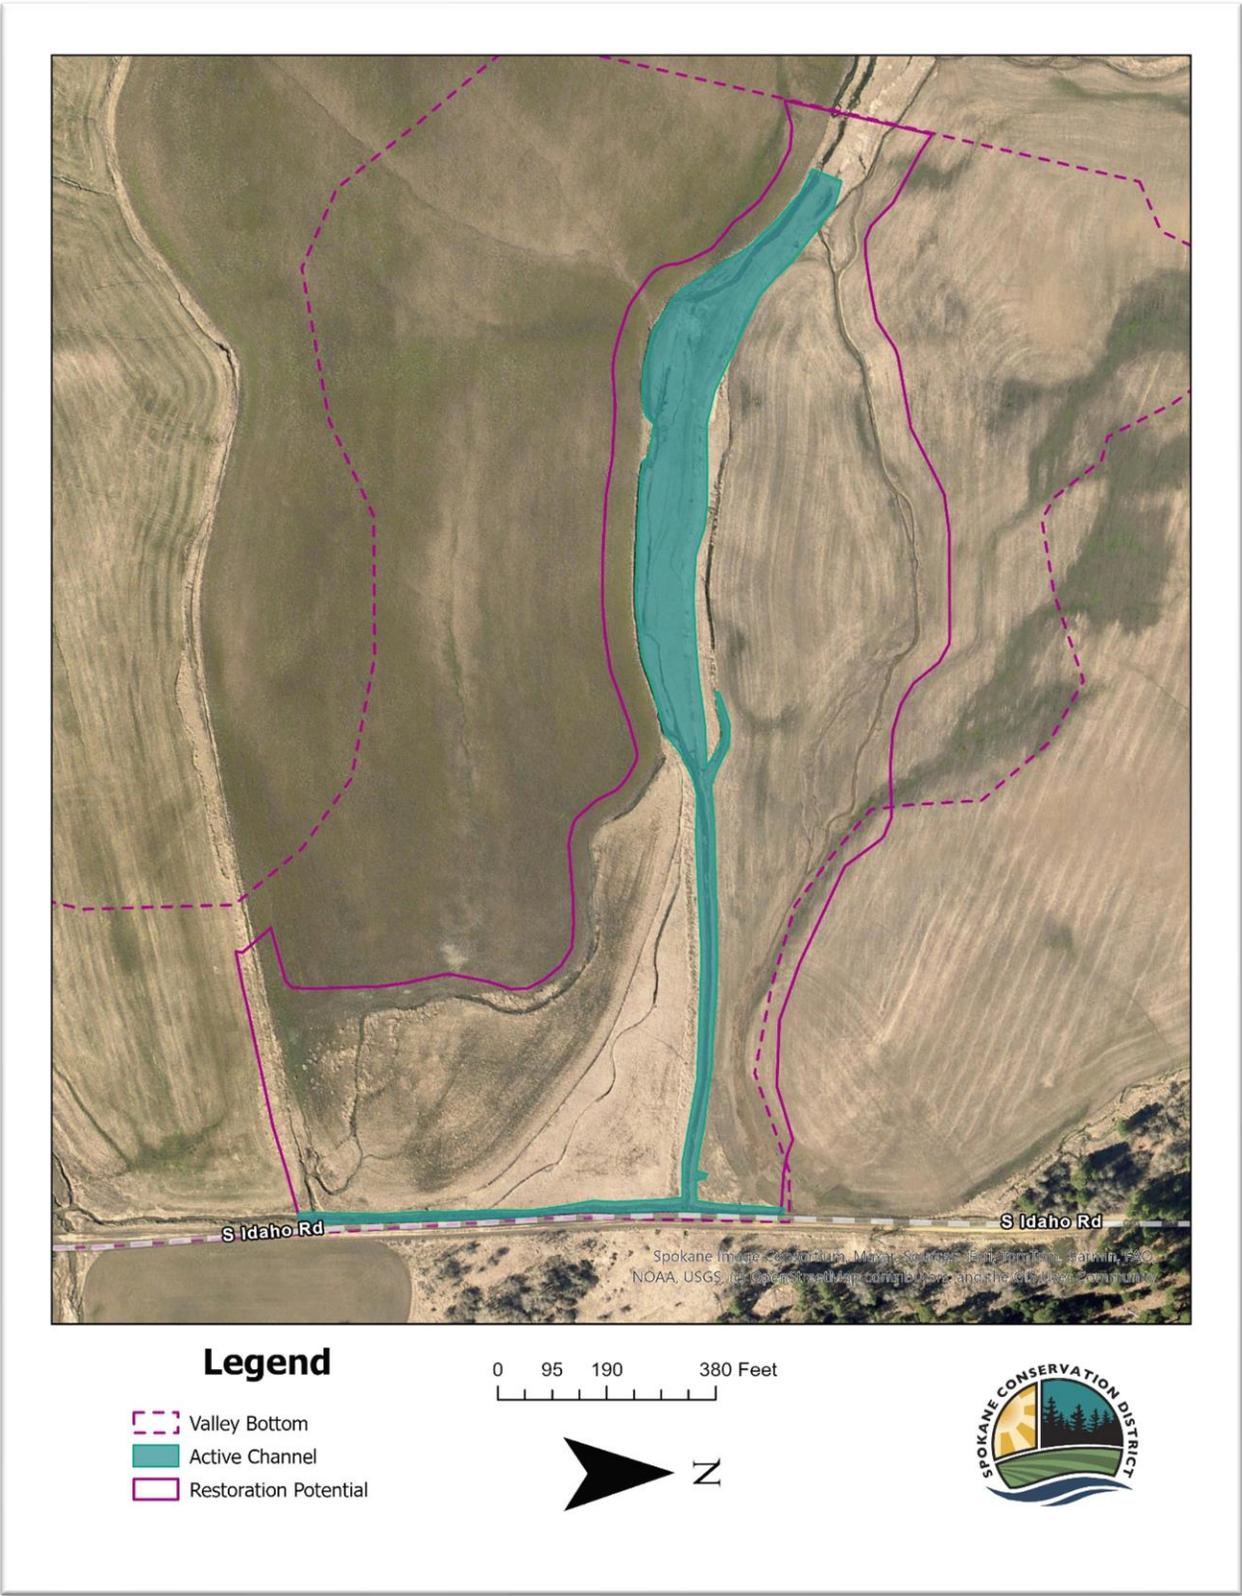
Figure 3. Mapped active channel, modeled valley bottom, and the restoration potential.

The current channel condition is an incised, channelized stream representative of Cluer and Thornes Stage 2 or Stage 3. The channel is actively maintained as such to maximize agricultural land, and the active channel comprises approximately 6% of the modeled valley bottom (Figure 3). Unless land management practices change, the channel will remain as such.

<u>Feature</u>	<u>Area, ft²</u>	<u>% of Valley Bottom</u>
Active Channel	144,371	6%
Geomorphic Potential	1,071,022	45%
Valley Bottom	2,359,909	100%

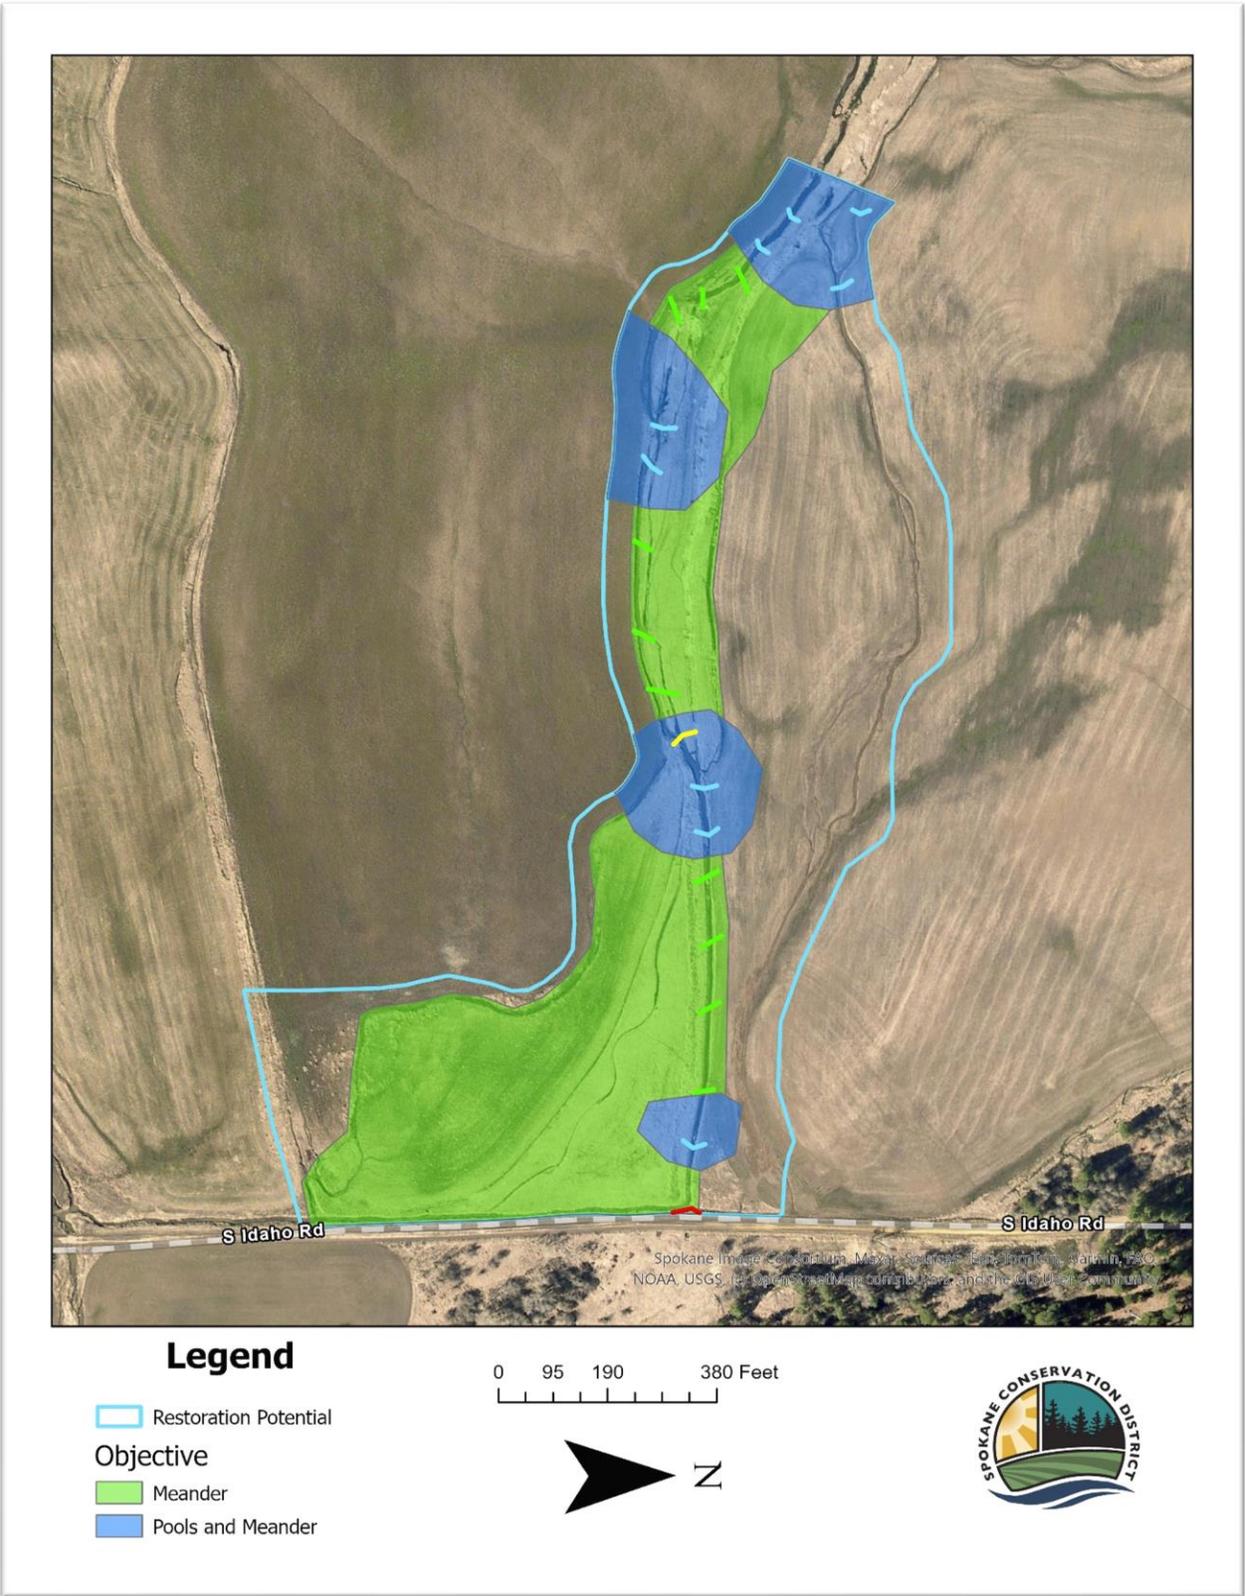
Figure 4. Site map colored by the goals.

Considering the opportunities for restoration in light of risks and landowner goals, one reach for restoration was identified. The lowermost portion of the largest stream body within the site was chosen for LTPBR practices. This reach was inferred to have a low risk and greater opportunity for geomorphic activity. Within this reach, structures will be installed to target expansion of the active channel in directions with the lowest risk of impacting nearby cropland.

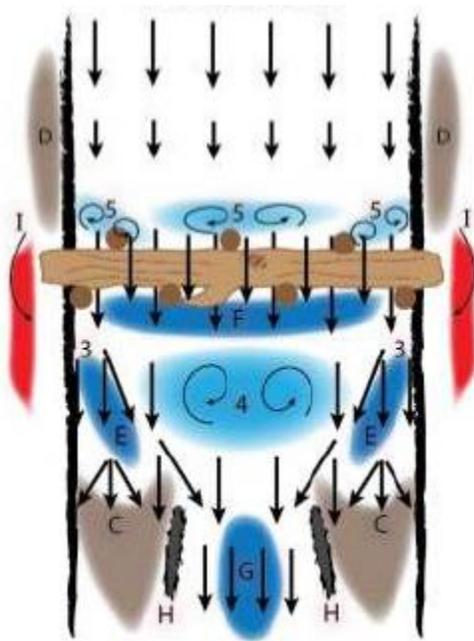
Figure 5. Hypothesized hydraulic and geomorphic responses associated with channel-spanning structures from Figure 3.5 from Camp (2015a).

These structures are used to create deep, slow water, increase frequency and magnitude of overbank flow, increase hyporheic flows, produce channel aggradation upstream, bar formation, bank erosion (if breached on ends), and sort sediment. The key goals for these structures at this site are to form deep pools that collect sediment and aggrade and increase hyporheic flows.

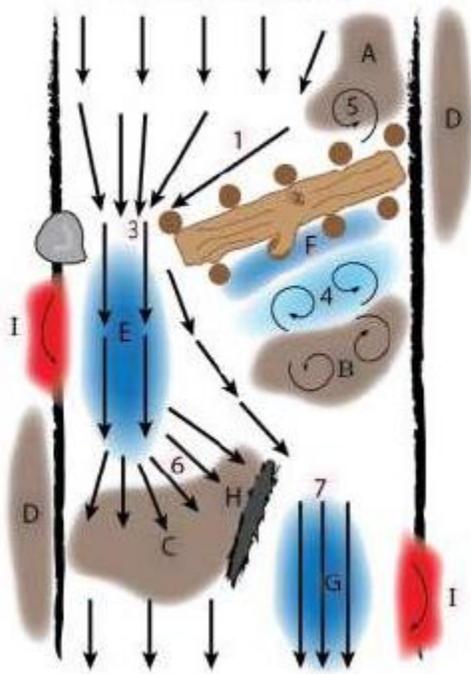
Figure 6. Hypothesized hydraulic and geomorphic responses associated with angled, channel-spanning or bank-attached structures from Figure 3.5 from Camp (2015a).

These structures are used to force convergent and overbank flow, create eddies behind the structure, induce bank erosion, form scour pools and bars, sort sediment, and create channel avulsion. The key goals for these structures at this site is forcing convergent and overbank flows to reconnect floodplains.

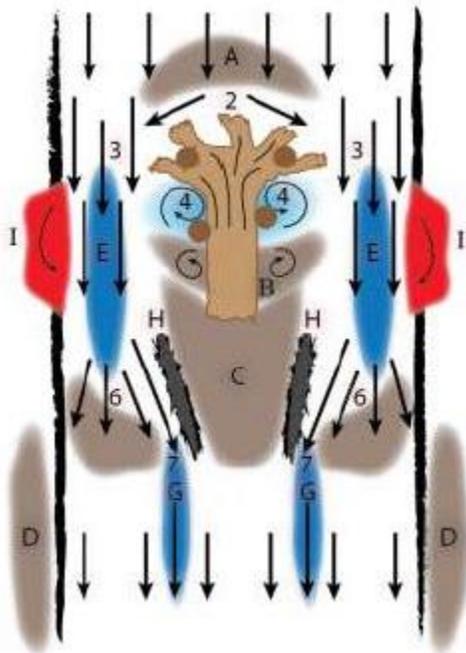
Figure 7. Hypothesized hydraulic and geomorphic responses associated with splitting, channel-spanning or mid-channel structures from Figure 3.5 from Camp (2015a).

These structures are used to force overbank flow and flow separation, create eddy in lee of the structure, induce bank erosion, form scour pools and bars, sort sediment, and create channel avulsion. The key goals for these structures at this site is to force overbank flow separation to reconnect floodplains.

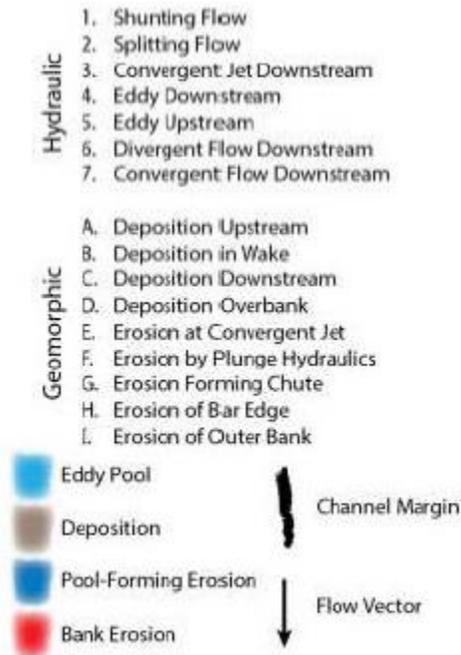
Structure Types Legend

Figure 8. Legend for Figures 5-7. Hypothesized hydraulic and geomorphic responses associated with instream wood structures from Figure 3.5 from Camp (2015a).

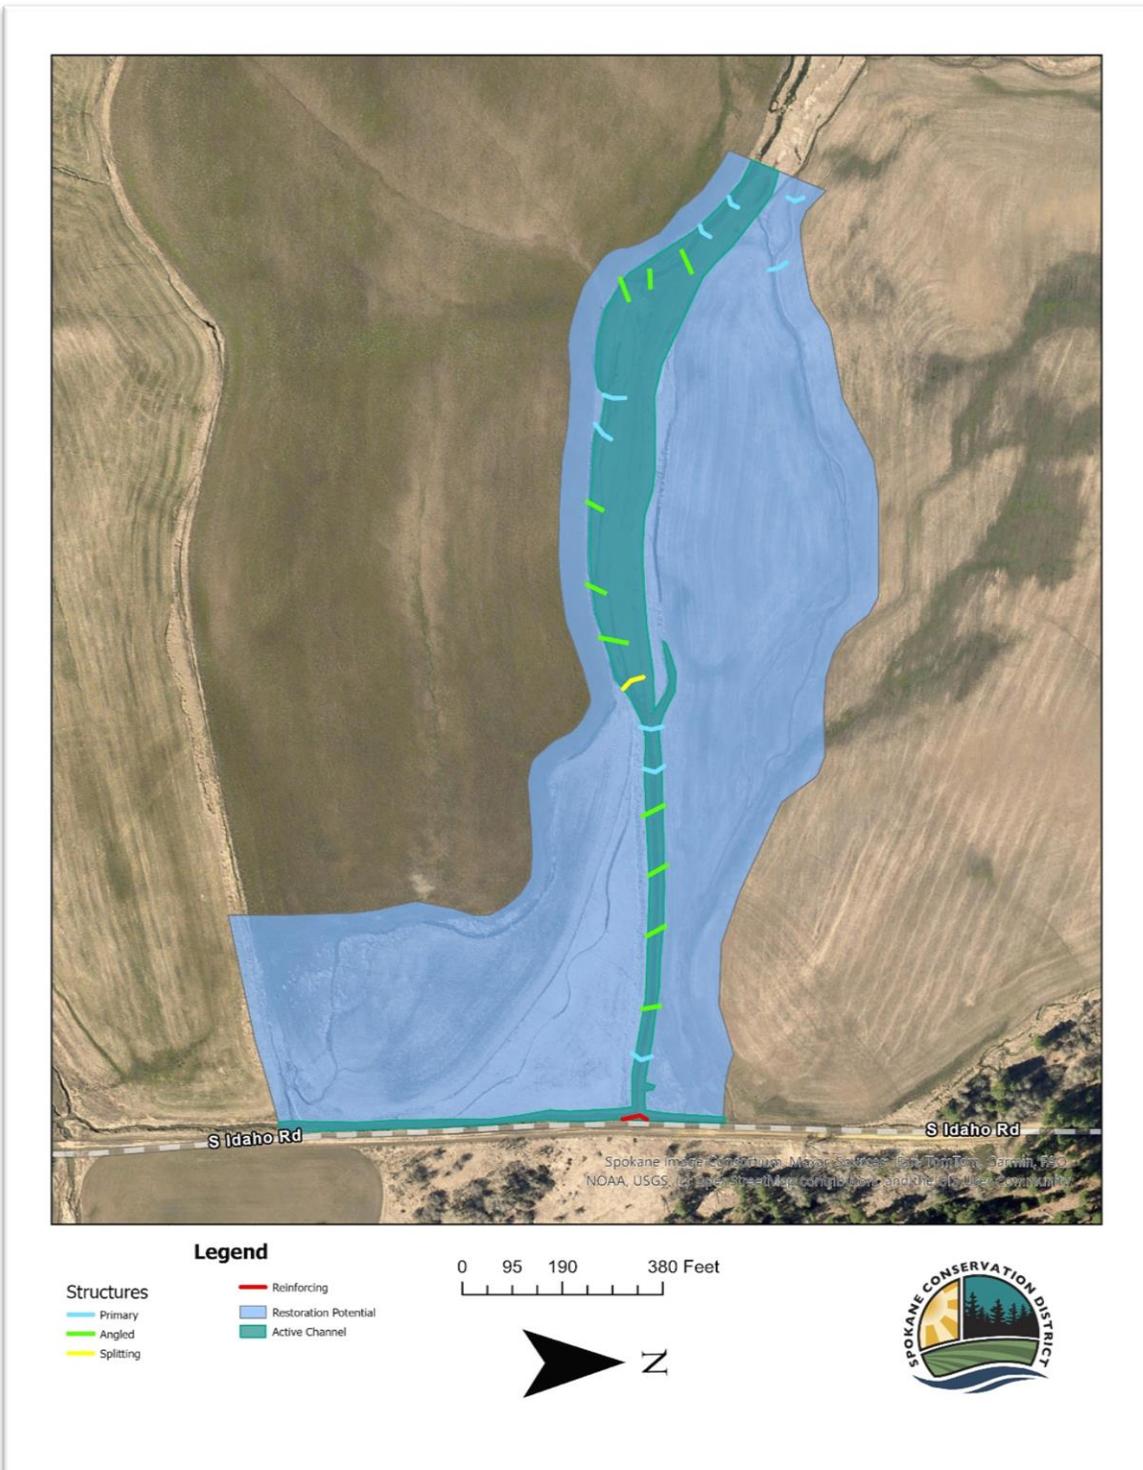
Figure 9. Locations of BDA and PAL structures, color-identified by structure type.
