BURIED GAS RISER PIPE INSPECTION USING MEDIUM AND LONG-RANGE GUIDED WAVES

3.1. Results 24NB Gas Riser No.1

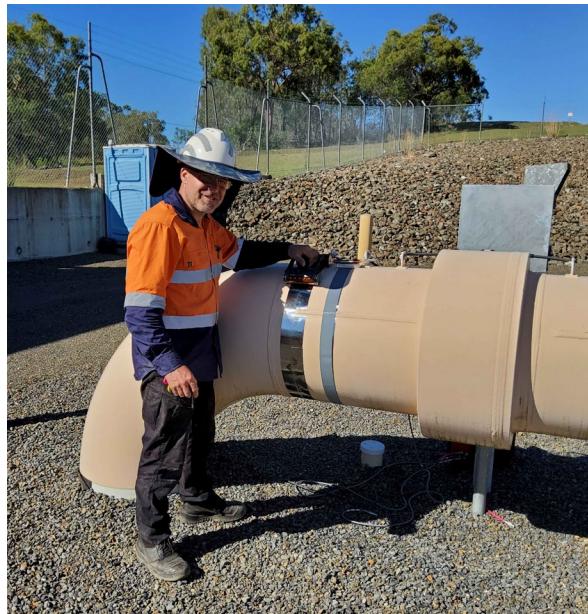
External corrosion primarily occurs at the soil-to-air interface and within buried sections where moisture and oxygen are most prevalent. Environmental exposure leads to localized oxidation beneath protective wraps and in inaccessible buried areas, resulting in wall thinning that can lead to catastrophic failure. Consequently, a reliable, non-invasive inspection method is required to manage these risks.

Figure 1. Soil-to-Air Gas Riser Interface

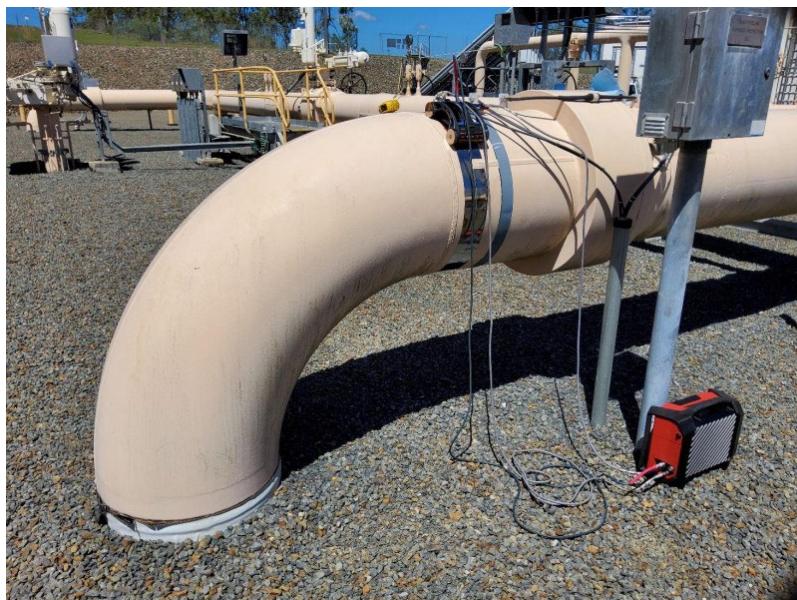
An LRUT Focus Scan was performed on the 24-inch NB gas riser at a frequency of 64 kHz. The datum was established at the edge of the insulated joint closest to the elbow, with the test location situated 525 mm from the datum.

Figure 2. 24NB Gas Riser No.1

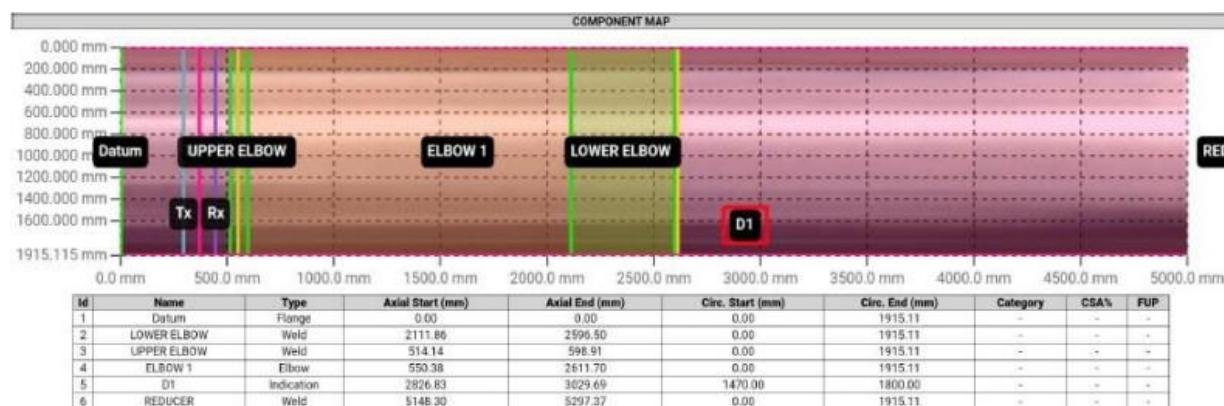
One area of moderate corrosion was identified below ground, yielding a 61% amplitude return. The indications immediately following the upper elbow weld are likely not significant defects; rather, they are attributed to the high gain required to overcome attenuation from the 25.8 mm wall thickness and the bituminous wrap. The actual defect indication was located below the ground line, 2800–3000 mm from the datum, and 1400–1800 mm circumferentially.

Figure 3. Gas Riser No.1 Component Map and Results

Based on this estimation, 'Defect 1' below the elbow is classified as having a moderate level of damage, representing at least a 10% loss of cross-sectional area (CSA), and warrants further investigation. The reducer at the main manifold was clearly visible at 5.2 m, confirming a successful inspection of the entire pipe segment from the datum to the reducer.

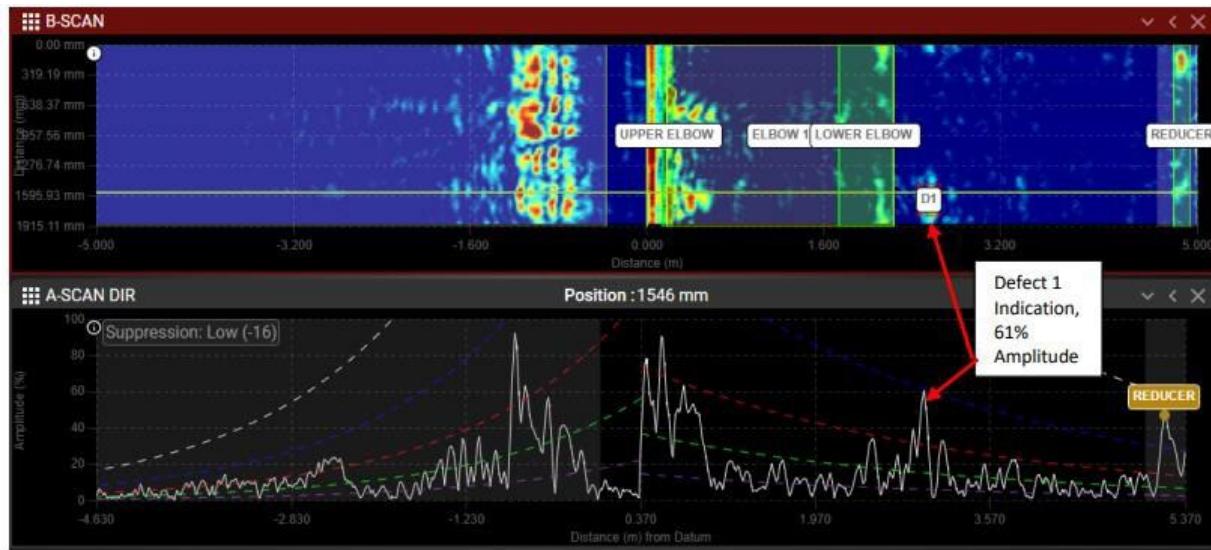
Figure 4. 24NB Gas Riser No.1 A and B Scan LRUT Focus

Note that the sound energy decays rapidly as it propagates along the pipe, particularly upon entering the wrapped section. The amplitude of any reflections must be compensated for based on distance. Typically, known reflectors are used to generate a Distance Amplitude Correction (DAC) curve to illustrate the rate of attenuation. This DAC curve is represented by the blue line in the A-scans.

The vertical position of this curve along the X-axis is calibrated based on the amplitude of the weld reflections. The white line represents 100% screen height, while the red and green lines denote 6-decibel (dB) intervals used to classify indications as minor, moderate, or severe relative to the weld returns.

Typically, two or more spool welds are used as reference reflectors to calculate the DAC curve. In this instance, the first weld is located in close proximity to the initial pulse. The second weld is clearly visible, though it appears as a broadened signal (spanning from 2.2 m to 2.5 m) due to the differing path lengths around the 90-degree elbow.

The third visible weld reflection at 5.2 m could not be utilized for the DAC calculation; its signal strength was significantly higher than the lower elbow weld, suggesting that the T-intersection at the reducer acts as a major reflector—far exceeding the profile of a standard spool weld. Consequently, a precise DAC could not be calculated, and an estimated DAC was employed instead.

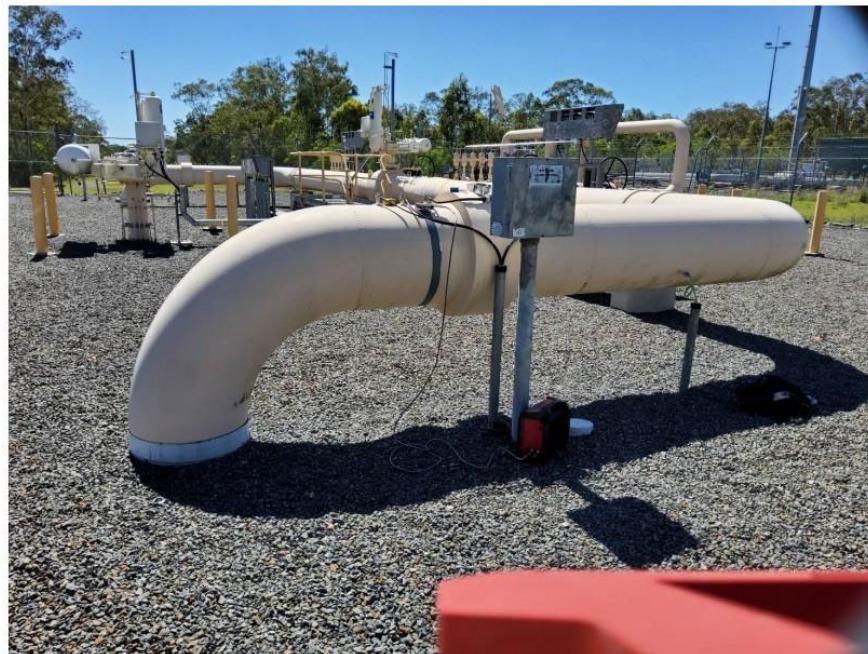
An LRUT Focus Scan was performed on the 24-inch NB Gas Riser No. 2 at a frequency of 64 kHz. The datum was established at the edge of the insulated joint closest to the elbow, with the test location situated 215 mm from the datum.

Figure 5. 24NB Gas Riser No.2

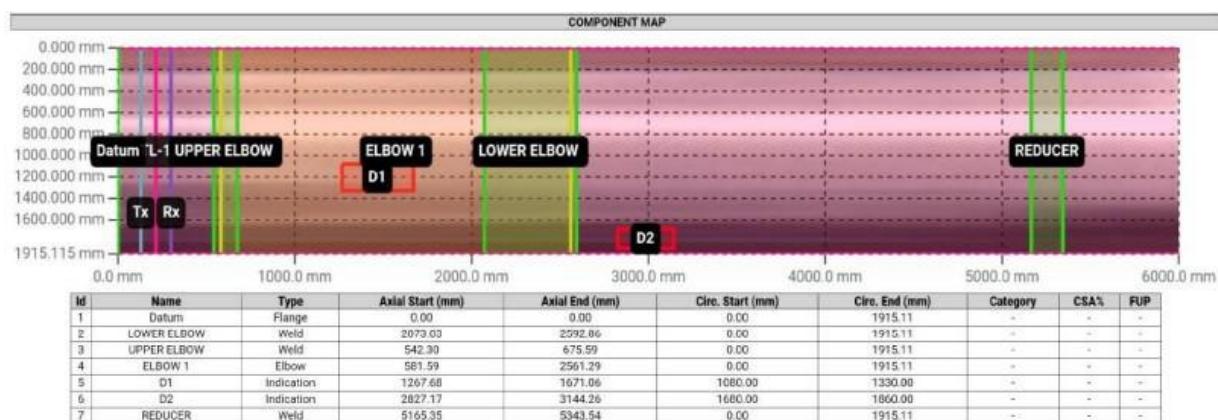
Figure 6. 24NB Gas Riser No. 2 Component Map and Results

Two minor-to-moderate defects were detected using LRUT FOCUS. Defect 1, located within the elbow, produced an A-scan reflection amplitude of 55% screen height. Defect 2, situated below the ground line, yielded an amplitude of 53%. It should be noted that sound energy attenuates rapidly as it propagates along the pipe, particularly upon entering the wrapped section.

Based on the estimated DAC, Defect 1 (located within the elbow) is considered minor. However, Defect 2—situated just below the ground line at 3,000 mm from the datum and approximately at the 10 o'clock position—exhibits a moderate level of damage and warrants further investigation. The reducer on the main pipe was clearly visible at 5,200 mm from the datum, confirming a successful inspection of the entire segment from the datum to the reducer.

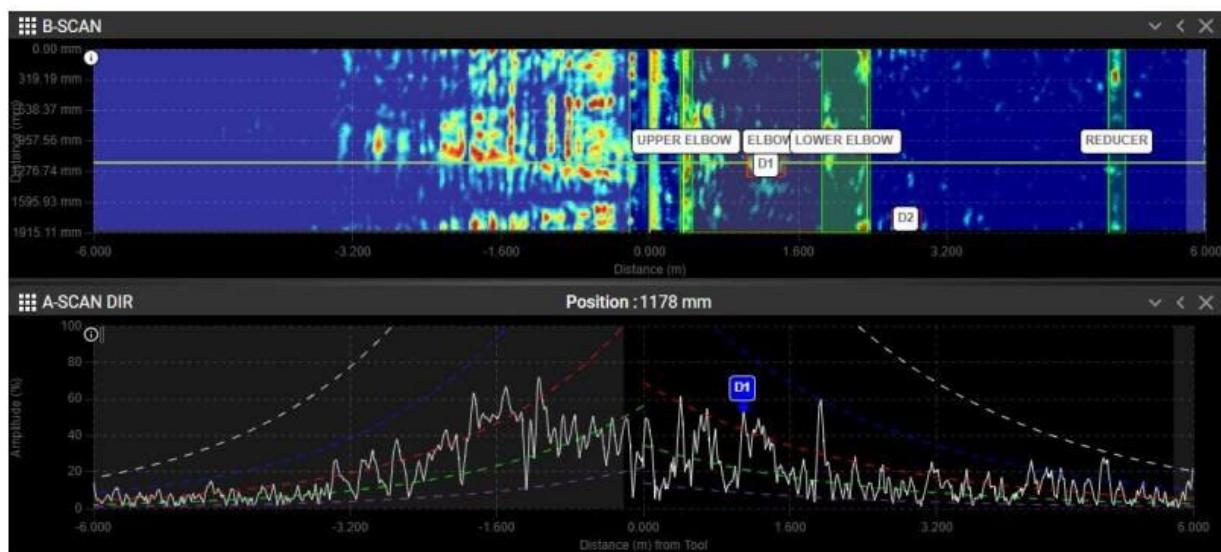
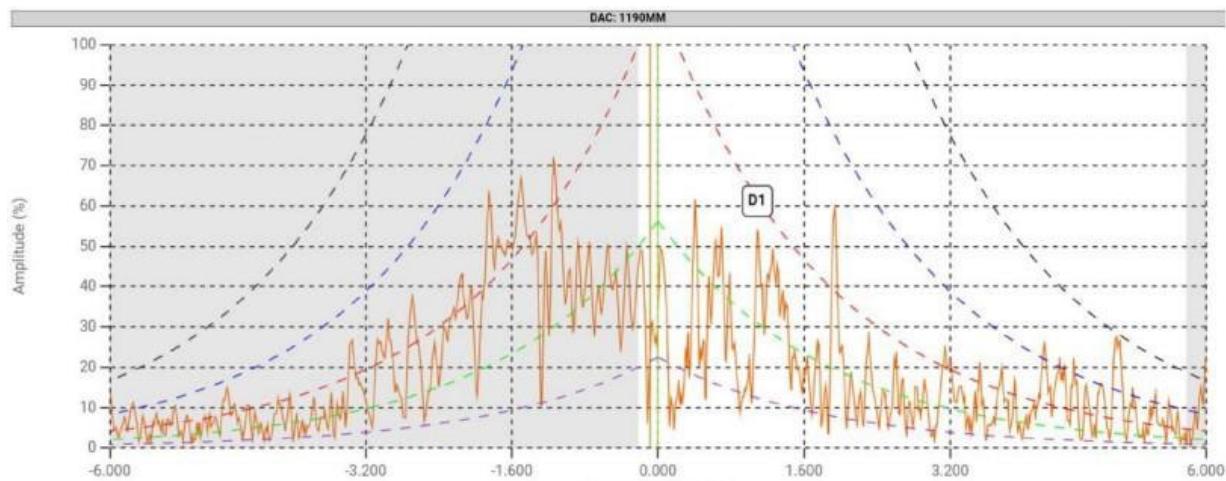
Figure 7. 24NB Gas Riser No. 2 A and B Scans showing Defect 1

Figure 8. 24NB Gas Riser No. 2 A Scan showing Defect 1

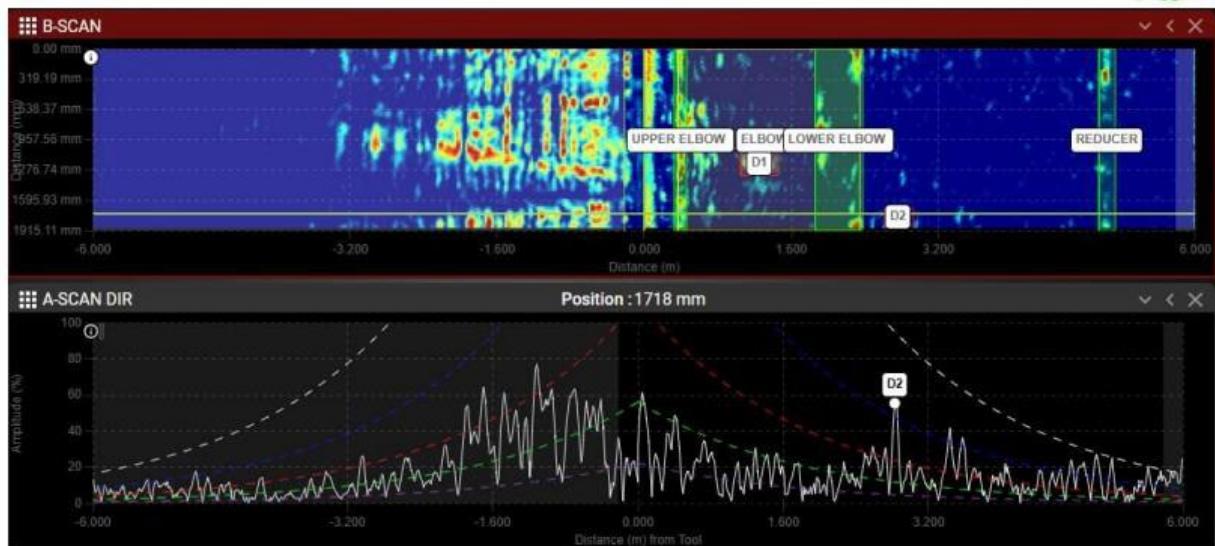
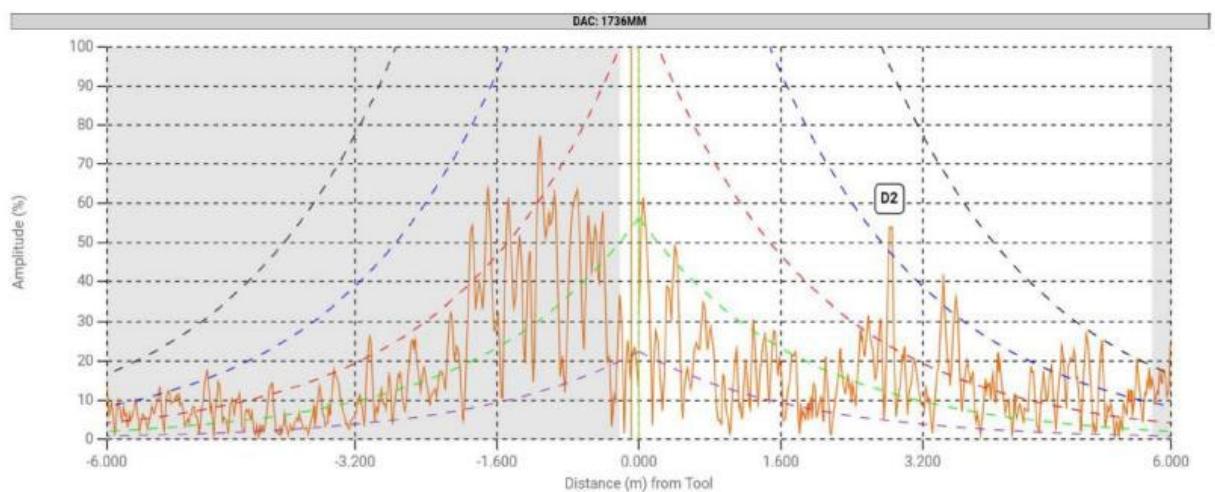
Figure 9. 24NB Gas Riser No. 2 A and B Scans showing Defect 2

Figure 10. 24NB Gas Riser No. 2 A and B Scans showing Defect 2

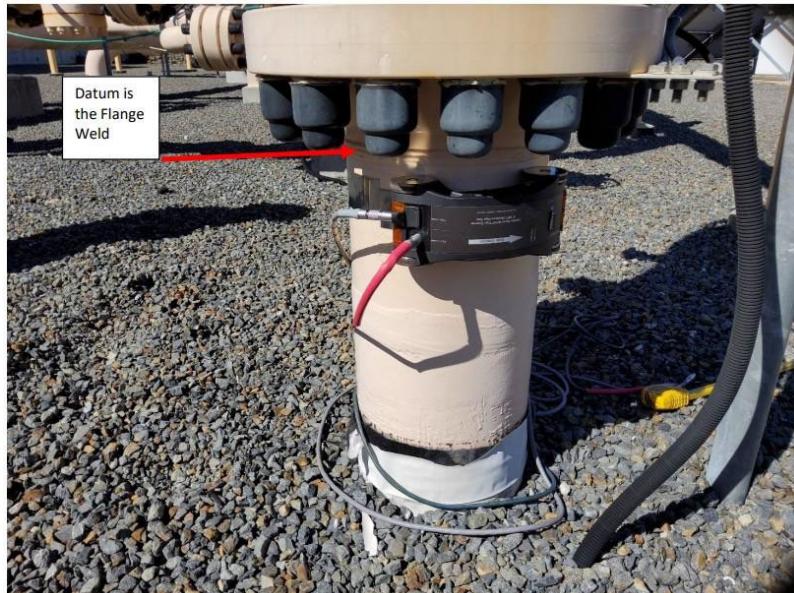
Figure 11. 10NB Gas Riser

The 10-inch NB vertical gas riser consisted of 12.7 mm wall thickness carbon steel Schedule 60 pipe. This riser was initially inspected using LRUT Lite, which revealed that the vertical 10-inch spool was welded to a 90-degree elbow approximately 1,400 mm below the datum. Given the relatively short length of the area of interest, a medium-range scan was performed at a frequency of 64 kHz.

The datum was the weld below the flange shown in Figure 11. The 12 o'clock position was defined as the circumferential point facing the entry gate fence (the camera location in Figure 11), with the clockwise direction oriented looking up. The test location was 50 mm from the datum.

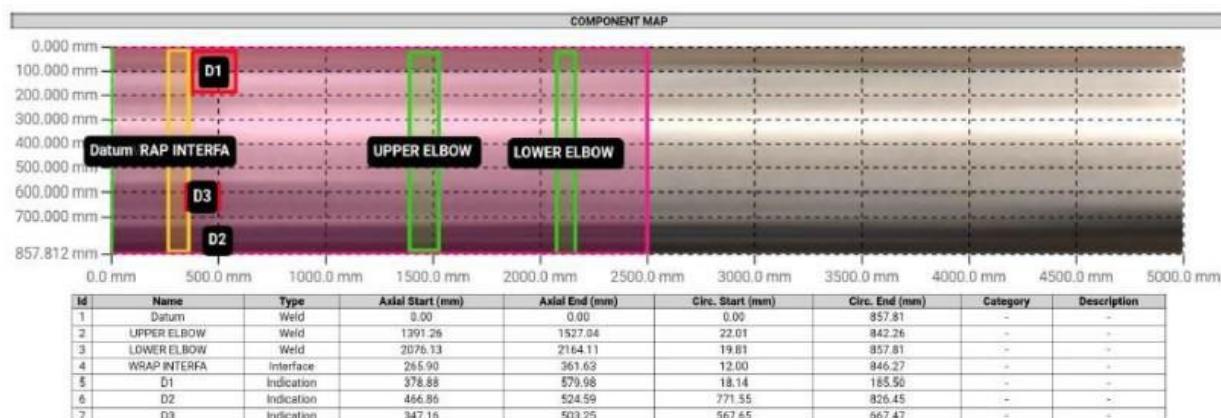
The EMAT MRUT method demonstrated sufficient range to detect the first and second 90-degree elbow welds, located approximately 1,400 mm and 2,000 mm below the datum, respectively. Due to its superior resolution and sensitivity, MRUT was selected for the 10-inch NB pipe scans. While a 128 kHz scan was trialled for maximum sensitivity, the depth of penetration was insufficient, and the elbow welds were no longer detectable.

Figure 12. 10NB Riser Component Map and Results

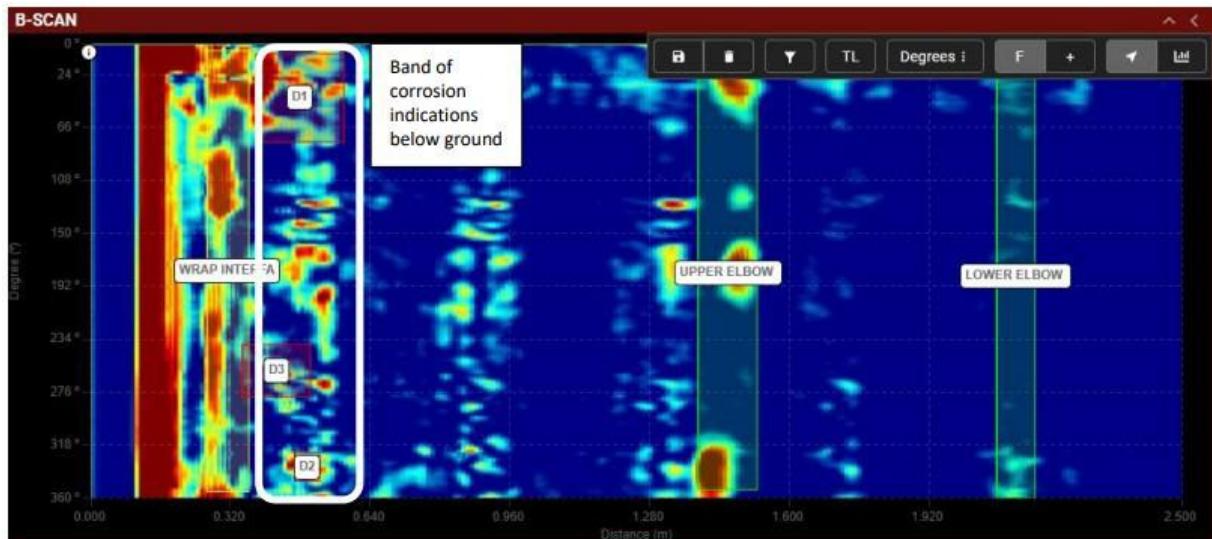
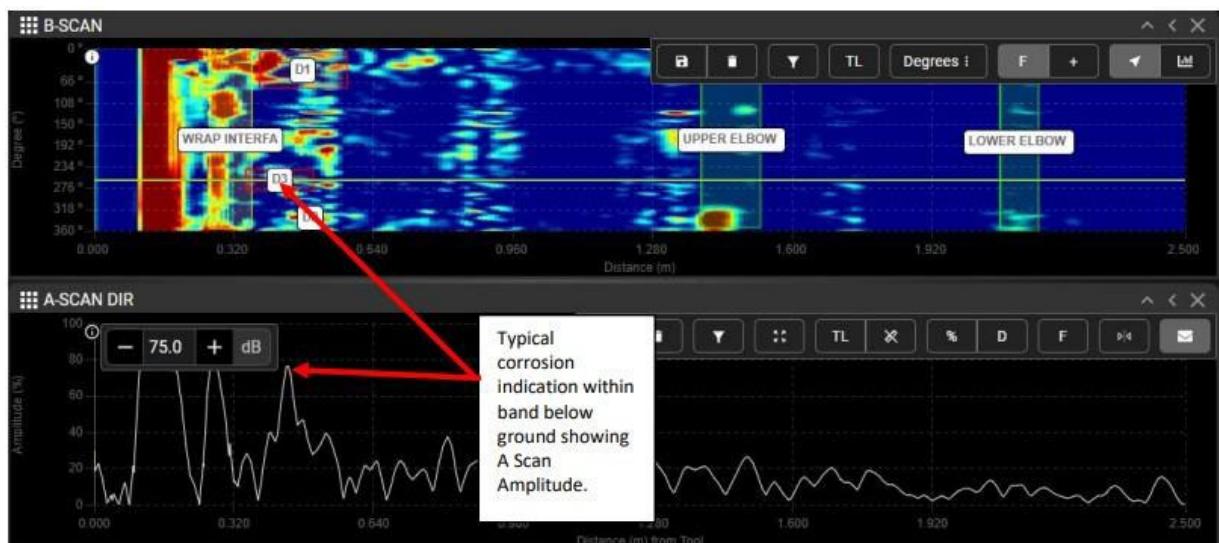
Figure 13. 10NB Riser B Scan

Figure 14. 10NB Riser A and B Scan

The interface between the painted bare pipe and the wrapped section is visible in the scan; however, it is difficult to distinguish between potential defects and interface signals. A distinct band of moderate corrosion is evident below ground, approximately 375 to 580 mm from the datum. The strongest indications in this region yielded an 85% A-scan amplitude, suggesting that the corrosion is moderate to severe. Additionally, several areas of minor corrosion indications were observed throughout the buried portion of the pipe.
