CASE STUDY

How a medium-voltage GIS manufacturer improved safety and optimized equipment with an innovative rupture disc design

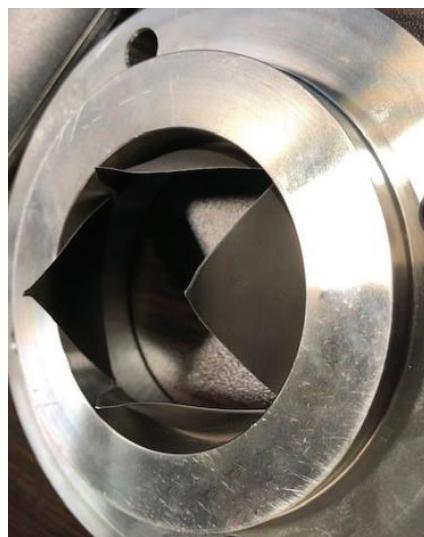
The dual-welded disc assembly with a cross scored disc solves fragmentation and installation challenges

- Switch from a circular scored disc to a four-petal PCR disc to prevent fragmentation
- Weld the disk into an insert-and-shell design to prevent movement, slippage and deflection of the disc. Welding also protects the disc from damage when handling it.

The welded rupture disc design provides a drop-in solution that eliminates extra components, offers simple installation and provides a secure, leak-tight seal with a non-fragmenting disc. As a result, the manufacturer has improved the safety and performance of their equipment, with:
