# CASE STUDY

## How a high-voltage GIS manufacturer improved safety and equipment longevity through collaborative engineering

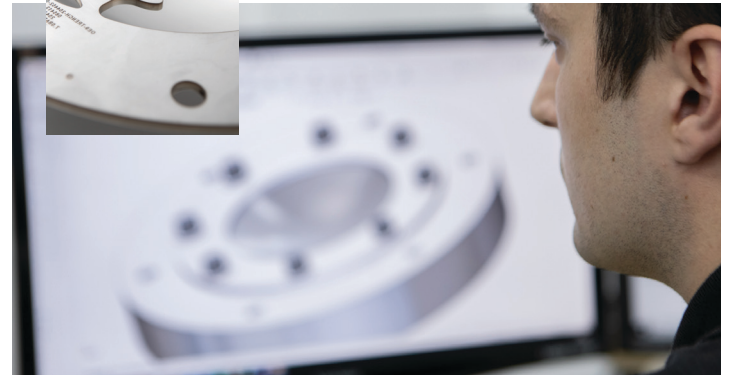
Collaborative working enabled a successful re-design of both the rupture disc and the switchgear housing

- The manufacturer revised their housing design process to ensure the mating surface design matched the rupture disc's interface requirements perfectly;
- Our Design Engineers modified the rupture disc's support ring design to offer more robust support;
- Together, we developed a comprehensive test program that included burst tests with the discs installed on the new housings.
