# *Jackson-Bell* *Model 8 Radio Analysis*

By Richard Gray and Jim Ryan

This document is a collaborative effort by Internet and telephone between Jim Ryan as the set owner and Richard Gray as the document reviewer.

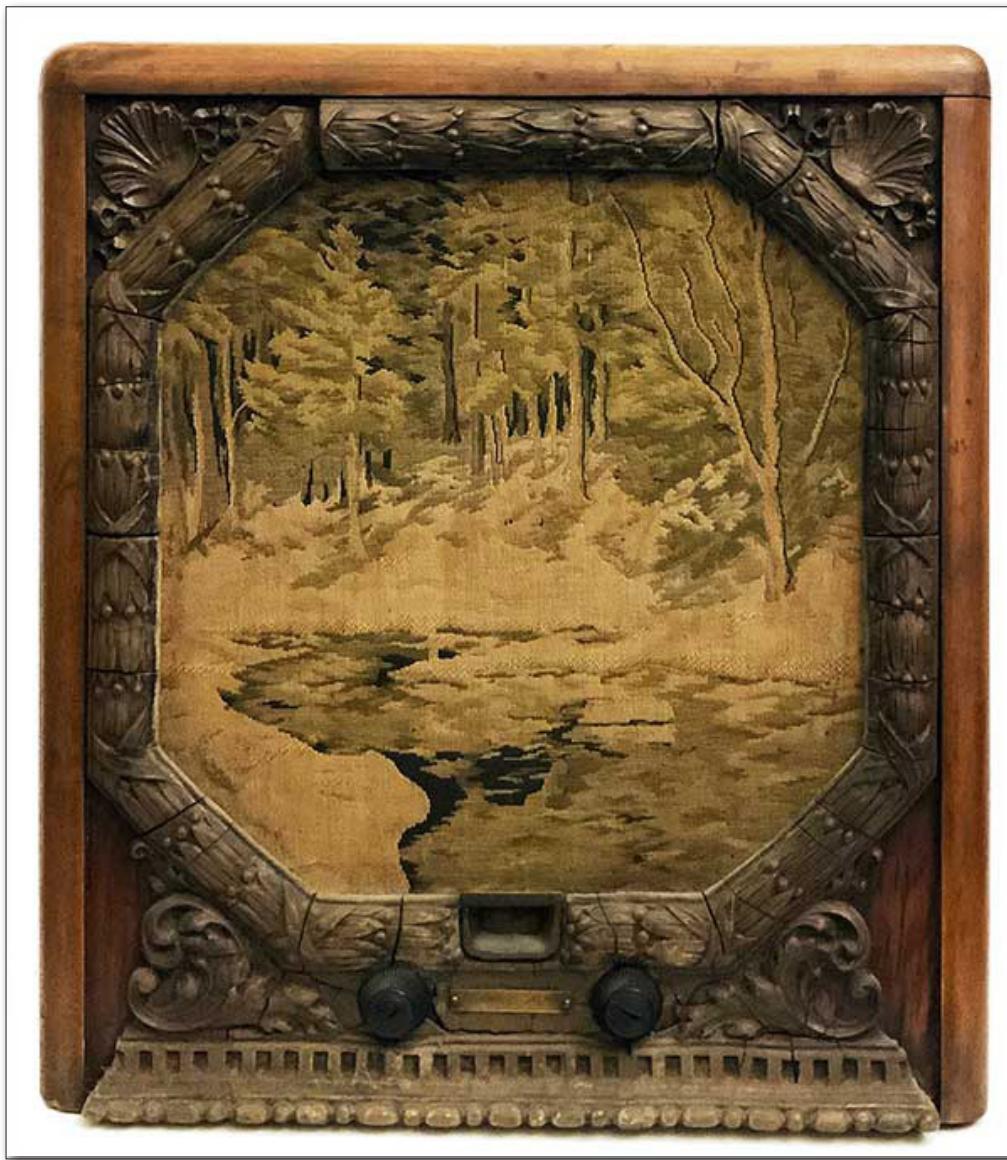
The Model 8 cabinet has a distinctive tapestry grill cloth.

The ornate repwood trim has suffered obvious deterioration.

The cabinet is in decent condition with some repwood shrinkage.  
The damage might be repairable with wood putty and refinishing.

The grille cloth is badly faded with no holes.

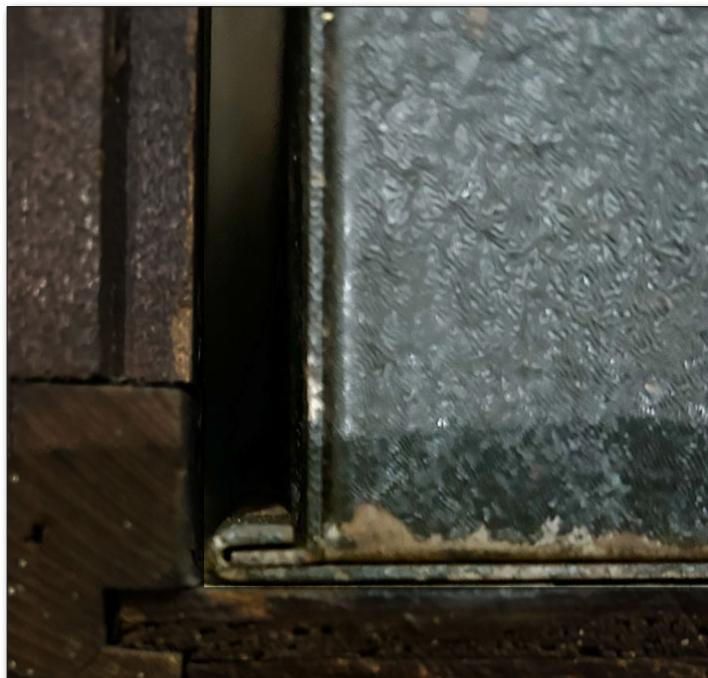
The Model 8 metal pan-and-rail system shown above helps guide and anchor the chassis. See the image on the next page for another view of how this system was implemented.

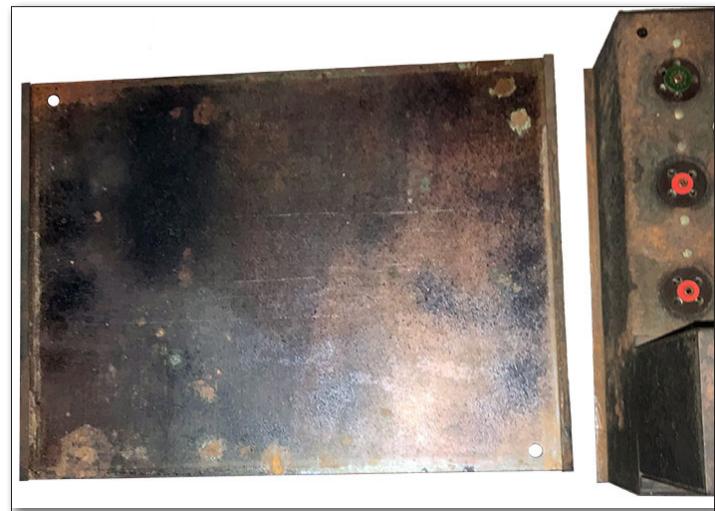
Another view of the metal plate-and-rail system used in the Model 8. The channels formed in the metal plate were designed to receive the chassis rails.

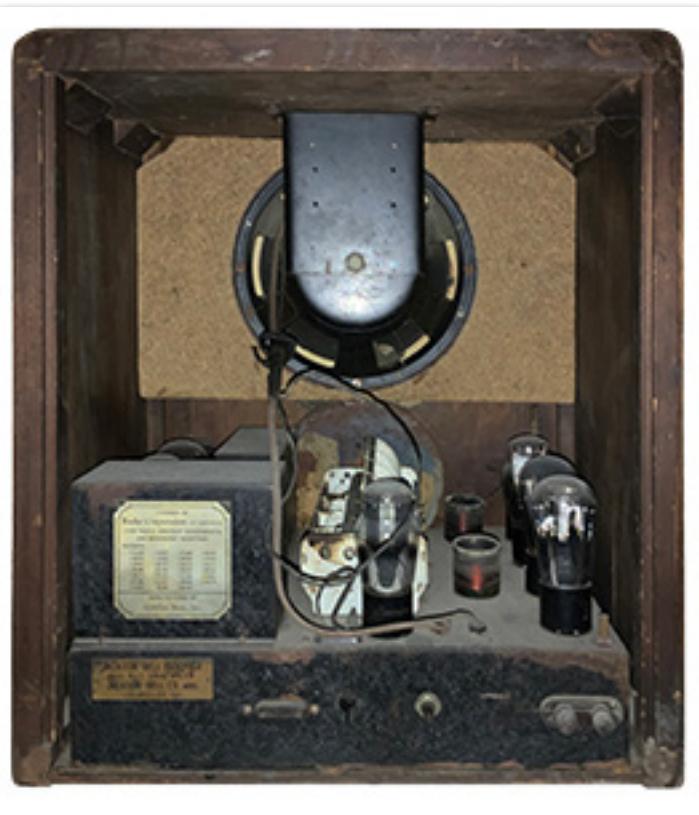
**Rear view of the Model 8 cabinet & components**

**Note speaker mounted to top of cabinet**

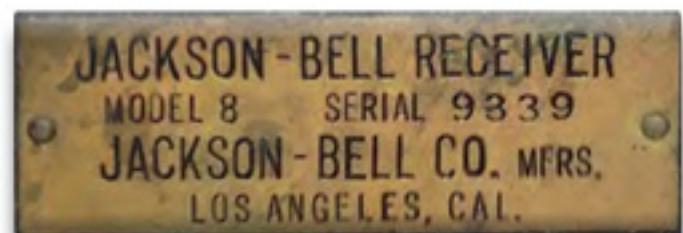
**The metal ID plate attached to the model 8 chassis**

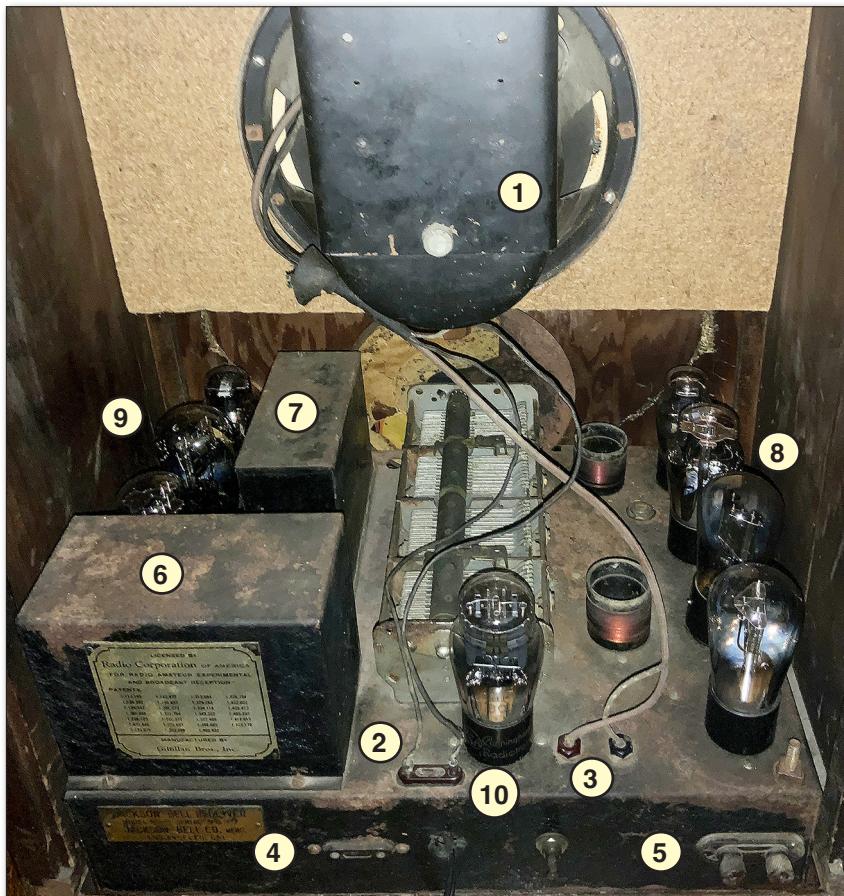
Chassis layout viewed from the cabinet rear

1. Speaker suspended from top of cabinet.
2. Voice Coil plug and connector pins
3. Speaker Field Coil through chassis wiring
4. Phono Input
5. Antenna and Ground terminals
6. Power Transformer
7. Capacitor Block
8. Right Side Tubes = 26, 26, 26, 27
9. Left Side Tubes = 71A, 71A, 27
10. Rectifier Tube = 80

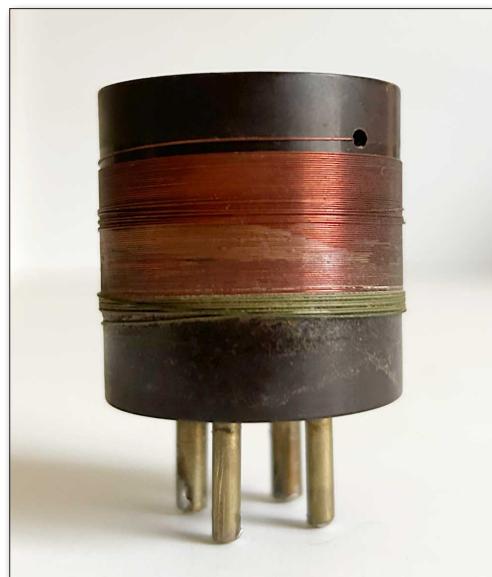
Type of coil installed on the Model 8 (2 on the top, 2 under the chassis)

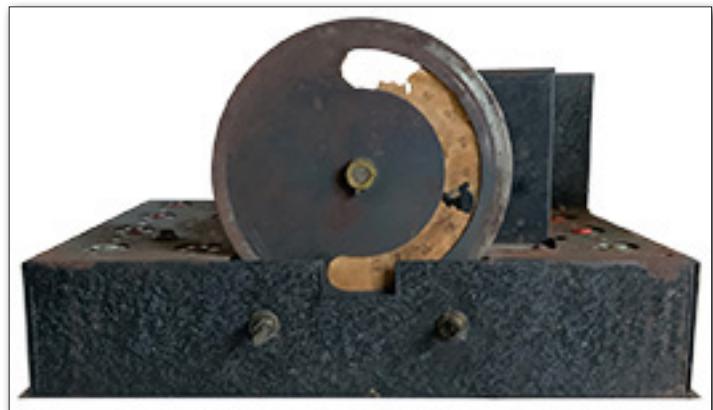
Front view of chassis with tubes removed

The chassis is somewhat rusted but otherwise in decent physical condition. Log Scale Dial.

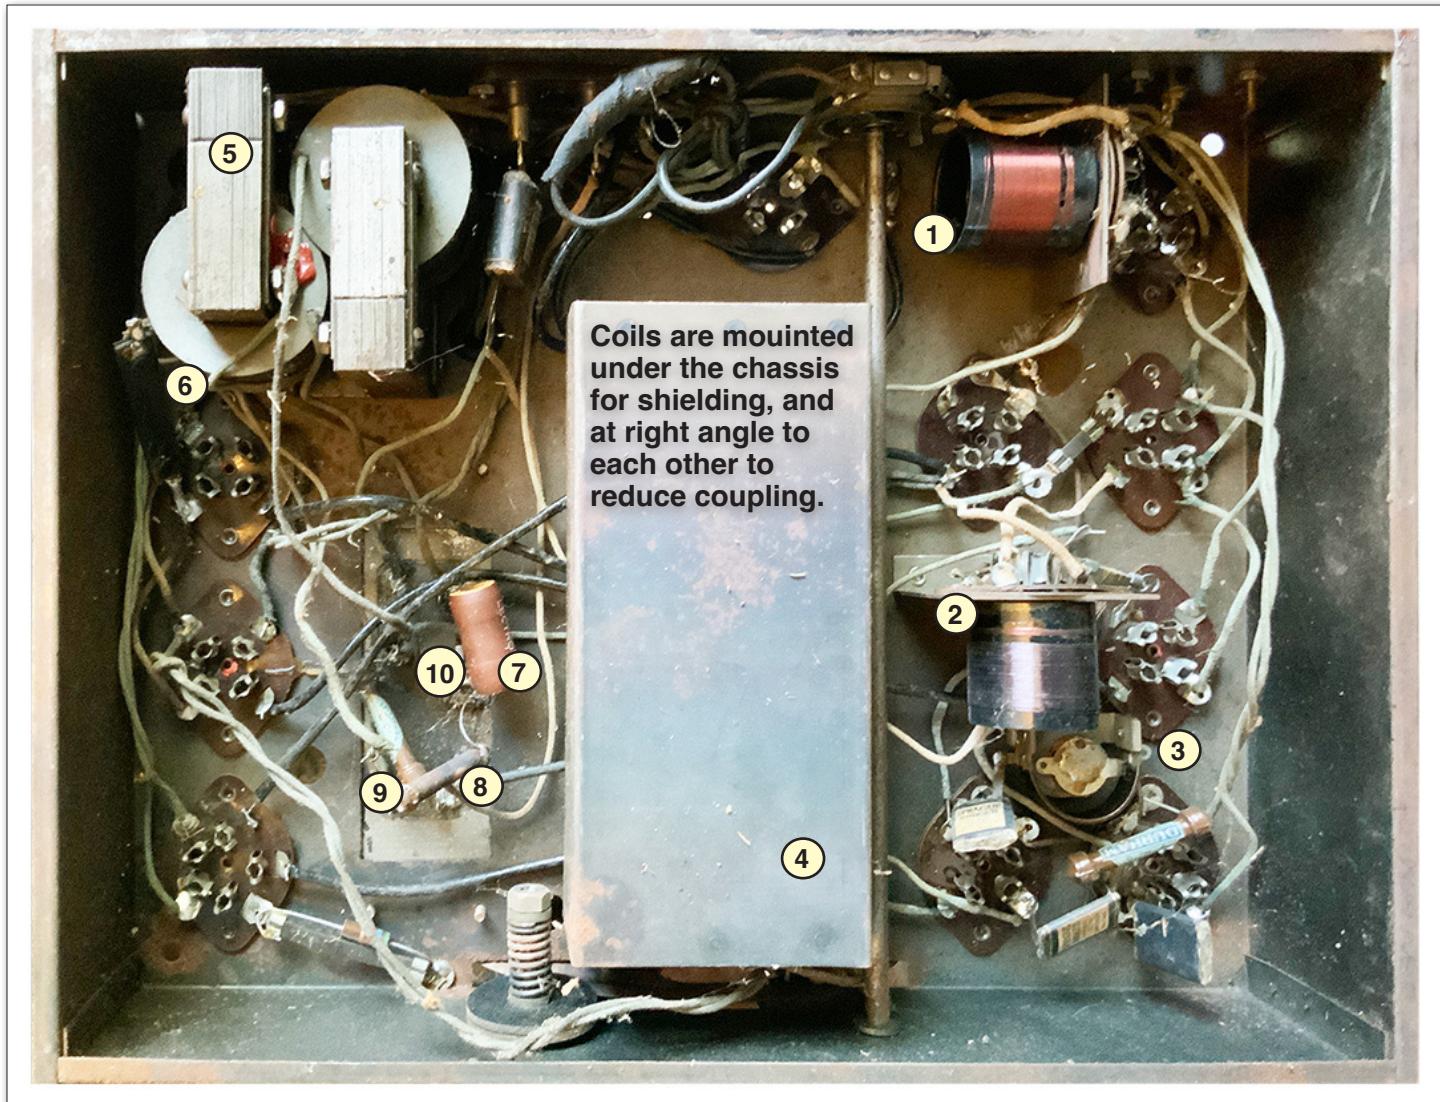
1. First stage R.F. Coil
2. 2nd R.F. Coil
3. Regeneration Control
4. Audio Transformer cover (2.5" Deep) with 1/2" gap on the sides only.
5. Power Supply Chokes (Power Transformer & Filter Capacitors on the top of the chassis)
6. .8 ohm resistor - probably added or a factory fix? (close-up at left)
7. R.F. section resistor - now 336 ohms
8. Center Tap resistor now open.
9. 171A Filament transformer winding center tap good
10. Also now open

Several of the old resistors had opened, and attempts were made at repairs. The values that were used for bridging bad parts do not match the schematic values. In addition, some bad (open) resistors remain.

A wiring change was made, attaching the center tap of the audio driver transformer to one side of the filament line. This was not a good idea.

There is a 0.8 ohm resistor in the filament lead of the 171-A's. This does not appear on the schematic. However, factory fixes are common. Alternatively, this may have been someone's attempt to fix the other problems.

Fortunately, it is easily moved back to where it belongs. Jim measured the resistance of the transformer winding. It seems correct.

With a minor amount of effort and parts, this set should be able to be put in working order.

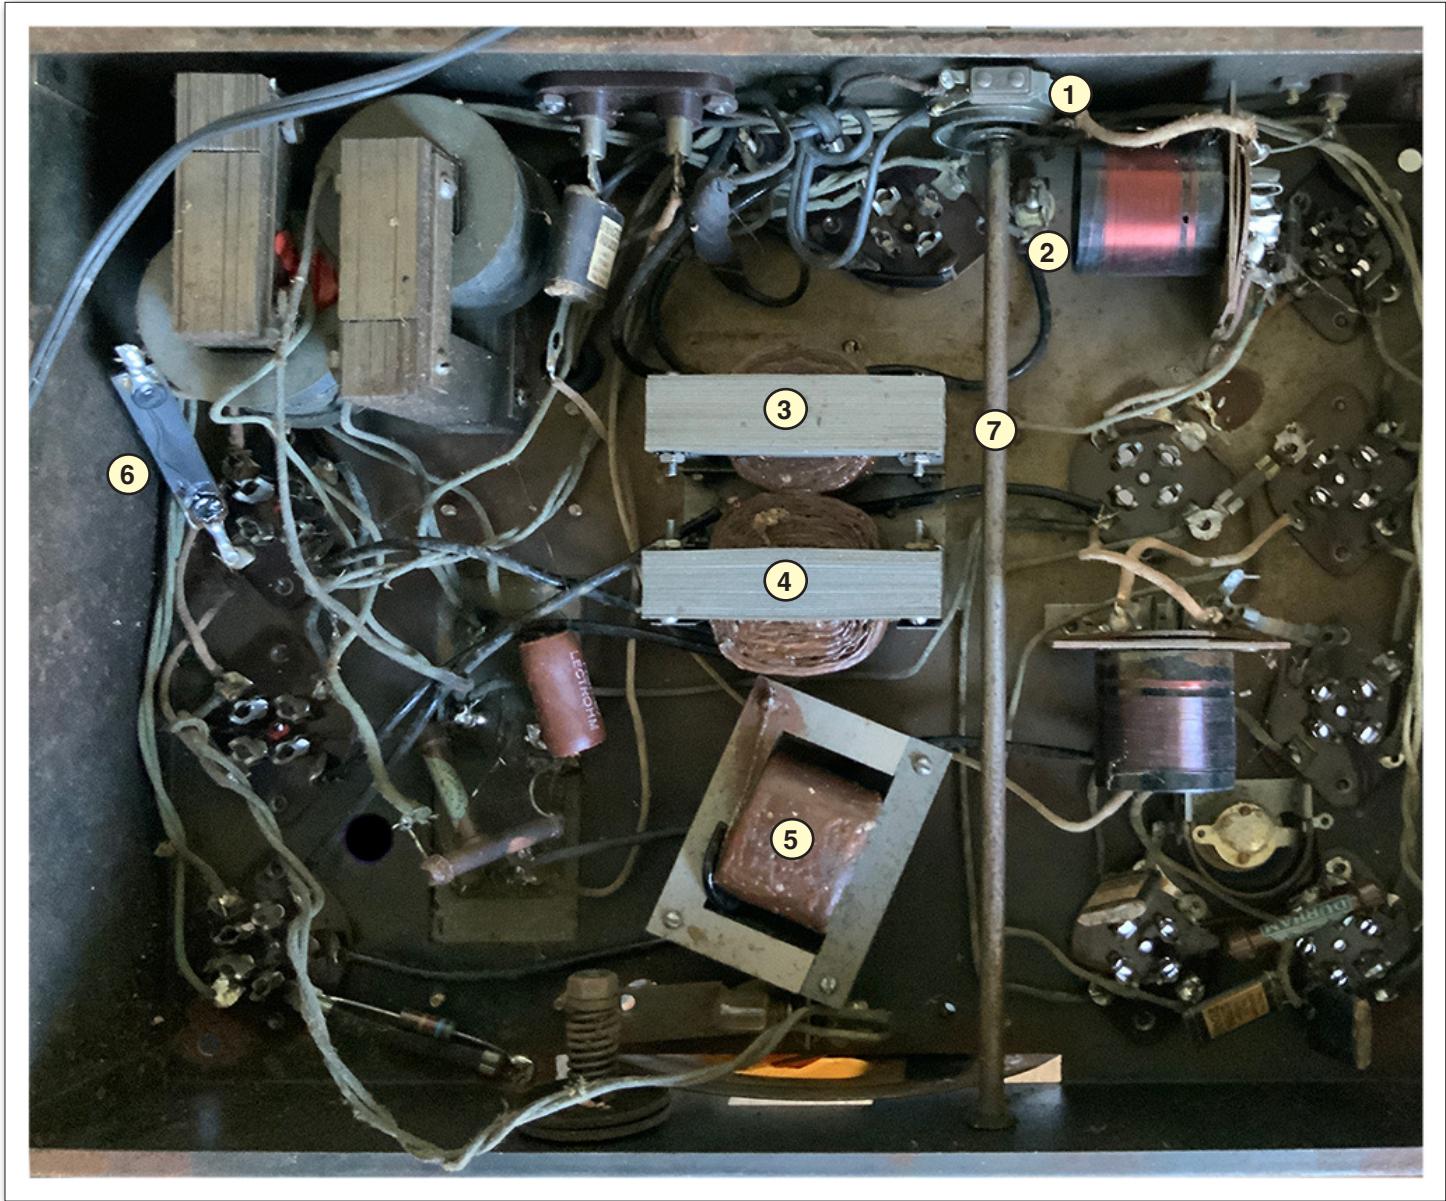
**Audio Transformer Cover Removed:**

1. Volume Control & Power Switch
2. Speaker field Output terminal
3. Push-Pull output transformer
4. Push-Pull driver transformer
5. Audio Transformer between detector and first audio stage
6. .8 ohm resistor - (enlarged on prior page)
7. Power/Volume switch shaft runs through the chassis (front to rear).

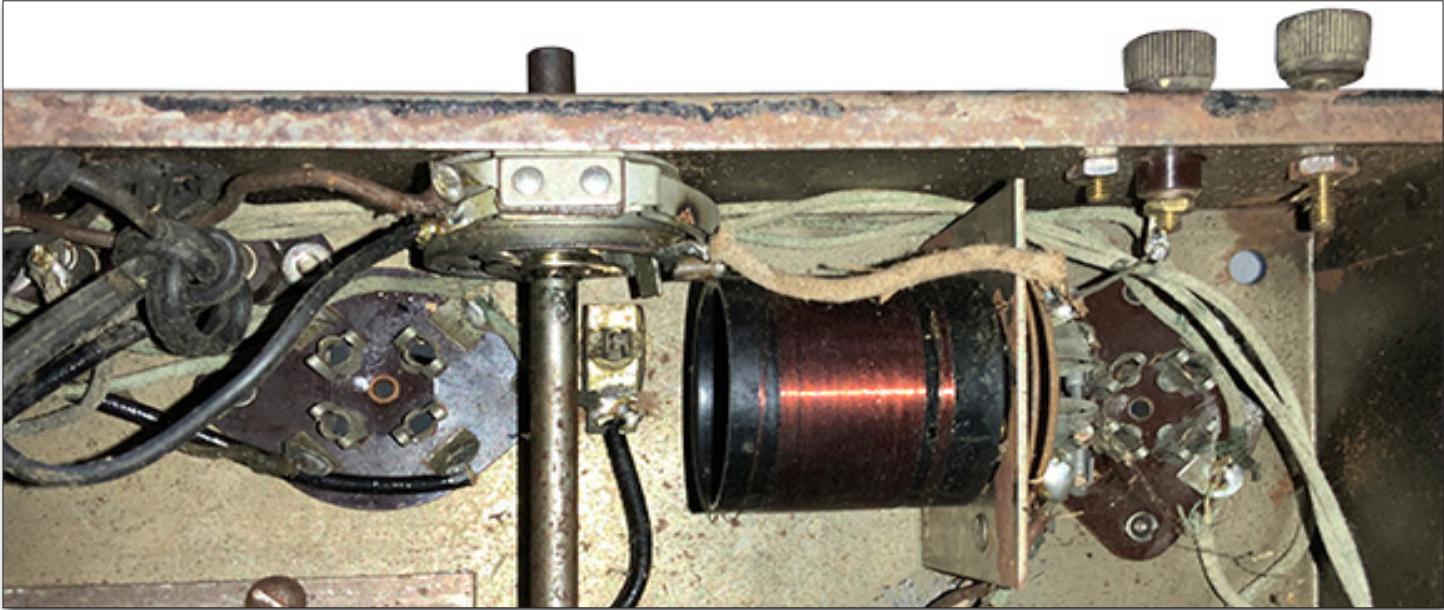
The combination power switch and volume control is mounted on the back, inside of the chassis. A shaft runs to the front of the chassis for mounting the control knob.

The pot is mounted on back of the chassis in the normal manner. The shaft extension is connected to the back of the pot, so no control is needed on the back of the chassis. The pot and switch run backwards - counter clockwise rotation increases the volume!

They had to put the pot in the back of the radio, or shield the coils - they chose the latter solution. If they had mounted the pot on a bracket, facing forward, it would have had a conventional rotation.

They could have used an off-the-shelf shaft extension. Presumably much less expensive than a custom machined shaft???

The volume control pot shorts the antenna; a common method in other period Sets. Jackson-Bell chose to machine a special shaft out the back on a standard control. This was expensive and the control turns backward from the convention of the day (or now)! A bracket and a conventional shaft extension would be a better and cheaper solution.

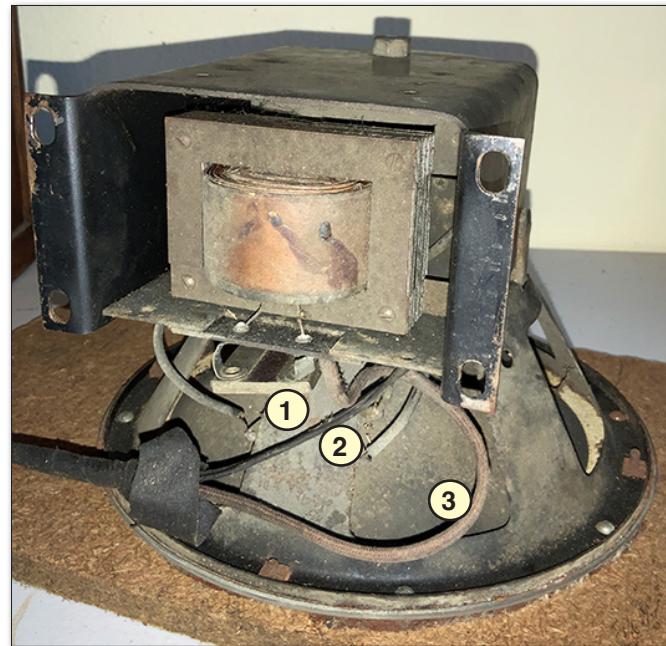
The speaker is mounted to the top of the chassis by four screws. Disassembly is not advised beyond what is seen at right.

The set has an unusual speaker connection. The matching transformer is on the speaker. The push-pull transformer is in the chassis. Later styles combined the two transformers for a cost savings.

1. 250pF capacitor
2. Field coil wires
3. Audio wires

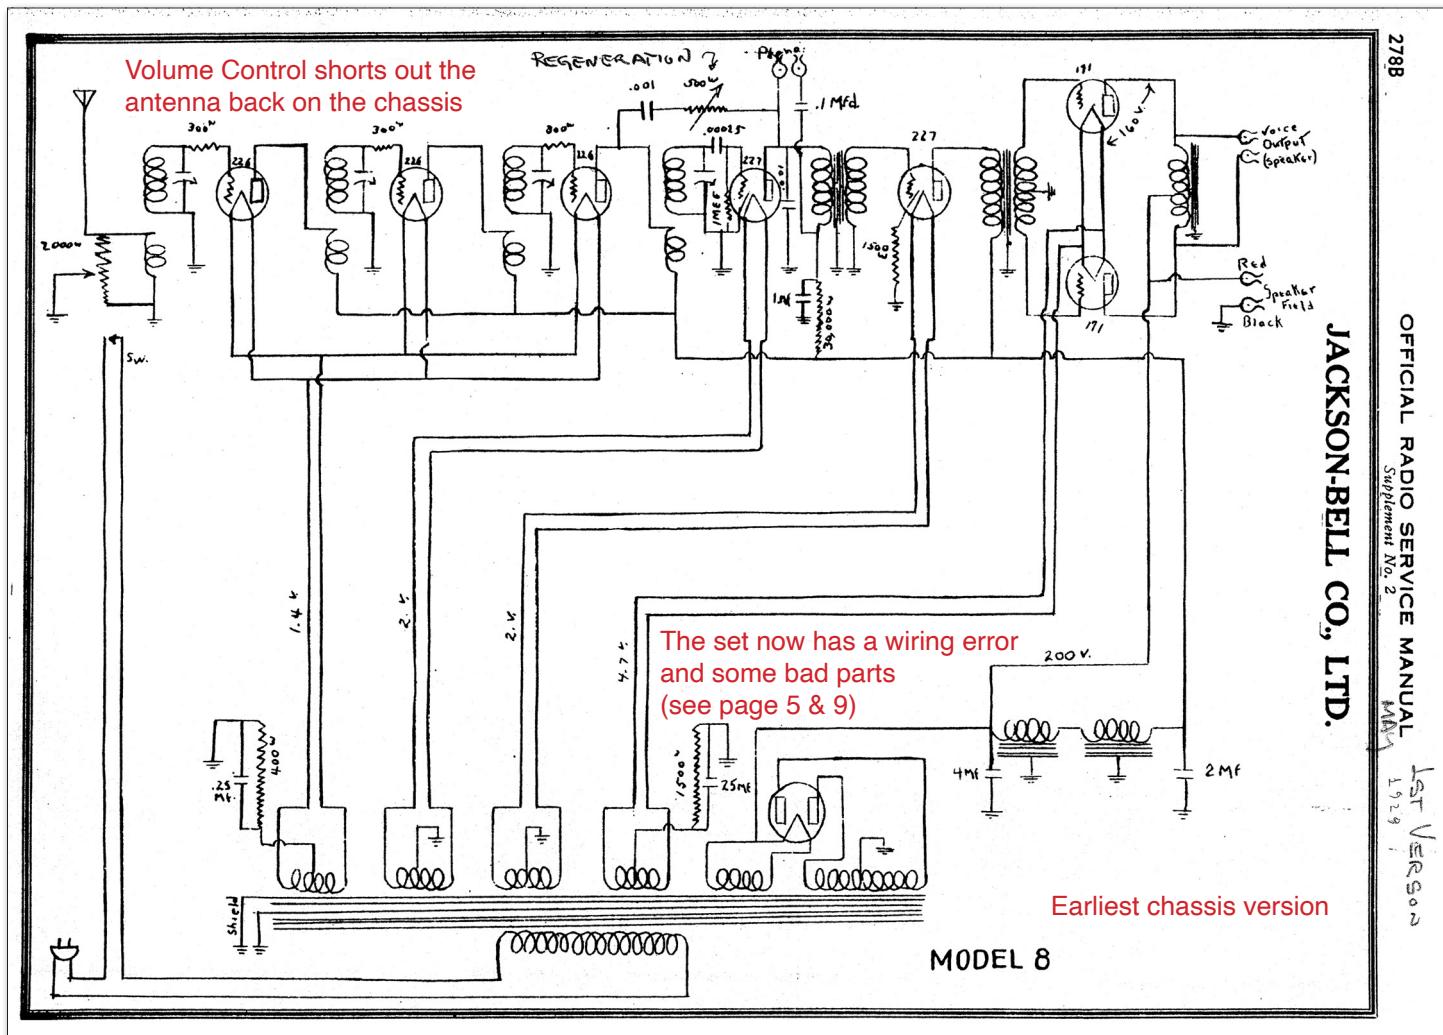
## Model 8 Schematic (Earliest Version):

This is the first of three different versions of the Model 8. The other two are the Model 845 & 845S.

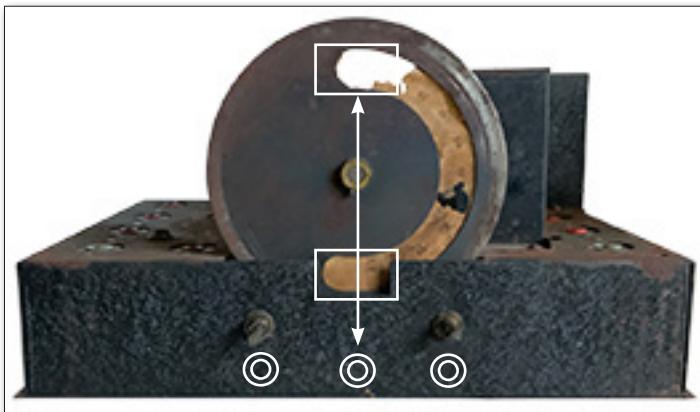
Advertisements for consoles show three controls which may have included a tone control. A suggestion of how this was accomplished is in the accompanying image below.

This would have required modifications to the chassis and how the tuning mechanism was driven. The table model control uses a side drive, while a center dial drive would contact tuning directly below.

Volume Control      Center Dial      Added Drive Knob      Tone Control
