### Chassis Identification

The Jackson Bell model 62 circuit had three major circuit revisions, reducing costs while maintaining performance.

**Jackson-Bell Model 62, Early, or Prototype, Chassis Version 1**  
**Chassis Control Number 62-82839**

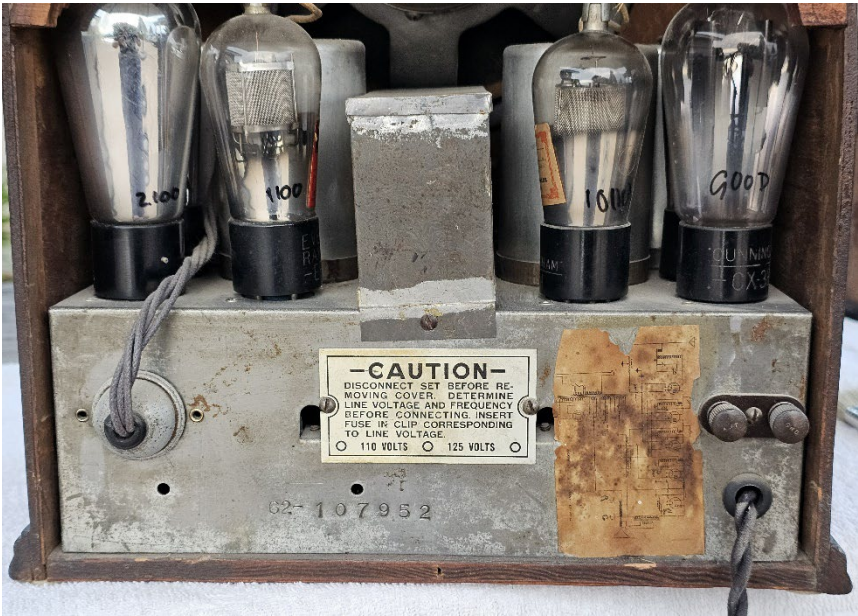
Version 2 Chassis, with a large Filter Block

The **Second Circuit Version** used 8uF Capacitors in the Power Supply to allow removal of the choke and filter capacitor in the detector circuit. Hum in the speaker is acceptable. Presumably, these changes reduced costs. The First Implementation used a larger Filter Block. The second implementation of the same circuitry used two Mershon Electrolytic 8uF capacitors, and small capacitor Filter Block

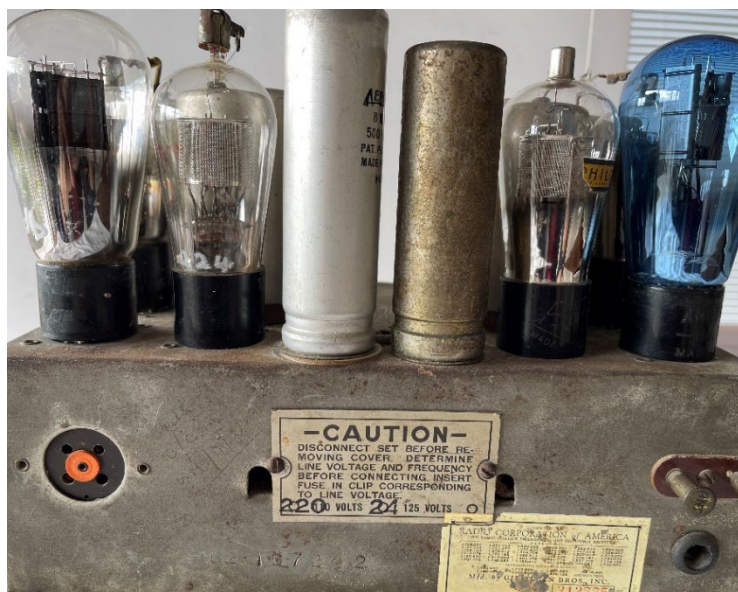
## Version 3 Chassis

This, 220-240 Volt, example is from Mark Thomson in New Zealand. A schematic attached to this Radio confirms a Series 3 Chassis. The Capacitors are not the original Meshon Types. However, in the Photograph, the Capacitor on the left is insulated from the Chassis

The **Third Version** put the speaker field coil in the power supply ground return; providing a negative voltage with respect to ground. It is used here to bias the 245-power output tube grid. There may be an above chassis Filter Block, or under chasses Capacitors.

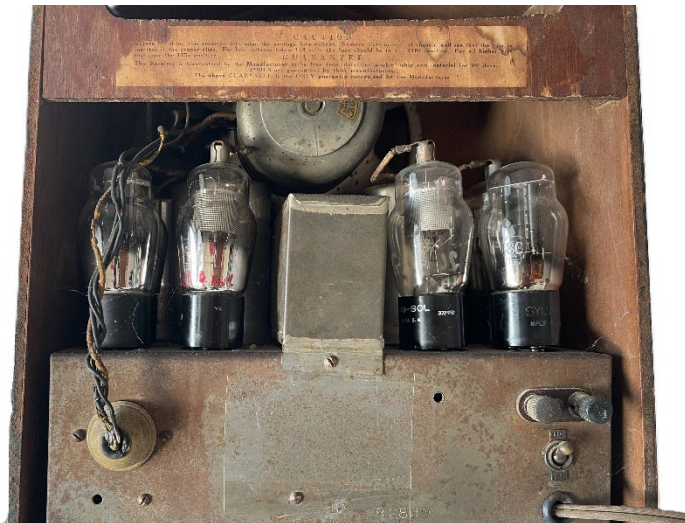
Version 1 Chassis with a Toggle Switch for Operating Voltage Selection  
Replaced by Fuse Block, Operating Voltage Selection, on Later Version 1 Chassis  
All other Version 1 Circuitry appears to be the same

Mark Thomson, New Zealand has the Earliest Chassis Control Number Jackson Bell 62 we have ever seen. This Radio was bought on eBay in the United States. The Chassis the Version 1 Chassis, without a Fuse Block.

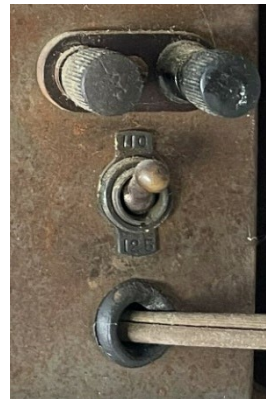
**Closeup view  
of Voltage  
Selection Switch**

The Chassis is scored. There was a Label, or Schematic Drawing on the back of the chassis, perhaps cut out with a knife?

The Voltage Switch Reads "110" and "125"

The Chassis has been repaired with new Capacitors  
The Power Cord has been replaced

The Filter Inductor, and the (punched?) holes in the Chassis are a poor fit  
This may be indicative of a Prototype
