# MPI SFFF 19079: What's Coming Out of Tile Drains?

## Final Report

Sarah McArley (nee de Bruin) and Carl O'Brien  
AgFirst Consultants  
March 2025 revision 1

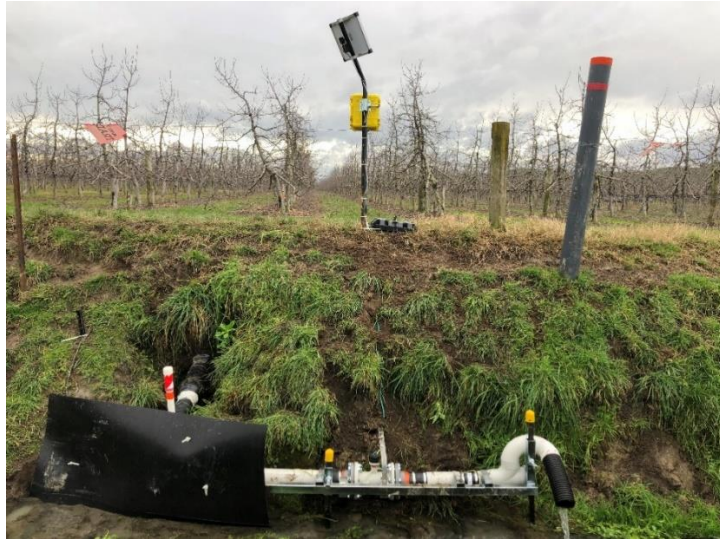
Figure 3: Tile drainage flow meter equipment, installed at a monitoring site, allowing for continuous flow data capture

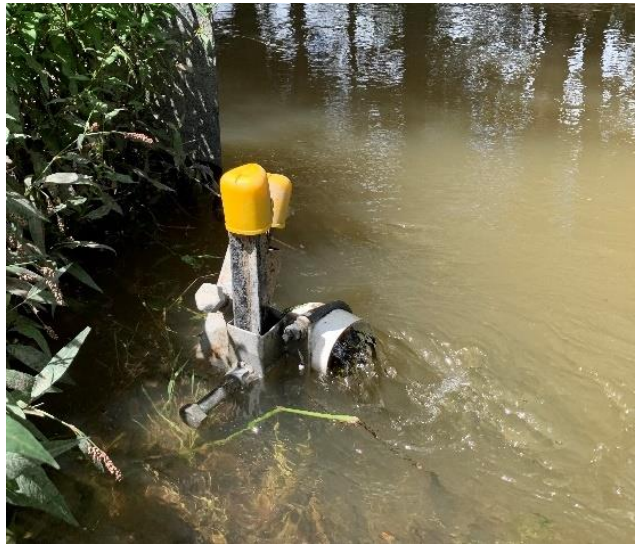
Figure 4: Installed tile drainage flow meters enabled flow data capture on sites where the receiving water body regularly submerged the tile exit, therefore inhibiting manual flow data collection during monitoring runs. This allowed more regular data capture at these sites.
