# Current Challenges in Midstream Facility Operations

Current Challenges in  
Midstream Facility  
Operations

September 24  
8:30 am-Noon

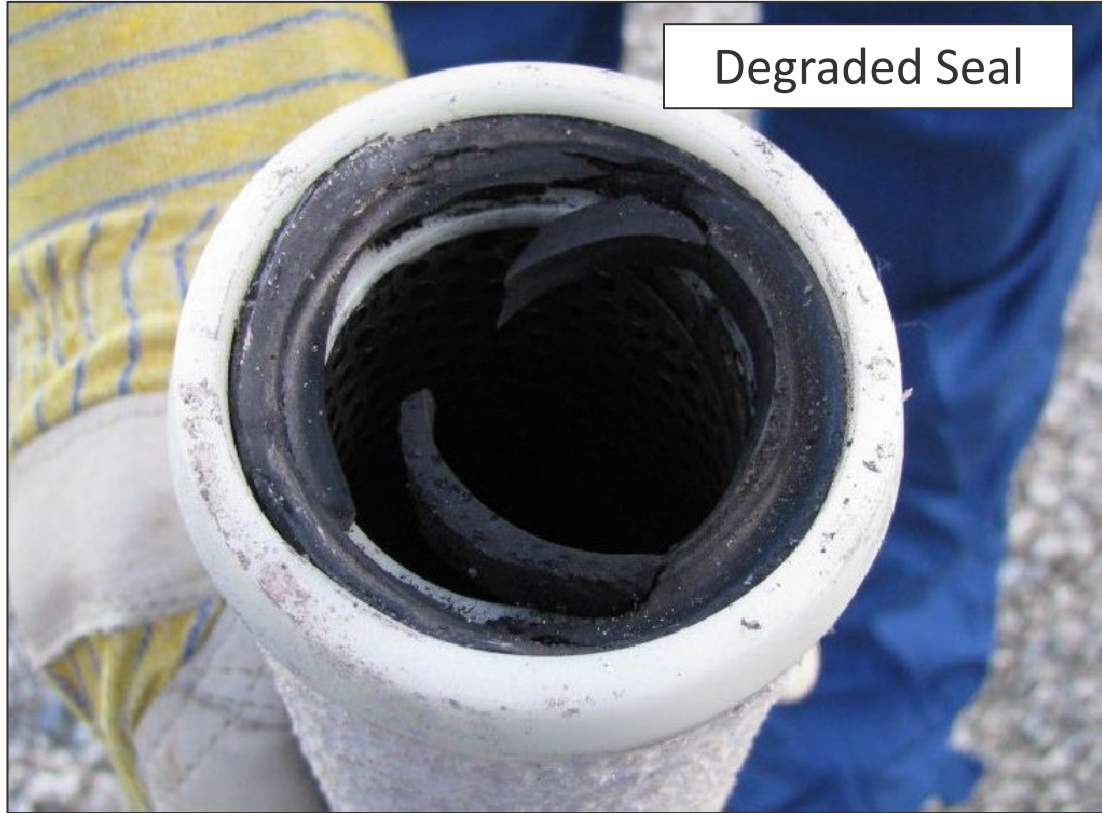
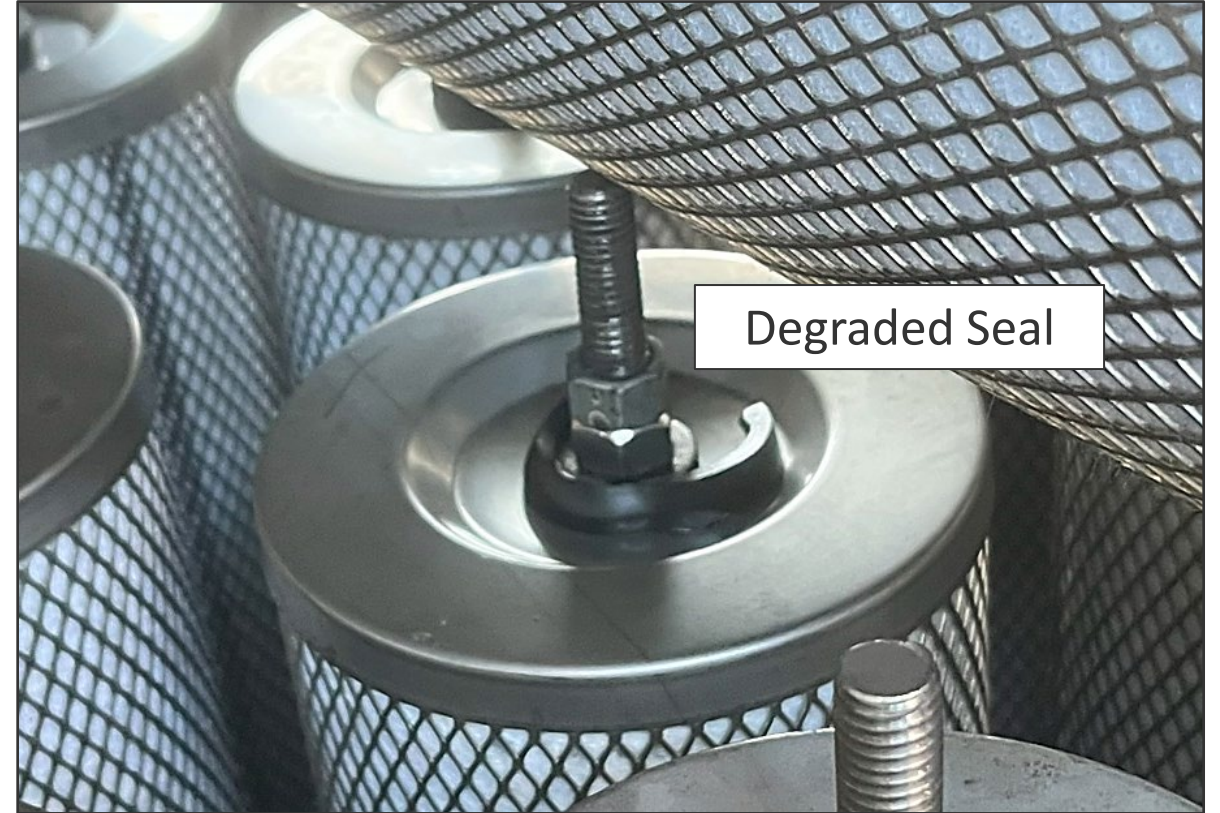
# Elastomer Deformation and Degradation

# Case Study 5 – Chemical and Mechanical Incompatibilities

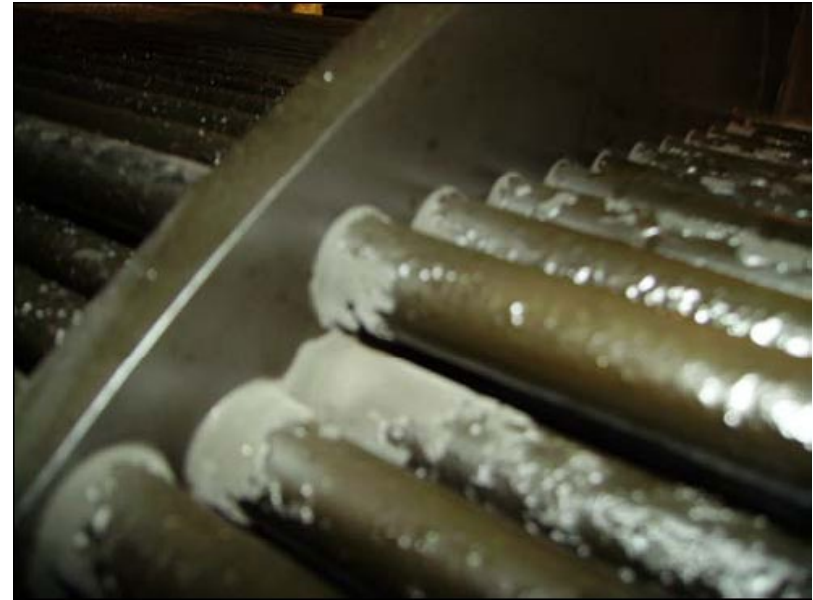
# Reboiler Tube Failures

- Original troubleshooting request – provided with:
  - photo of reboiler tube sheet showing plugged tubes (top 5.5 rows)
  - upper right quadrant was first pass – tubes plugged equally because of U-Tube shape
  - photo of tubes showing some poorly adhering scale/deposit
- Previous bundle lasted 13 years – this bundle only 6 years
- Asked to determine the corrosion mechanism leading to the tube failure and heat medium leak into the amine solution

- Corrosion concentrated to inlet of first bundle pass
- Mechanism appears to be scale buildup followed by loss of scale
- What could cause scale delamination?
  - tube vibration from excessive boiling
- What causes excessive boiling?
  - too high a heat flux
  - recommended max flux is 6300-7400 BTU/hr/ft<sup>2</sup>
  - calculated heat flux is 11,500 BTU/hr/ft<sup>2</sup>
- Why was the heat flux so high?
  - Heat medium flow and temperature increased
    - to accommodate new users in the heat medium loop
- Previous bundle was 2-pass; new bundle was a 4-pass (major contributor!)
  - despite comments that the new bundle was identical, it was not
  - had it been still 2-pass, heat flux on first pass would have been half of 11,500 BTU/hr/ft<sup>2</sup>, which is below the recommended max flux

- Install a new **2-pass** bundle
- Change reboiler metallurgy to stainless steel
- Clean lean/rich exchanger
  - rich feed temperature only 185°F (85°C)
  - resulted in poor stripping in the regenerator column
  - forced too much acid gas into the reboiler
  - generated too much H<sub>2</sub>S-related corrosion products that could break off
- Monitor rich outlet temperature from L/R exchanger to determine fouling rate and cleaning schedule
- Optimize lean amine circulation rate to control rich loading
- Optimize heat medium flow rate to control flux and reboiler temperature
  - Set a new regenerator overhead target temperature to ensure stripping in the column and not the reboiler

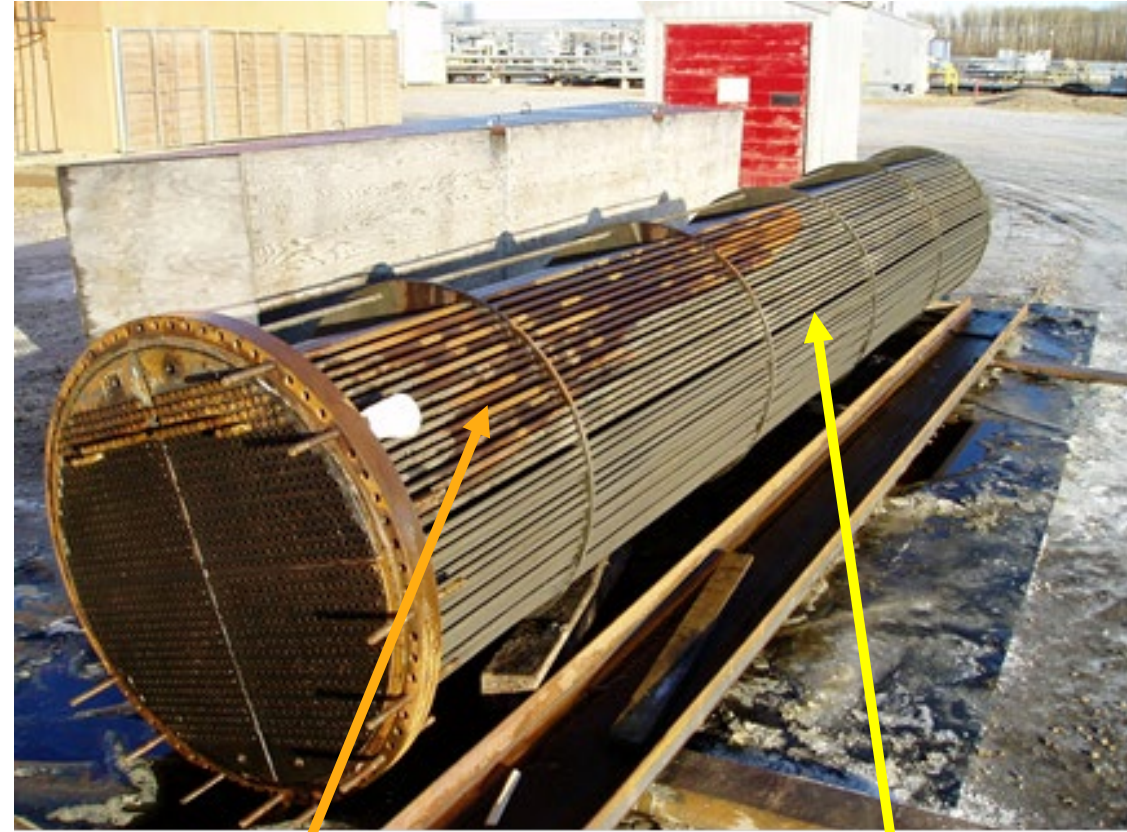
# Reboiler Tube Failures

Note lack of damage on second-pass tubesheet and tubes

First-pass

Rust color - more recent laydown of Mackinawite ( $\text{Fe}_2\text{S}$ ) or bare metal – poor/no protection

Greyish scale – Pyrite ( $\text{FeS}_2$ ). Normally seen in reboilers. Good corrosion protection when present – however, is very brittle

Mackinawite or  
no scale at all

Heat medium in

Heat medium out

Pyrite  
Scale

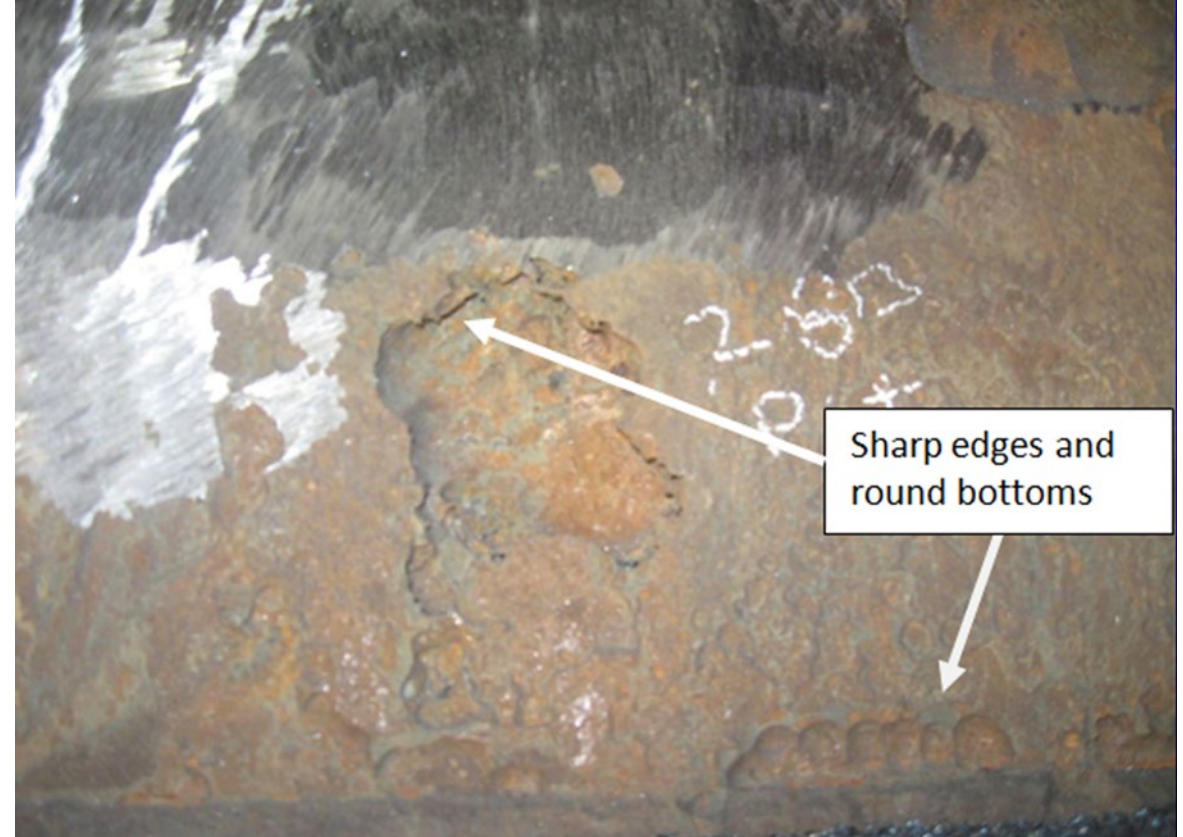
# Contactors Corrosion

- First train of a three-train CO<sub>2</sub> removal facility had a turnaround after three years of production
- Absorber inspection showed massive corrosion in the midpoint of the contactor
  - most corrosion focused between trays 8 and 11
  - lower 1/3 and upper 1/3 showed no excessive corrosion activity
  - corrosion had characteristic CO<sub>2</sub> attack appearance
    - sharp edged – rounded bottoms
- Corrosion in absorber LCV and indication of rich side fouling
  - flash drum, L/R exchanger

- Convert solvent from MDEA:DEA blend to a piperazine activated chemistry
  - faster CO<sub>2</sub> absorption
  - easier to predict and control bulge point and temperature
    - will be lower in the column and cooler with better control
- Improve lean amine cooling capacity
- More frequent feed gas and amine analysis
- Optimize circulation rate for bulge temperature control
  - control rich loading to max 0.55 mol/mol
  - control equilibrium loading below 80%

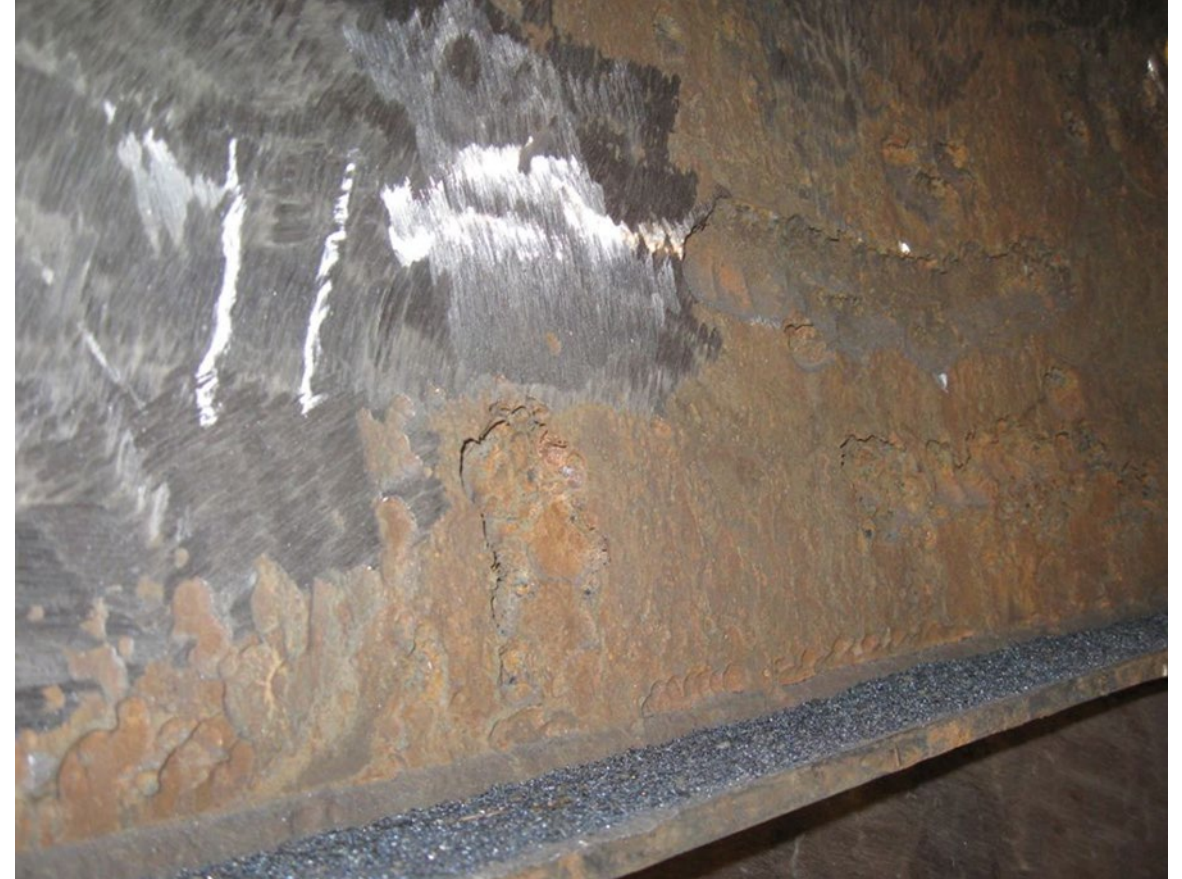
# Contactors Corrosion – Gather data!!

- Amine plant was using a generic formulation blend of MDEA and DEA
  - DEA added to enhance CO<sub>2</sub> removal requirements of the solvent
- No temperature probes to measure temperature profile within the column
- No direct measurement of rich loading or effective control of amine circulation rate vs feed gas composition and flow rate
  - feed gas composition assumed to be consistent with design case
- Summer issues with lean amine coolers
- Amine blend composition only known during quarterly amine analyses

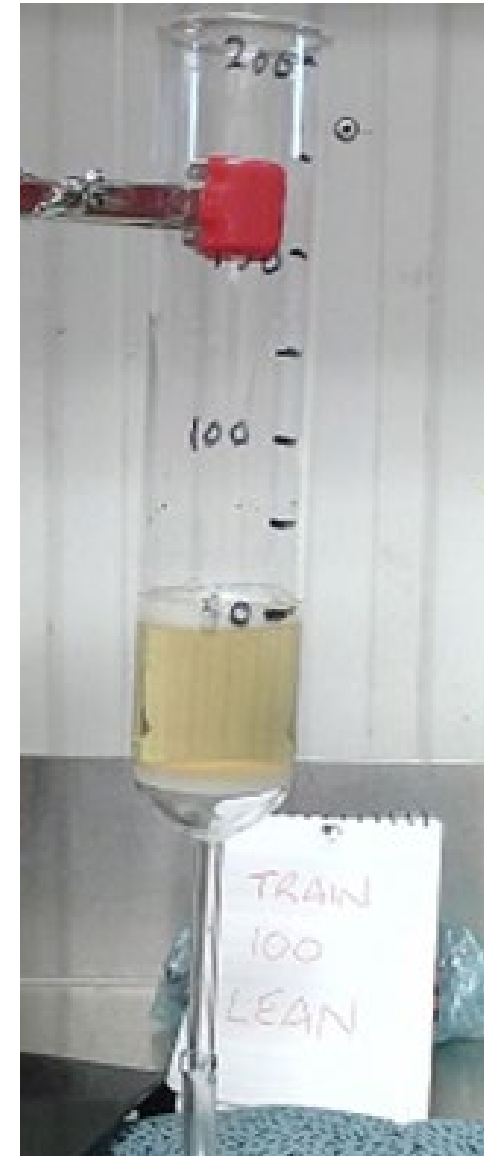
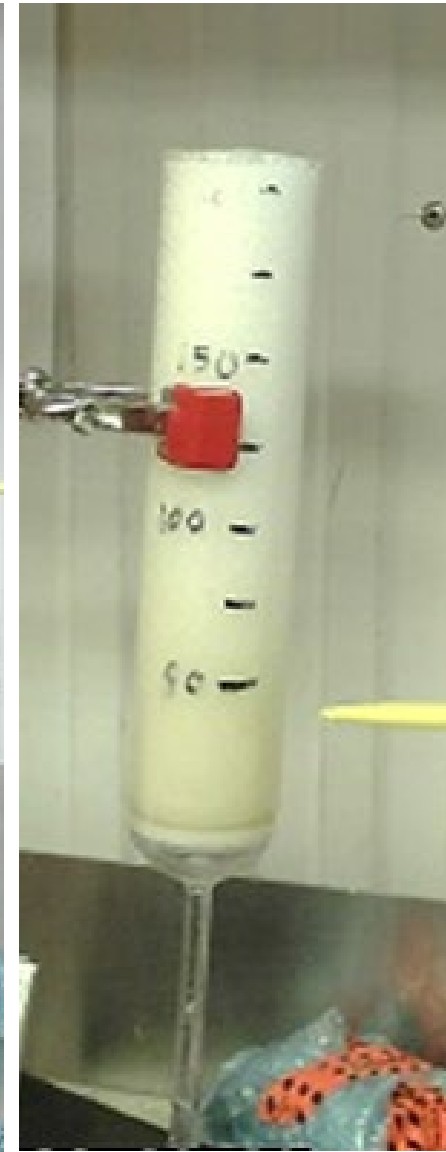
# TEG Foaming – Properties

- Low surface tension associated with high foaming tendency
  - allows the surface of a bubble to expand easily
  - HCs have low surface tension
  - **TEG has relatively high surface tension**
- Also requires the introduction of a surfactant
  - Inlet fluids carryover
  - corrosion inhibitor, soap sticks, compressor lube oil, etc.
- Viscosity increases stability
  - TEG viscosity very high (15.8 cP at 68°F)
  - makes it hard for bubble wall to get thin and collapse once formed

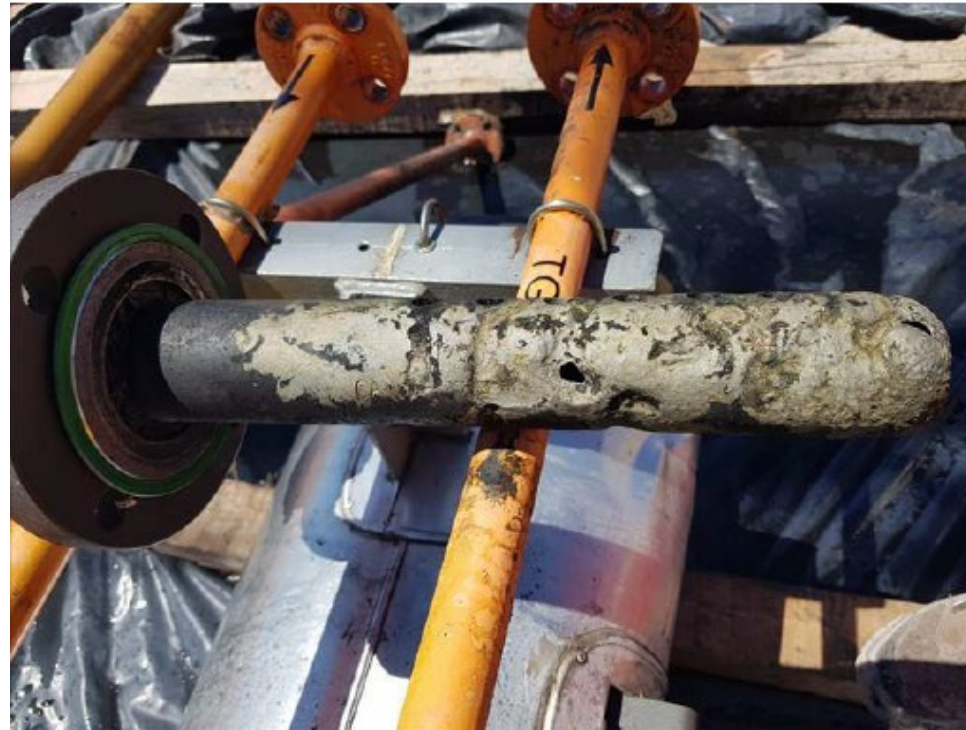
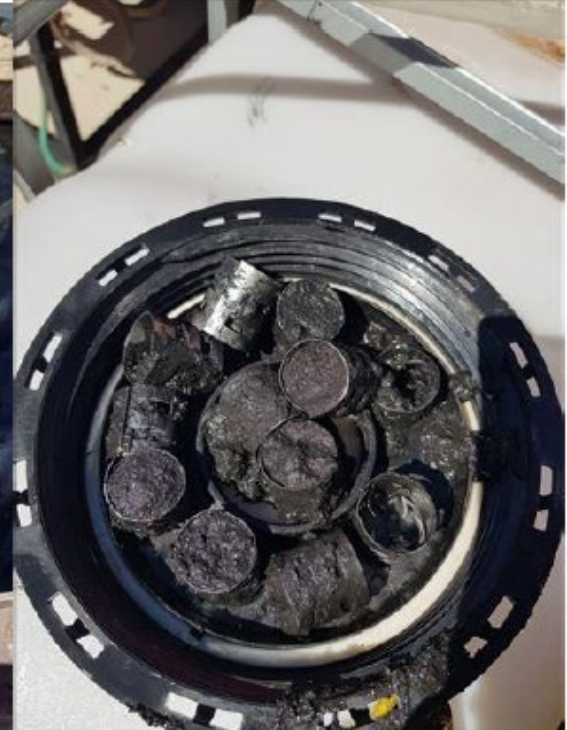
- Shut down and inspect still
  - corrosion damage to rich glycol distributor
  - completely plugged packing
- **Gather Data!!!**
  - analyze solids, glycol and feed gas
    - composition and size distribution
    - pH, Fe, TSS
    - CO<sub>2</sub>, H<sub>2</sub>S
    - inlet separator/coalescer

- Equipment
  - Replace still internals with 316LSS components (packing, reflux coil, distributor)
  - move stripping gas to packed column
  - consider 5-micron absolute filtration
  - heat trace inlet coalescer CVs to avoid hydrates
- Operating conditions
  - drop flash drum pressure to 50 psig from 80 psig
  - optimize TEG circulation rates and stripping gas rates

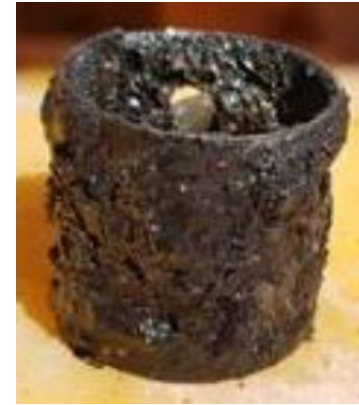
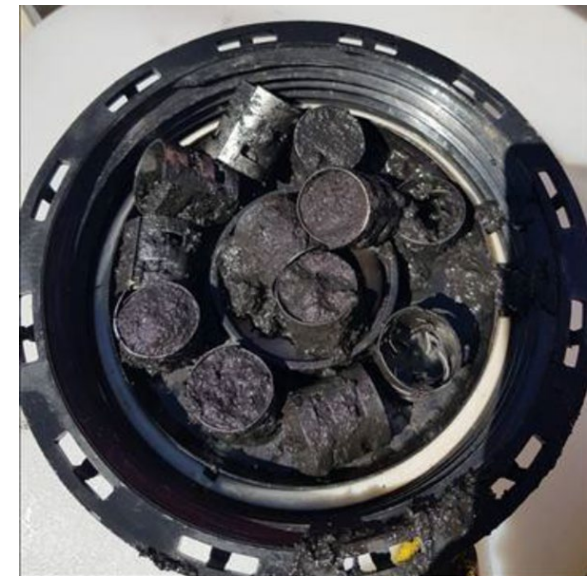
- corrosion damage to rich glycol distributor
- completely plugged packing
- About 95% iron sulfide corrosion products and rust – ***how is this possible in a sweet system?***

Component	Iron Sulphide (FeS <sub>2</sub> )	Ferric Oxy-Hydroxide III (Fe <sub>3</sub> O(OH))	Ferrous Sulfate Monohydrate (FeSO <sub>4</sub> •H <sub>2</sub> O)	Oxidized Iron (Fe <sub>3</sub> O <sub>2</sub> )	Sulphur (S)
Wt%	76	4	14	5	1
Source	H <sub>2</sub> S corrosion byproduct	Oxidized FeS <sub>2</sub> (sample care or in-process?)	Oxidized FeS <sub>2</sub> (sample care or in-process?)	Rust	Reaction of H <sub>2</sub> S and Oxygen

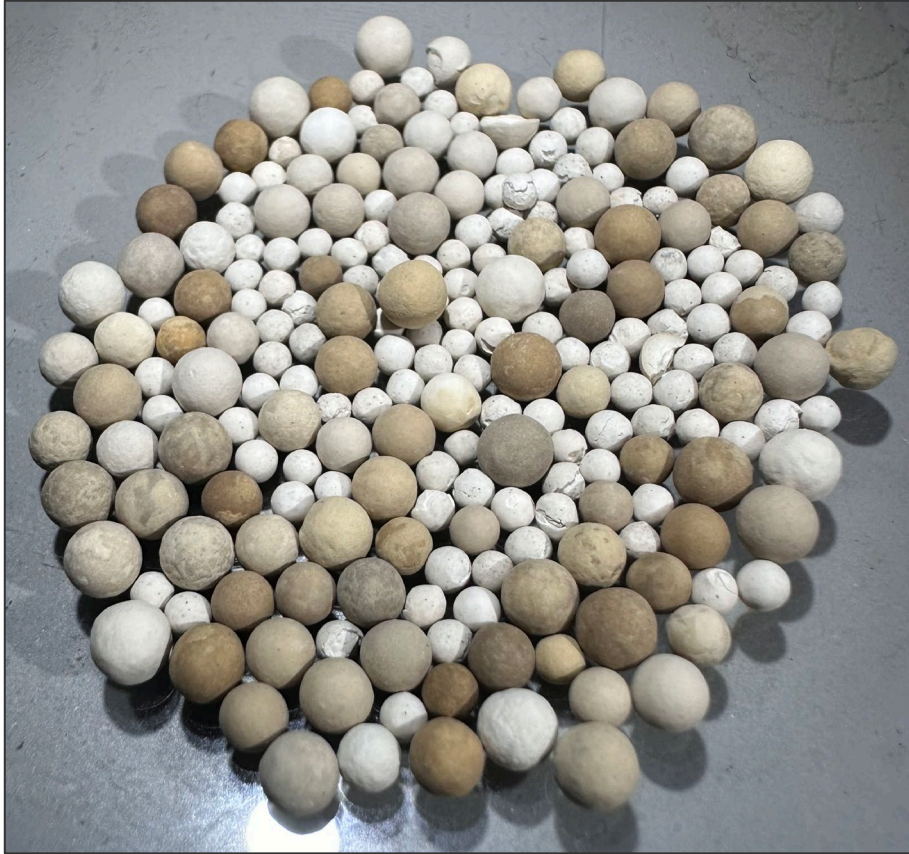
# Sample as Received

- The sample appeared to contain two or three different mesh sizes.
- The larger mesh sizes varied in color from off-white, tan, brown and gray.
- The small mesh size had a more consistent off-white color.
- A small portion of the large mesh size molecular sieves showed signs of cracking and erosion.
- A large portion of the smaller mesh size molecular sieves showed signs of cracking/breaking, and erosion.
