## HEBER DOMESTIC WATER IMPROVEMENT DISTRICT · NAVAJO COUNTY, ARIZONA

# The backup plan got tested before it got built.

Heber DWID had already secured nearly **\$4 million** from WIFA to interconnect two water systems and add a second storage tank. That project is in design. On **August 26, 2026**, the district's only storage tank collapsed. Overnight, an operator ran a temporary line to the Black Canyon tank and put the town back in water. It was a hand-built preview of the funded project.

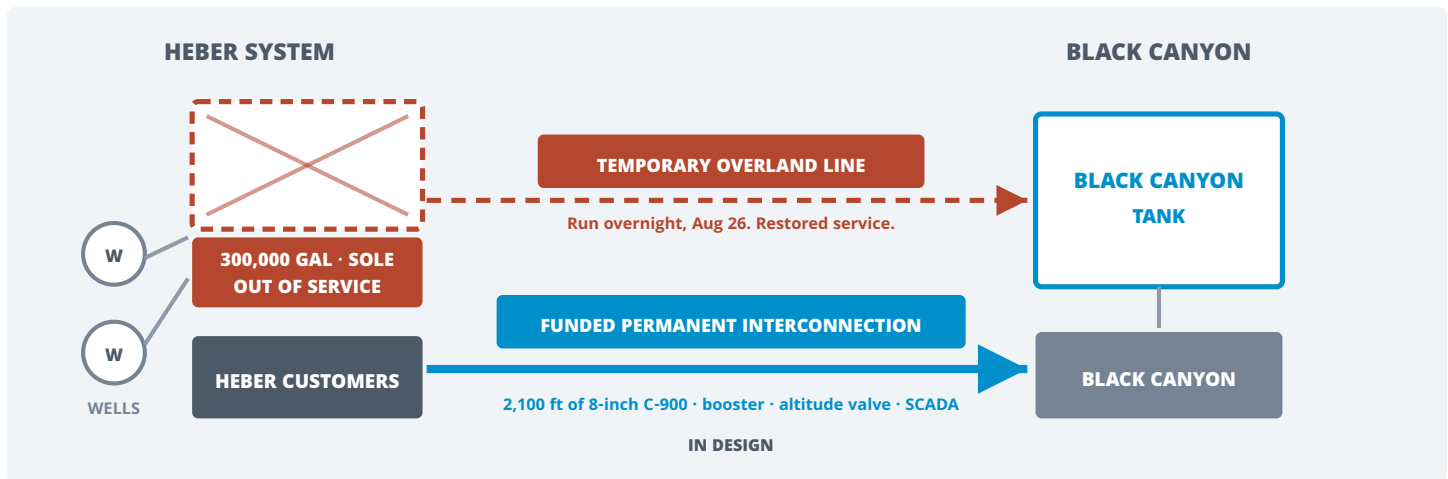
What the funded project builds permanently, the emergency improvised in one night.

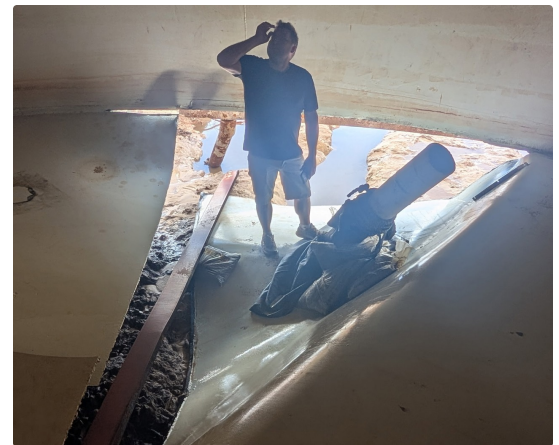
Inside the tank. The floor tore open at the seams and the whole bottom let go. The person is standing there for scale.

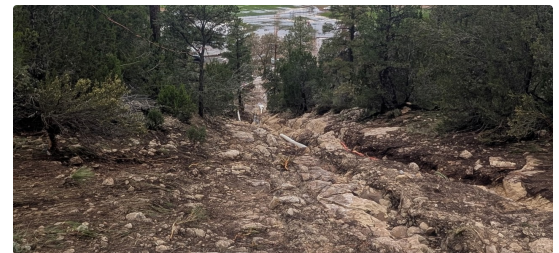
Where the water went. The scour channel runs from the tank site down to the school athletic fields.
