## MALONGO IT TOWER REMOVAL

Conbit was contacted by Chevron Angola to create access and remove the corroded section of an IT tower in Malongo, Angola. The top of the tower was severely degraded and no longer safely accessible. The tower stood over 40 meters in height, and the entire section above 30 meters, measuring 16 meters in the end, needed to be removed. Conbit engineered a safe access solution to remove the affected part of the tower.

Project Name  
Malongo IT Tower Removal

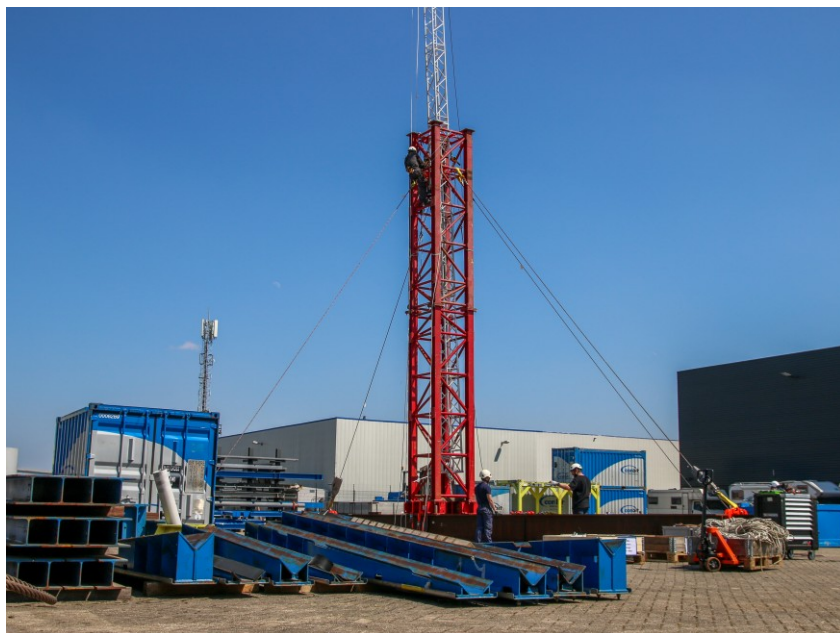
*Testing the access tower at the Conbit yard*

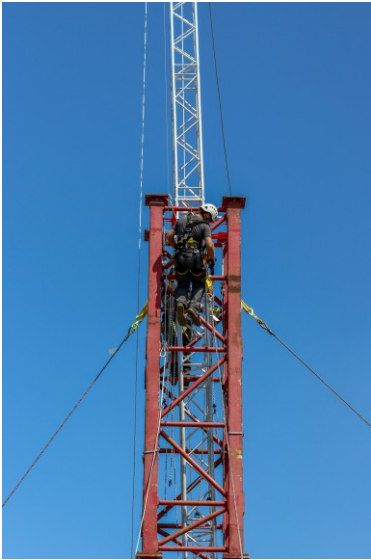
*Carrying out structural tests on the access tower at the Conbit premises.*

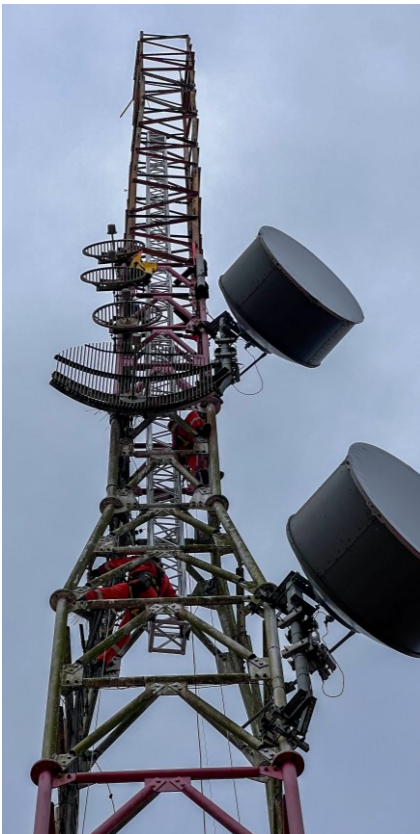
*Access tower in place to remove top of the IT tower*

To ensure technicians could safely access the corroded section, Conbit provided an access tower designed to offer secure connection points for rope access work in the upper part of the IT Tower. A maximum of 2 people could work above 30m on the access tower. It consisted of several aluminum L-struct (lattice sections) connected to each other and braced to the strong points of the bottom part of the tower by rigging equipment such as chain hoist, slings and Tirfor.

The removal of the top part was done by grinding and cutting using angle grinders, and saber saws. The removed parts were then lowered to the ground by ropes and rope access equipment.

The biggest challenge was finding a way to access the top part of the tower with the limited space available. The area to access the top part was 1.2m by 1.2m. With the access tower installed, there was just enough space for the rope access technicians to climb up and work.
