Liquefaction Ground Deformations and Cascading Coastal Flood Hazard in the 2023 Kahramanmaraş Earthquake Sequence

The 2023 Kahramanmaraş earthquake sequence produced extensive liquefaction-induced ground deformations and ongoing flooding along the shoreline of the Mediterranean port city of İskenderun, Türkiye. This study compiles field observations and analyses from cross-disciplinary perspectives to investigate whether earthquake-induced liquefaction was a significant factor for increasing the flood hazard in İskenderun. Geotechnical reconnaissance observations following the earthquakes included seaward lateral spreading, settlement beneath buildings, and failures of coastal infrastructure. Three presented lateral spreading case histories indicate consistent ground deformation patterns with areas of reclaimed land. Persistent Scatterer Interferometry (PSI) measurements from Synthetic Aperture Radar (SAR) imagery identify a noticeably greater rate of pre- and post-earthquake subsidence within the İskenderun coastal and urban areas relative to surrounding regions. The PSI measurements also indicate subsidence rates accelerated following the earthquakes and were typically highest n

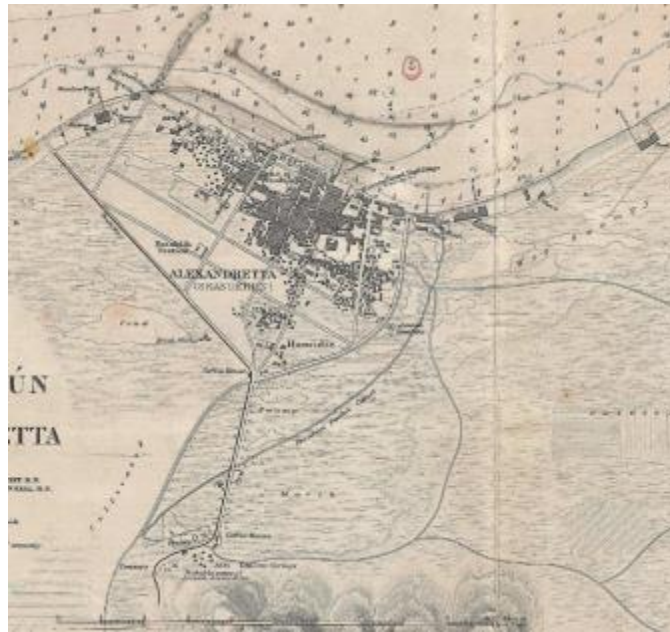
Figure 1. Historical map of İskenderun dated 1916 [obtained from the National Library of Turkey by Nalça (2018)].

The İskenderun shoreline was built out during the city's development. The 1916 shoreline depicted in Figure 1 approximately aligns with present-day Atatürk Boulevard. It represents the approximate border between reclaimed and naturally formed land. A satellite image of İskenderun in 1969 presented by Taftsoglou et al. (2023) shows reclaimed land built out beyond the 1916 shoreline but typically short of the present-day shoreline. These sources indicate the extent of shoreline filling just prior to the French Mandate period, and just prior to the 1970's industrialization. The 1916 and 1969 historic shoreline extents and location of the İbrahim Paşa channel are traced with post-earthquake observations in Figure 2. These provide a basis to delineate potential subsurface constraints on the extent of liquefaction and lateral spreading.

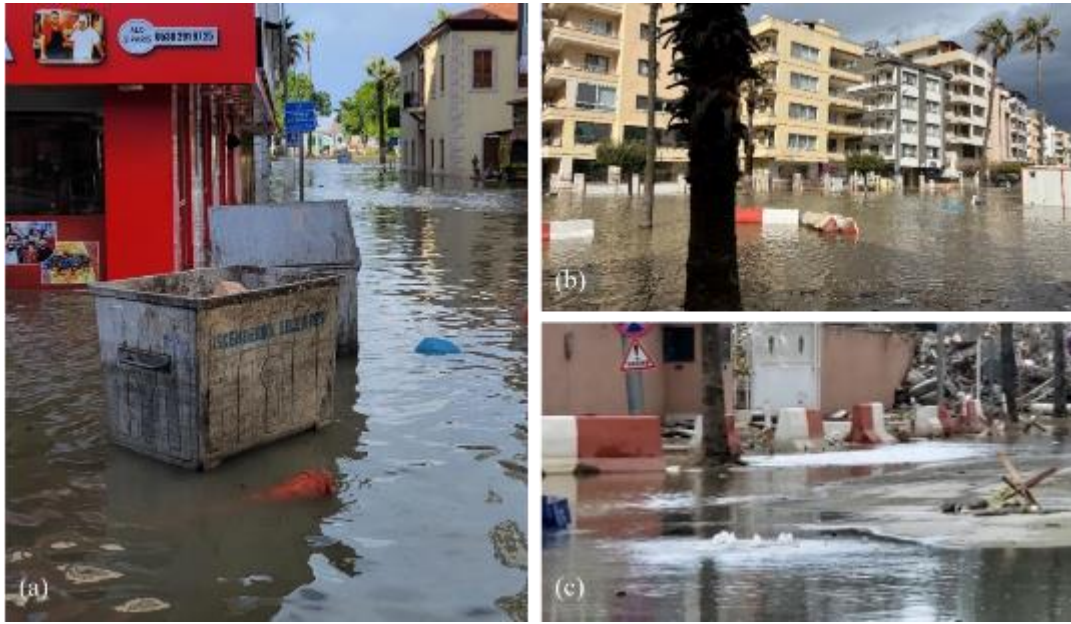
Figure 4. Flooding in İskenderun on March 29, 2023 along (a) Mareşal Fevzi Çakmak Street in the Yenişehir District, over 250 m from the shoreline (36.5912N, 36.1698E), and (b-c) Bahçeli Sahil Evler Street in the Çay District (36.5910N, 36.1792E), where water was observed expelling from a drain (36.5900N, 36.1768E).

The reports of flooding were consistent with observations by the GEER team of several building owners pumping water from their basements on March 28, 2023. The GEER team encountered notable flooding on March 29, 2023 (Figure 4). By the afternoon on this day, moderate rainfall and strong winds (i.e., reaching ~50 kmph due south, with higher gust speeds) impacted the İskenderun area. The nearest active tide station located in Arsuz indicated that the initiation of flooding aligned with the time at which the sea level was nearing high tide (VLIZ-IOC 2023). Waves were observed to overtop the existing seawall within the Yenişehir District. The flooding extended to over 250 m inland. The observed flood extents are indicated in Figure 2 (solid blue lines). The approximate flood extents in Figure 2 (dashed blue lines) were assumed from observations, discussions with locals, and drone coverage by local news reports (e.g., A Haber 2023). Flooding advanced at least two roads in from the shoreline, including past Mareşal Fevzi Çakmak Street (Figure 4a). The

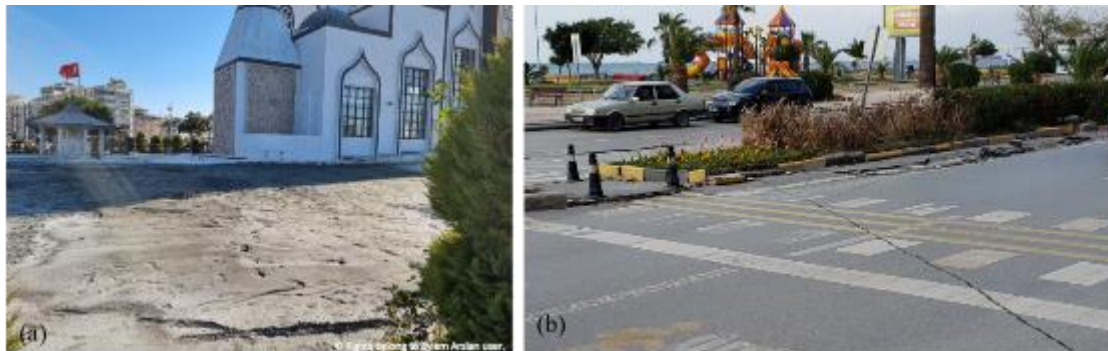
Figure 6. Post-earthquake ground deformations observed near the Nihal Atakaş mosque: (a) sediment ejecta (36.5933N, 36.1574E; photo by Eylem Arslan taken February 14, 2023), and (b) lateral spreading along Atatürk Boulevard (36.5933N, 36.1594E; March 28, 2023).

Transect LS-1 measured on March 28, 2023 indicated a maximum lateral ground displacement of 54 cm over a distance of 65 m. It extended from a rubble mound seawall to the median of Atatürk Boulevard, in an area of post-1916 and pre-2016 reclaimed land. The seawall at this location appeared to be 0.5 to 0.8 m lower than the recently placed segment of seawall in front of the mosque; however, it was not clear whether this reduced seawall height existed before the earthquake. The overall extent of this spread to the south may have been constrained by the shopping mall structure.

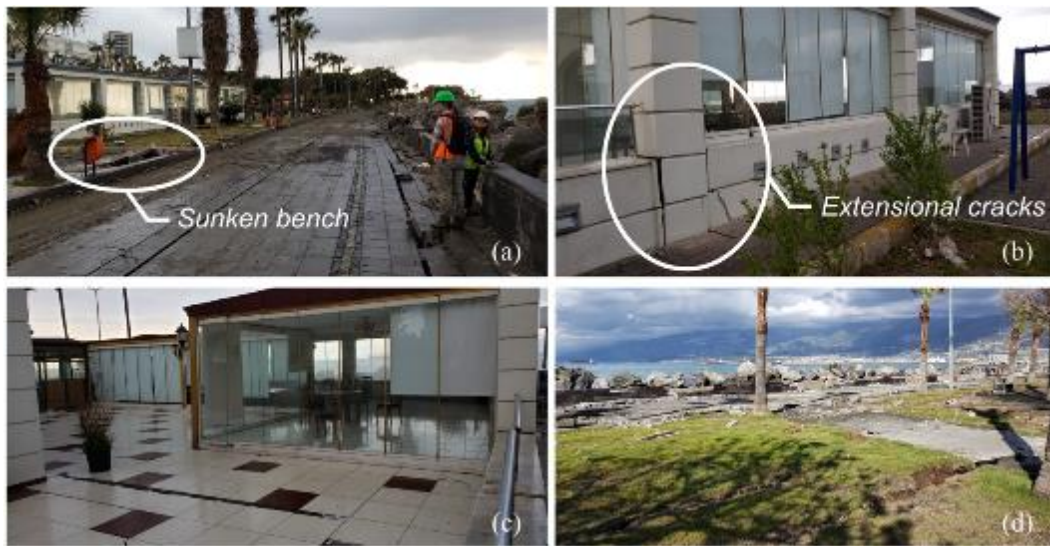
Figure 9. Lateral spreading at the Doğan restaurant and Emekliler park observed on April 1, 2023: (a) sunken park bench and shorefront damage behind Doğan restaurant patio (36.5936N, E36.1674E), (b) patio east exterior wall damage (36.5934N, 36.1672E), (c) patio damage (36.5935N, 36.1671E), and (d) transect LS-4 in Emekliler park (36.5930N, 36.1687E).

cracks were observed parallel to the shoreline between the seawall and Atatürk Boulevard (Figure 9a and 9d). The Teysir restaurant that had partially collapsed due to the March 29 storm surge is situated just east of the Emekliler park (Figure 8). A park bench situated along the shorefront walkway adjacent to the Doğan restaurant appeared stable during a reconnaissance visit on March 28, 2023, but had sunken into the ground following the March 29 storm surge and flood (Figure 9a). A one-story patio dining structure within the Doğan restaurant exhibited severe ground cracks through the floor and exterior walls (Figures 9b-c).

Transect LS-2' only considered cracks along the base of the exterior patio wall and concrete fence of the Doğan restaurant (Figure 9b and right of Figure 9c). The cracks were measured over a limited distance from the north edge of the patio to the north edge of the two-story restaurant building. This transect was plotted in Figure 7b by matching the accumulated displacements at the northeast corner of the patio (i.e., 14.8 m from the seawall in LS-2). Cracks were concentrated with a total width of 10.5 cm along the column at the south edge of the patio (~25 m from the seawall), and a width of 14 cm at the north edge of the restaurant building (~28.5 m from the seawall). Despite these structurally controlled concentrations of cracks along the building, the total displacements along the extent of LS-2' approximately matched those along LS-2 and LS-3.

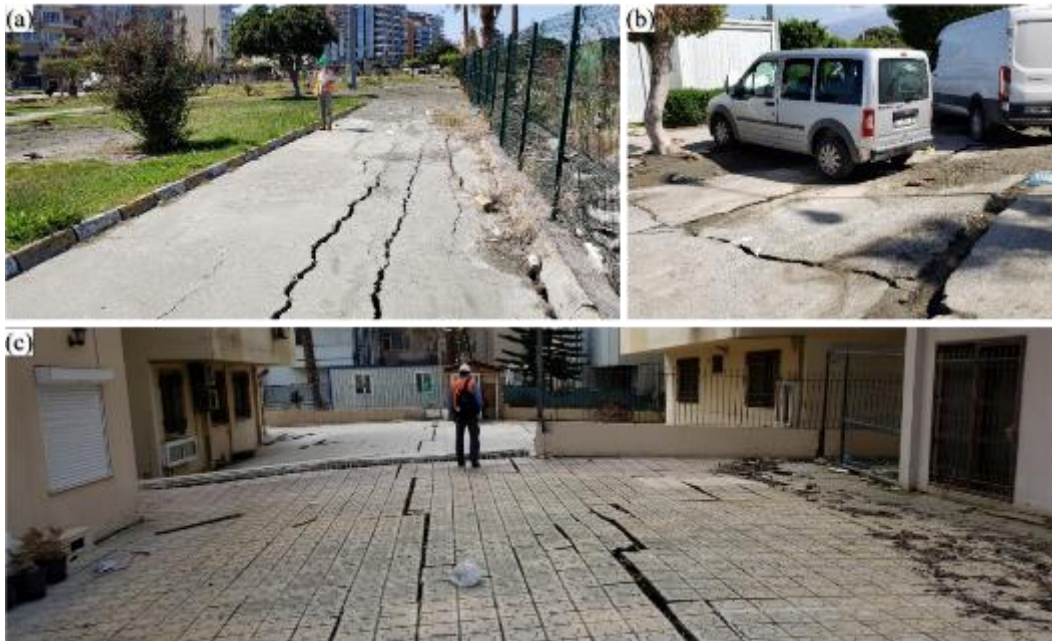
Figure 11. Post-earthquake ground deformations observed in the Çay District: (a) possible sand ejecta and lateral spreading near boat dock (36.5915N, 36.1789E; April 1, 2023), (b) cracks along Atatürk Blvd at the north end of transect LS-5 (36.5908N, 36.1767E; April 1, 2023), and (c) ground deformation and extensional cracks between settled buildings near LS-7 (36.5907N, 36.1792E; March 28, 2023).

estimated 1916 shoreline but intersected the 1969 shoreline. Lateral spreading between the shoreline and the north edge of Atatürk Boulevard (i.e., 0 to ~100 m from the shoreline; Figure 7d) was not measured due to the low visibility of cracks within the lawn area and an inability to access the boat dock during these site visits. Over 50 cm of additional lateral displacement is believed to have occurred within this area based on a previous walkthrough (e.g., Figure 11a).

Ground cracks were concentrated within the space between the two rows of 5-story buildings between Atatürk Boulevard and Bahçeli Sahil Evler Street (i.e., ~120 to 140 m from the shoreline; Figure 7d), suggesting over 20 cm of lateral extension in this area along LS-6 and LS-7 (Figure 11c). LS-5 depicted more gradual cracking between the buildings, which could potentially be attributed to a redistribution of crack patterns by a nearby 7-story building over a rigid foundation that had not settled. With the available information, it remains difficult to evaluate whether the cracks between the buildings resulted from ground deformation patterns influenced by building settlement (e.g., Moug et al. 2023; Figure 11c), overall seaward lateral spreading, or a combination of these or other mechanisms. Additional
