# Drying Behind or Under Shower and Tub Surrounds

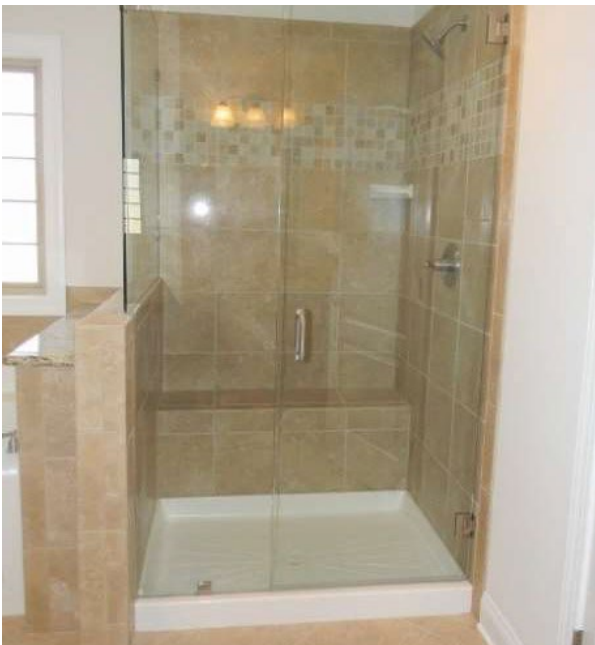
When there is a water supply line leak behind or under a shower or tub, it might be possible to dry affected drywall and framing from the other side of the tile or fiberglass surround by coming in from behind or under it. Remember, to dry wet materials, we just need to provide hot, dry air to the water and be able to confirm the wet materials are left in a state that won't promote microbial growth. If the supply line leak is in an exterior wall, it may be necessary to open the surround if we can't get air to that area from either side of the surround. Most times, if the leak is in the exterior wall behind the surround, the plumber will have to open it up to repair the leak.

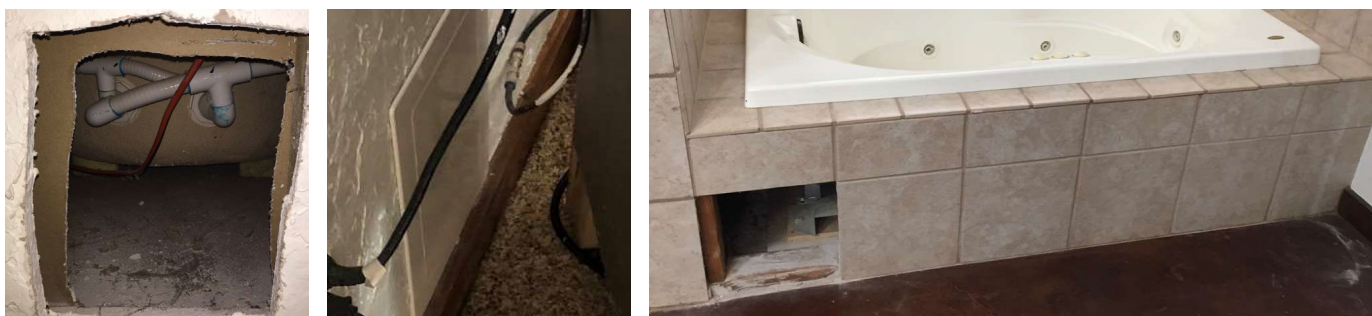
Once we identify what is wet, we can duct hot, dry air from our dehumidifier into the wall, while taking daily penetrating moisture meter readings inside the wall with a moisture probe attachment. See photo below for how to access under a tub surround. If removing one tile, be sure to not crack the tile so it can be reinstalled.

If you are in a state where there are shear walls on the adjacent wall, you will need to consult your local building codes before drilling holes in shear walls. I always tell restorers we can get hot, dry air into very small holes, and the hardest part might be obtaining good photos of our final moisture content readings to ensure we reached our dry targets. It will be much easier and less expensive to repair drywall instead of a shower or tub surround. The photos above are from a previous home I lived in in Texas, where I needed to access under my ceramic tile tub surround to dry under my tub. I simply cut a one-foot square of drywall out of the adjacent bedroom wall and once dry installed a simple plastic cover so it would be possible to access under the tub for any future repairs. I was also able to remove one tile to access where the water line needed to be repaired and reinstalled with matching grout.
