## 8 NOISE WALL

### 8.1 Definitions

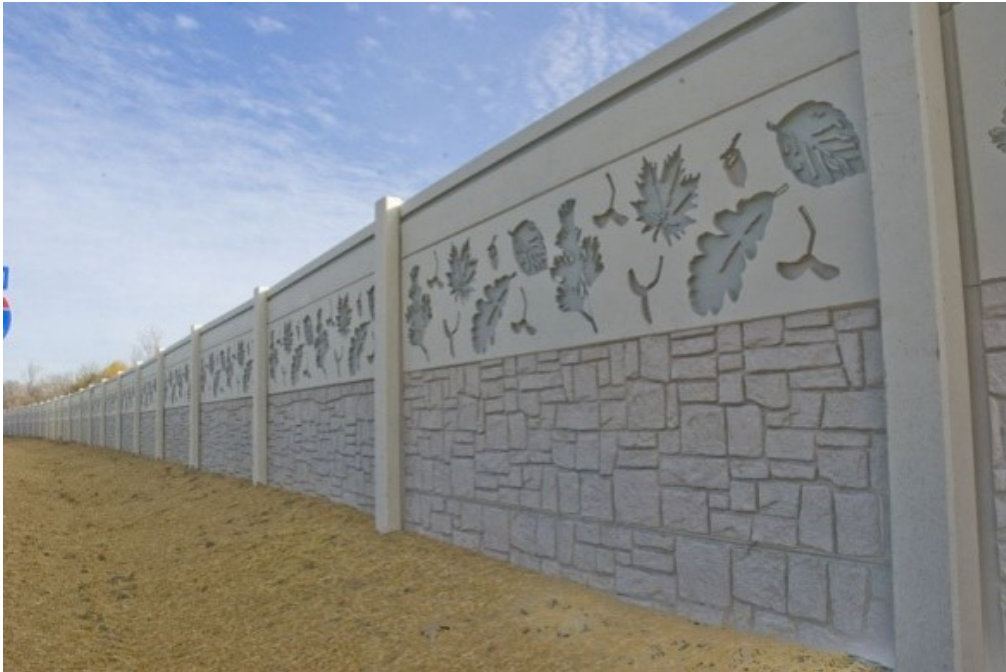
**Figure 8-3: Noise wall mounted on soil**

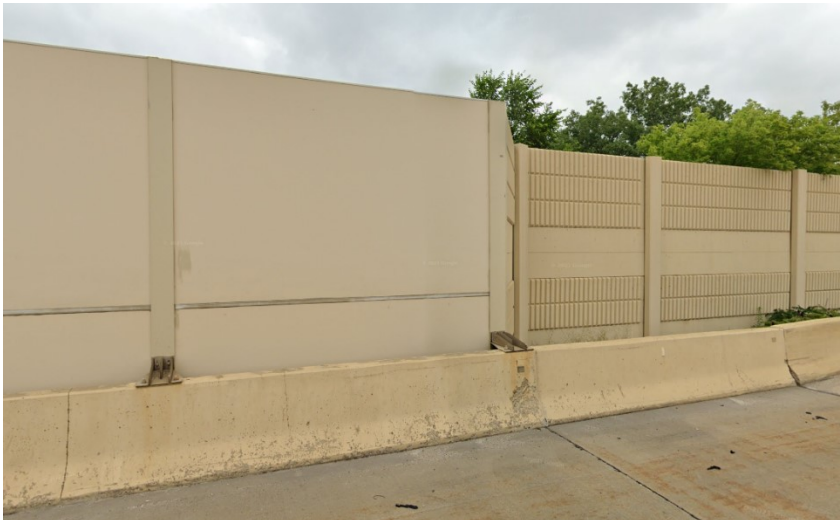
**Figure 8-4: Noise wall mounted on crash barrier**

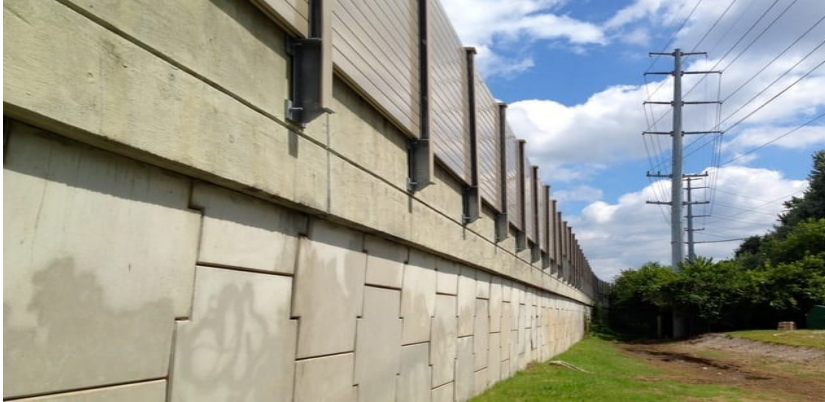
**Figure 8-5: Noise wall attached to retaining wall**

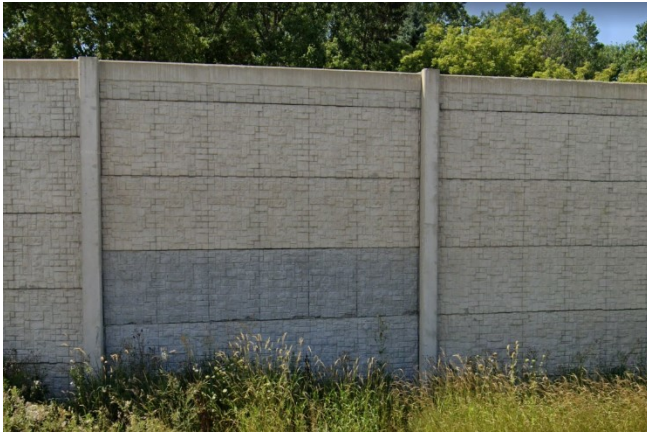
**Figure 8-8: Noise wall with vertical joints at posts and horizontal contacts between panels**

The purpose of the joint inspection is to identify distressed joints between noise wall panels that could affect the performance of the noise wall. Joints may be sealed and distresses to seals should also be captured. Joints may be expansion joints, compression joints, strip seal expansion joints which use a waterproof gland, or some other joint type. Noise walls with expansion joints in the center of masonry panels are considered “T-types” and those with expansion joints in columns are considered “H-types.” Joints present at post and panel noise walls are typically not exposed to view and are interior to the post. The horizontal contact between panels of a noise wall is not considered a joint as there is no material present to define the element such as joint compound or filler.

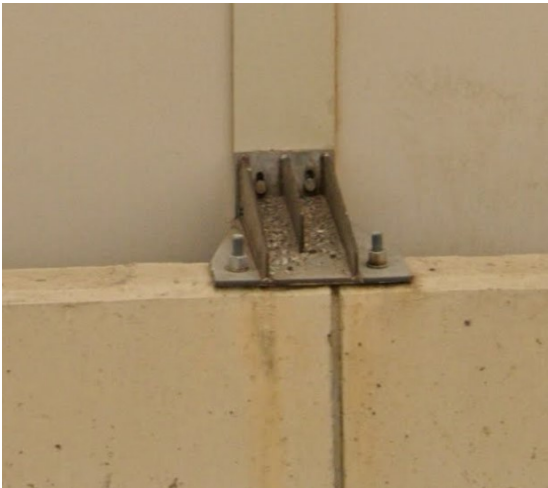
**Figure 8-10: Noise wall attachment to concrete barrier**

Attachments such as anchors or other connections are used to connect the noise wall to a structure which in turn supports the noise wall. This subsection discusses the attachment joining the noise wall to a foundation, bridge, retaining wall, concrete barrier, or other structure.

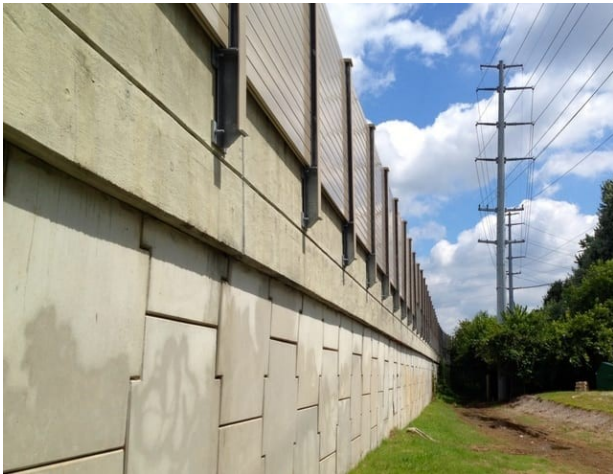
**Figure 8-11: Noise wall attached to retaining wall**

The support for the noise wall may be a foundation, bridge, or other structure. The bridge or other structure (such as a retaining wall) are inspected as described in the MiSIM for bridges or Section 3 for retaining walls. The noise wall is typically attached to a foundation or retaining wall. A noise wall may wrap around a bridge and have both foundation and bridge support. In these cases, rate both elements of foundation and bridge or structure attachment element.
