CASE STUDY

Croydon Universities NHS Trust Hospitals

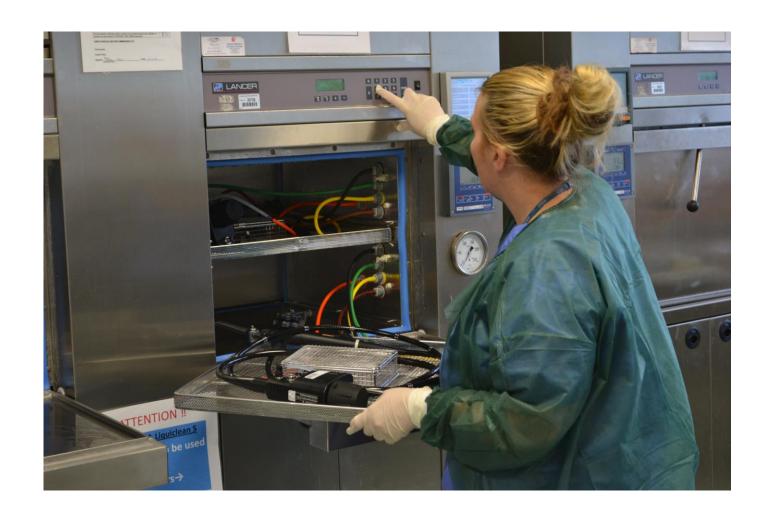
This bank of 6 machines sterilise medical utensils by way of special cleaning process delivered at very high temperature and are critical for patient care services.

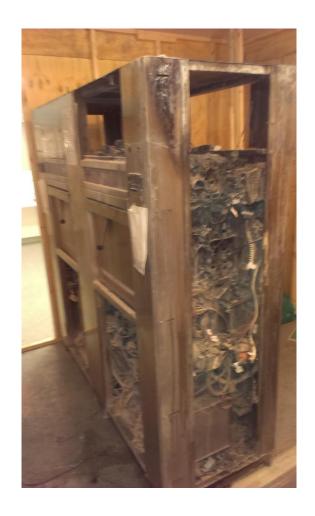
This is one of the machines following a serious internal fire which resulted in significant water and smoke damage as well as the loss of the machine and critical patient care services

The affected room and adjoining areas were cleaned and redecorated, and a replacement machine was ordered. The machines were on the 4th floor, so water damage was extensive.

Prior to the installation, the Trust consulted their fire systems specialist as to what measures might be employed to mitigate a serious re-occurrence.

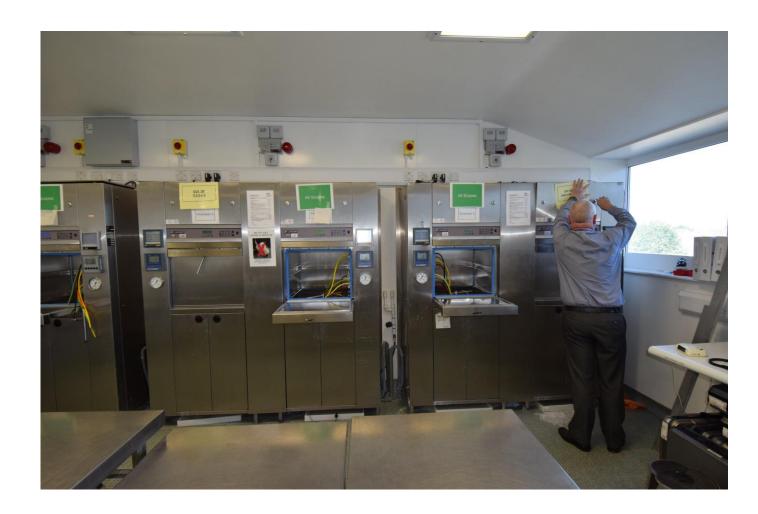
Within 7 months of installation a second fire event occurred – however it was a very different story – Here is the hospital engineer opening up the machine access panels

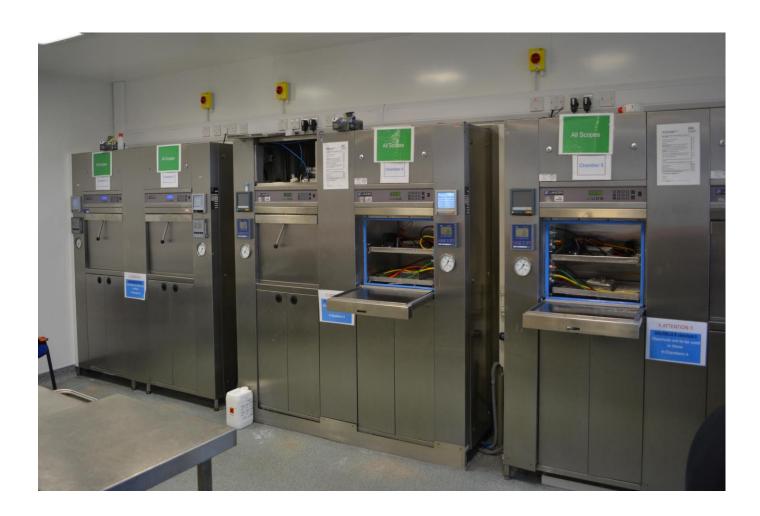
Post fire –

- Machine overhauled & repaired
- System re-armed with FirePro
- Patient care resumed
