# **MAINTENANCE CONSULTANCY SUCCESS STORIES**

## OFF-SHORE GAS LIFT COMPRESSOR WELDING RUPTURES

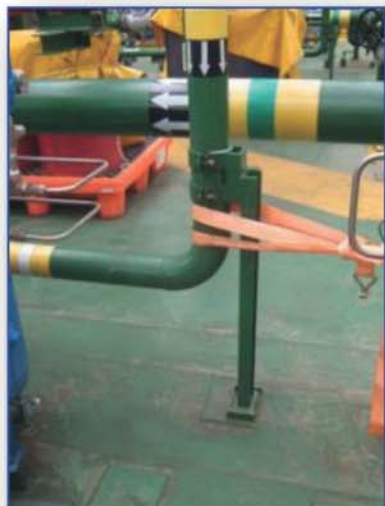
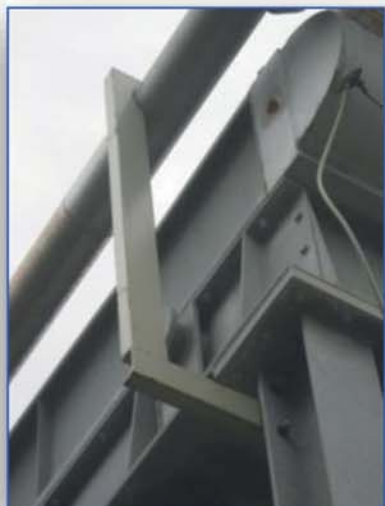
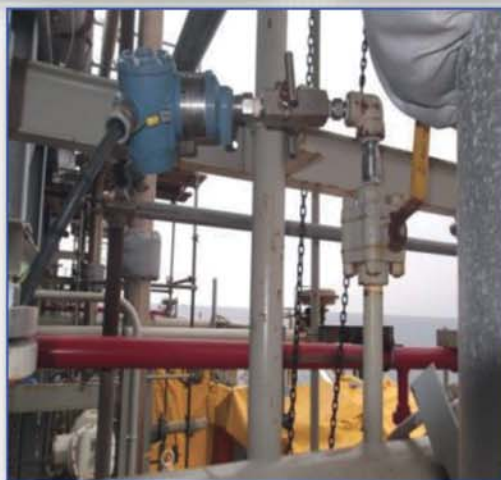
*Examples of inadequate supports for piping and instruments*

- high vibrations since the first start-up
- skid design failed to consider alternating forces
- poor support design

- acoustical study revealed the necessity for:
  - restriction orifices
  - new support installation

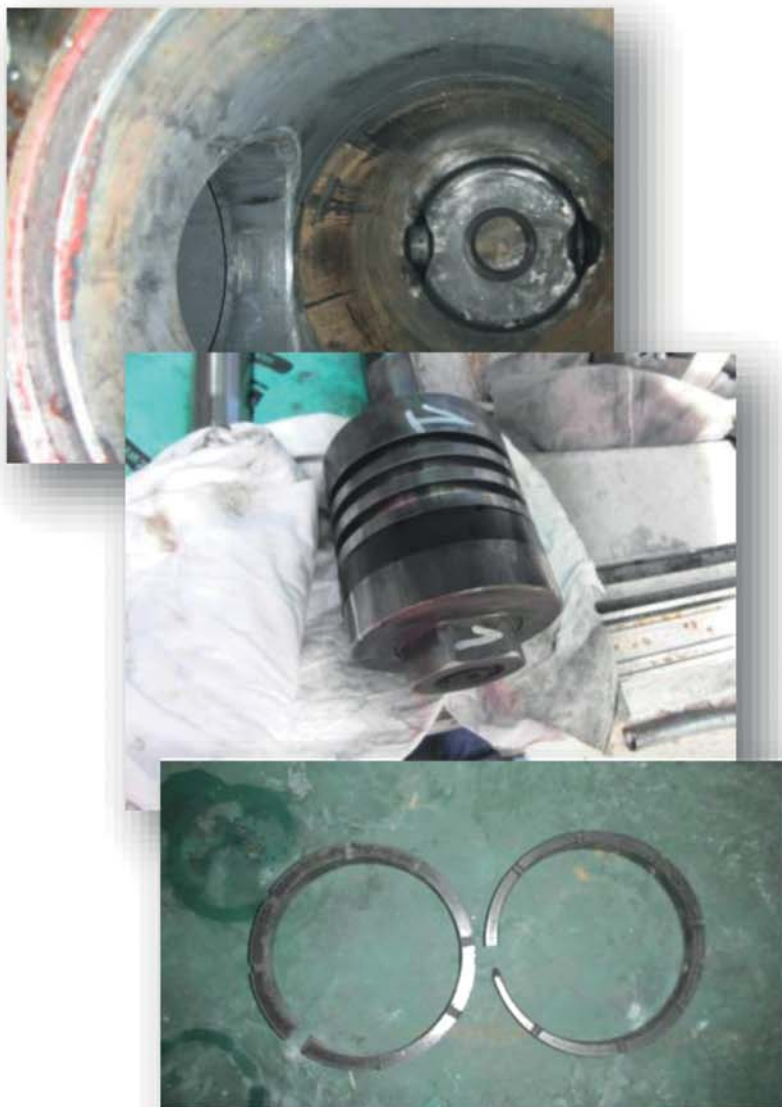
- rapid wearing of PTFE piston sealing elements

*Cylinder internal, piston and bands*

- high performance PEEK material suggested
- scheduled temperature monitoring program

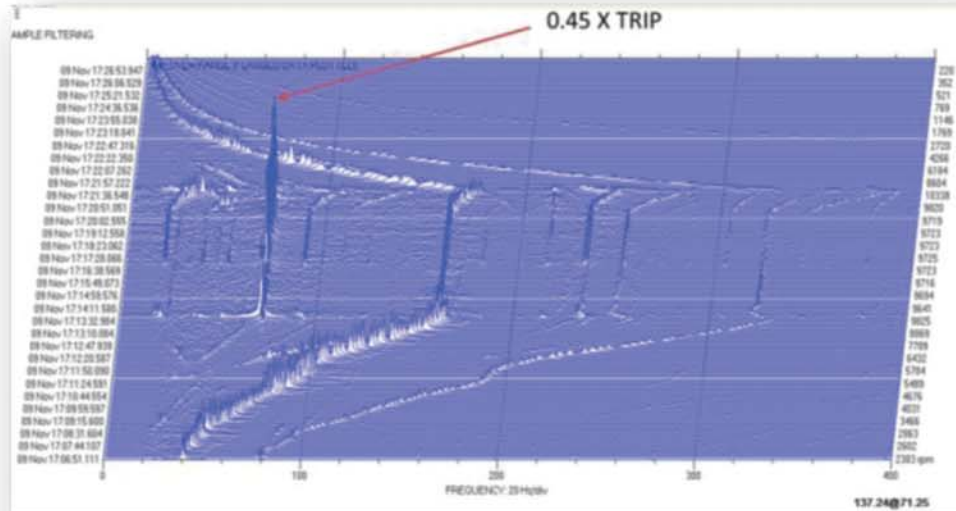
*Bearing Vibration Spectrum*

- high vibrations, both low and high frequency, after maintenance stop

- substitution of some bearings with 4-lobe types (low-frequency vibrations)
- trim balancing (for synchronous vibration)

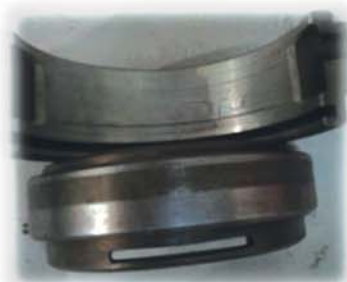
*Old bearing*

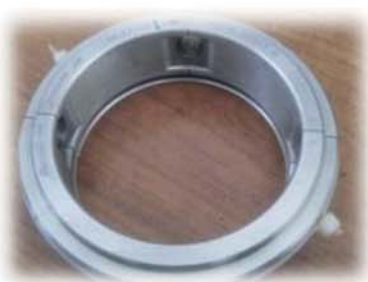
*New bearing*

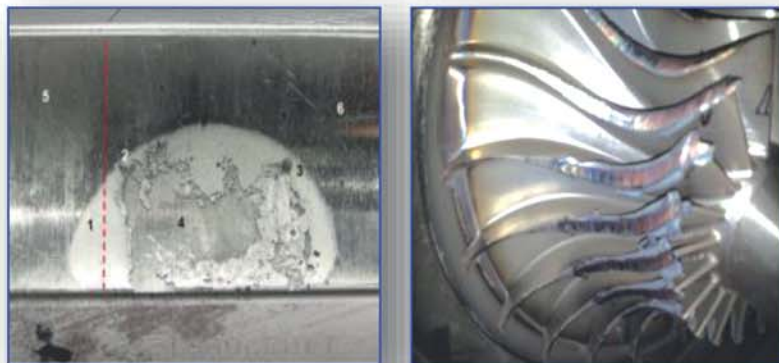
*Damaged bearing pad and impeller*

- high vibrations
- major damages to bearings and impeller

- increased clearances on new bearings
- check of the rotor design
- check of the new bearing arrangement

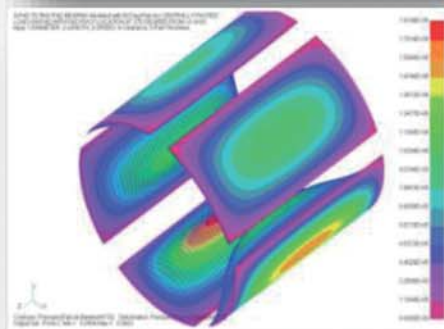
*Lateral analysis*

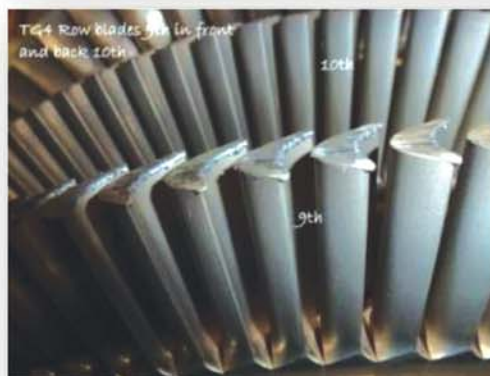
- severe damages to the rotors
- casing bow (non uniform expansion), resulting from an insufficient thermal insulation of the casing

*Rubbing of blades*

- re-calculation of the thickness of the thermal insulation
- suggested correct procedure for turbine warm-up
- revised seals radial clearance

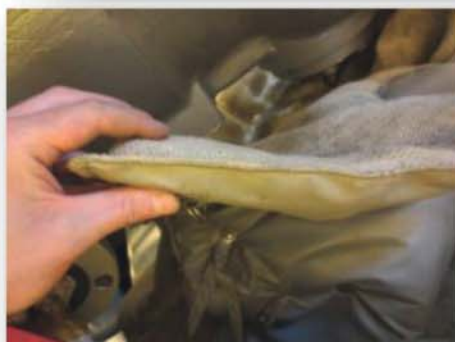
*Bottom half cylinder insulation blanket thickness*

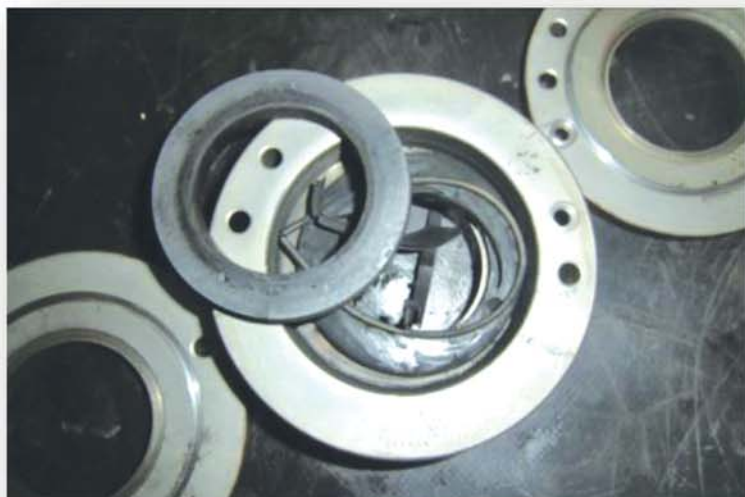
*Ruined packing rings*

- recurrent rod scratching
- chromium on the rod surface

- roughening treatment to increase the transfer film capacity
- suggested high performance PEEK material

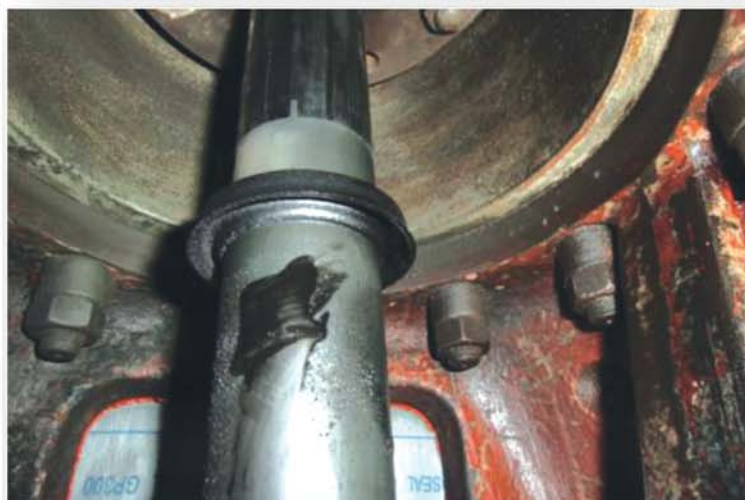
*Rod wearing*

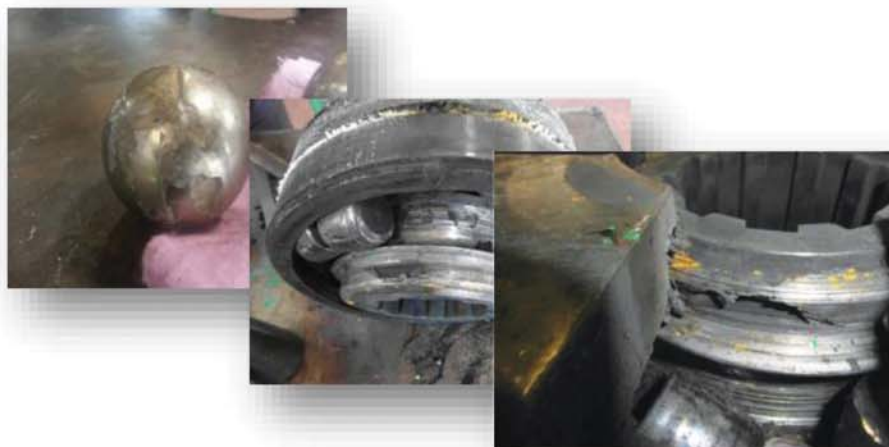
*Bearing failures*

- reported also one catastrophic rupture

- new bush design
- superbolt style tightening method
- detailed tightening procedure

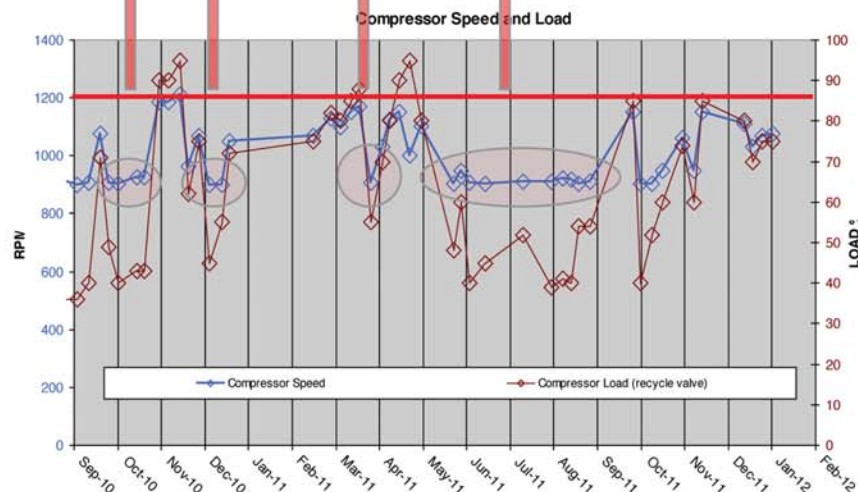
Correlation between rotation speed and vibration

- correlation between rotation speed and high vibration
- mechanical resonant frequencies

- keep rotation speed over a minimum level

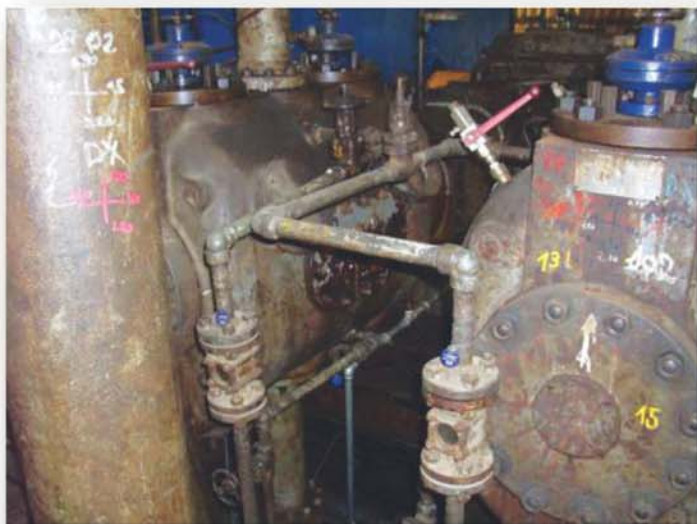
*Cylinders*

- high cylinder vibrations
- high pin load caused by higher suction pressure

- 2<sup>nd</sup> stage cylinder bore diameter modified
- high-resistance rolled thread tie-rods
- volume bottles size increased

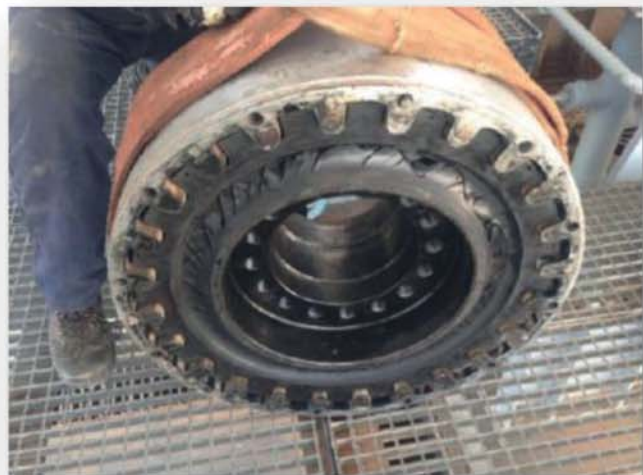
- found damaged coupling

*Damaged coupling*

- coupling substitution
