Full Scope Refurbishment of Storage Tank 2026

Project Overview

C&D Access was engaged to deliver a full-scope, out-of-service refurbishment of an above-ground storage tank at a major UK terminal. The asset required extensive mechanical renewal, advanced inspection, surface preparation, and coating readiness works due to identified degradation, coating breakdown, and integrity concerns across multiple structural areas.

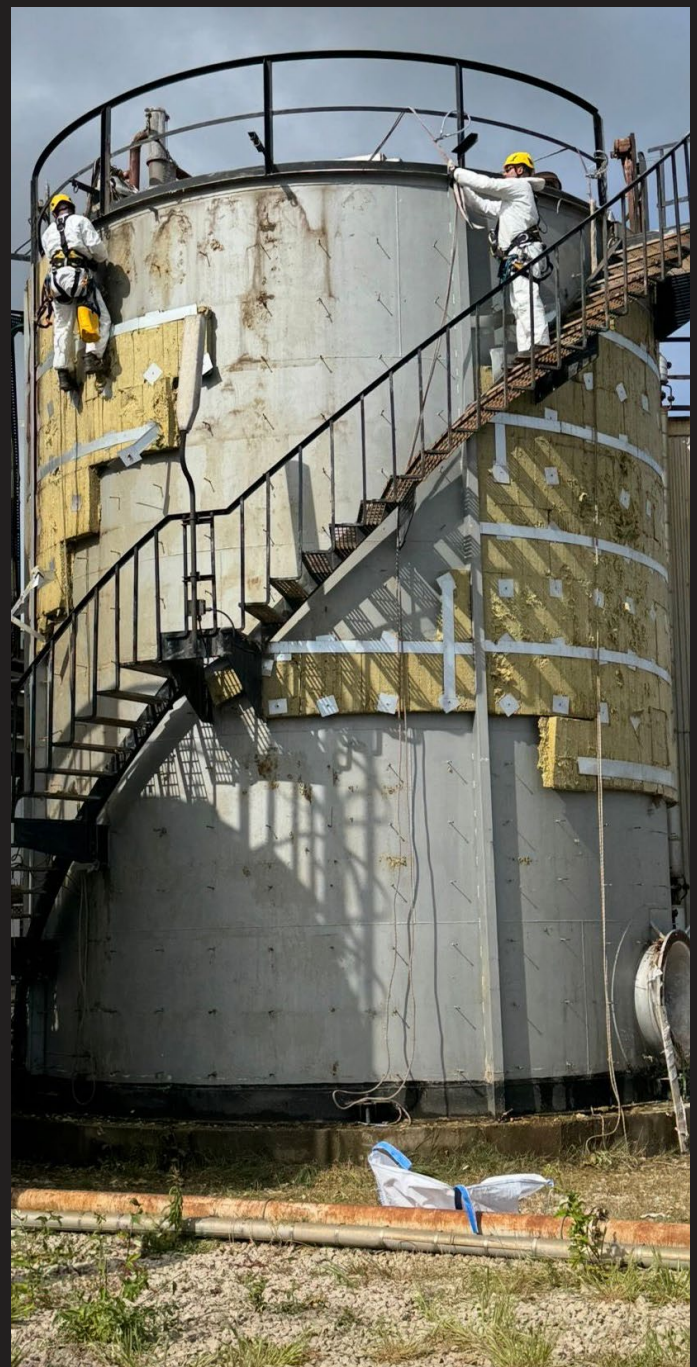
Removing tank insulation using Rope Access

The tank was fully isolated and prepared for entry. Existing insulation was removed from the tank shell, including the extraction of all insulation pins to expose the underlying steelwork. This enabled unrestricted access for inspection and refurbishment activities and formed the foundation for subsequent surface preparation works.

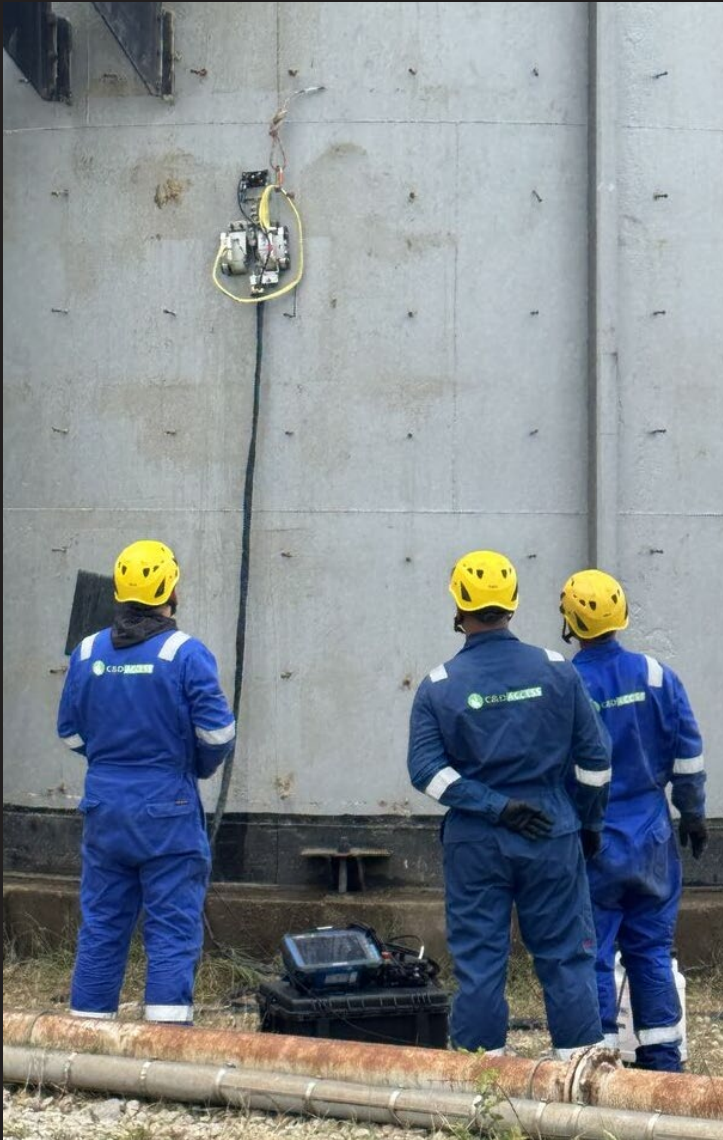
Using state-of-the-art technology for Phased Array NDT

- External visual assessment to identify corrosion, coating breakdown, deformation.
- Phased Array Ultrasonic Testing (PAUT) corrosion mapping of the tank shell to determine remaining wall thickness.
- Ultrasonic thickness measurements of the roof, sump, shell, and all nozzles.
- Magnetic Particle Inspection (MPI) of sump and shell nozzles to detect surface-breaking indications.
- UAV-assisted roof inspection to safely assess roof structure condition without the need for working at height.

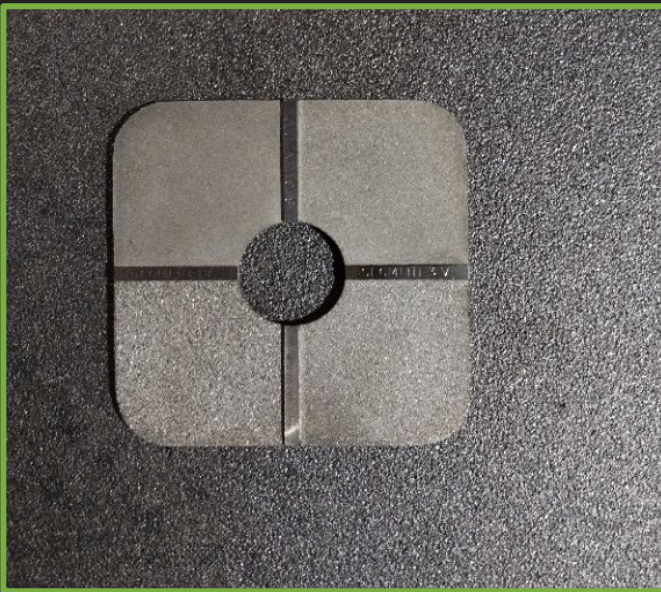
Surface roughness medium using ISO comparator (G)

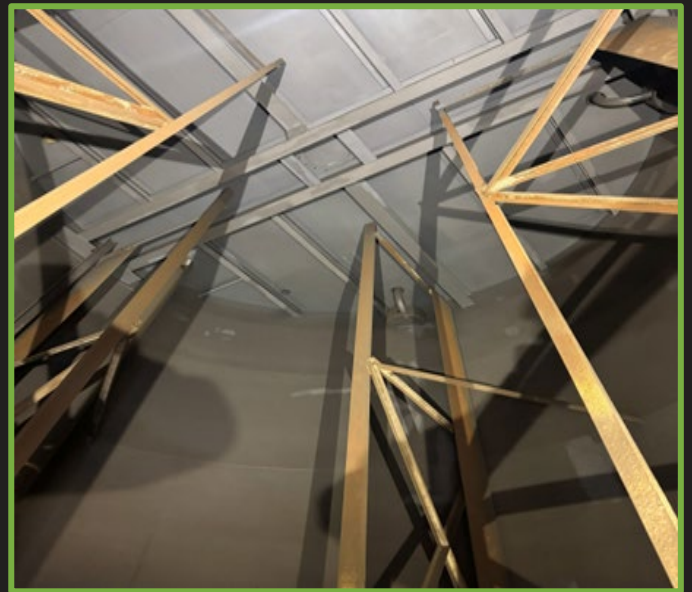
Post lining application on tank shell and roof

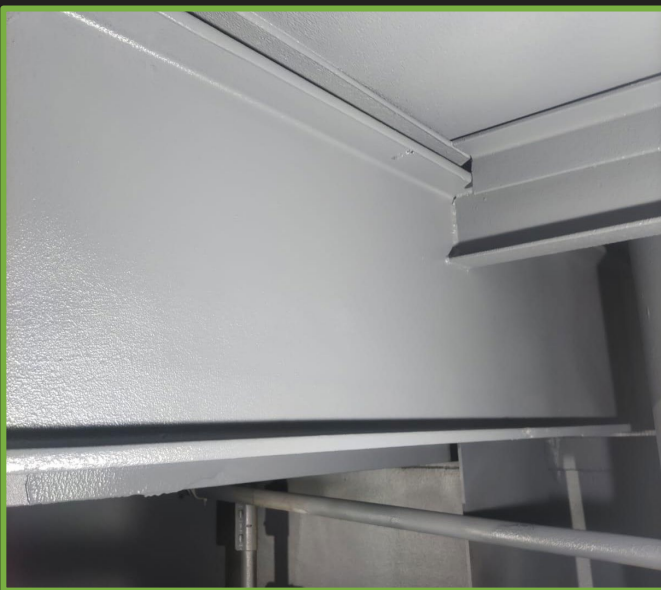
Post lining application of tank roof structure

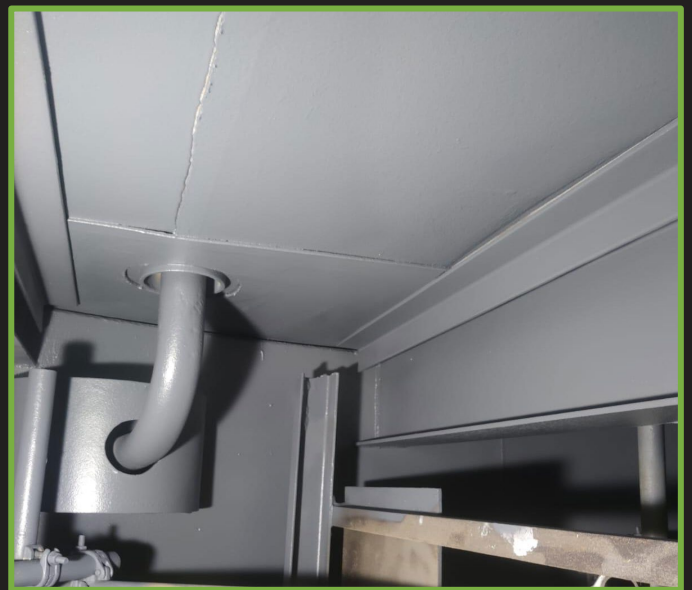
Post lining application of tank roof structure

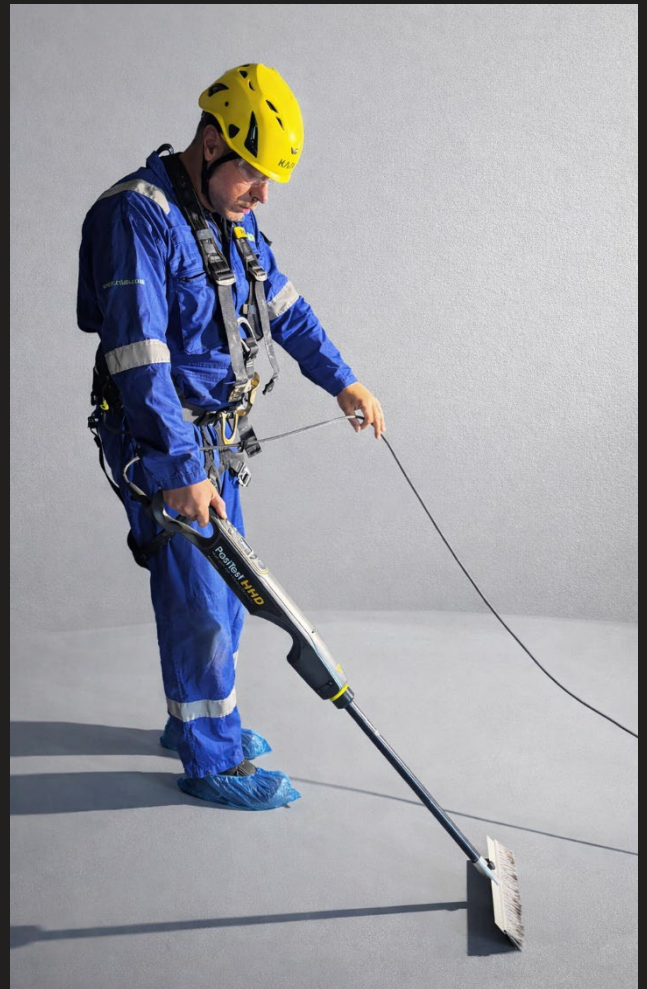
High Voltage Holiday Testing

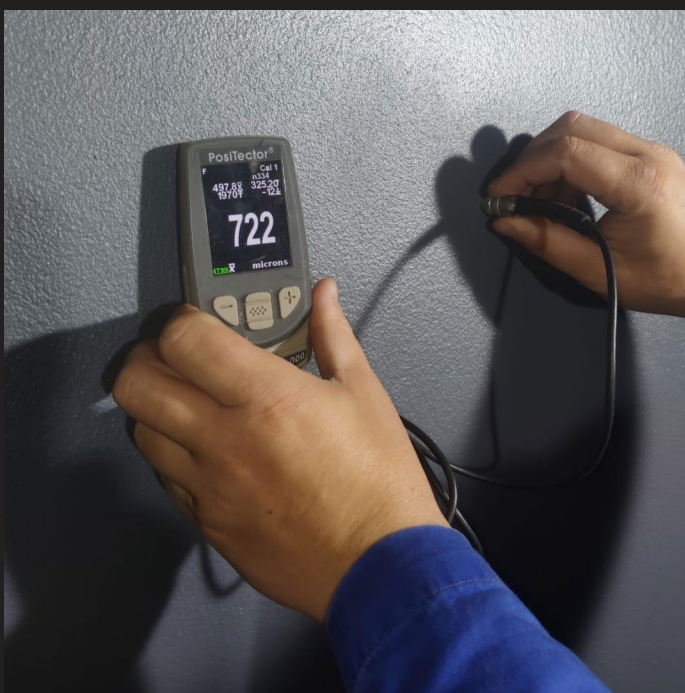
DFT Paint Thickness Measurement

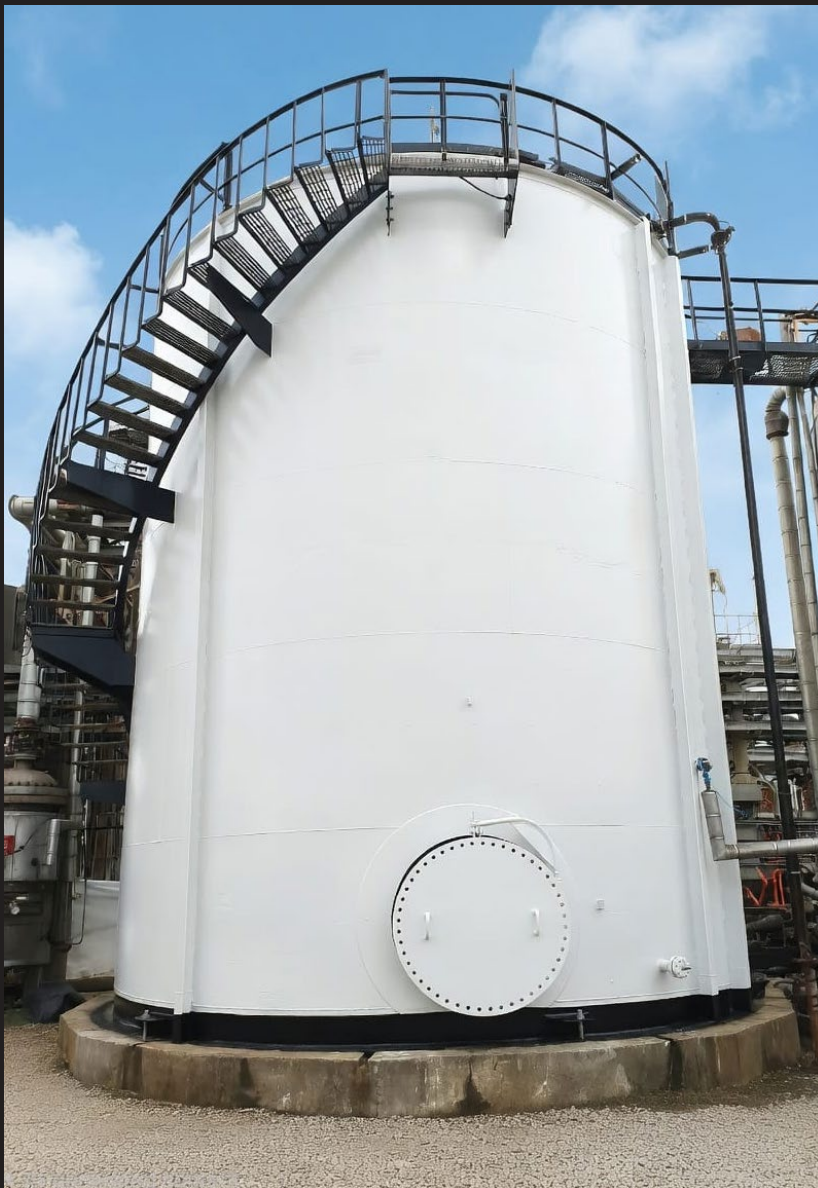
Fully refurbished tank

The project was completed within 8 weeks with a strong focus on safety, quality assurance, and environmental compliance, resulting in the restoration of structural integrity and extension of the tank's operational service life.
