**A Guide for Good Samaritans to Help Remediate  
Abandoned Hardrock Mines in the US**

by  
Olenka Forde

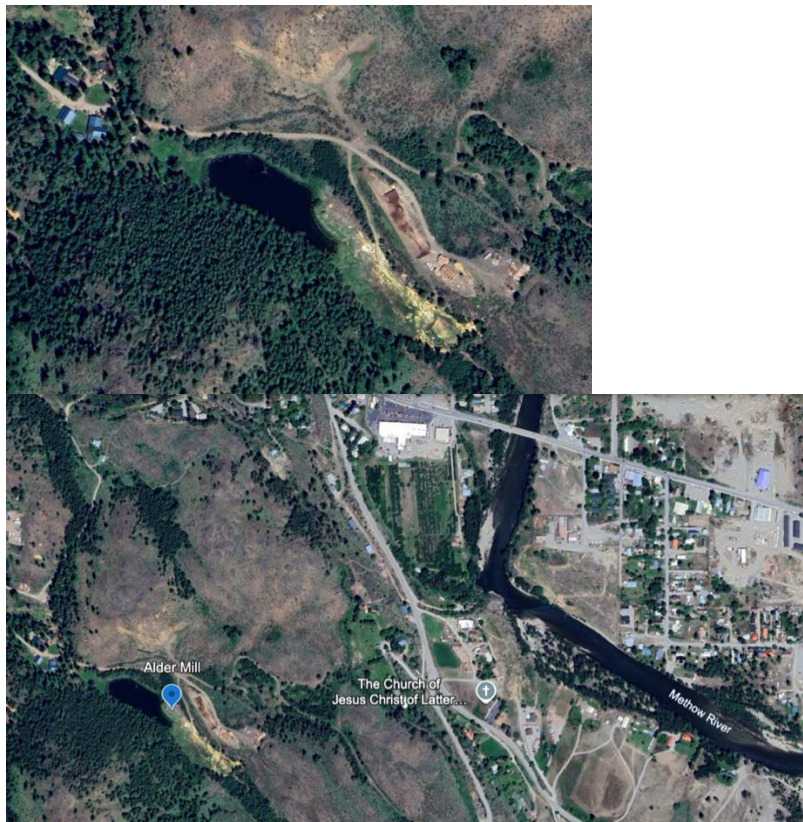
Figure 1a, 1b: Google Earth Aerial Image of Alder Mill. 1a is zoomed into the site and 1b is zoomed out. Retrieved January 14, 2025.

The Alder Mill site is an abandoned flotation mill that operated from 1949-1952 and concentrated ore from various gold (Au) and copper (Cu) mines. The site is on private property in Okanogan County, approximately 0.4 miles from the Town of Twisp, Washington, and adjacent to the Methow River (Figure 1). Historically, there were two unlined tailings ponds. The lower tailings pond was excavated and remediated in 2004. The upper pond remains on site, covering an area of 10 acres, and poses an ongoing concern for contamination to the surrounding environment and water sources. The tailings contain potentially economically recoverable Cu, zinc (Zn), and nickel (Ni). Alder Mill is a Good Samaritan candidate site due to the potential for metal recovery from waste and the need for restoration to reduce heavy metal contamination to the Methow River and nearby domestic drinking water wells.

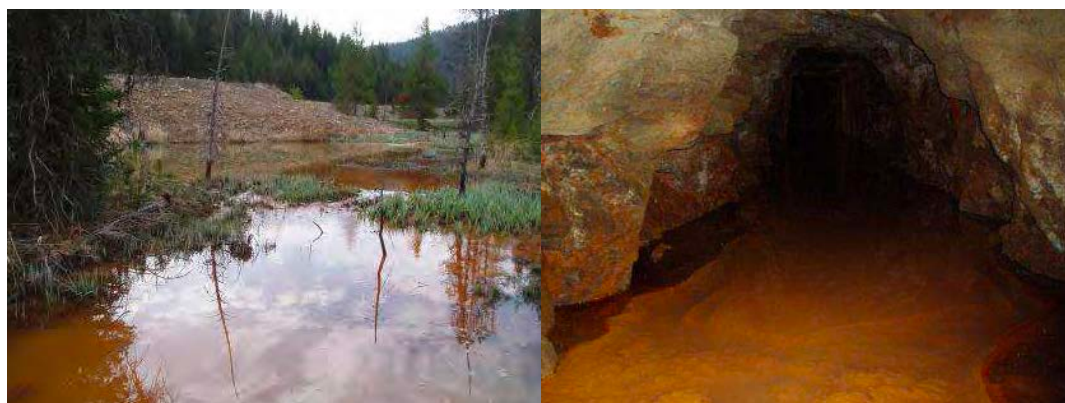
Figure 2: Photographs of part of the lowest settling pond (left) and of the Blacksmith tunnel adit (right) (CES, 2013).

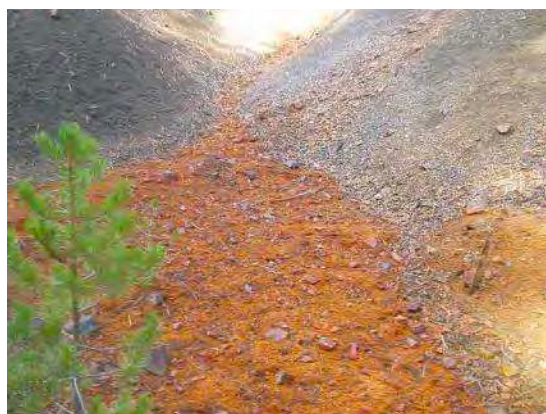
Figure 3: Photograph of overflow from adit across Waste Rock Pile #2 (CES, 2013).

In addition to water contamination, another environmental concern at Congo Gulch Mine is the large volume of tailings and waste rock piles in the stream channel at Congo Gulch. Waste Rock Pile #1 is approximately 15,000 yd<sup>3</sup> and covers 0.9 acres north of the adit, extending downslope to the Congo Gulch. Waste Rock Pile #2 is approximately 20,000 yd<sup>3</sup> and covers 11 acres southeast of the adit (Figure 3); this waste pile has partially eroded into Congo Gulch. Two smaller tailings piles are near the mill and cyanide plant.

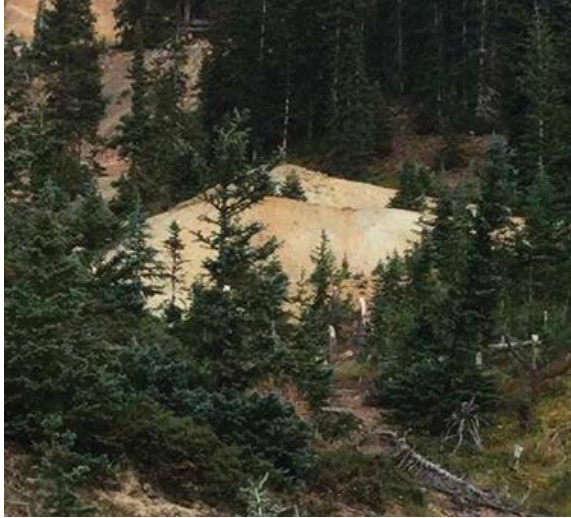
Figure 2: Base of waste rock pile (AI, 2020).

The other environmental hazard of concern at English Maid Mine is the waste rock pile located directly west of the adit on-site. Soil samples from the waste rock pile were measured to exceed EPA Recreational and Industrial SLs for As and Pb. The same soil samples exceeded either or both EPA Birds and Mammals and Plants and Invertebrates Soil SLs for Sb, As, Cd, Cu, Pb, Mn, Se, and Zn. A summary of these notable concentrations are 15.2 mg/kg Sb, 87.5 mg/kg As, 2.18 mg/kg Cd, 90.2 mg/kg Cu, 2460 mg/kg Pb, 464 mg/kg Mn, 3.01 mg/kg Se, and 549 mg/kg Zn. Additionally, synthetic precipitation leaching procedure (SPLP) was performed to assess leaching potential of the waste rock, but since none of the metals exceeded the 20x EPA MCL, the metal levels were not predicted to adversely affect groundwater quality. The waste rock pile was observed to have eroded downstream, and storm events were expected to increase runoff of the rock as sediment into the PPE streambed.

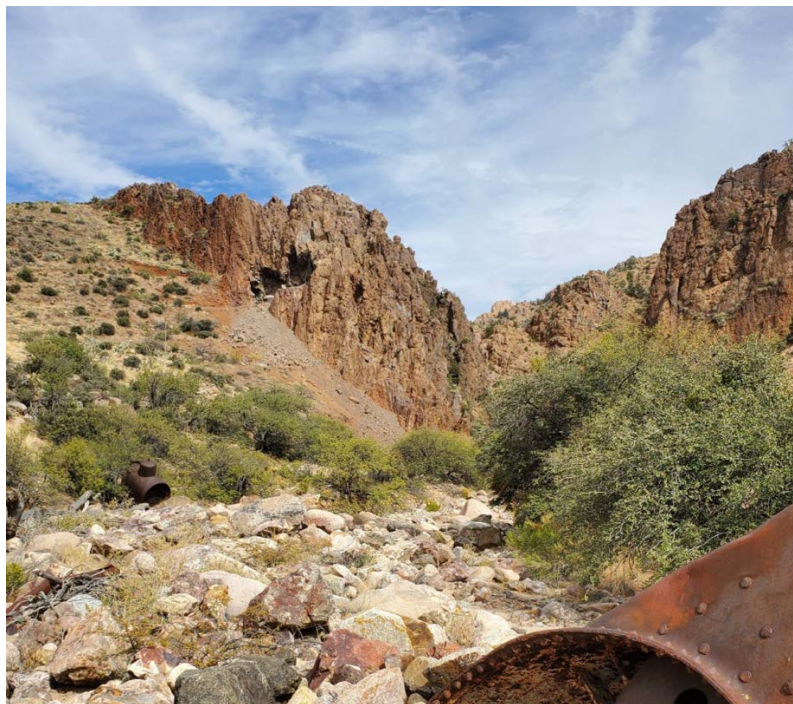
Figure 1: Photograph of the remains of Grand Reef Mine as seen from Laurel Wash.

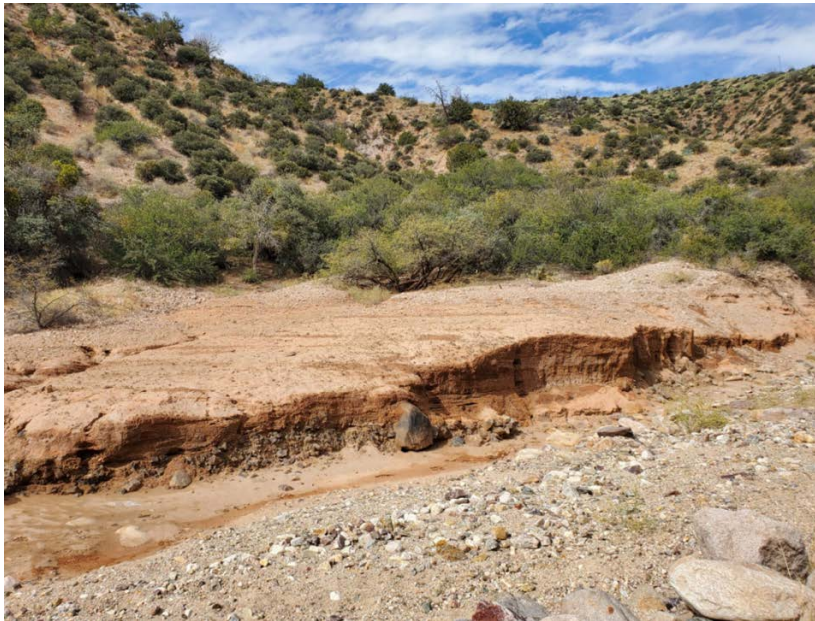
Figure 2: View of Grand Reef tailings within Laurel Wash on Arizona State Trust Land.

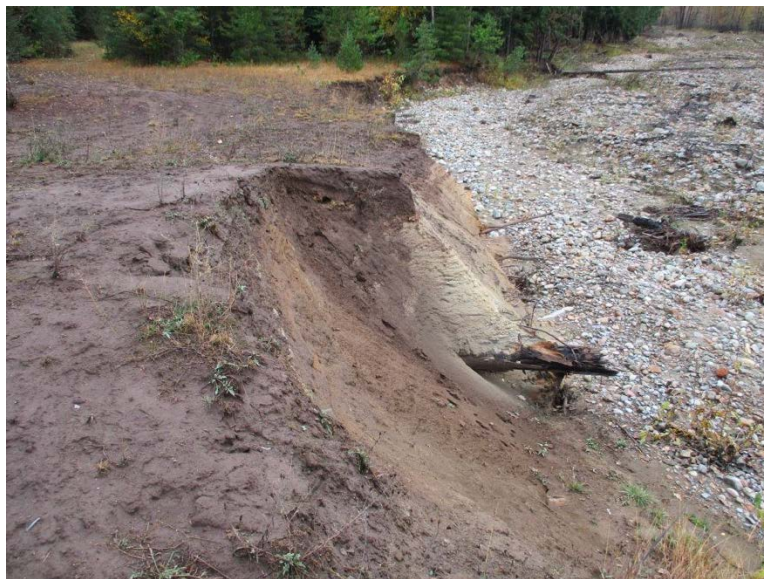
Figure 2: Cut bank where tailings erode into Lightning Creek (IDEQ, 2016).

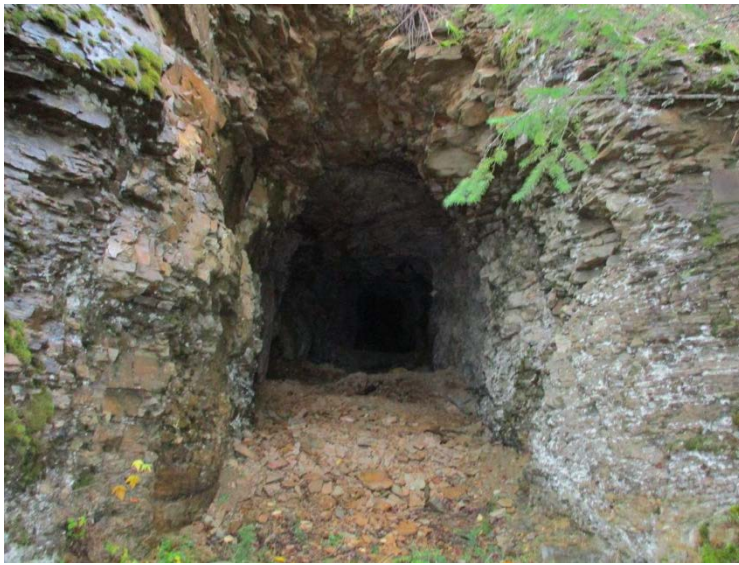
Figure 3: Photograph of Adit #1 opening (IDEQ, 2016)

Hope Mine has eight adits. Adit #1 is 300 ft north of the mill (Figure 3). The road leading from Adit #1 to the mill site is built from a waste pile (which exceeded RSLs). Adits #2-8 are approximately 1000 ft northeast of the mill and tailings pile in a forested area. In the 2016 PA/SI, these adits were found to be mostly dry, except for Adit #3 and 4. Standing water in Adits #3 and #4 did not flow into surface water or contact waste piles.

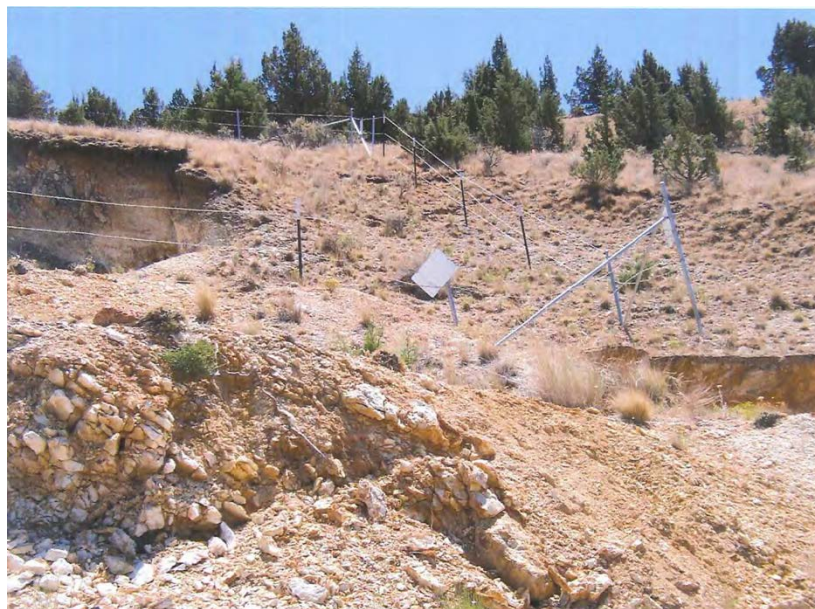
Figure 1: Photograph of a glory hole on-site (SGI, 2008a).

The site has numerous tailings and waste rock piles, as well as glory holes, adits, a furnace and other structures. A 2004 Ecological and Human Health Risk Assessment (HHRA) for the Oregon Department of Environmental Quality (ODEQ) surveyed soil samples from various locations on Horse Heaven Mine. The HHRA found the largest (calcine) tailings pile contained 19,300 mg/kg sulfate and up to the following metal concentrations: 120 mg/kg mercury (Hg), 72.3 mg/kg zinc (Zn), 32 mg/kg copper (Cu), 27.6 mg/kg nickel (Ni), 20.2 mg/kg chromium (Cr), and 9.9 mg/kg arsenic (As). The characteristics of the upper and southern tailings piles were similar, with the highest concentration of Hg followed by lower but present concentrations of Zn, Cu, Ni, Cr and As. The D-tube furnace, located in a sparsely vegetated area between the calcine and upper tailings piles, presented some of the highest heavy metal concentrations. This location recorded up to 2,740 mg/kg Hg, 375 mg/kg Cu, 267 mg/kg Zn, 109 mg/kg Ni, 104 mg/kg Cr, 65.6 mg/kg As, and 27.8 mg/kg As.

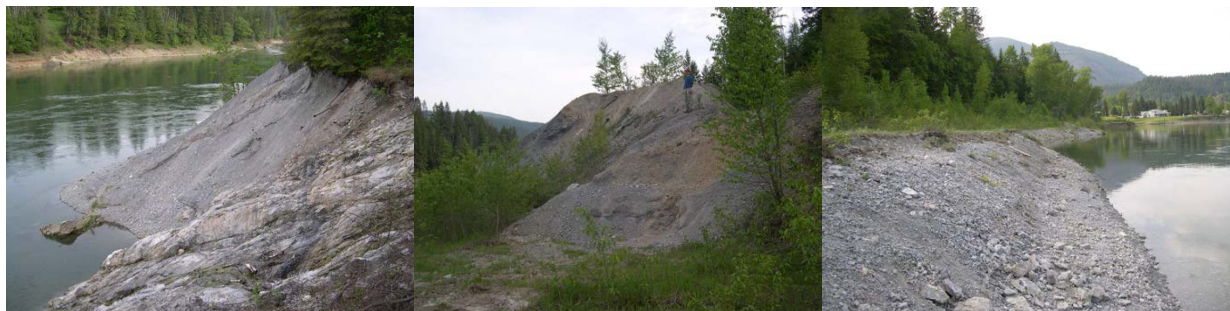
Figure 2a (left): Photograph of Waste Rock Pile #1 facing south.

Figure 2b (middle): Photograph of Waste Rock Pile #2 facing south.

Five waste rock piles of various sizes are located on-site. Waste Rock Piles #1, #2, and #3 (1,250 yd<sup>3</sup>; 3,150 yd<sup>3</sup> and 24,250 yd<sup>3</sup> respectively) sit adjacent to Pend Oreille River (Figure 2a-c). Waste rock pile #4 (6,670 yd<sup>3</sup>) is not along the river but extends from Waste Rock Piles #2 and #3. Waste Rock Pile #5 is the smallest of the five (3 yd<sup>3</sup>) and sits between the upper and lower access road entrances. While no active seepage from the waste rock piles were observed during a 2007 site visit, Waste Rock Piles #1-#4 showed evidence of surface water runoff east towards Pend Oreille River. The 2007 Initial Investigation Report (IIR) found concerning levels of heavy metals in the waste rock piles on Metaline Mine. Soil

samples from Waste Rock Piles #1-#4 revealed arsenic (As) concentrations as high as 31.6 mg/kg, Cd as high as 32.7 mg/kg, Pb as high as 1970 mg/kg; all exceeded the Model Toxics Control Act (MTCA) Method A criteria (Hart Crowser, 2007). The ecological protection criteria were also in exceedance for Zn of up to 8440 mg/kg, nickel (Ni) of up to 46.5 mg/kg and mercury (Hg) of up to 1.76 mg/kg.

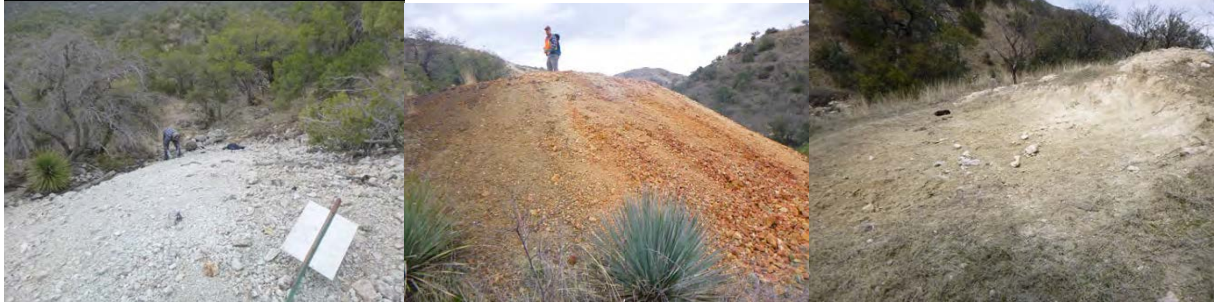
Figure 2a: Photograph of waste rock pile at Walker Mine (left), Double Header Mine (middle), and mill tailings at St. Louis Mine (right) (ECM, 2023).

The waste rock and tailing piles (Figure 2) at all seven mines could be considered for reprocessing, particularly for Cu, Pb, and Zn. The 2023 PA/SI reported elevated concentrations of Cu (up to 21,900 mg/kg), Pb (up to 107,000 mg/kg), and Zn (up to 8,000 mg/kg) across the sites. Additionally, As (up to 1,870 mg/kg), Ba (up to 3,230 mg/kg), Sb (up to 1,550 mg/kg), Ag (up to 403 mg/kg), Cd (up to 75.3 mg/kg), Hg (up to 50.5 mg/kg) exceeded Environmental Protection Agency (EPA) Ecological Soil Screening Levels (Eco-SSLs). Further sampling would need to be conducted to identify the volume of material and distribution of minerals and metals, including critical minerals.
