BULLETIN NUMBER: SB-0019

SUBJECT: Washing Sensitive Areas

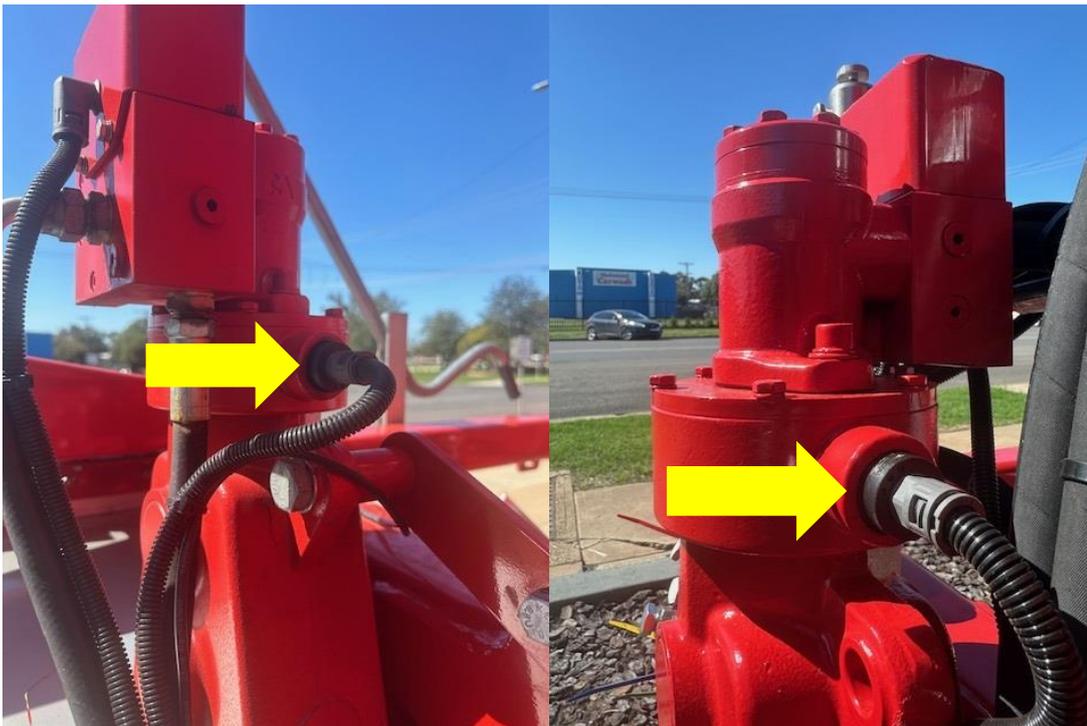
The Gearbox sensor has 2 O-rings and sealing grease around it. Please be aware if the sensor or area close to has high pressure water directed at it or around this can lead to water leaking inside leading to possible degradation of internal components.

This is an information Bulletin advising the need to be careful when washing and cleaning machines.
