CASE STUDY: Finding Seepage Paths in a Dam - Australia

# DAM SEEPAGE INVESTIGATION TO FIND NINE SEEPAGE PATHS ALONG LEAKING DAM

Willowstick LLC

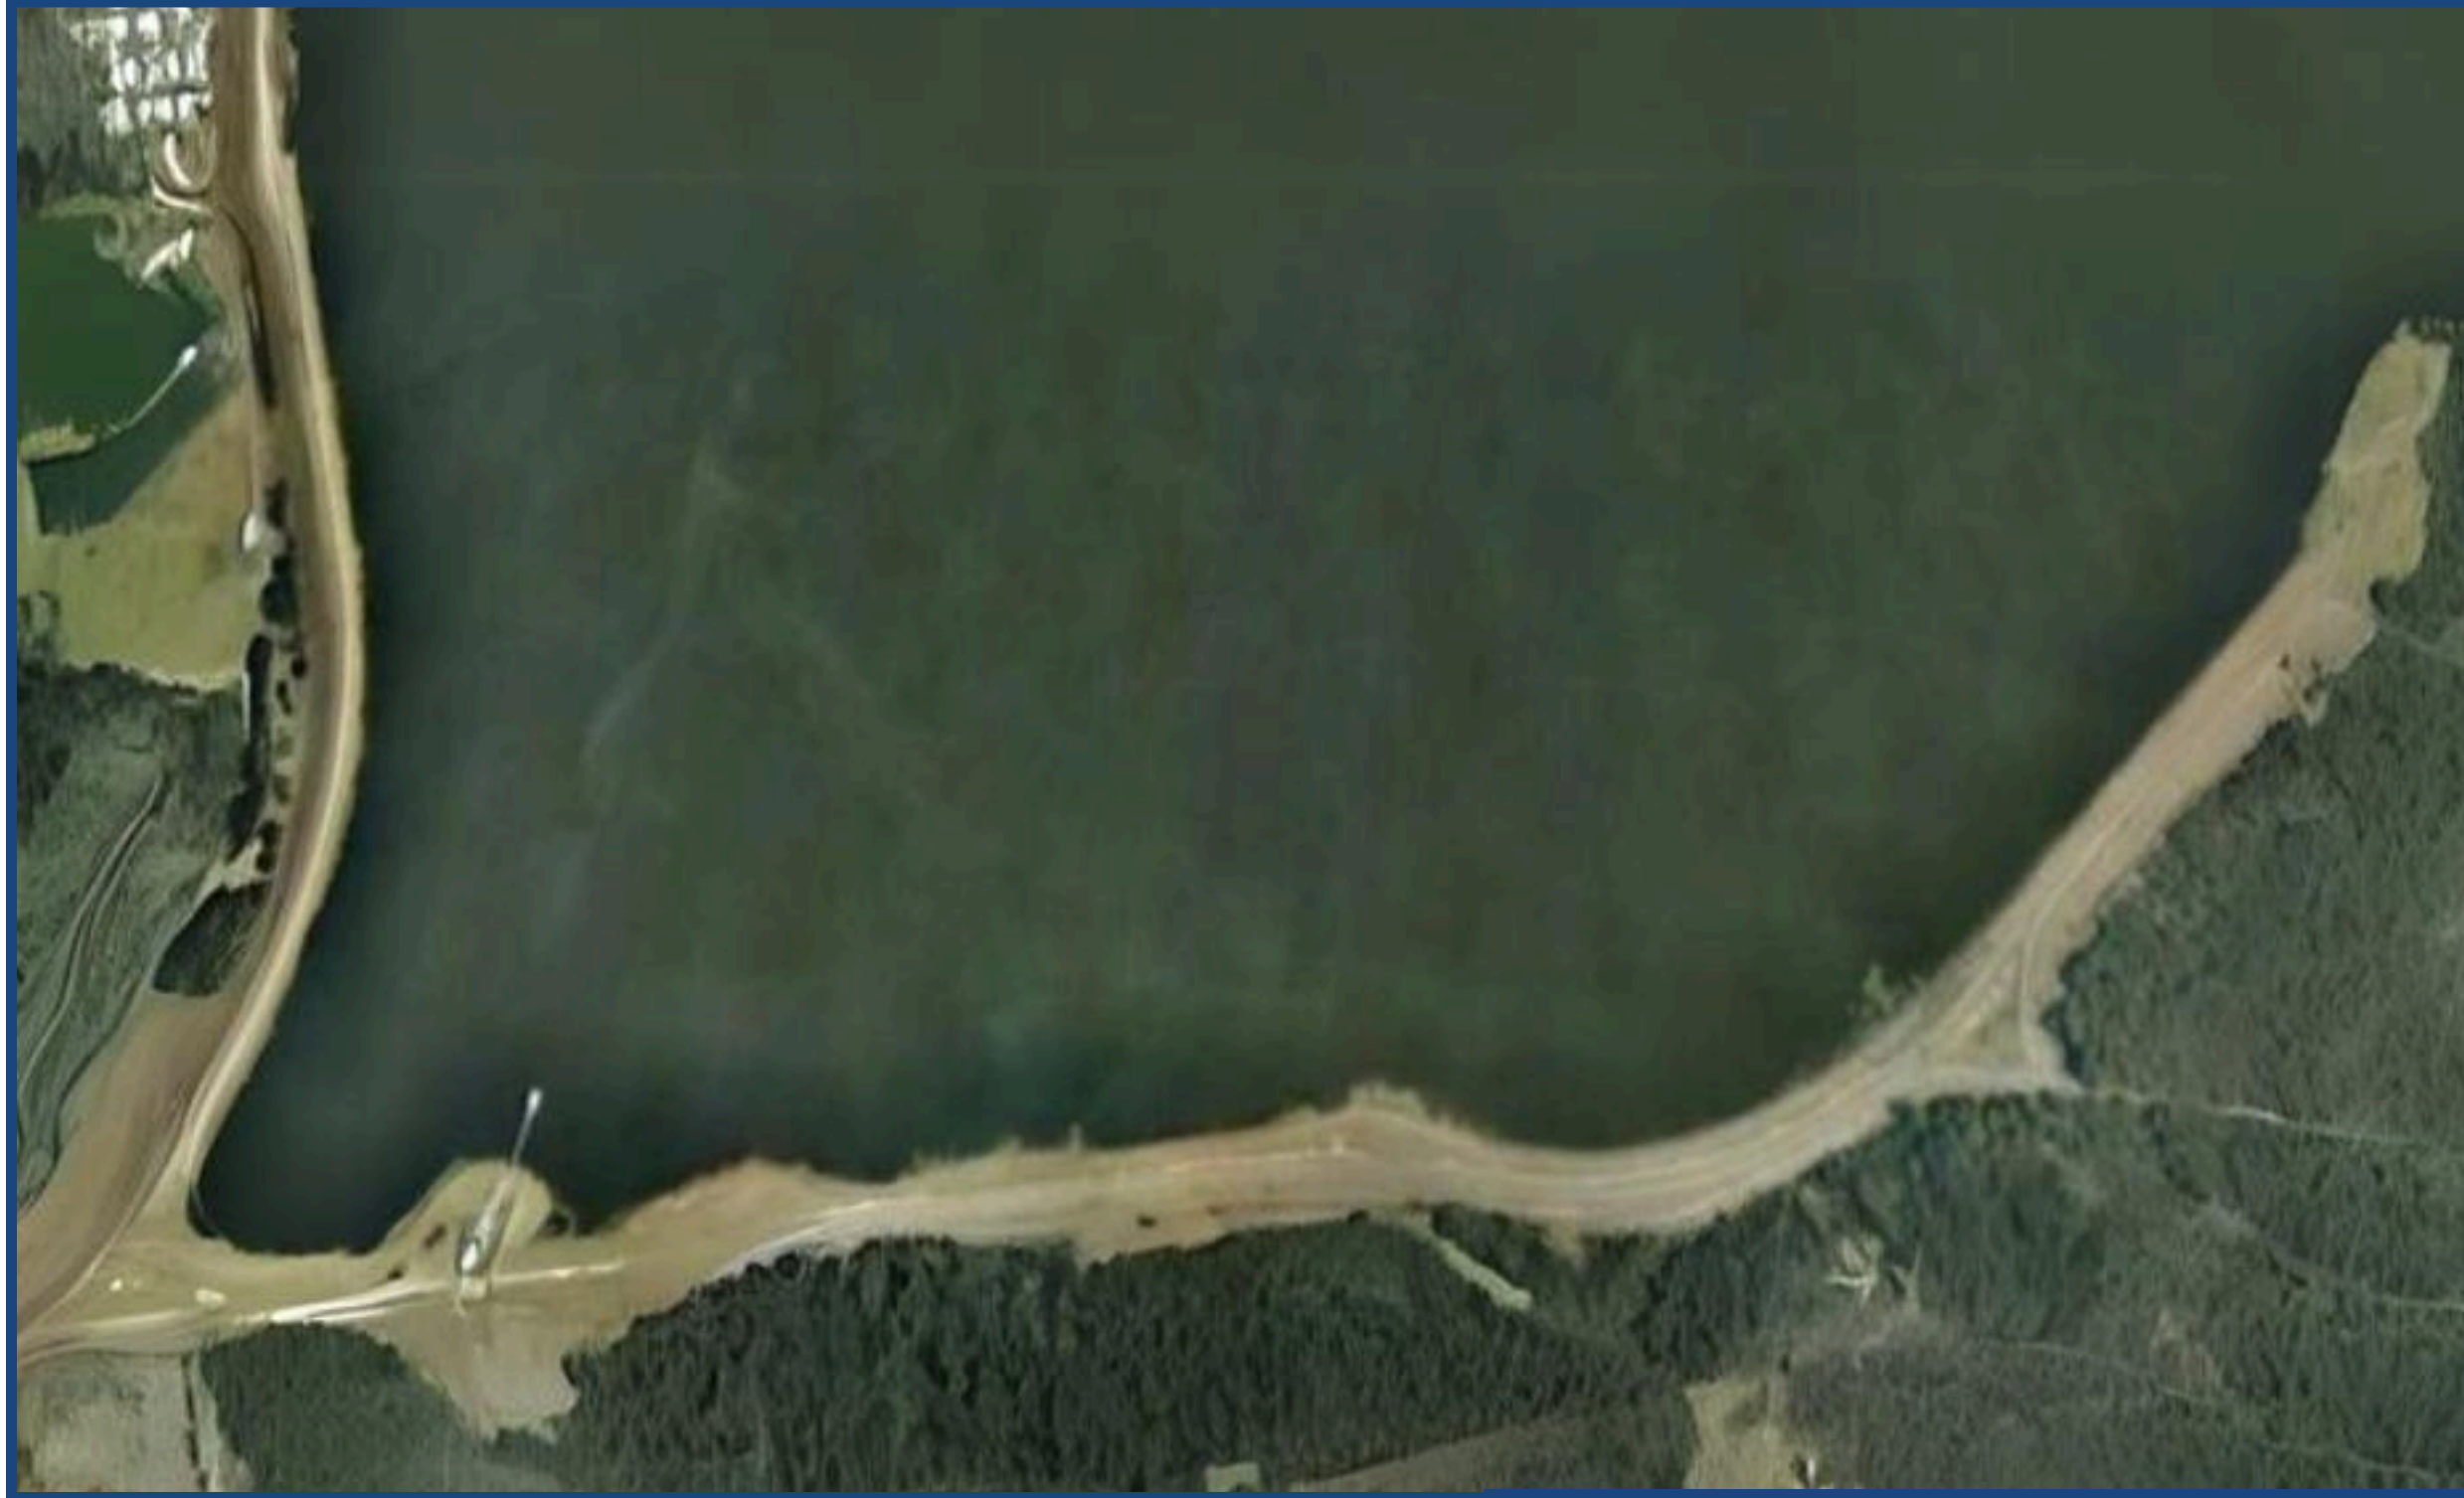
Location of Job Site and Survey
