# IDENTIFIES SEVERAL POTENTIAL LEAKS ALONG A 4KM HEADRACE TUNNEL IN CENTRAL AMERICA

Willowstick LLC

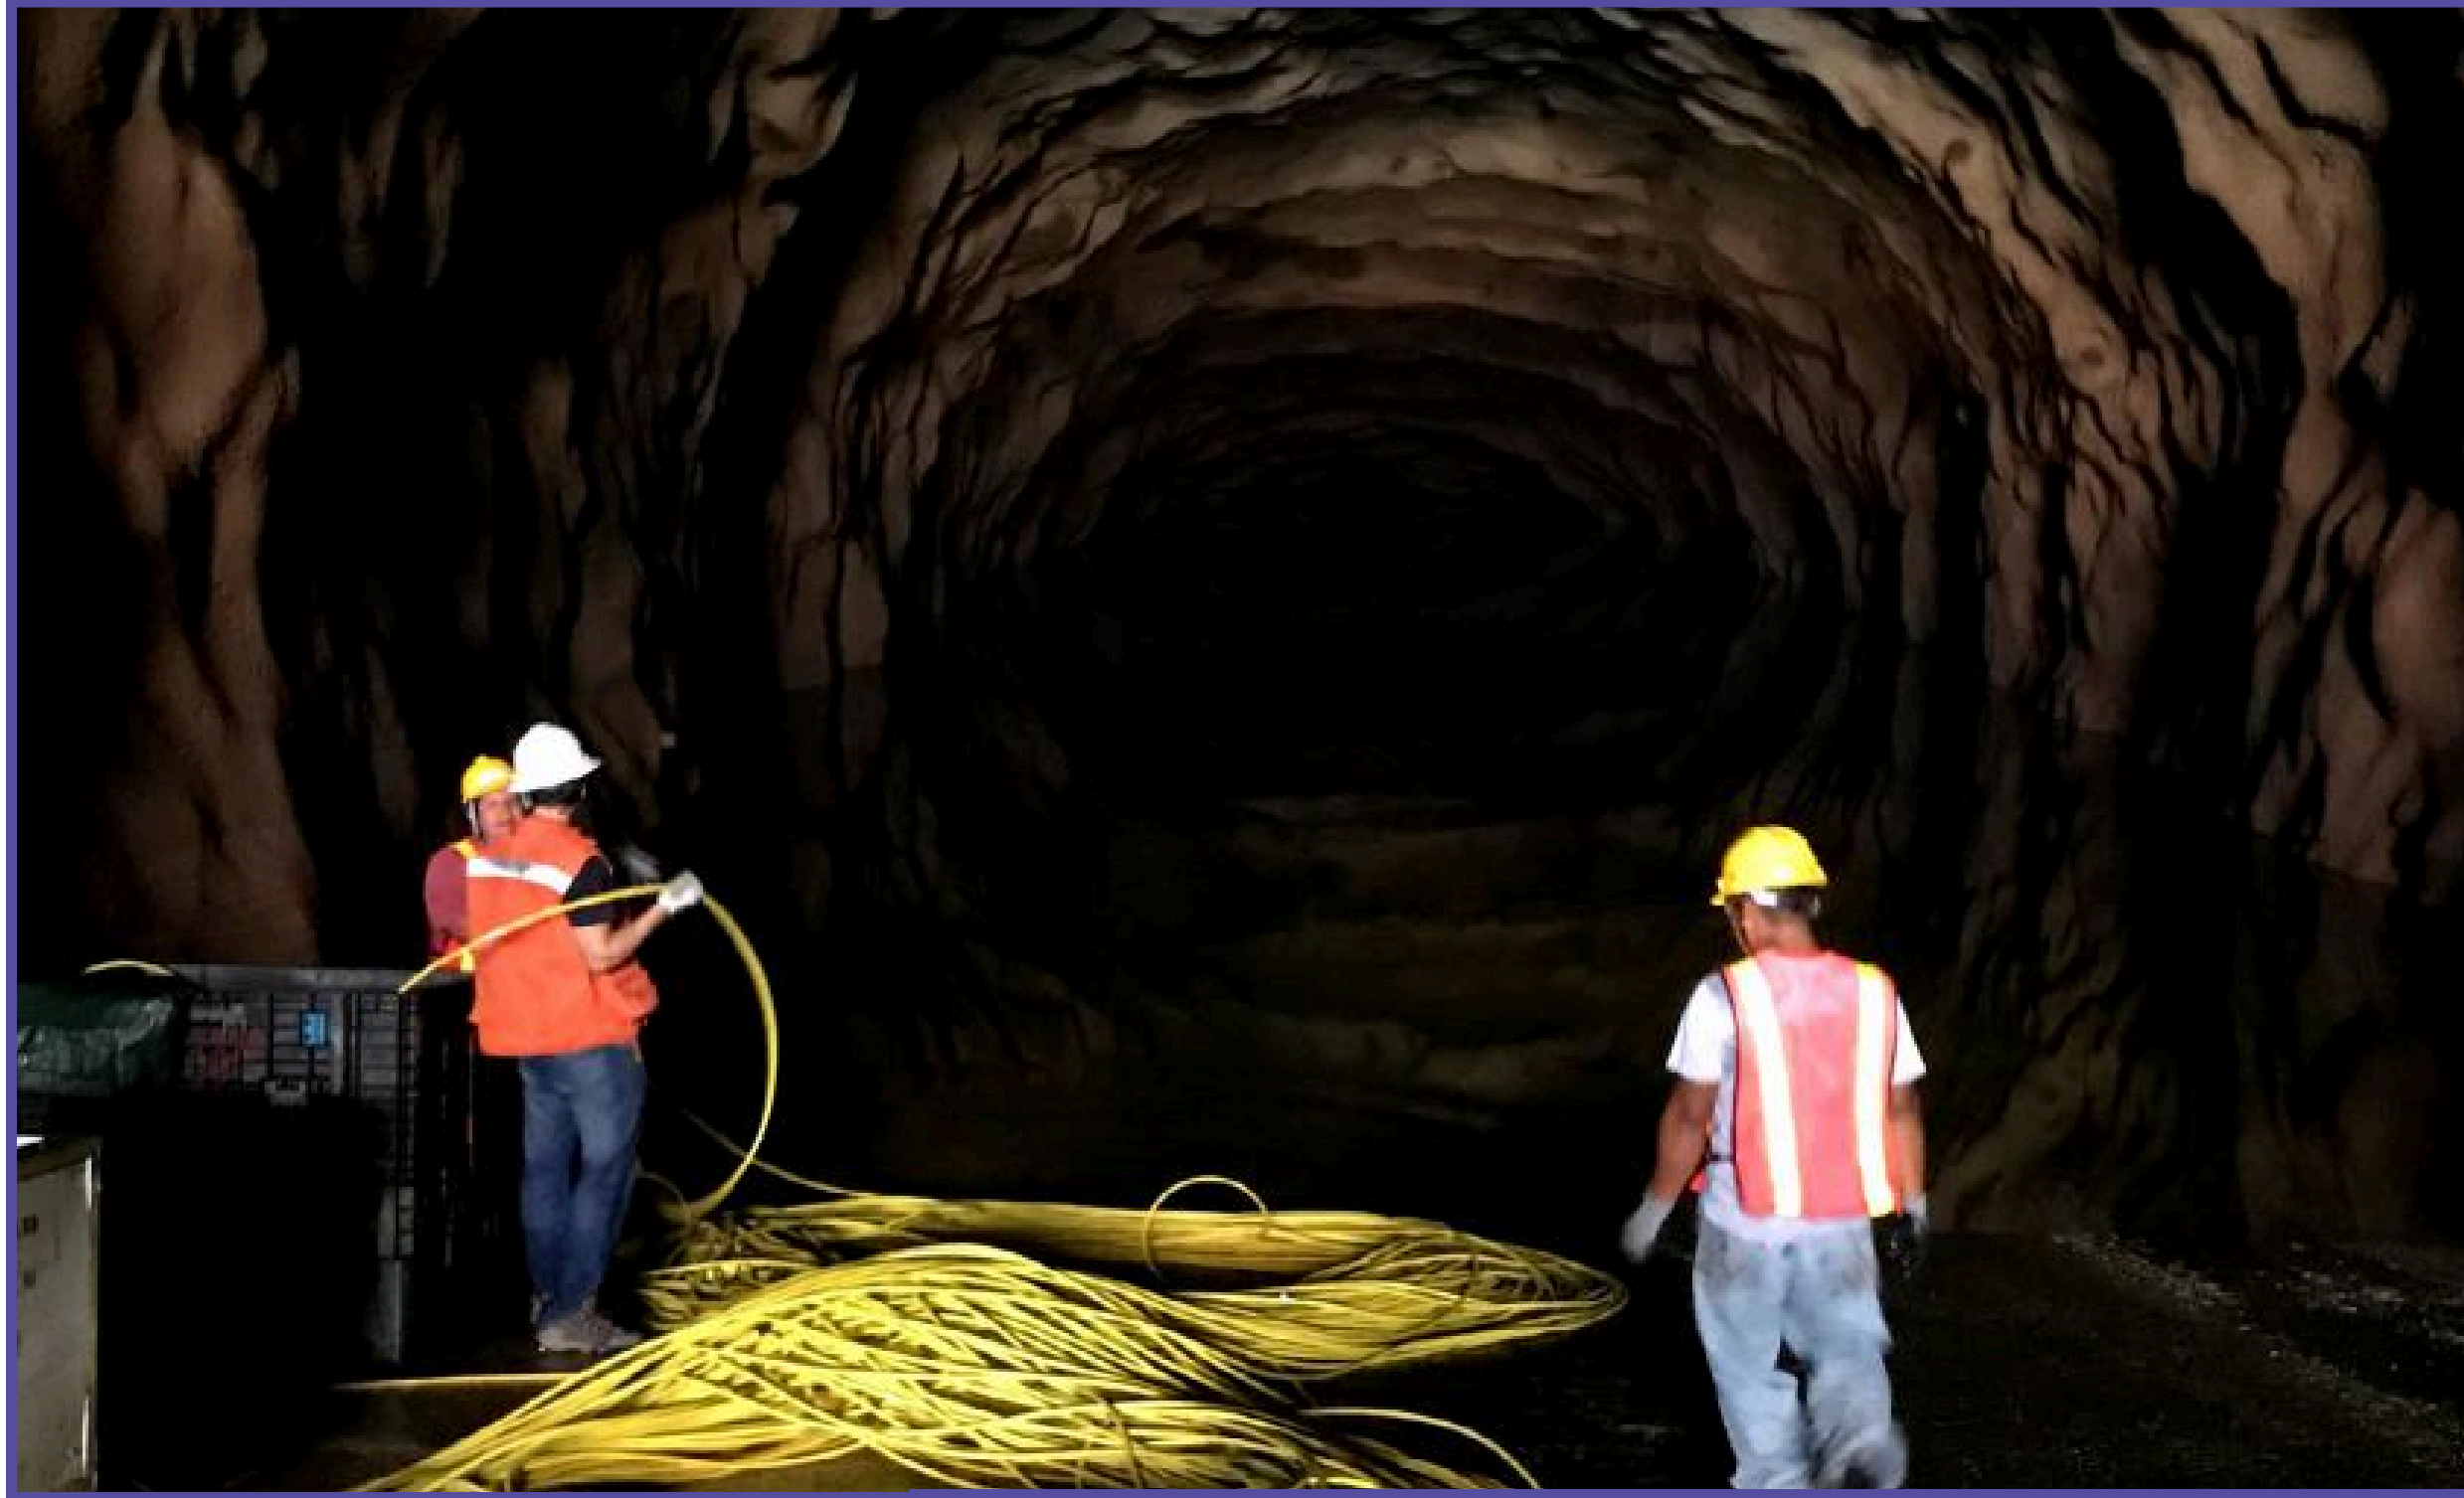
The tunnel where tests and studies were conducted
